# Bassett Creek Main Stem Stabilization Project

## Minneapolis, Minnesota

FINAL REPORT  
February 2022

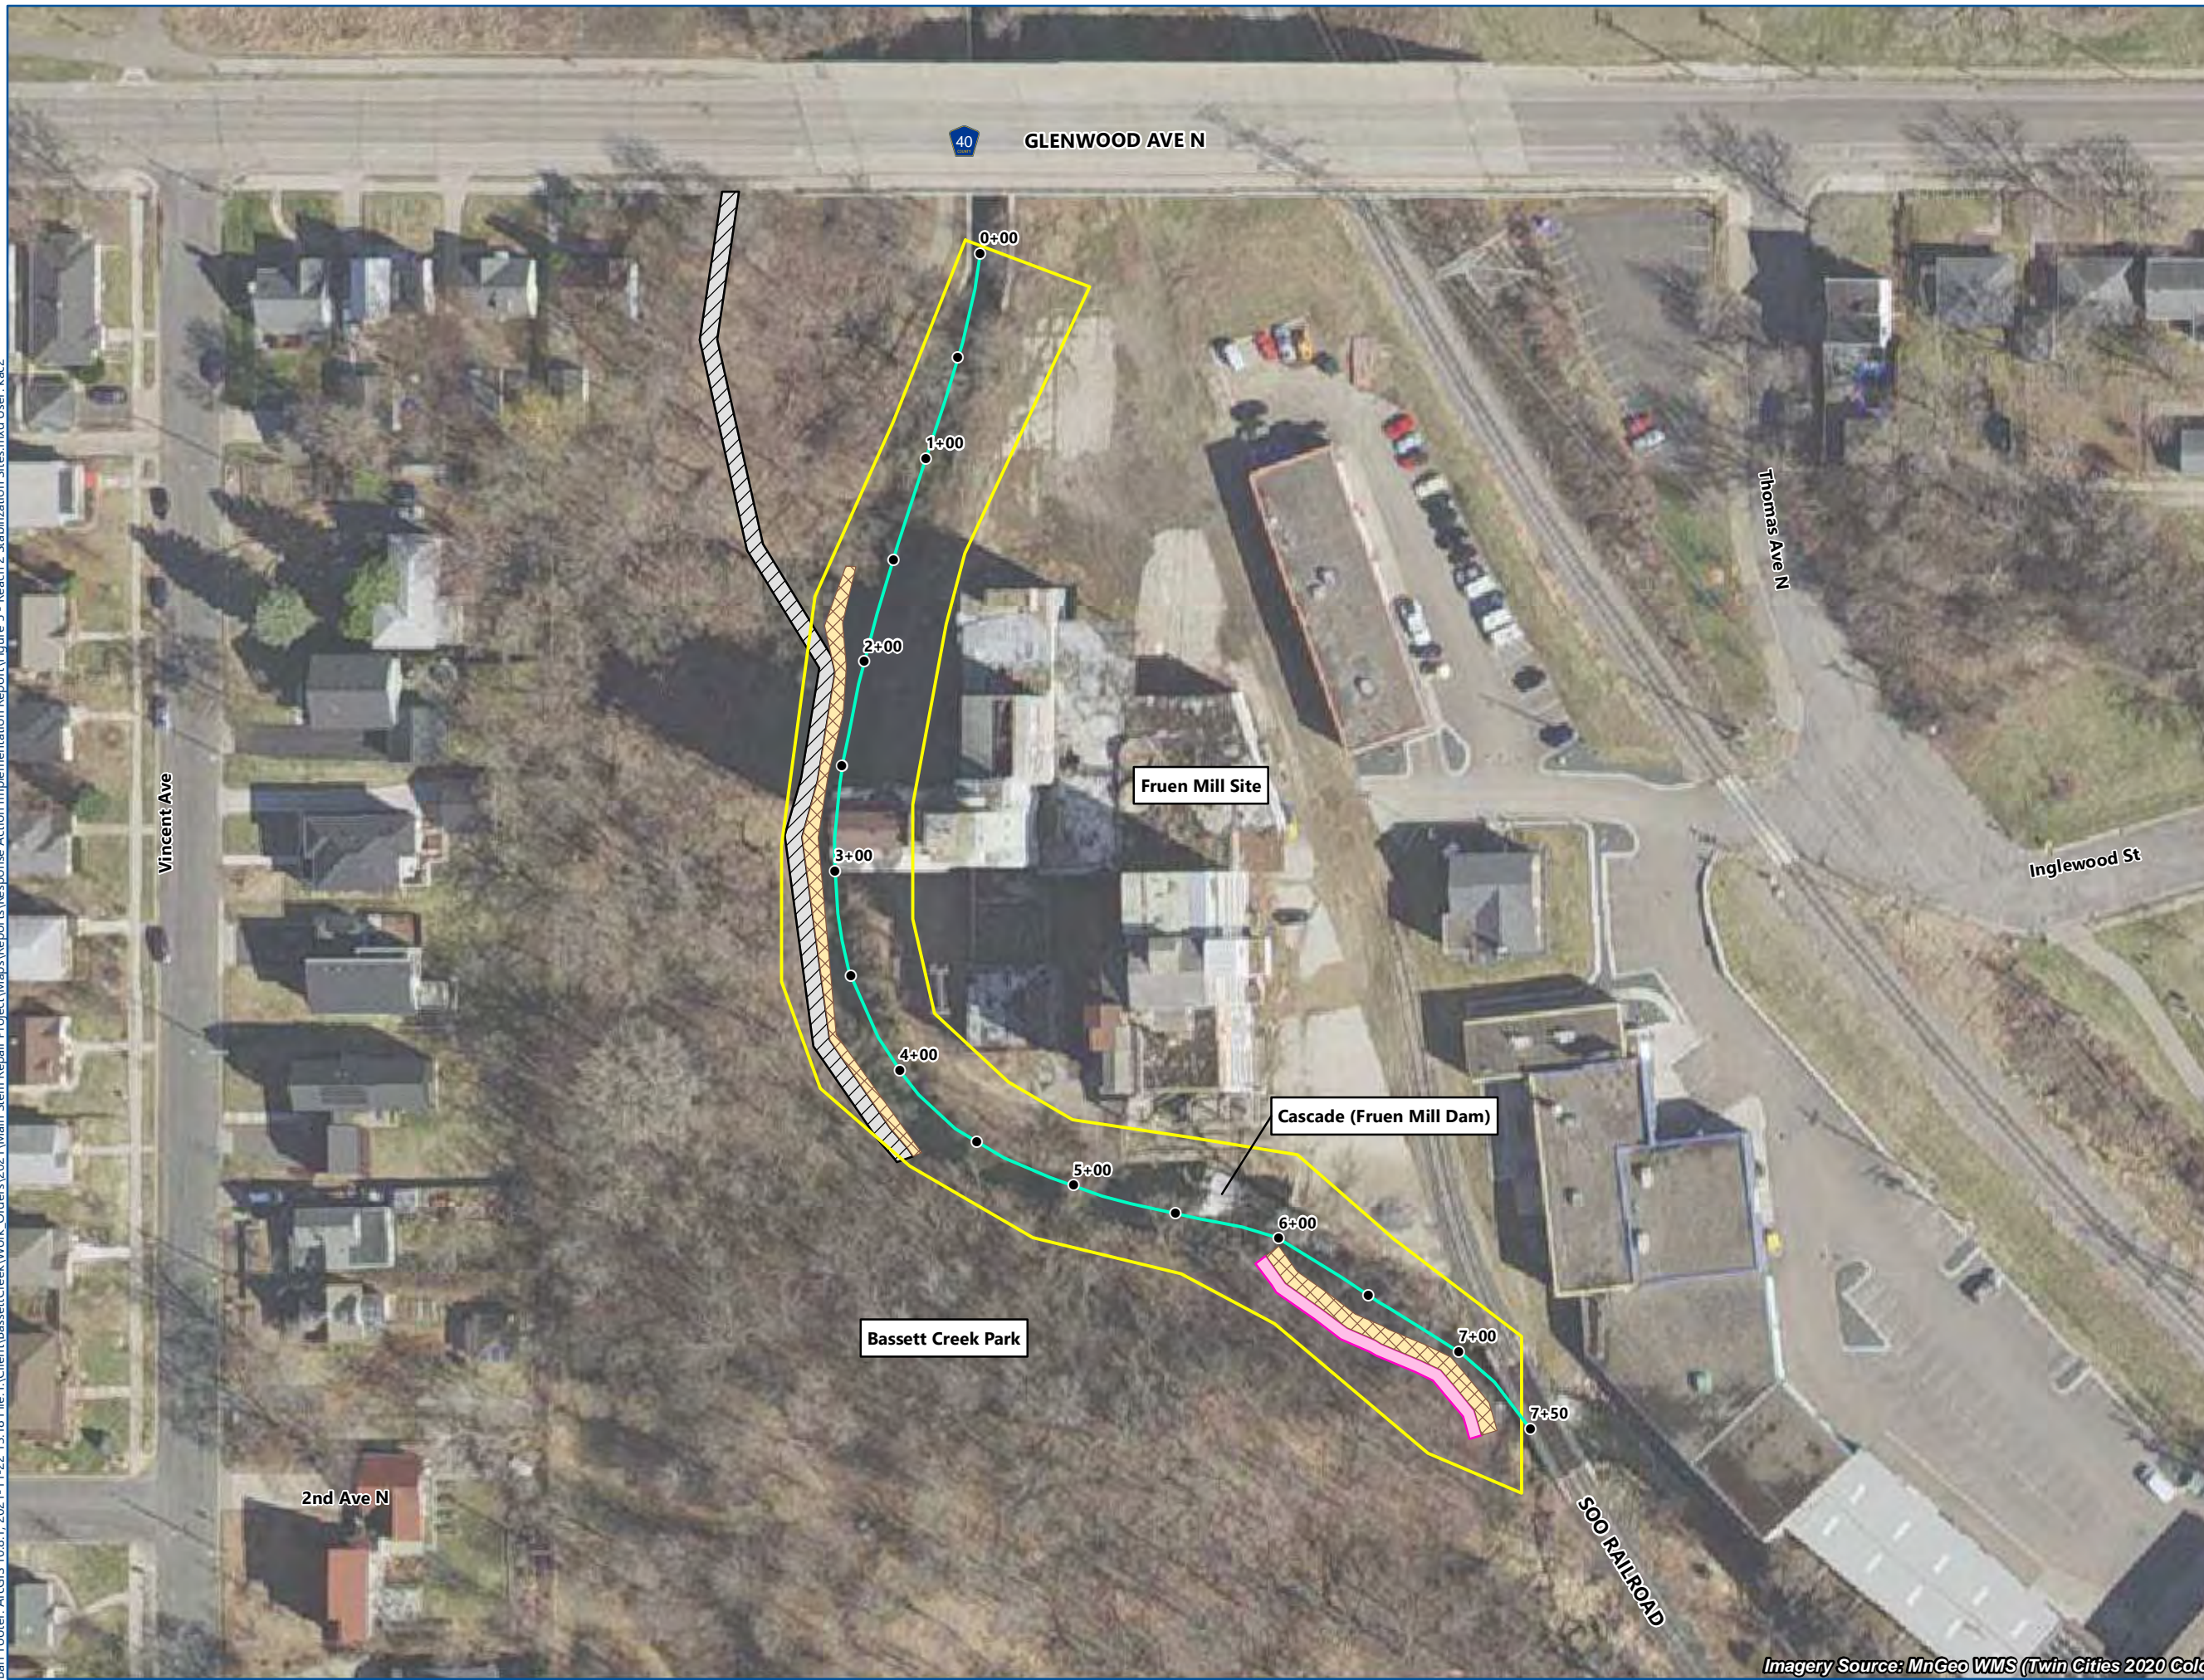
FIGURE 4

REACH 2 STABILIZATION SITES  
 Bassett Creek Main Stem Erosion  
 Repair Project  
 Minneapolis, Minnesota

At Reach 2, approximately 485 feet of the existing walking trail was improved using a 4-inch thick MnDOT class 5 aggregate (Figure 4). Sunram installed 417 feet of riprap to stabilize the toe of the stream bank below the walking trail and the VRSS. The riprap along the walking path was installed around the historic walls currently present, ensuring that no impacts were made to these structures. Sunram installed 141 feet of VRSS on the downstream portion of the Reach 2 project area. Additional VRSS was added to accommodate the contour of the existing slope and the creek's meander. The VRSS and riprap installed at the downstream portion of Reach 2 were designed to protect the toe of the exposed high bank and minimize further erosion caused by the creek flow; the high bank itself was not graded in order to minimize disturbance at the top of the bank and is anticipated to gradually vegetate over time.
