Bassett Creek Main Stem Stabilization Project

Minneapolis, Minnesota

FINAL REPORT
February 2022

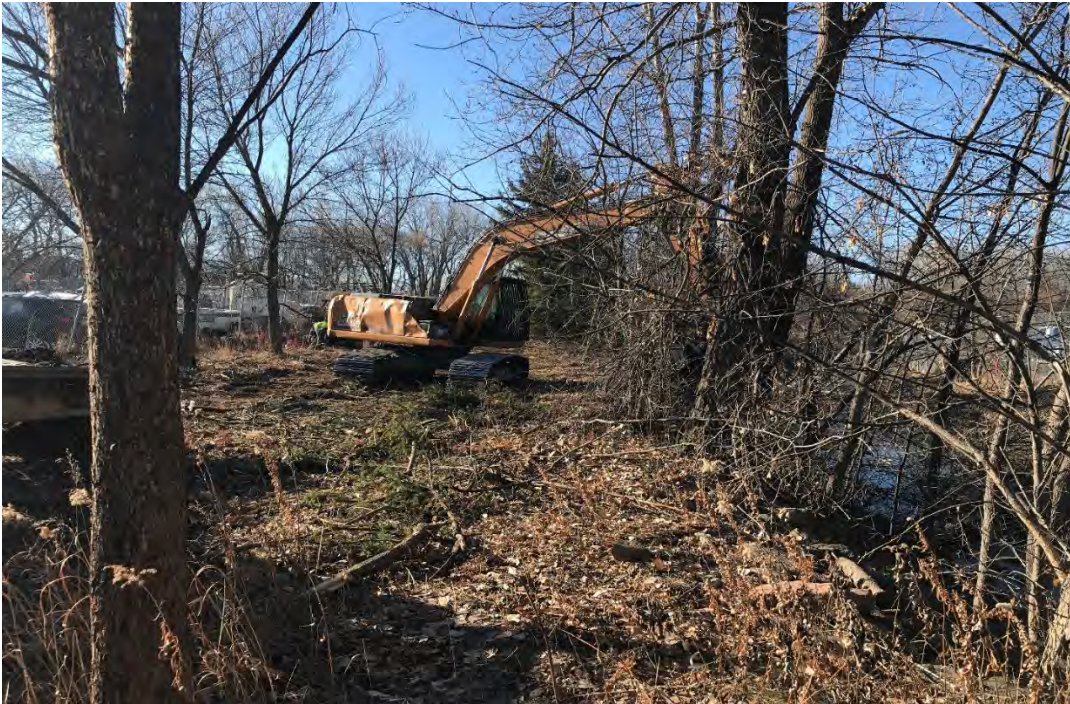
Reach 1: Tree and shrub clearing along the southern bank upstream of the Irving Ave. footbridge (12/1/2020)

Prior to construction activities, trees and debris were removed along the southern bank approximately 800 feet upstream and 200 feet downstream of the Irving Avenue footbridge. Targeted tree removal was required in areas along the banks where interference with equipment was anticipated. Approximately 850 feet of chain linked fence was removed from the northern bank between the channel and Pioneer Paper and was replaced following tree clearing. Approximately 135 cubic yards of large debris and 259 tons of contaminated soils were removed from the channel and along the southern bank during the installation of boulder vanes. These quantities were reduced from the quantities estimated for the approved design plans ([90% plans, October 2017](#)) due to the modification of the design at the Pioneer Paper property and the removal of VRSS installation in Reach 1.

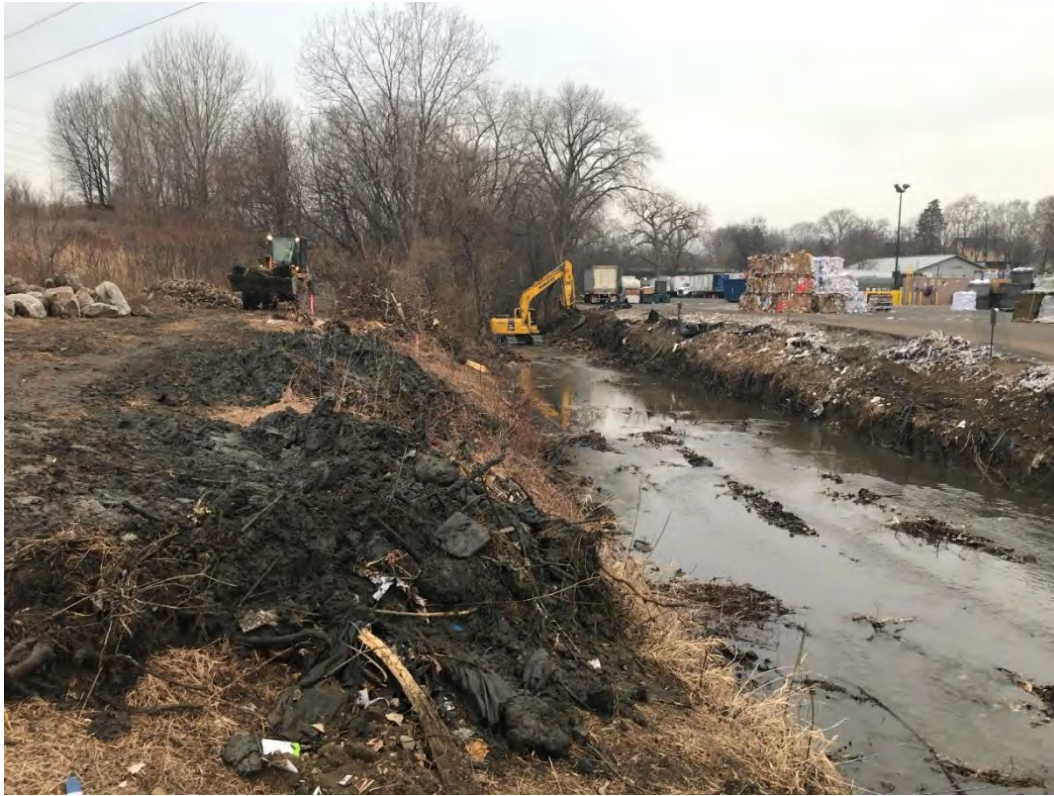
Reach 1: Removal of debris within the channel and installation of riprap (12/7/2020)

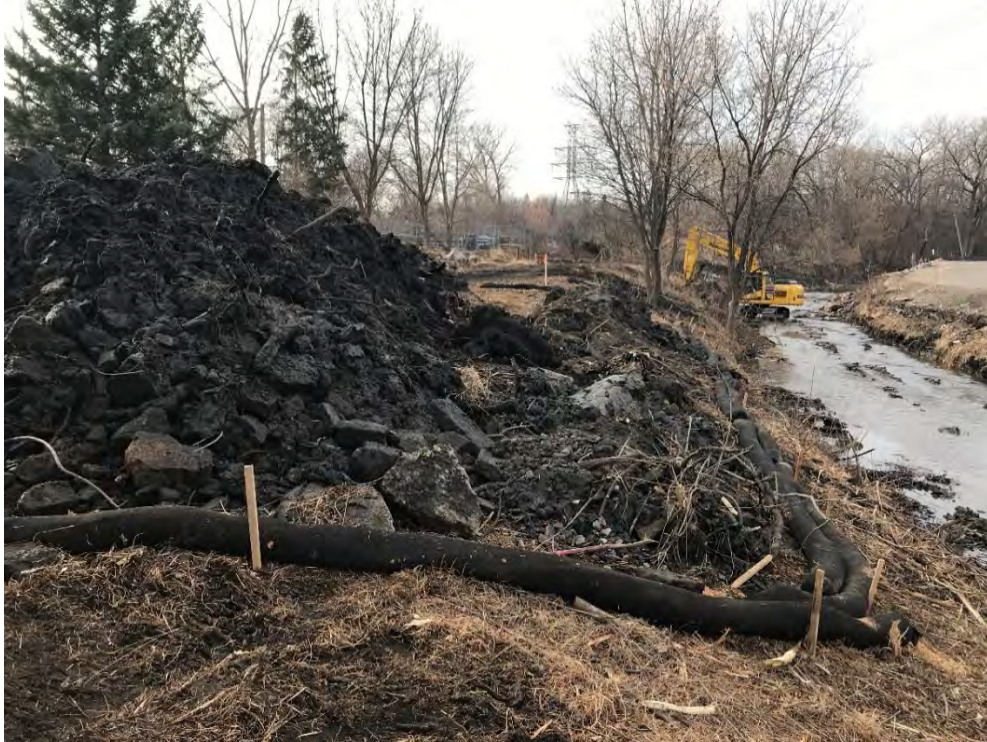
Reach 1: Stockpile of debris and contaminated soils with erosion control logs (12/8/2020)

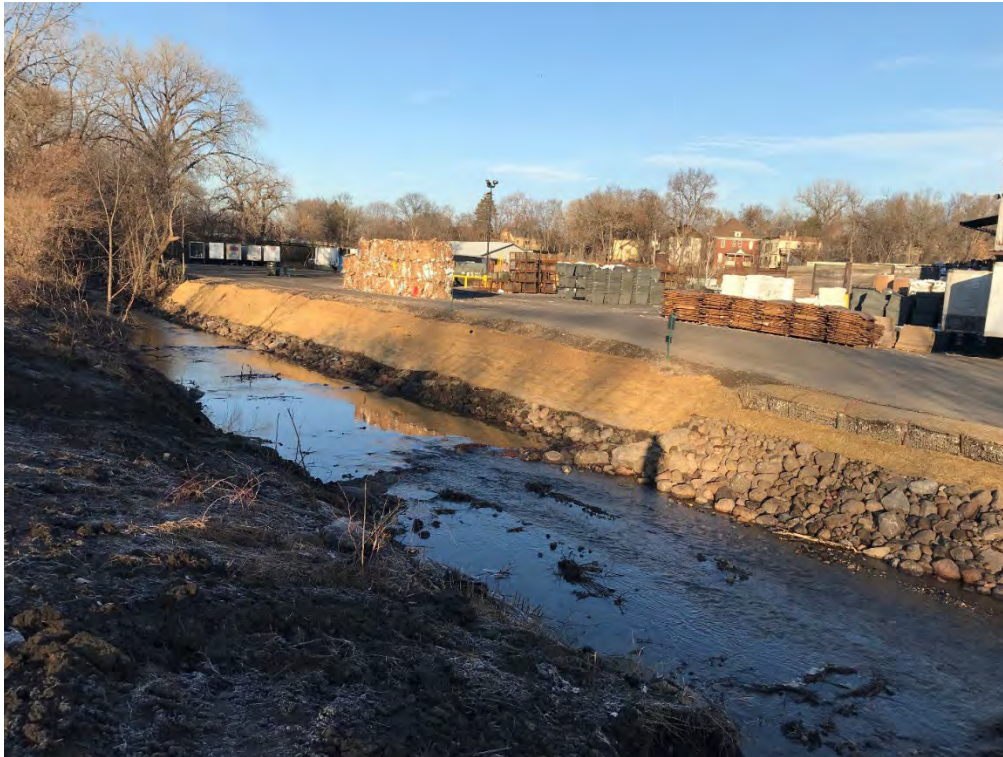
Reach 1: Installed riprap and erosion control blanket along northern bank (12/10/2020)

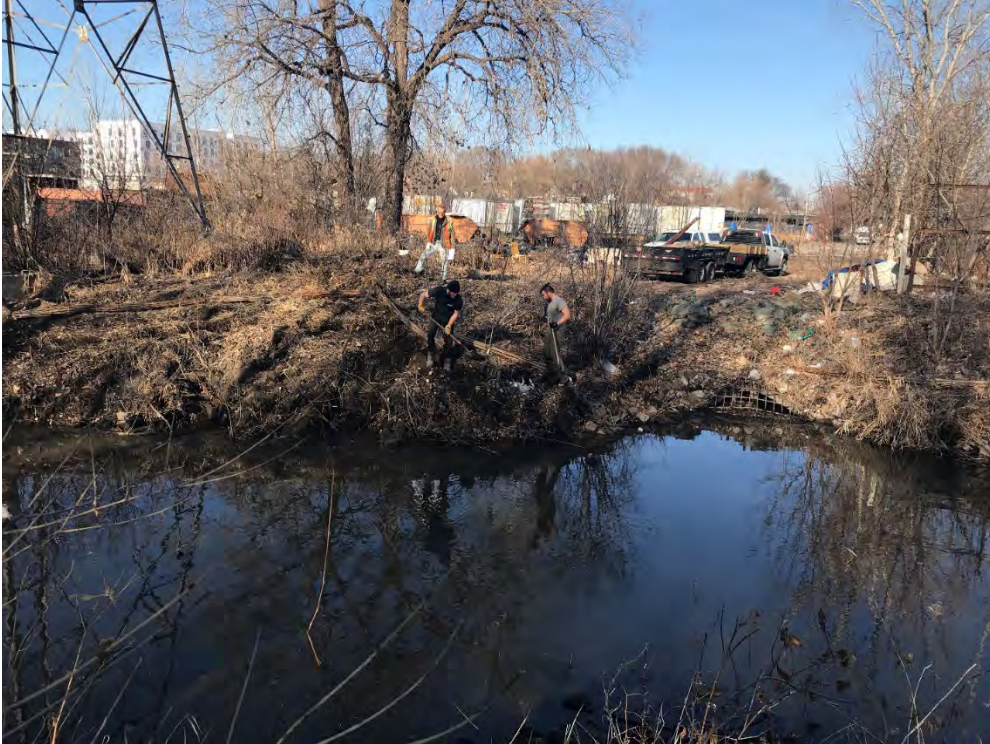
Reach 1: Landbridge Ecological installing fascines near culvert upstream of Van White Memorial Blvd. (12/10/2020)

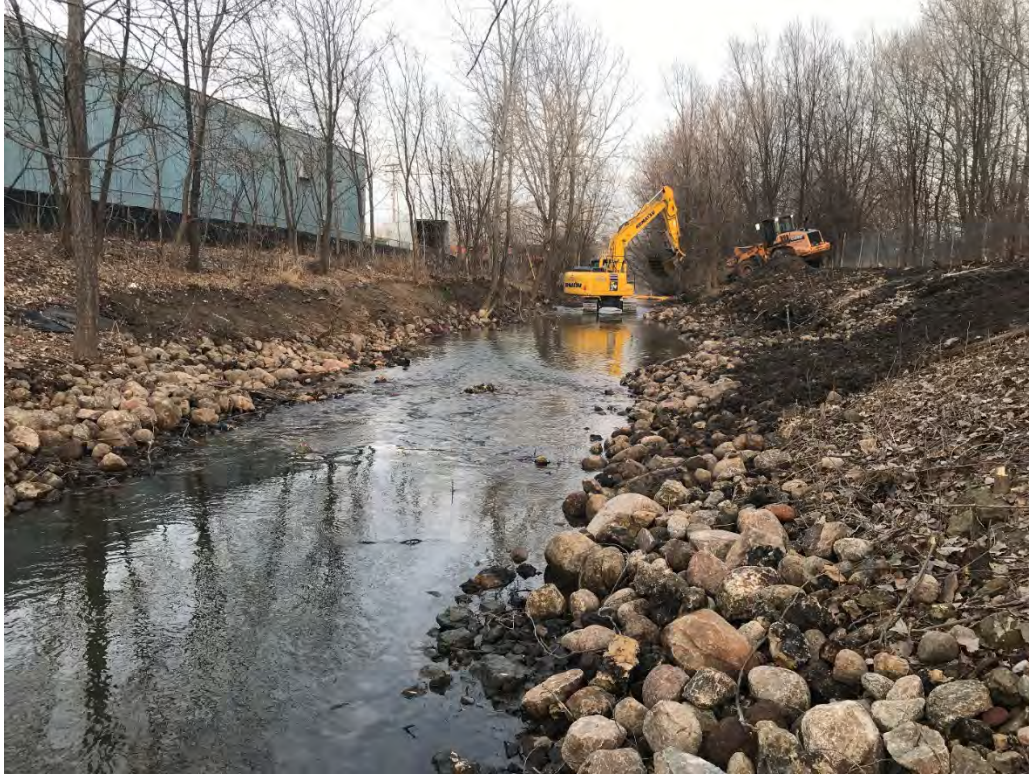
Reach 1: Installation of riprap downstream of Irving Ave. footbridge (12/10/2020)

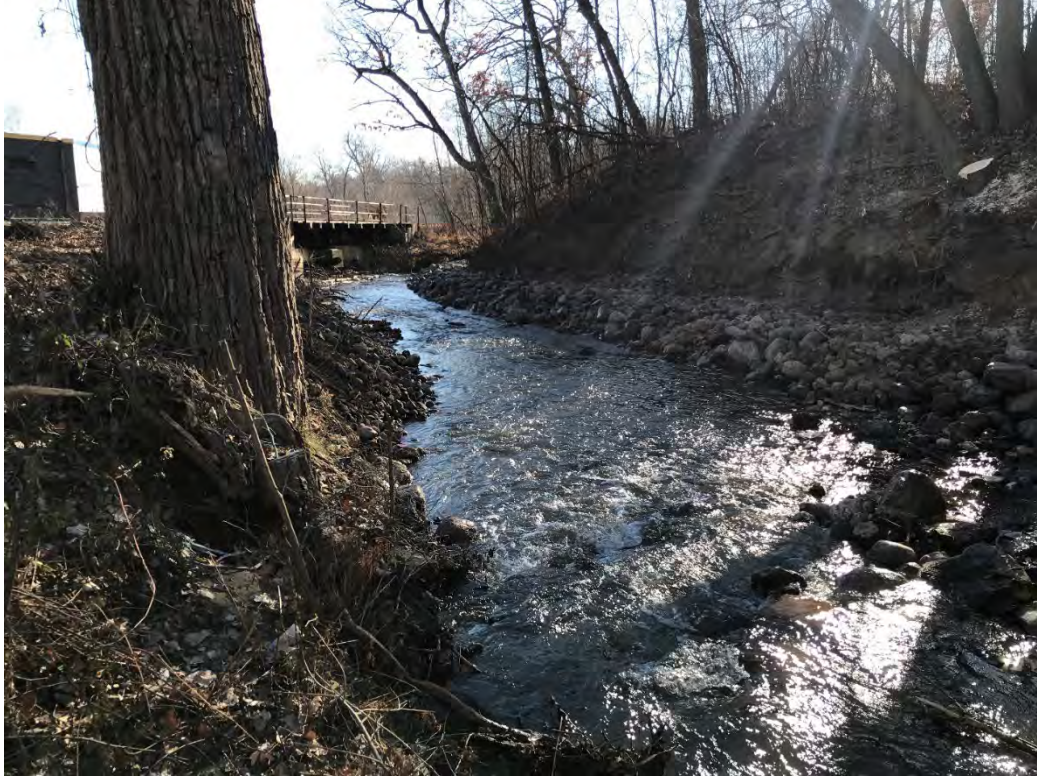
Reach 2: Installed riprap on downstream portion of the reach (12/1/2020)

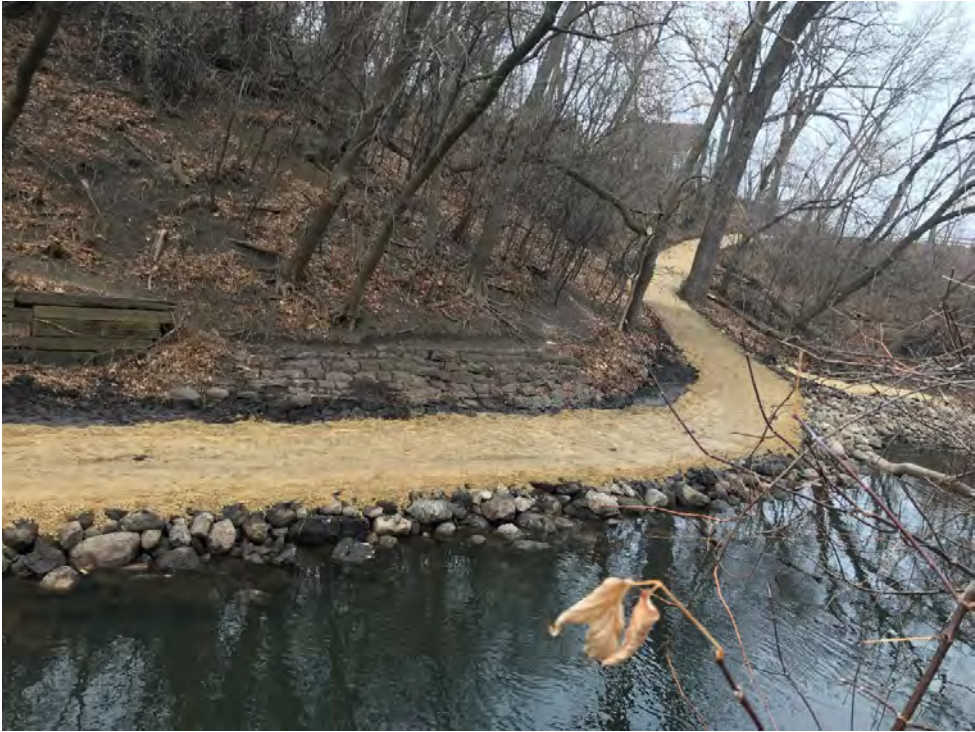
Reach 2: Installed riprap and trail improvement (12/8/2020)

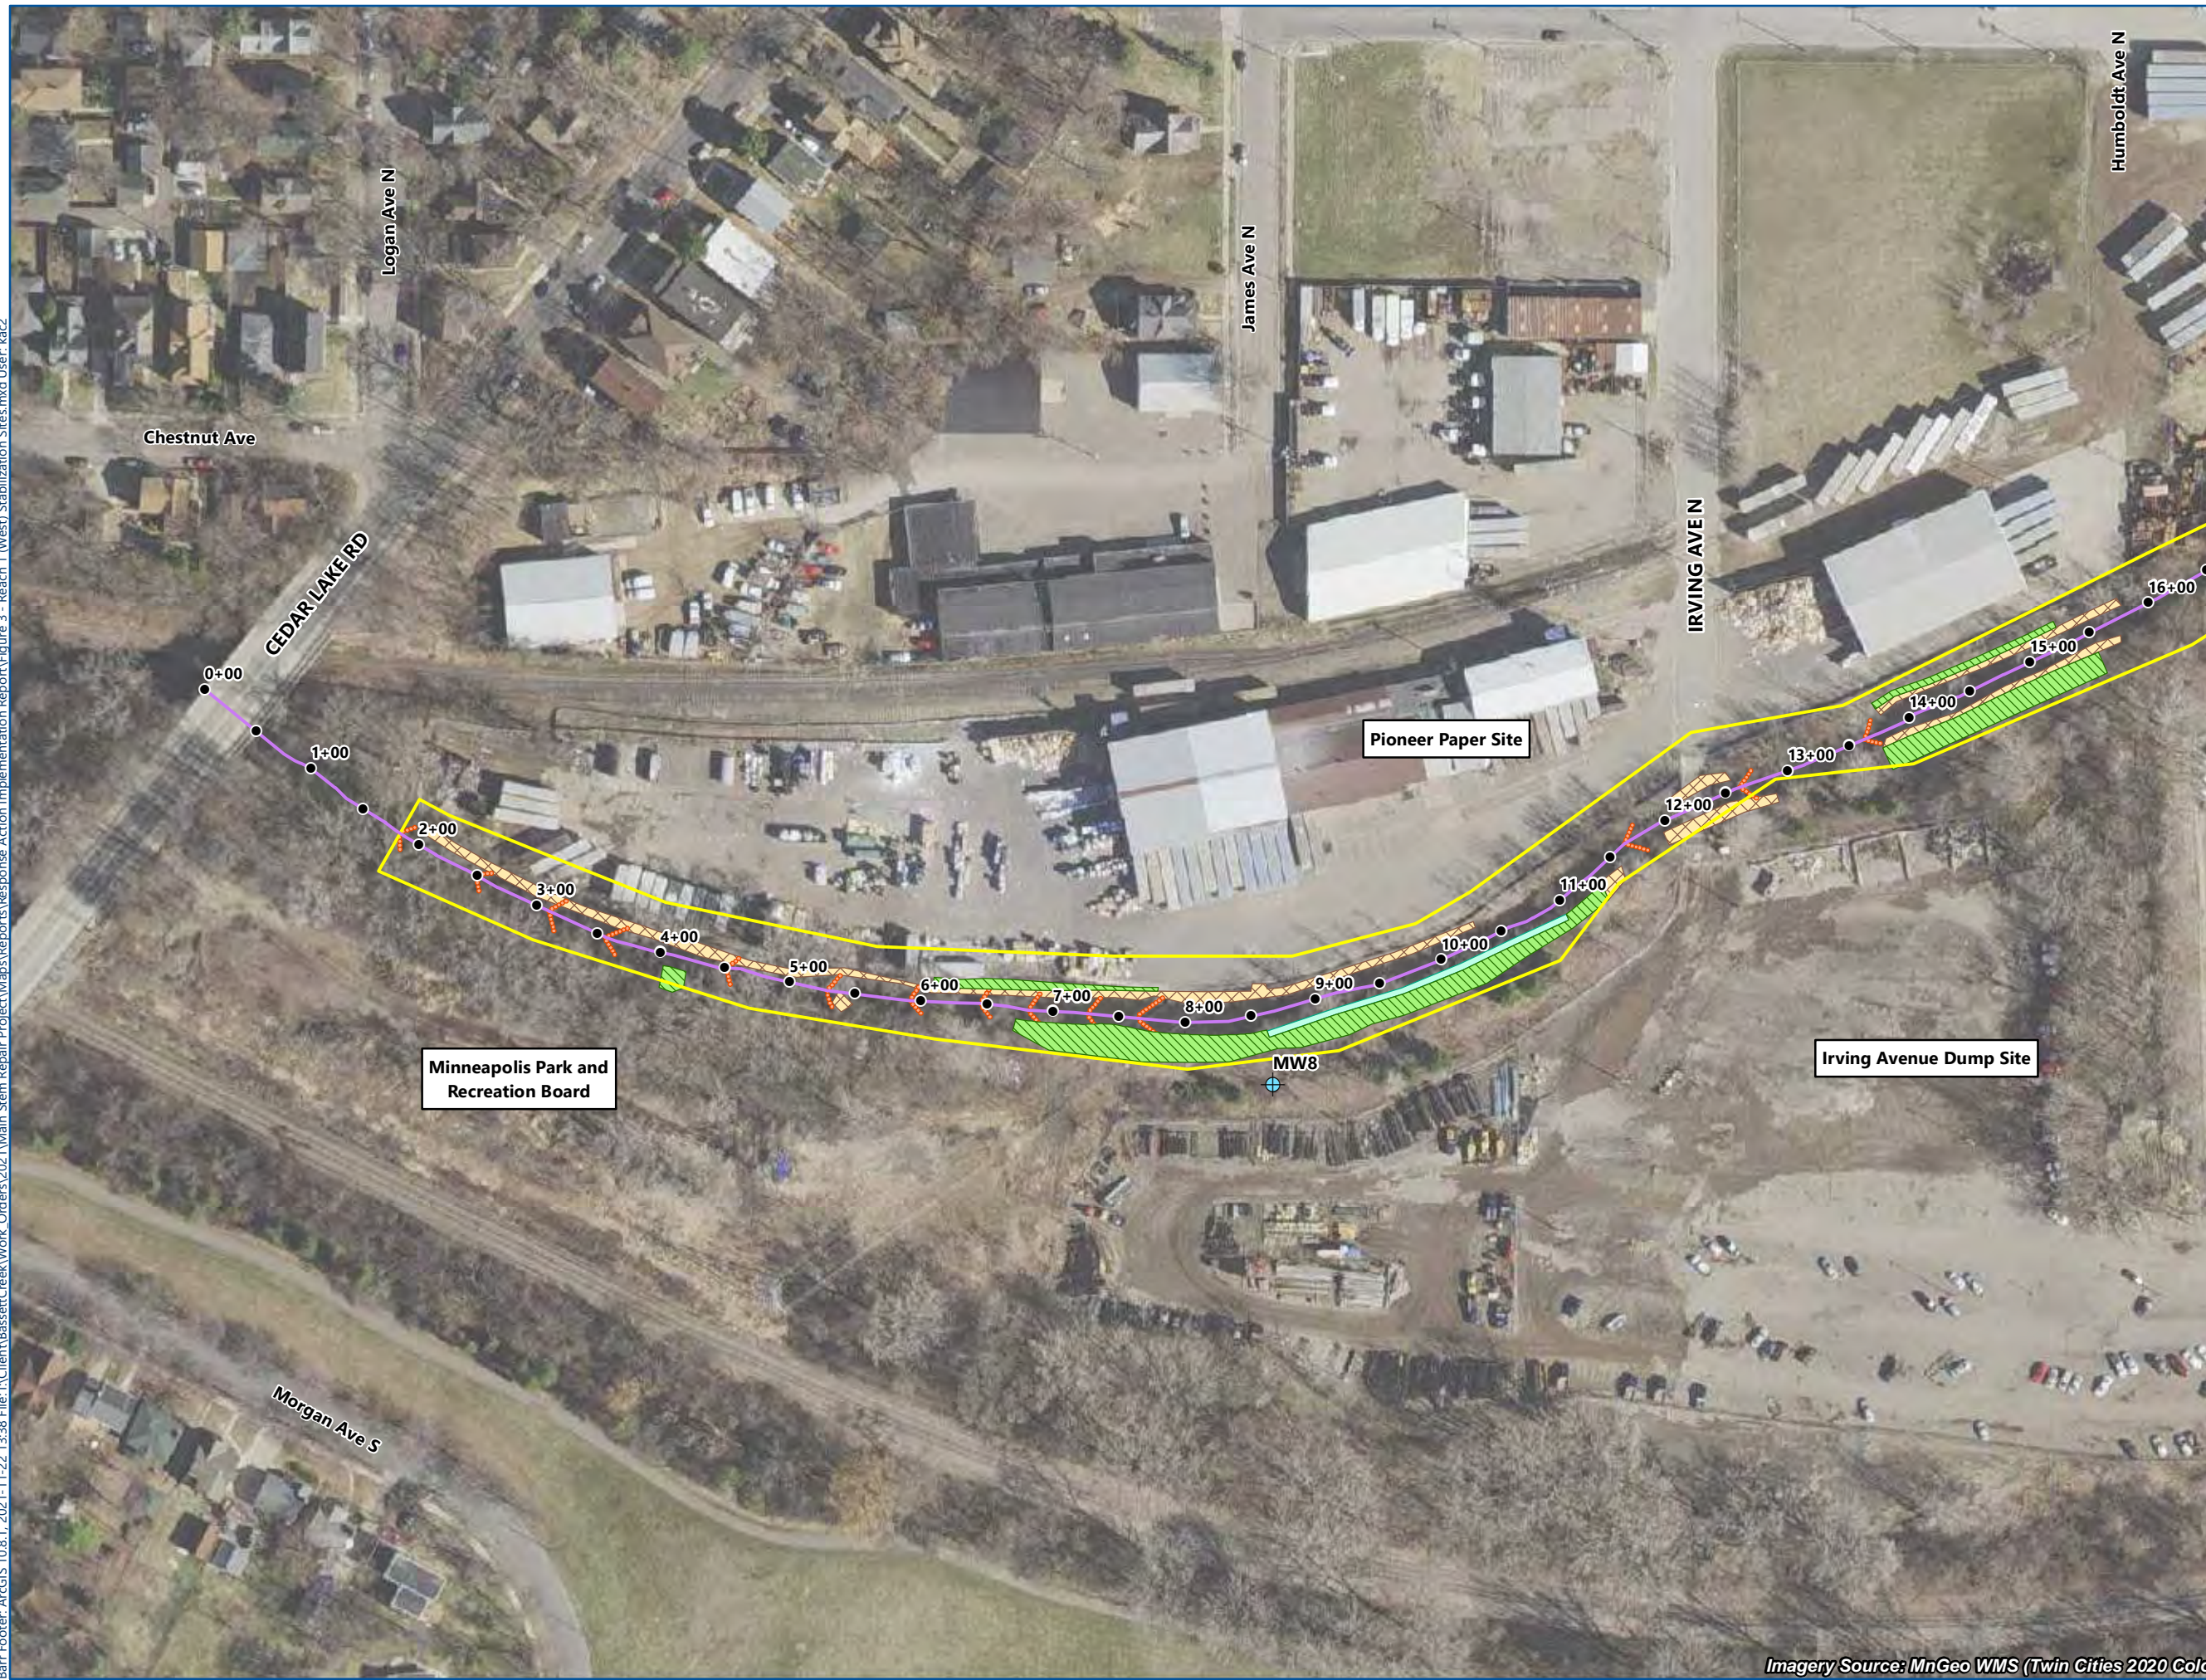
FIGURE 2

REACH 1 (WEST) STABILIZATION SITES
 Bassett Creek Main Stem Erosion Repair Project
 Minneapolis, Minnesota

north side of the creek in Reach 1 (Figure 2). The access allowed by the property owner was not sufficient for the installation of the proposed vegetated reinforced soil slope (VRSS); the modified design included debris removal and installation of riprap toe protection on the lower portions of the slope only (accessed via the creek channel), as well as bank grading, vegetation establishment, and installation of boulder vanes in the creek channel. In addition, the bid alternates designed for the east bank of the creek in Reach 2 on the Fruen Mill properties (Figure 4) were not constructed due to the pending redevelopment and restoration of larger areas on those properties that would need to coordinate with any work along the creek banks.

In Reach 1, Sunram installed a total of 1,220 feet of riprap (Figure 2 and Figure 3). Original plans called for 910 feet, but additional riprap was added beyond what was planned to further protect the bank and existing sewer outlets and to tie into the bank in a better position. Approximately 710 feet of fascines were installed by Landbridge along the edges of the banks in the center and downstream portions of the reach. Landbridge also installed approximately 1,380 feet of live stakes in the downstream portion of the reach. In spring 2022, Landbridge is expected to install additional rows of live stakes east of Van White Memorial Boulevard. Sunram installed 12 boulder vanes: 11 vanes in the upstream portion of Reach 1 and one vane further downstream. The original plan called for 10 vanes in the upstream portion of the reach; an additional vane was added to provide adequate spacing between vanes. Additional riprap and boulder vanes were also installed as part of the City's Irving Avenue Sanitary Sewer near the former Irving Avenue bridge as part of the sewer project site restoration, in coordination with this project. Those quantities are not reflected in this report.
