Feasibility Report for Bassett Creek Main Stem Restoration, Regent Avenue to Golden Valley Road (2024 CR-M)—DRAFT

Golden Valley, Minnesota

Prepared for
Bassett Creek Watershed Management Commission

April 2023

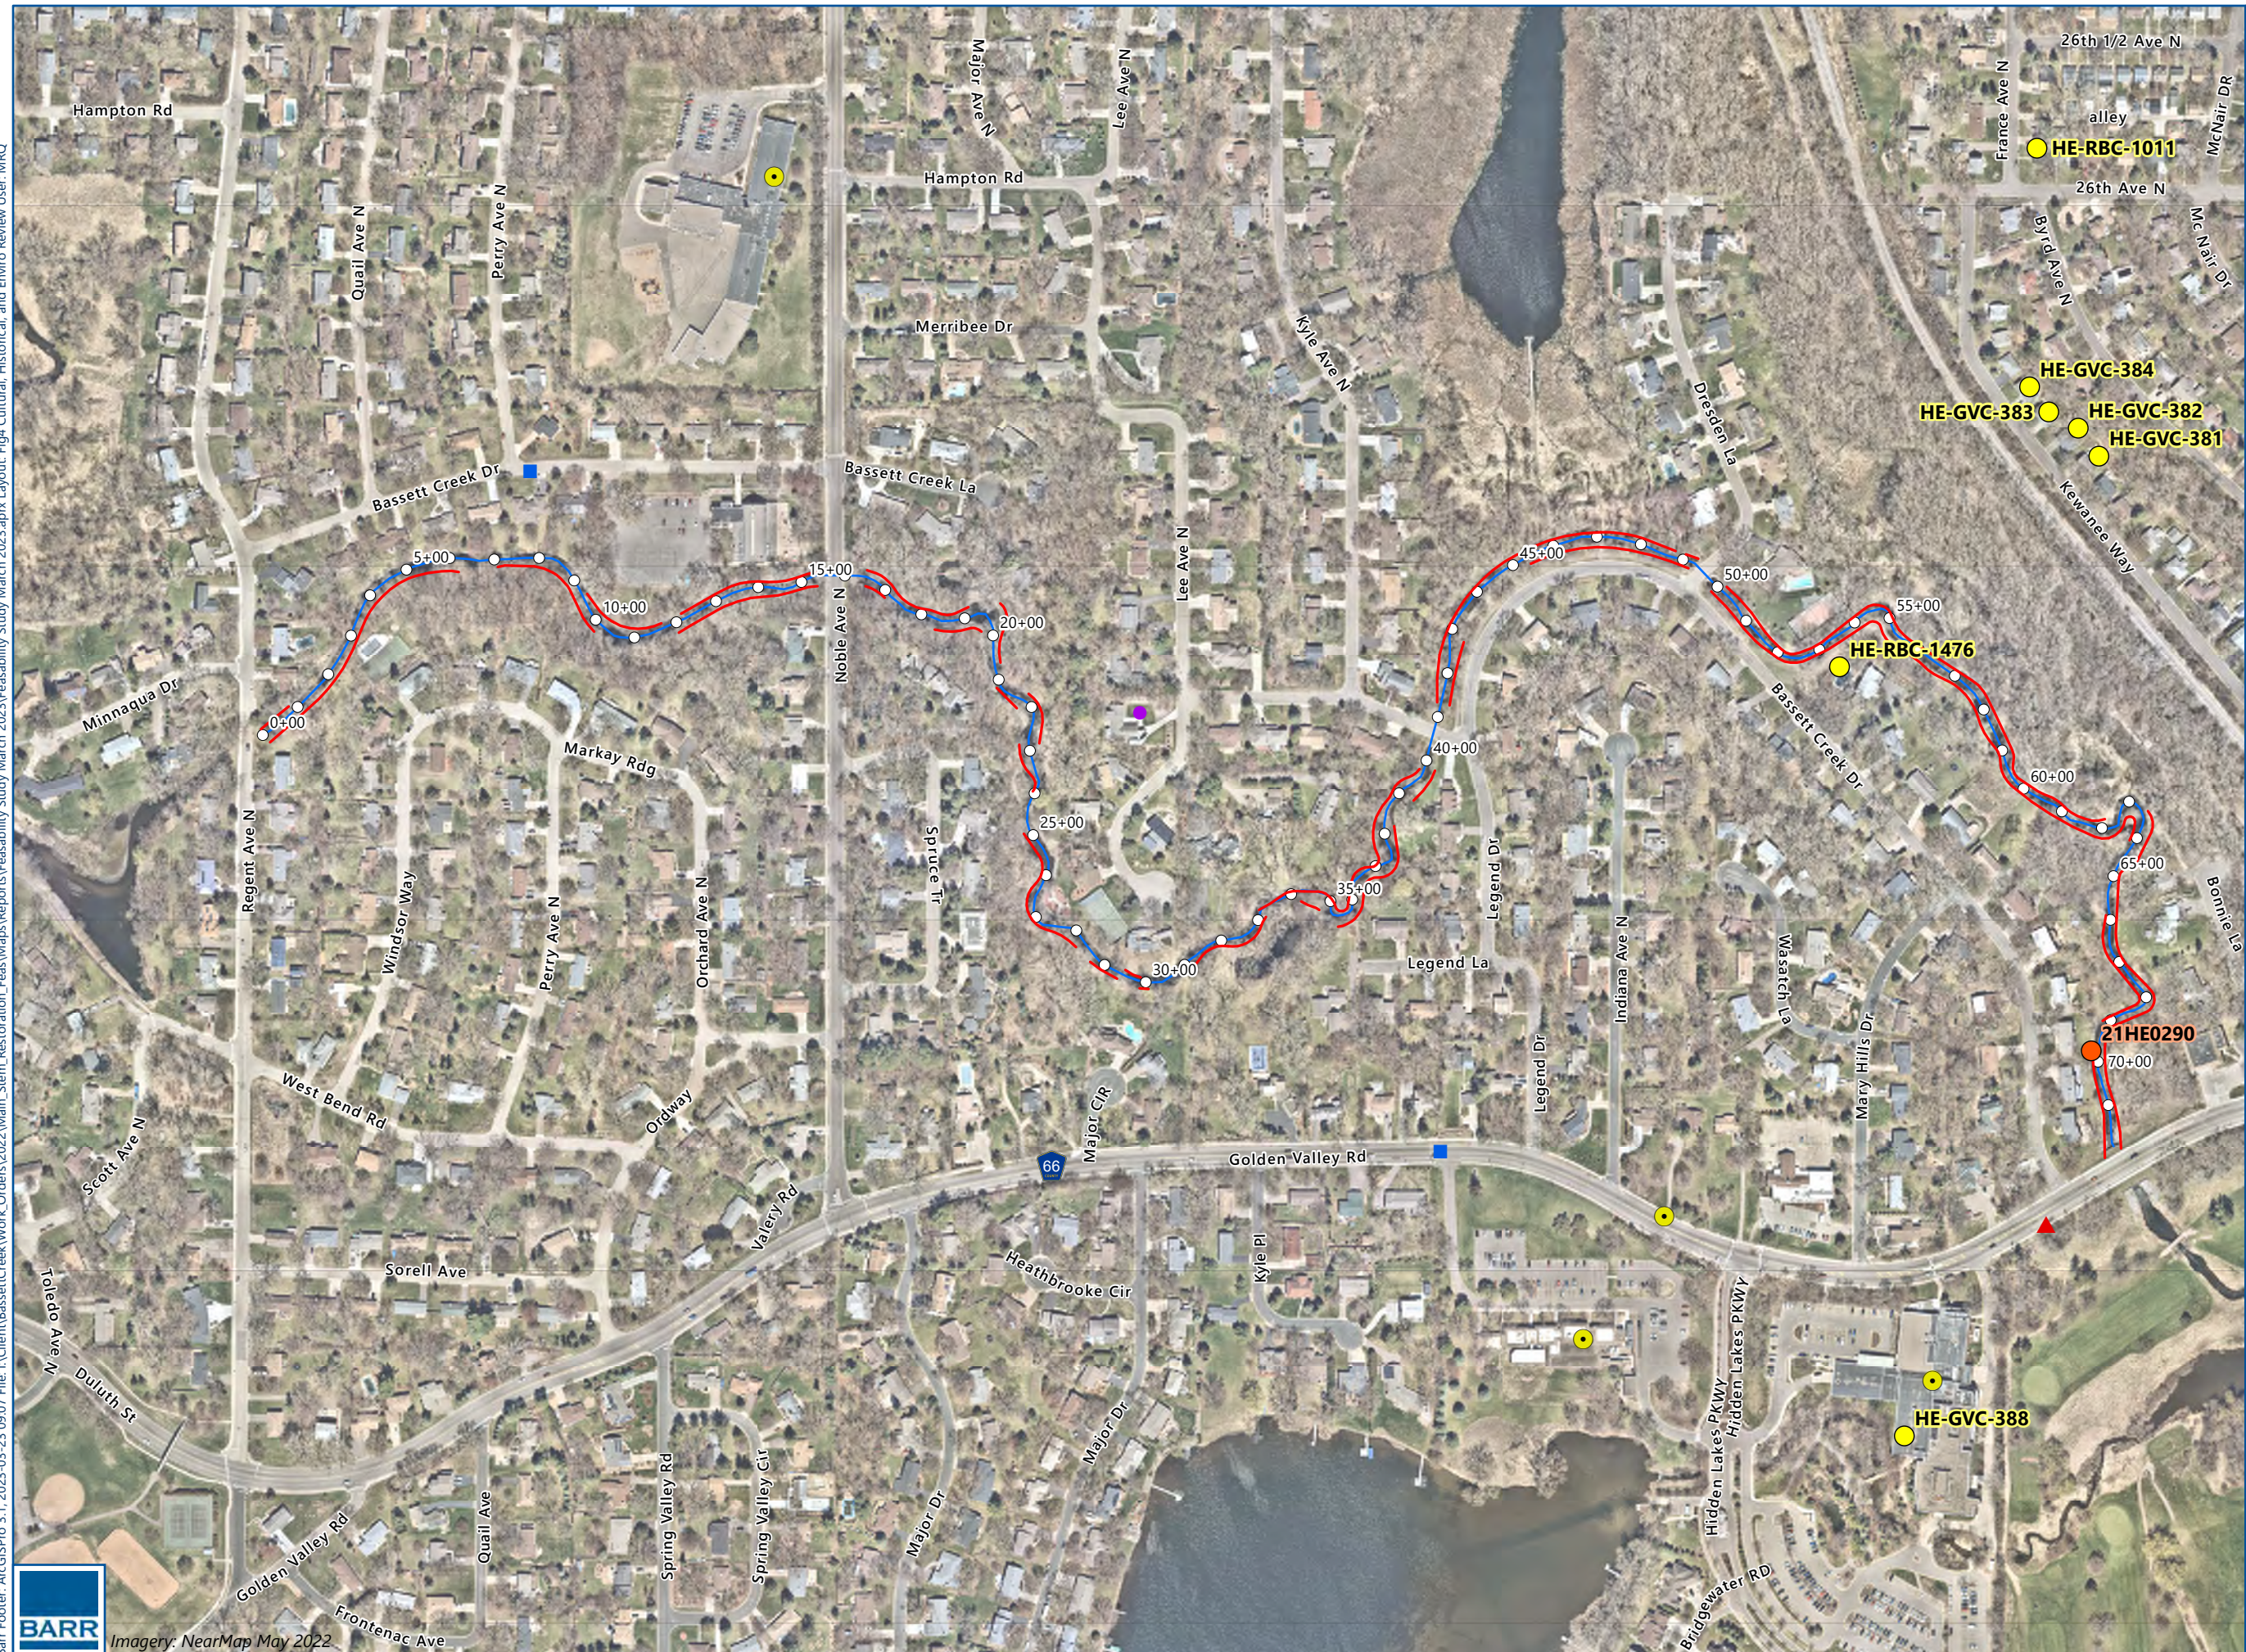
The Commission Engineer completed a cultural resources literature review of the project area and within a 1-mile buffer in October 2022. The literature review was directed toward identifying previously recorded archaeological sites, historic structures, and other cultural resources. The Commission Engineer requested data from the Minnesota State Historic Preservation Office (SHPO) to identify previously recorded archaeological sites and historic structures located within one mile of the project area. We also reviewed the Minnesota Office of the State Archaeologist (OSA) Portal for archaeological sites (Figure 3-3).

- Project Stationing
- Bassett Creek
- Erosion (from Golden Valley City Staff)
- Archaeological Site
- Historical Site
- What's in my Neighborhood (MPCA)
 - Multiple Programs
 - Hazardous Waste
 - Investigation and Cleanup
 - ▲ Tanks

The project area does not appear to have been previously surveyed for archaeological resources. If the project constitutes an undertaking subject to Section 106 of the National Historic Preservation Act, additional work to identify significant cultural resources may be required. In other words, if the project includes federal involvement (e.g., funding or permitting), then a federal agency may require an archaeological survey. Because the project will include some level of federal review and/or permitting, the Commission Engineer recommends conducting an archaeological survey.

A review of MPCA's What's In My Neighborhood database identified five historical leak sites that are located near Bassett Creek:

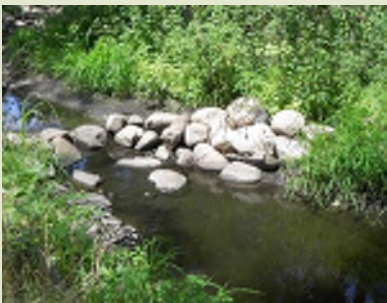
<p>Boulders buried in the stream bed and extending entirely across the stream (“cross vanes”) to achieve one or more of the following goals: re-direct flows away from banks, encourage sediment deposition in selected areas, and control stream bed elevations</p>	<p>Scour pools develop over time downstream of the center of the vane, which provide habitat diversity for species that prefer pools to faster flowing in-channel habitat.</p>

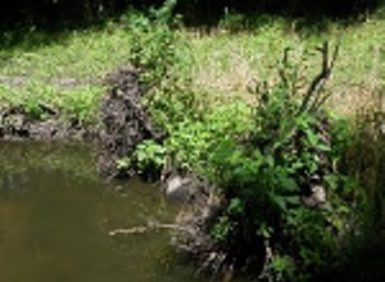
<p>Tree trunks with the root ball attached, installed either singly (root wads) or in conjunction with additional large woody debris and/or riprap to increase bank roughness and resistance to erosion, re-direct flows away from banks, and provide a bench for the establishment of riparian vegetation</p>	<p>Creates undercut/overhanging bank habitat features</p>
<p>VRSS/Toe Wood Bank Stabilization</p>

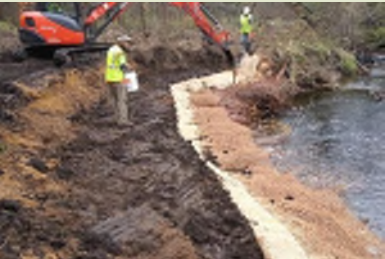
<p>Soil lifts created with a combination of root wads and long-lasting, biodegradable fabric and vegetated to stabilize steep slopes and encourage the establishment of root systems for further stabilization</p>	<p>Creates undercut/overhanging bank habitat features and vegetated floodplain bench/riparian habitat</p>
<p>Riprap Toe with Bank Grading and Vegetation Establishment</p>

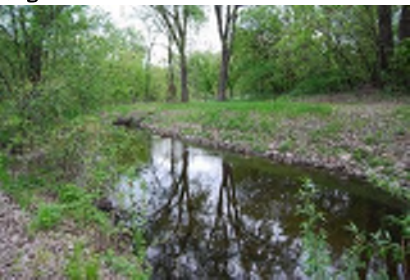
<p>Riprap placed along the toe of the streambank prevents undermining of the bank. Vegetating the bank provides surface protection while establishing root systems, and grading to a flatter slope makes the streambank less susceptible to erosion.</p>	<p>Vegetation placed above the riprap enhances riparian habitat and provides shading of the creek.</p>

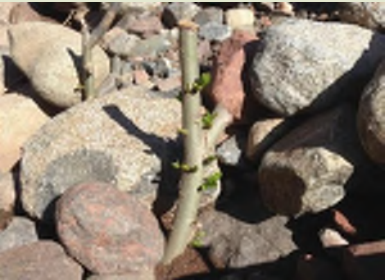
<p>Vegetated Riprap</p>

<p>Vegetated riprap incorporates habitat enhancement with hard armoring to stabilize steep slopes.</p>	<p>Creates vegetated riparian habitat and enhances biological connectivity between the channel and riparian area.</p>
<p>Fascines and Coir Logs</p>	<p>Fascines and coir logs can be placed along the toe of a stream bank in low-velocity areas to help establish vegetation and associated rooting systems to stabilize the stream bank.</p>	<p>Creates vegetated riparian habitat and adds roughness to dissipate energy at the toe of the slope.</p>

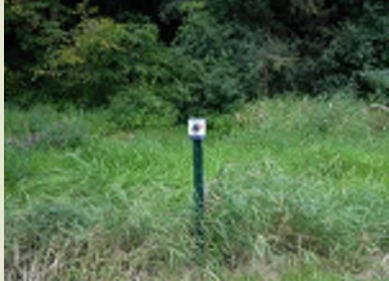
Vegetated Buffer

Established along a stream bank or overbank area to stabilize bare soils and increase resistance to fluvial erosion	Using trees, shrubs, and a seed mix of grass and forbs provides a diverse array of vegetation strata and habitat types. Allows for more naturalized aesthetics, with emphasis on native species.
