# About the Bassett Creek Watershed Management Commission (BCWMC)

Plymouth Creek Restoration (2026 CR-P)

# Plymouth Creek Restoration Project

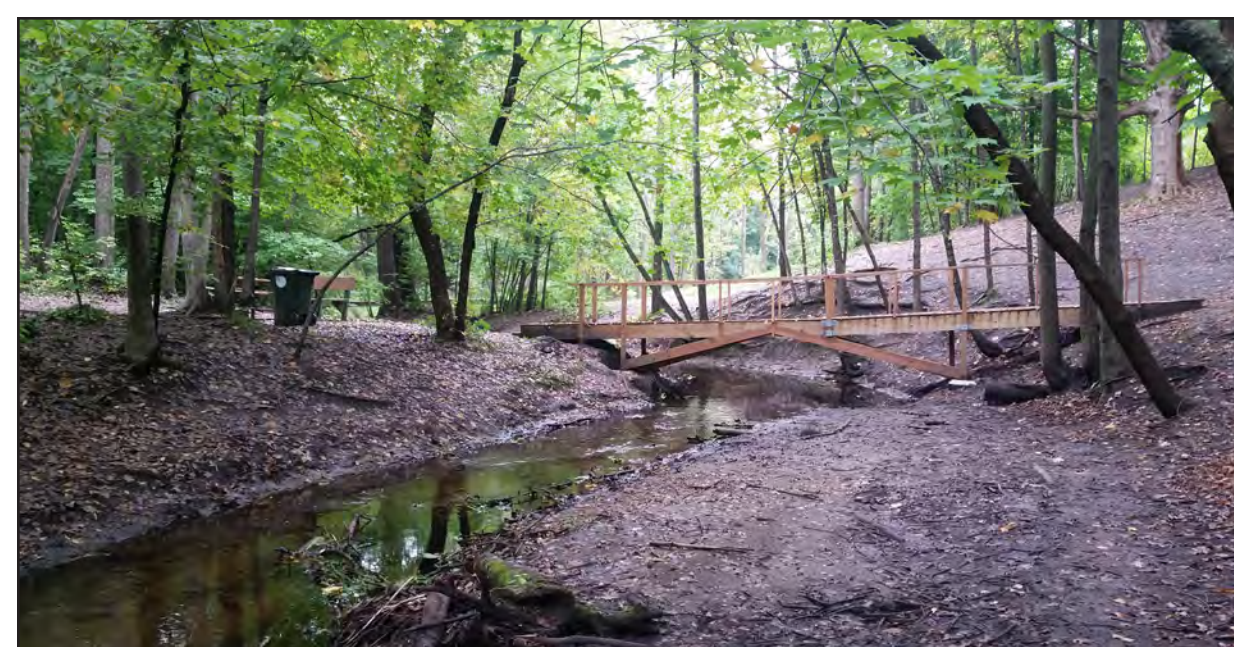
Wirth Lake outlet

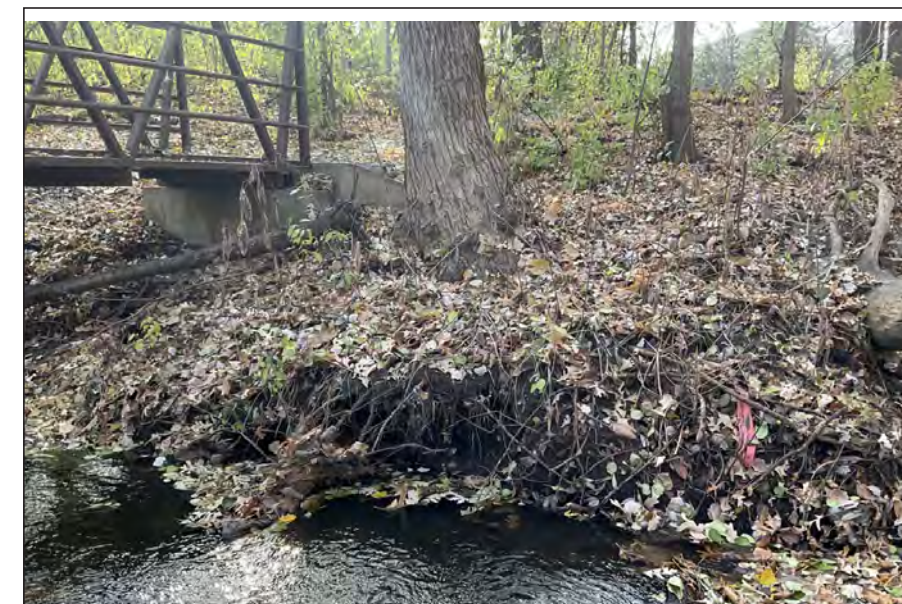
Streambank undercutting

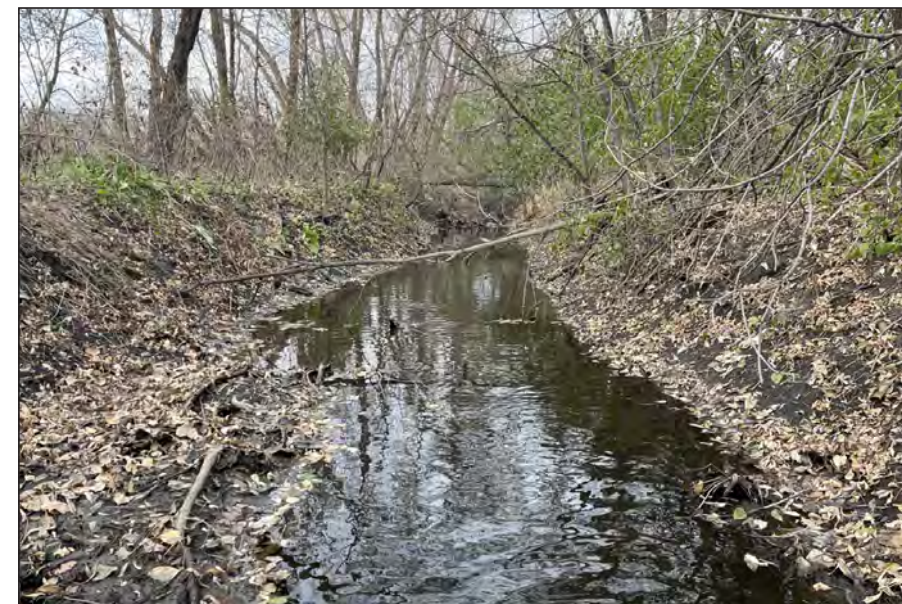
Entrenched channels

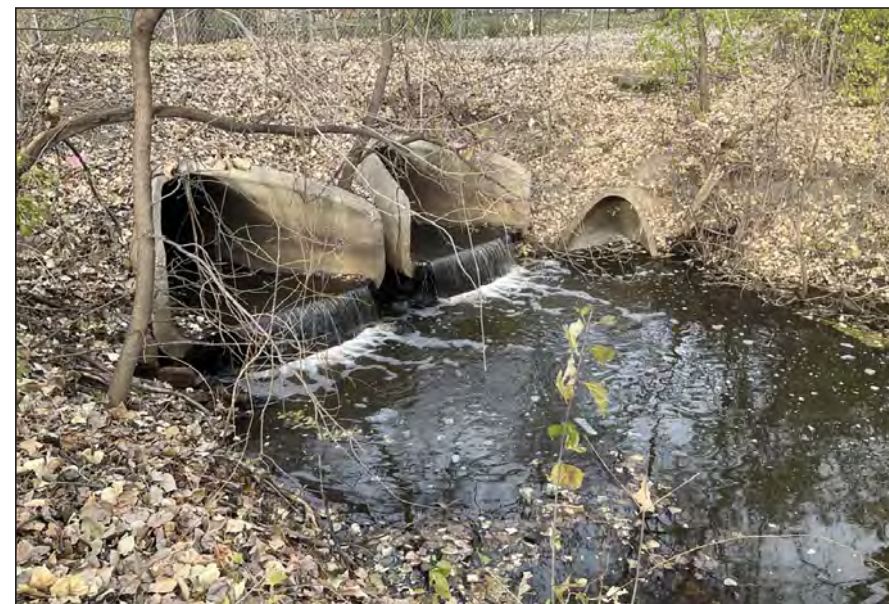
Scour near culverts

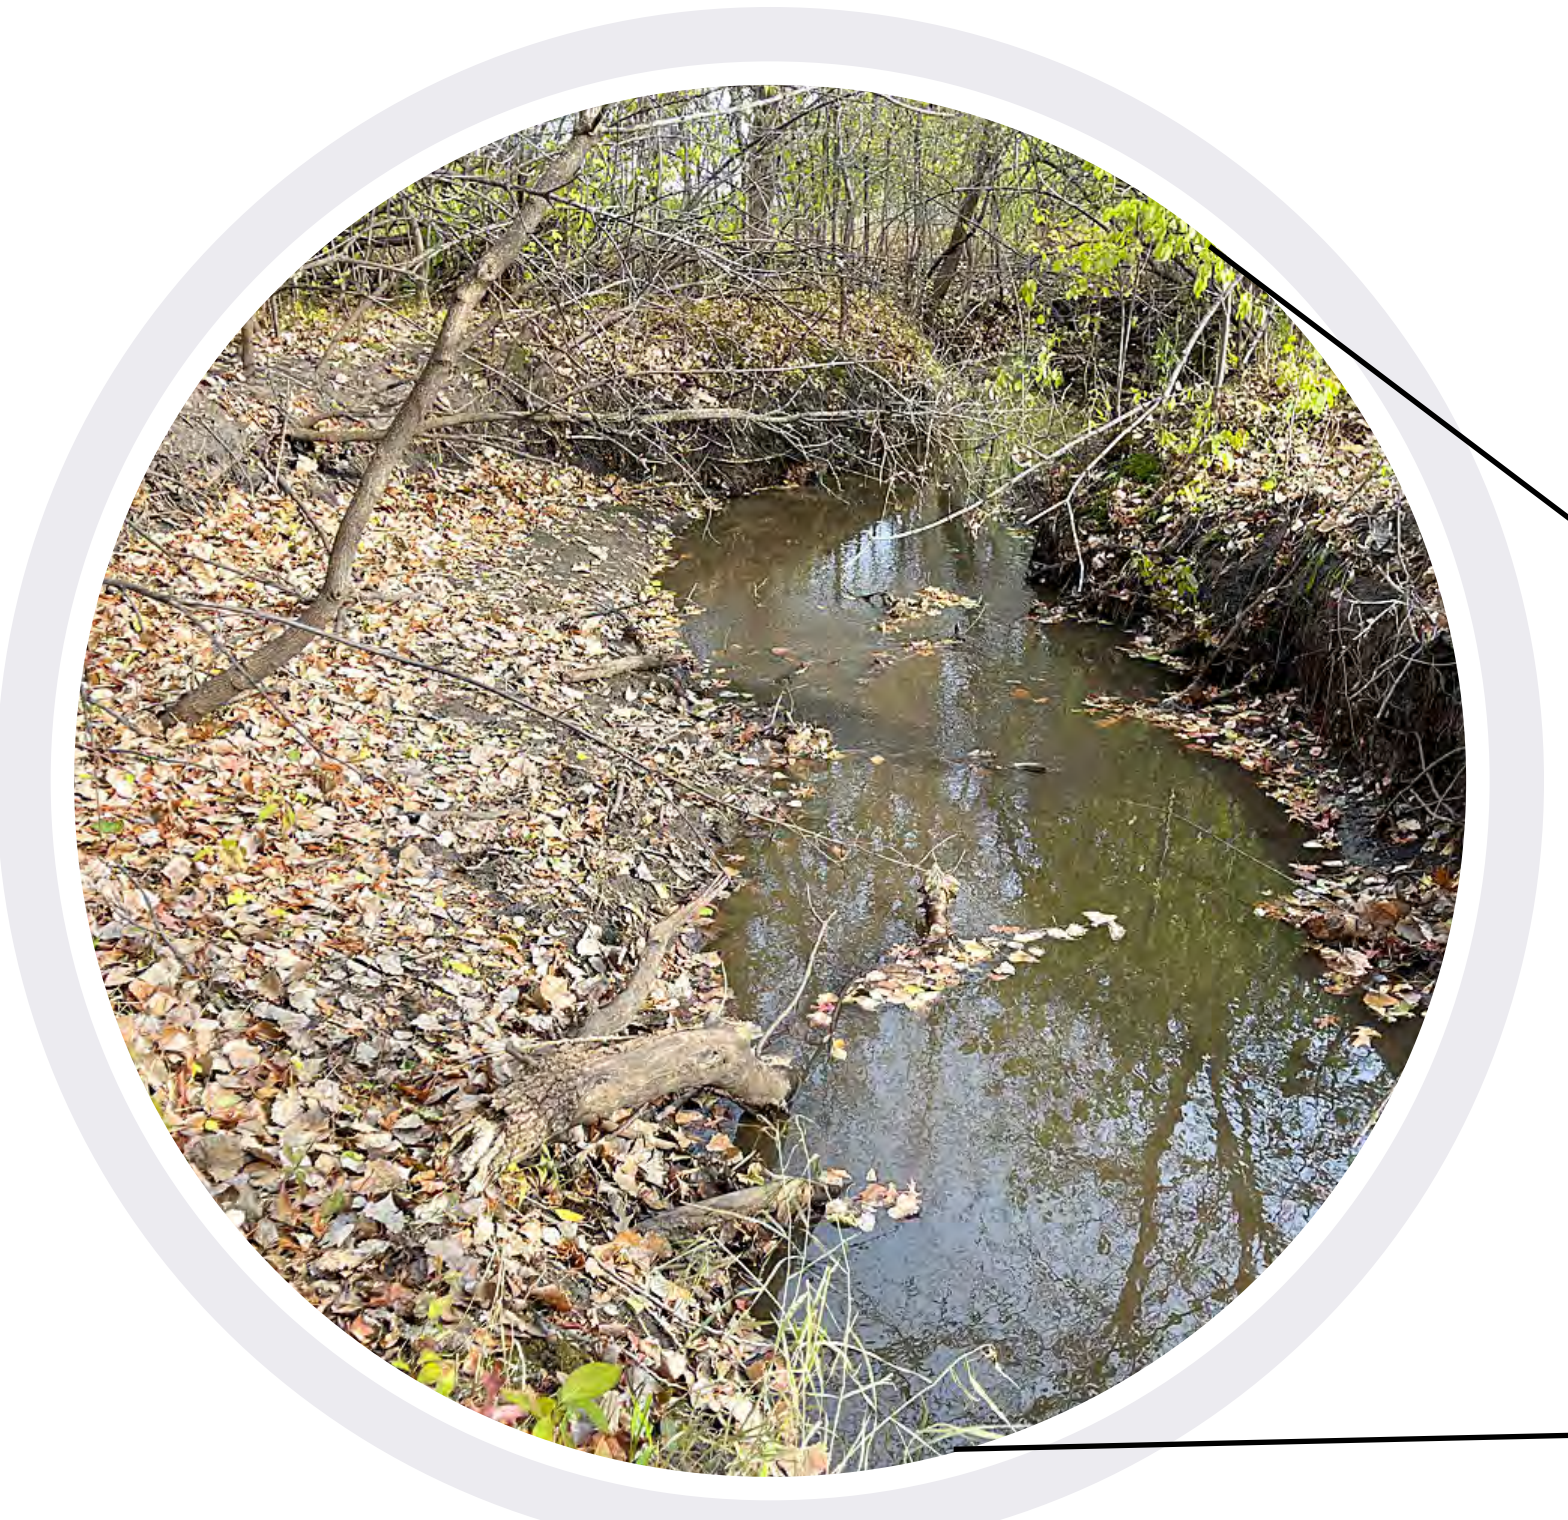
# Preliminary Concept for Reach 1, Dunkirk Lane to Yuma Lane

- Regrade channel and stream banks to improve floodplain connection and soften tight curves
- Stabilize stream bank toe with rock riprap, coconut-fiber (coir) log, or root wads
- Stabilize stream bank with vegetative material (seed, live plugs, shrubs, and/or live cuttings)
- Remove invasive buckthorn within riparian zone and replace with native plantings

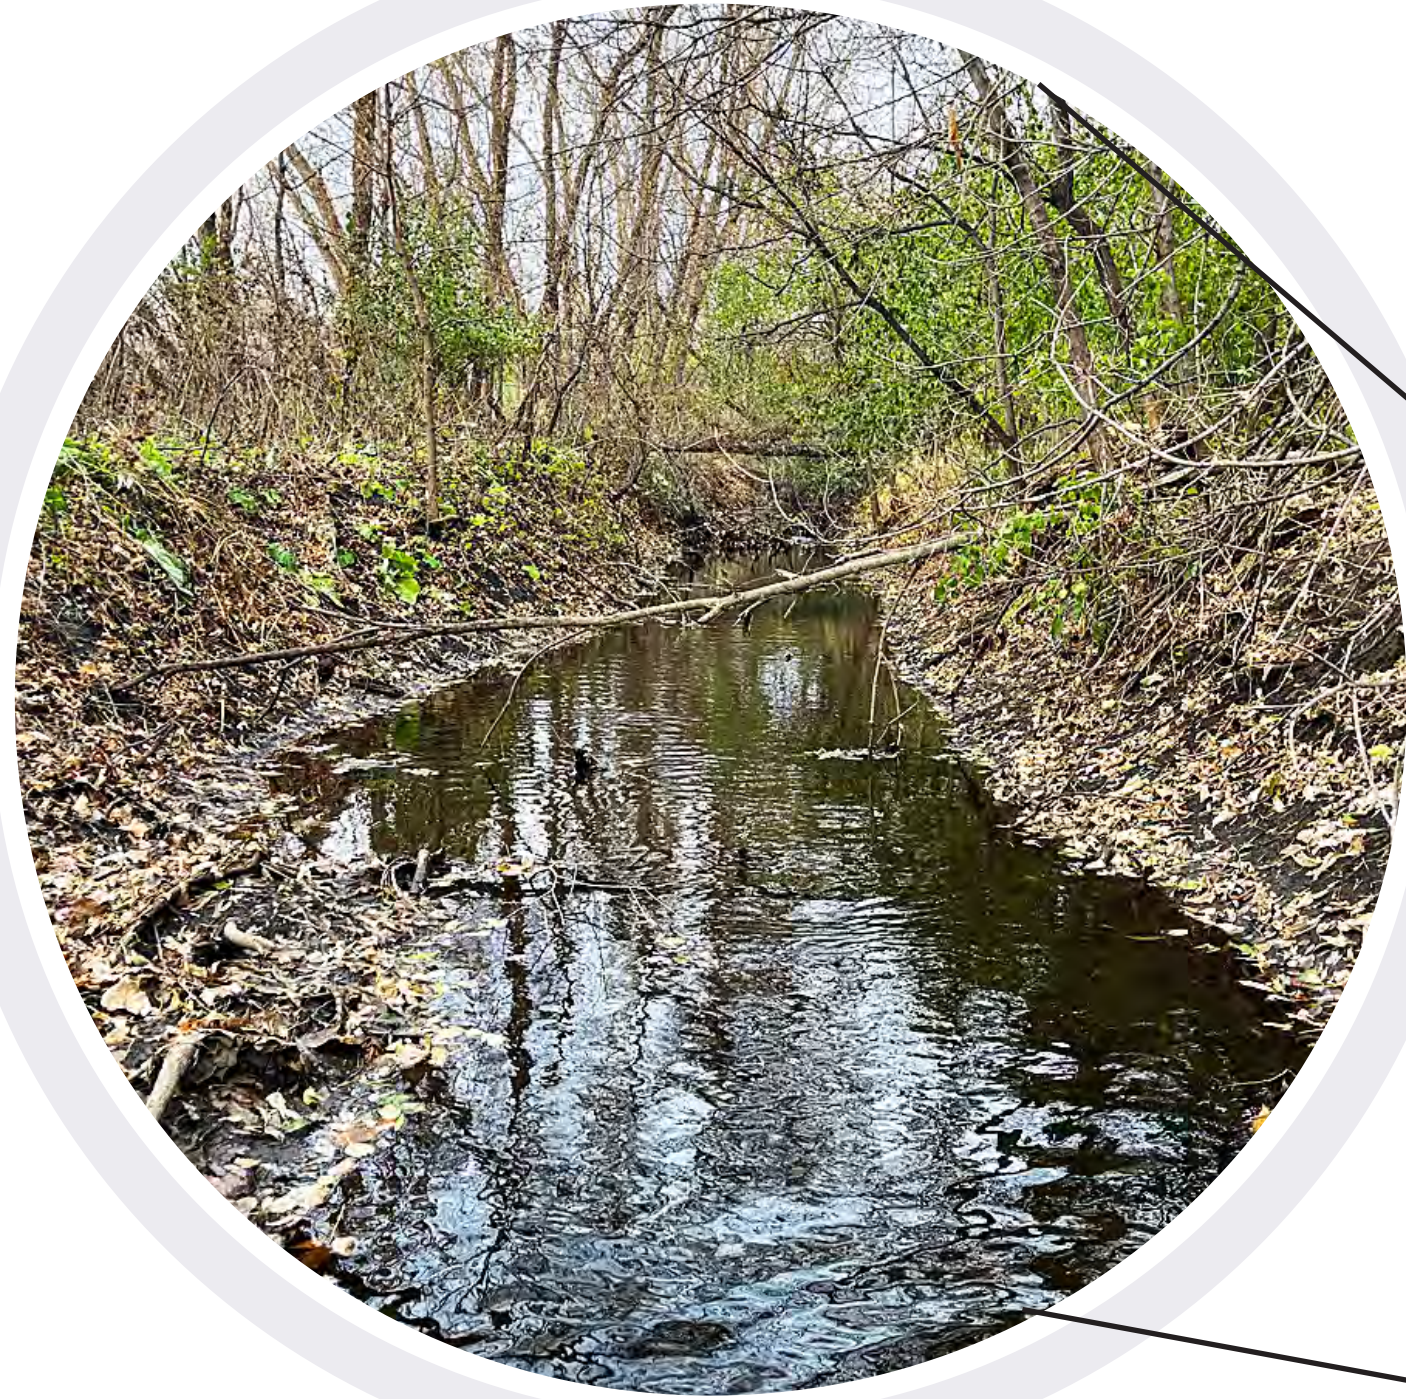
# Preliminary Concept for Reach 2, Yuma Lane to Vicksburg Road

- Regrade channel and stream banks to improve floodplain connection
- Install rock vanes to maintain channel grade and route erosive flows away from stream banks
- Stabilize stream bank with vegetative material (seed, live plugs, shrubs, and/or live cuttings)
- Remove invasive buckthorn within riparian zone and replace with native plantings

\* See channel re-alignment board for potential stream meander layout next to school.

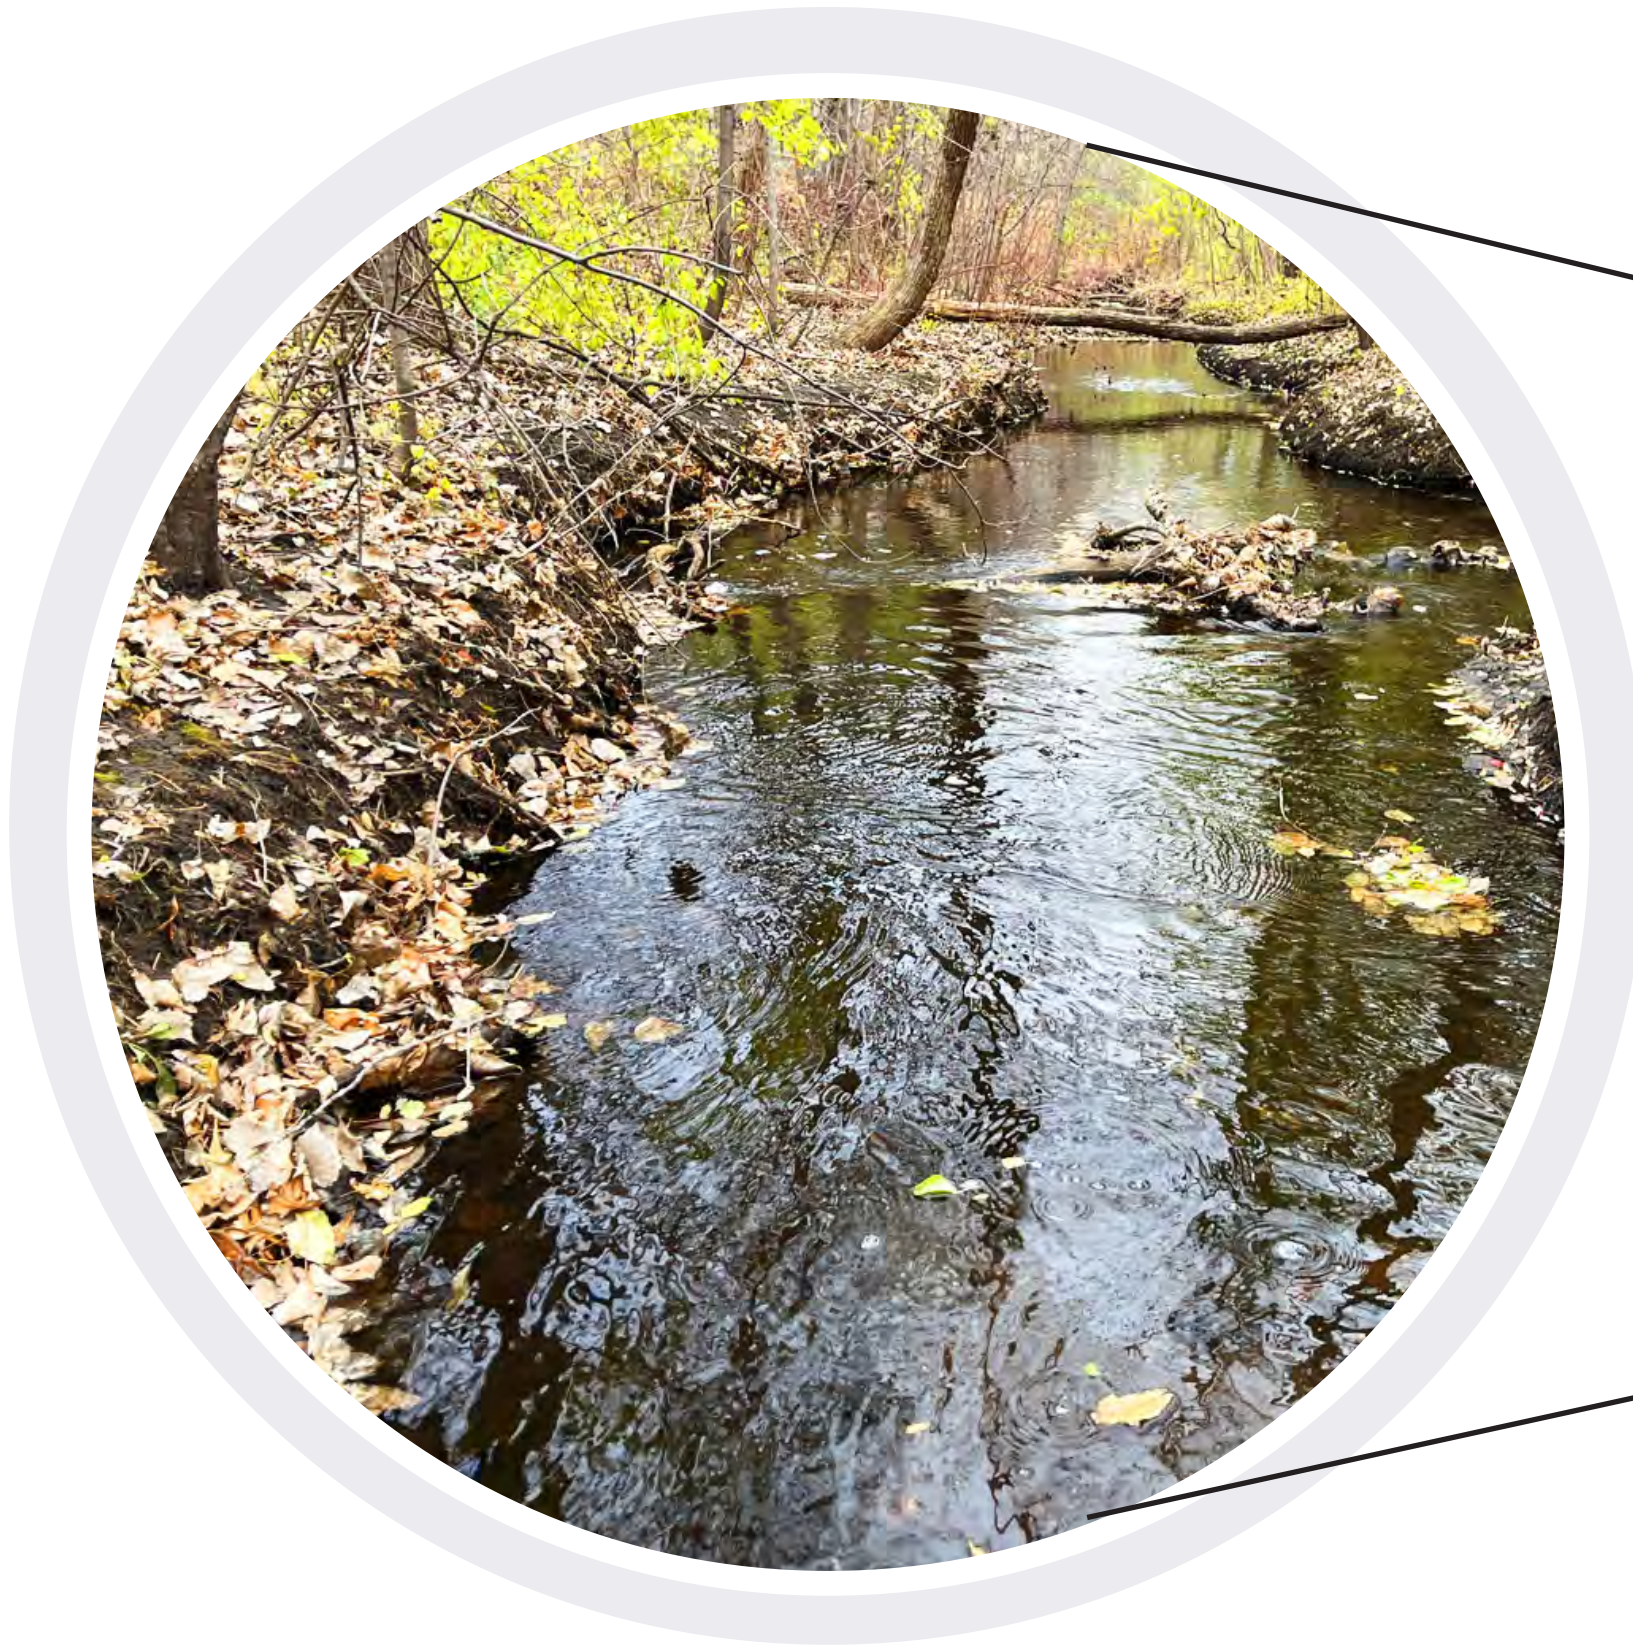
# Preliminary Concept for Reach 3, Vicksburg Road to Rockford Road

- Install rock vanes to maintain channel grade and J-hook vanes to route erosive flows away from stream banks
- Stabilize culvert outlets with grading, riprap, erosion control blanket, and/or live plugs and seed
- Remove invasive buckthorn within riparian zone and replace with native plantings

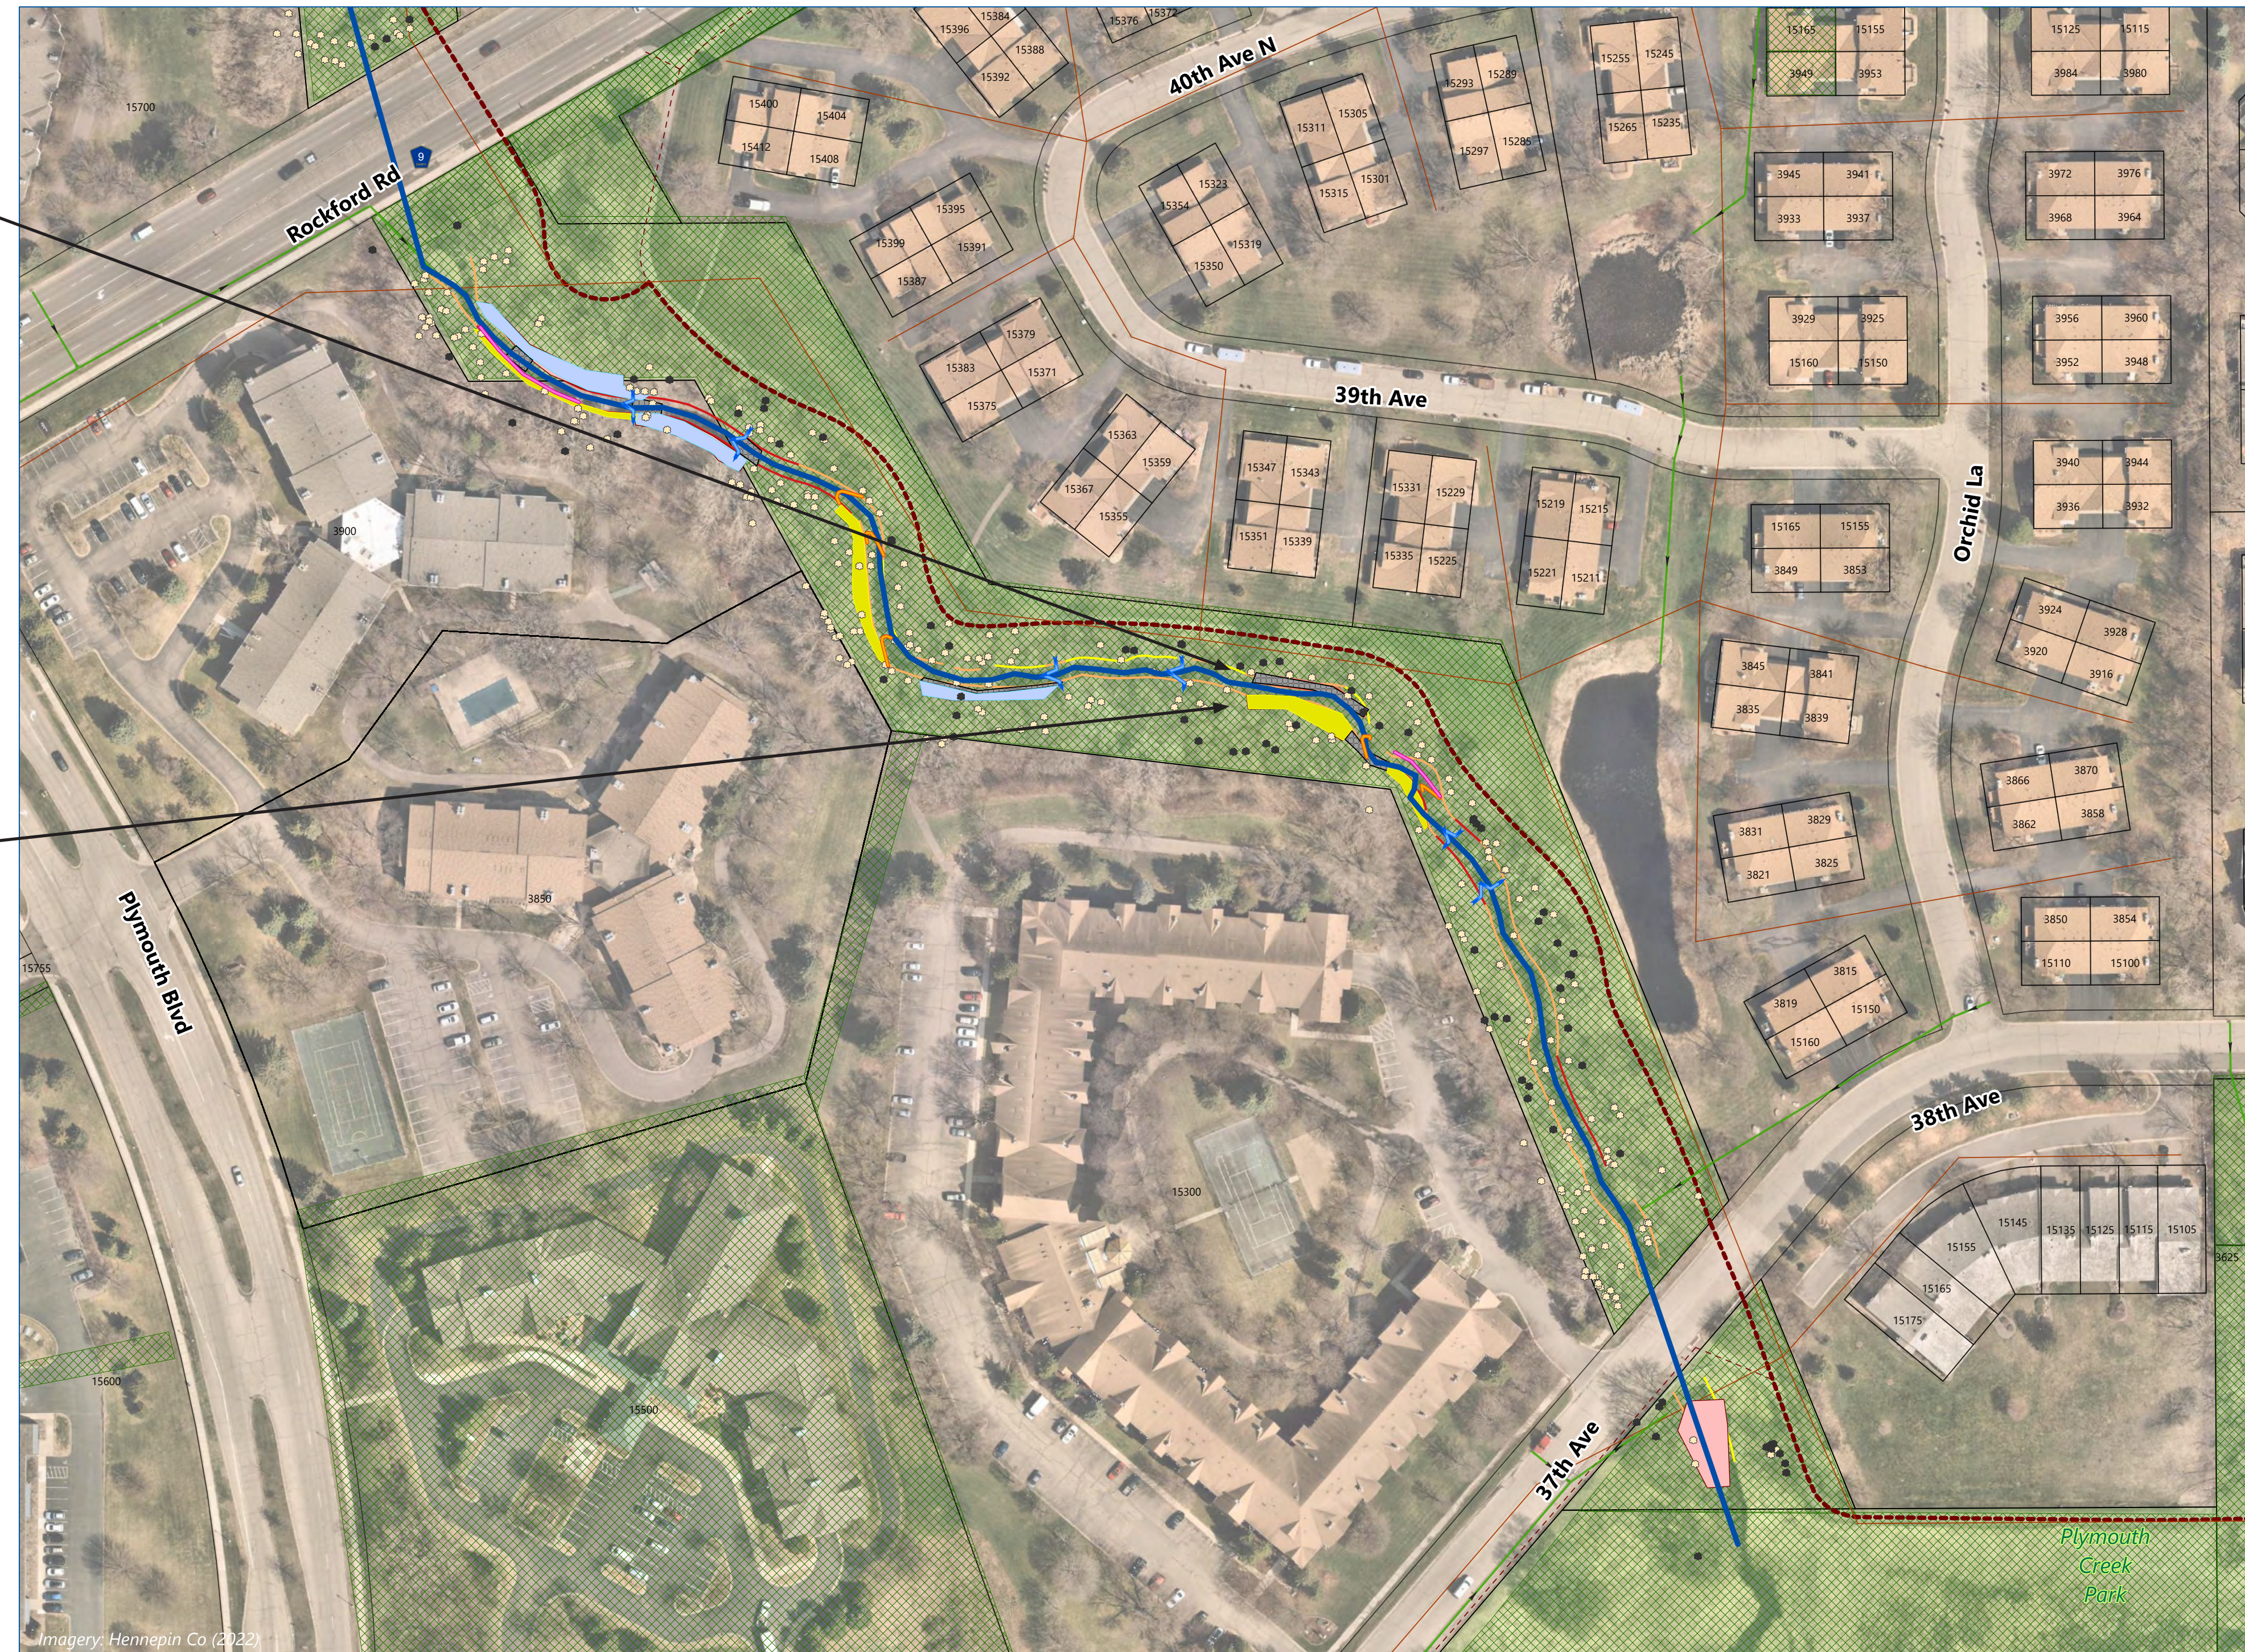
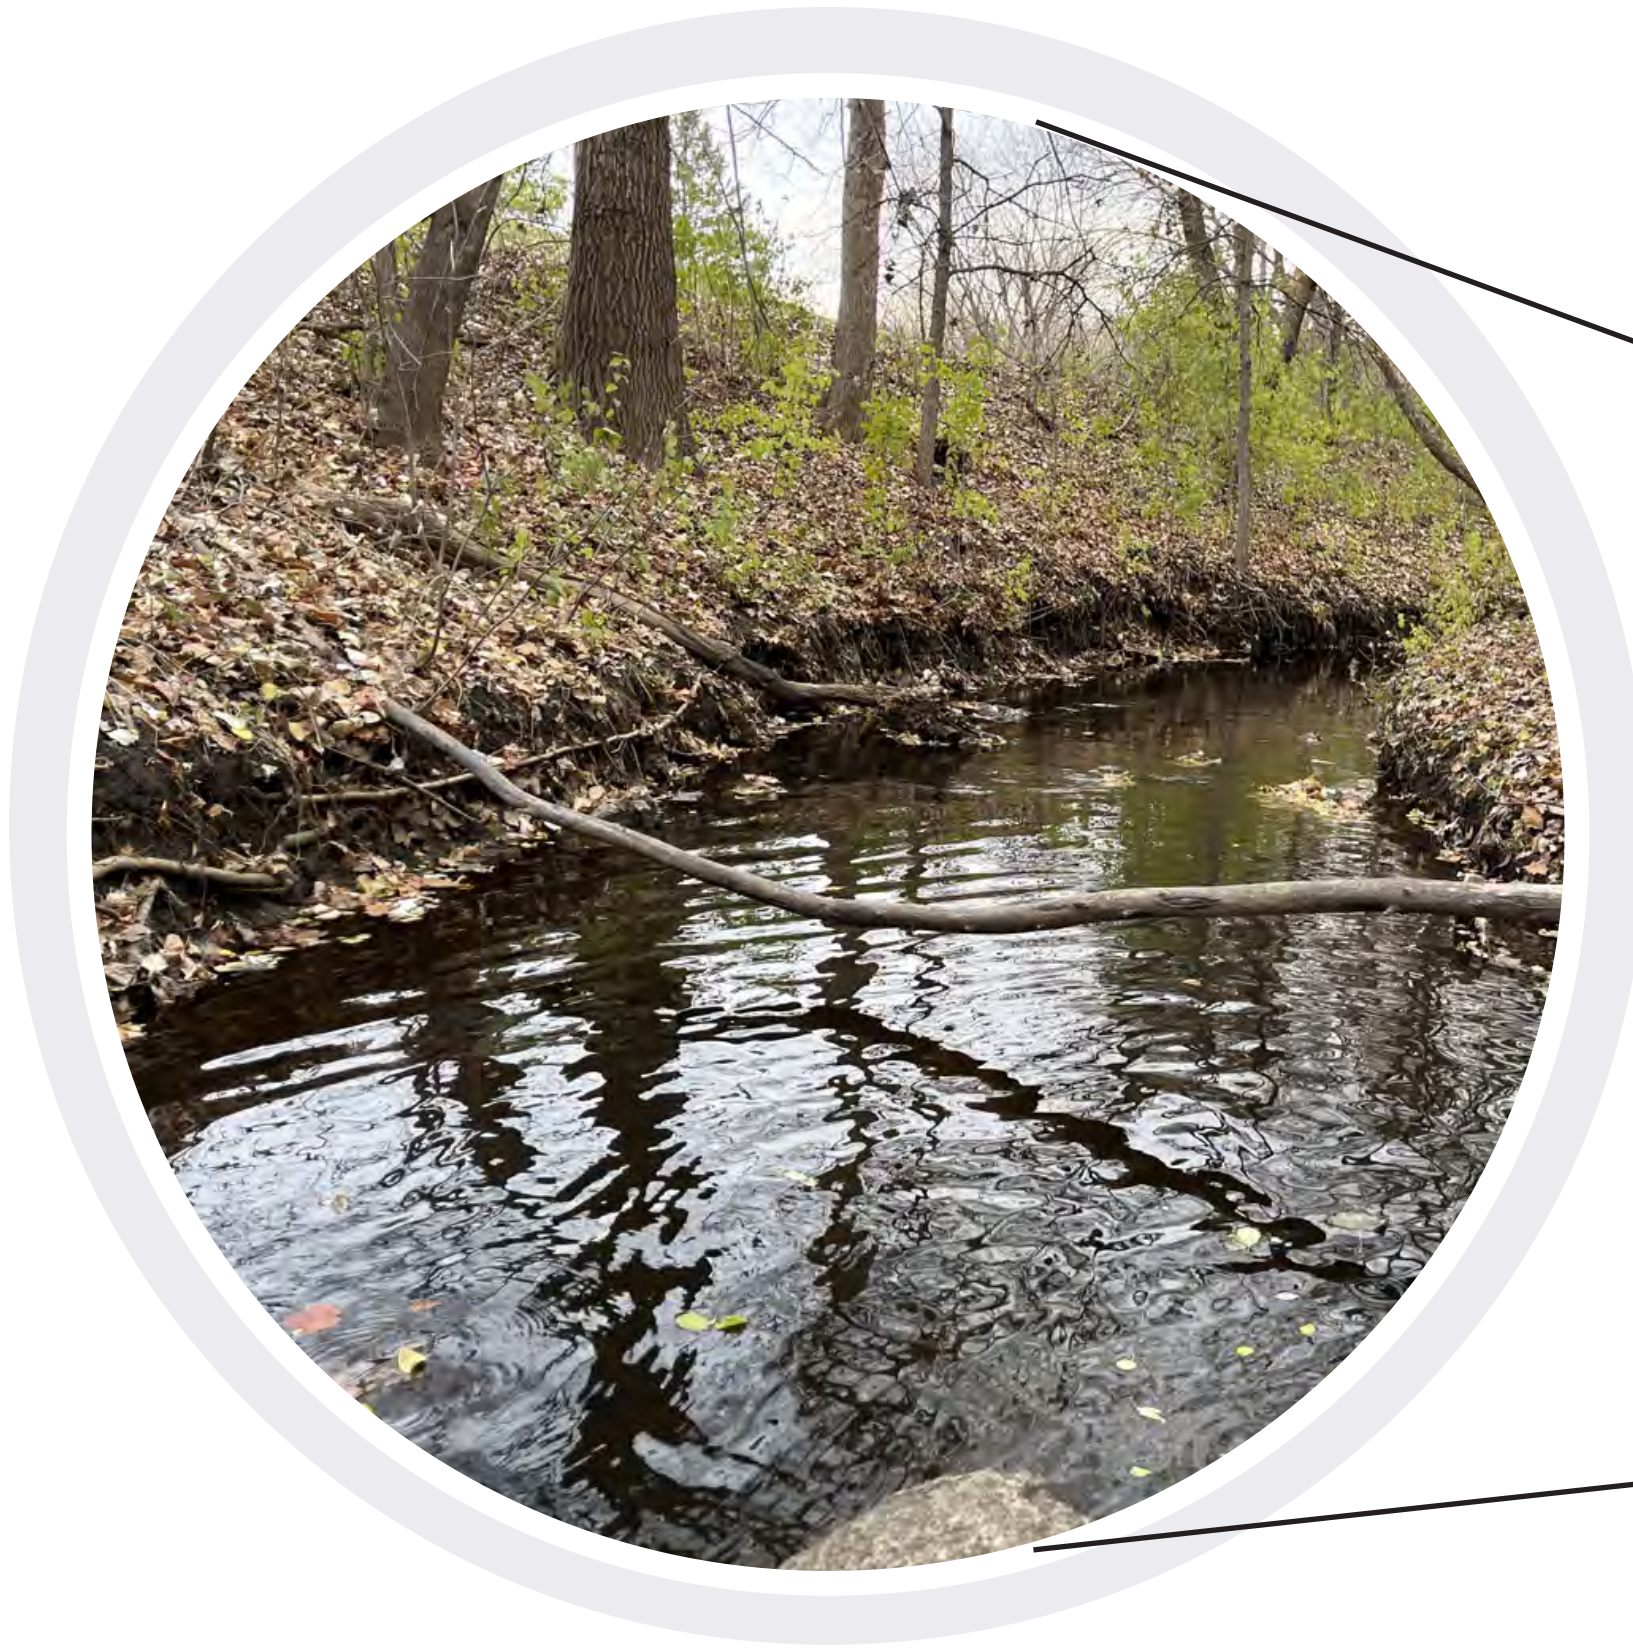
# Preliminary Concept for Reach 4, Rockford Road to 38th Avenue

- Install rock vanes to maintain channel grade and J-hook vanes to route erosive flows away from stream banks
- Grade banks, place erosion control blanket and live plugs with live stakes and seeding to enhance floodplain
- Remove invasive buckthorn within riparian zone and replace with native plantings
