Plymouth Creek Stream Restoration Project (2025 CR-P) Feasibility Report

Plymouth, Minnesota

Prepared for
Bassett Creek Watershed Management Commission

May 2024

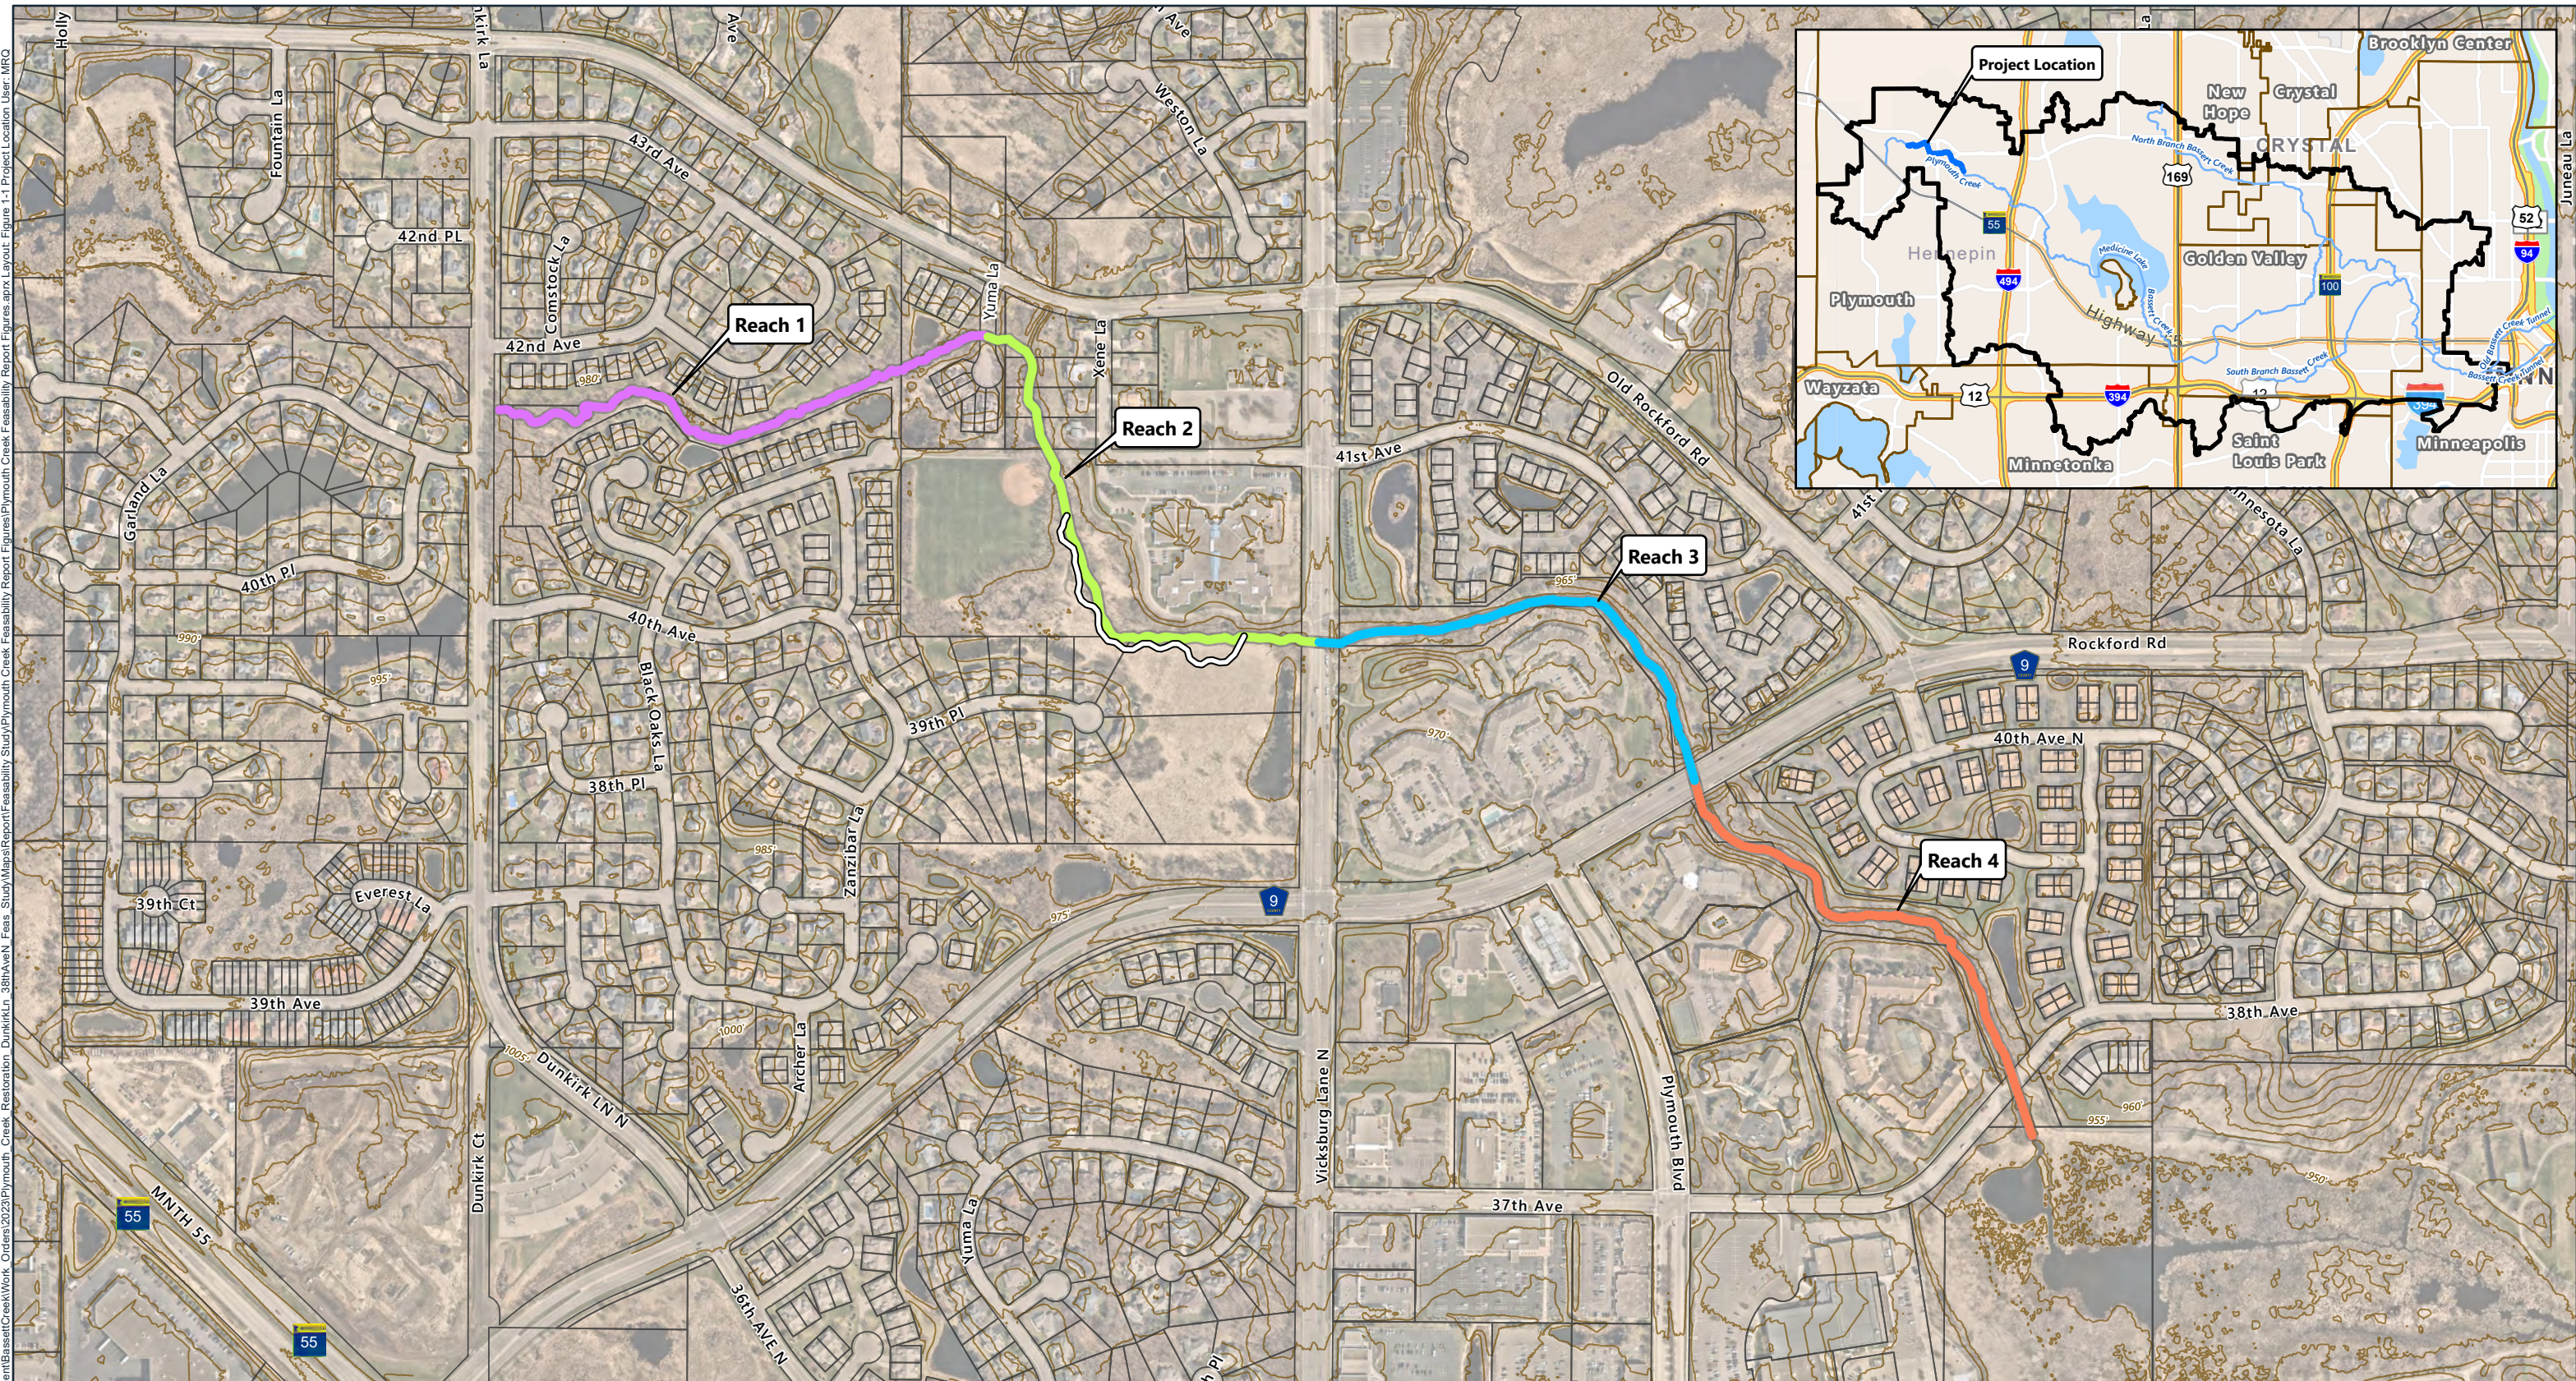
FIGURE 1-1

The Plymouth Creek Stream Restoration project area is located along Plymouth Creek between Dunkirk Lane North to 38th Avenue North behind Plymouth Ice Center (Figure 1-1). The project will focus on restoring eroding streambanks and improving aquatic and riparian habitats..

- Reach 1
- Reach 2
- Reach 3
- Reach 4

The 7,000-foot reach was broken into four separate reaches for mapping purposes. Reach 1 is located between Dunkirk Avenue and Yuma Lane, Reach 2 is between Yuma Lane and Vicksburg Road, Reach 3 is between Vicksburg Road and Rockford Road, and Reach 4 is between Rockford Road and 38th Avenue (see Figure 5-1 through Figure 5-4).. An alternative option for Reach 2 that includes a new meandering channel path is shown in Figure 1-1 and Figure 5-5.

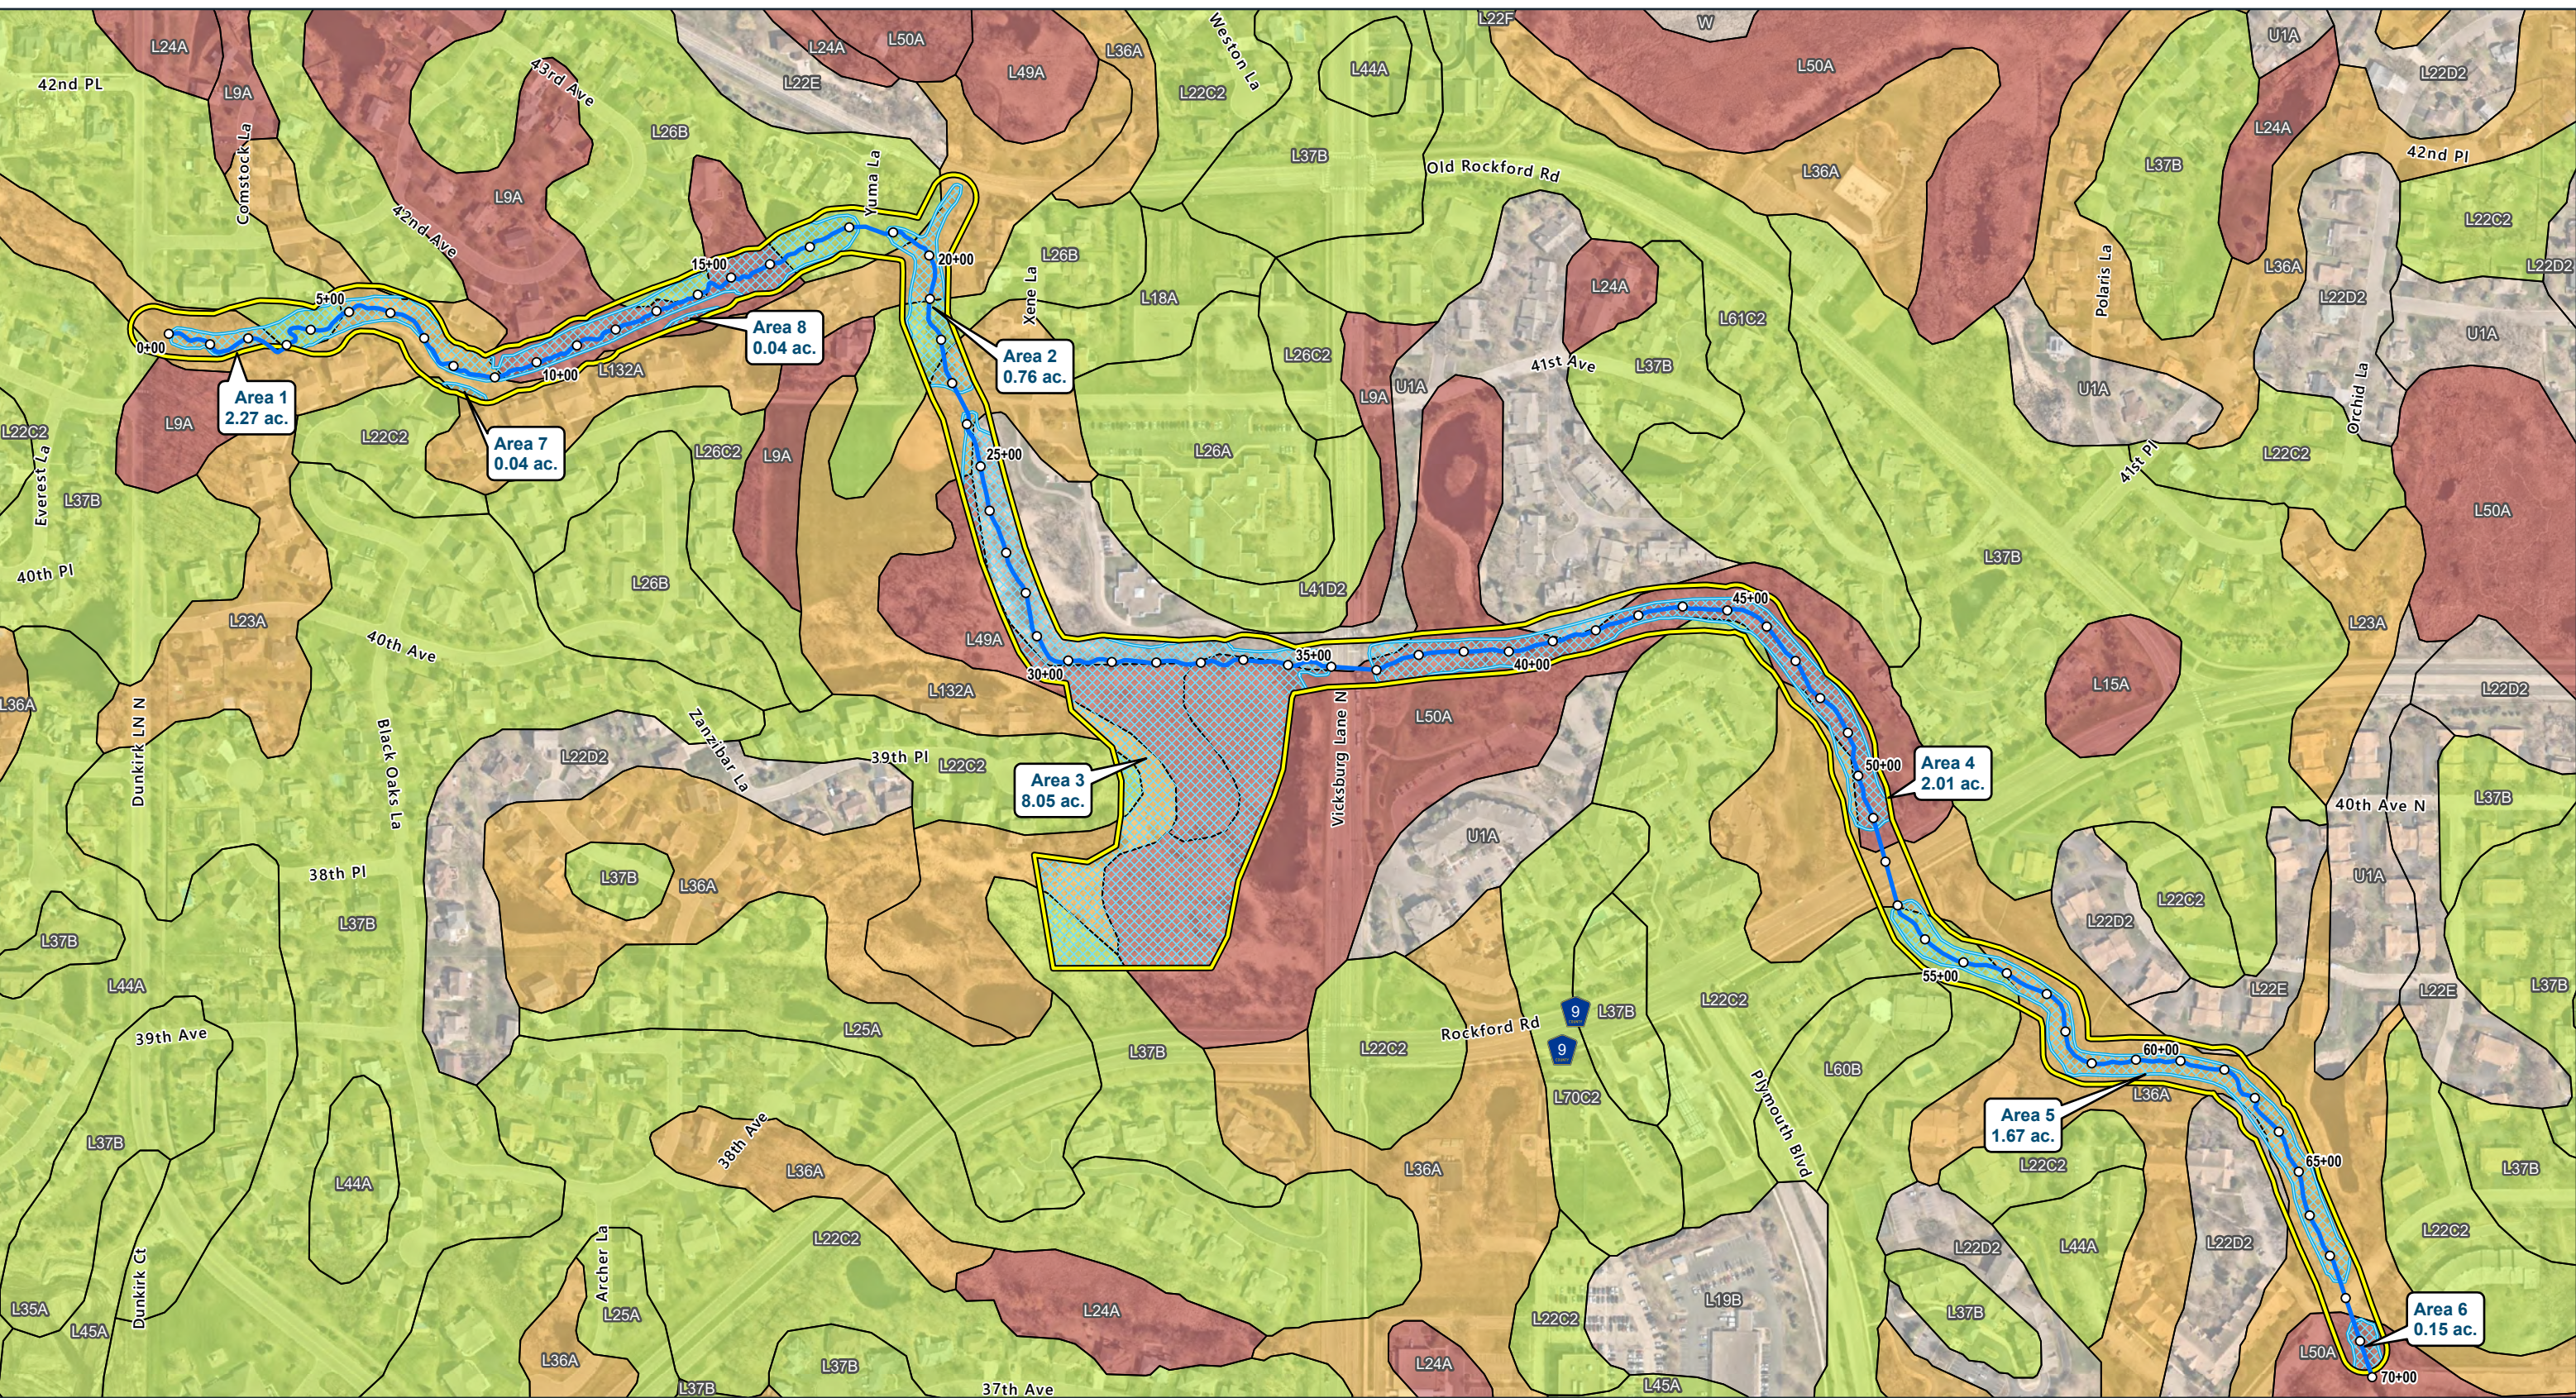
FIGURE 3-2

- Creek Stationing
- Plymouth Creek
- ▭ Study Area
- ▨ Desktop Delineated Wetland

- Hydric Soil Rating (USDA SSURGO)
- Non-Hydric (0%)
 - Predominantly Non-Hydric (1-32%)
 - Predominantly Hydric (66-99%)
 - Hydric (100%)

Our Level 1 review identified 17.02 acres of wetland area within the project area (Table 3-2 and Figure 3-2). This includes the area of the Plymouth Creek channel. The majority of the delineated wetlands are located adjacent to Plymouth Creek and are likely Type 1, Floodplain Forest wetlands. A large wetland complex (Area 3) is located at the northwest intersection of Rockford Road and Vicksburg Lane and is likely a combination of Type 2, Fresh (wet) meadow, and Type 3, Shallow marsh.

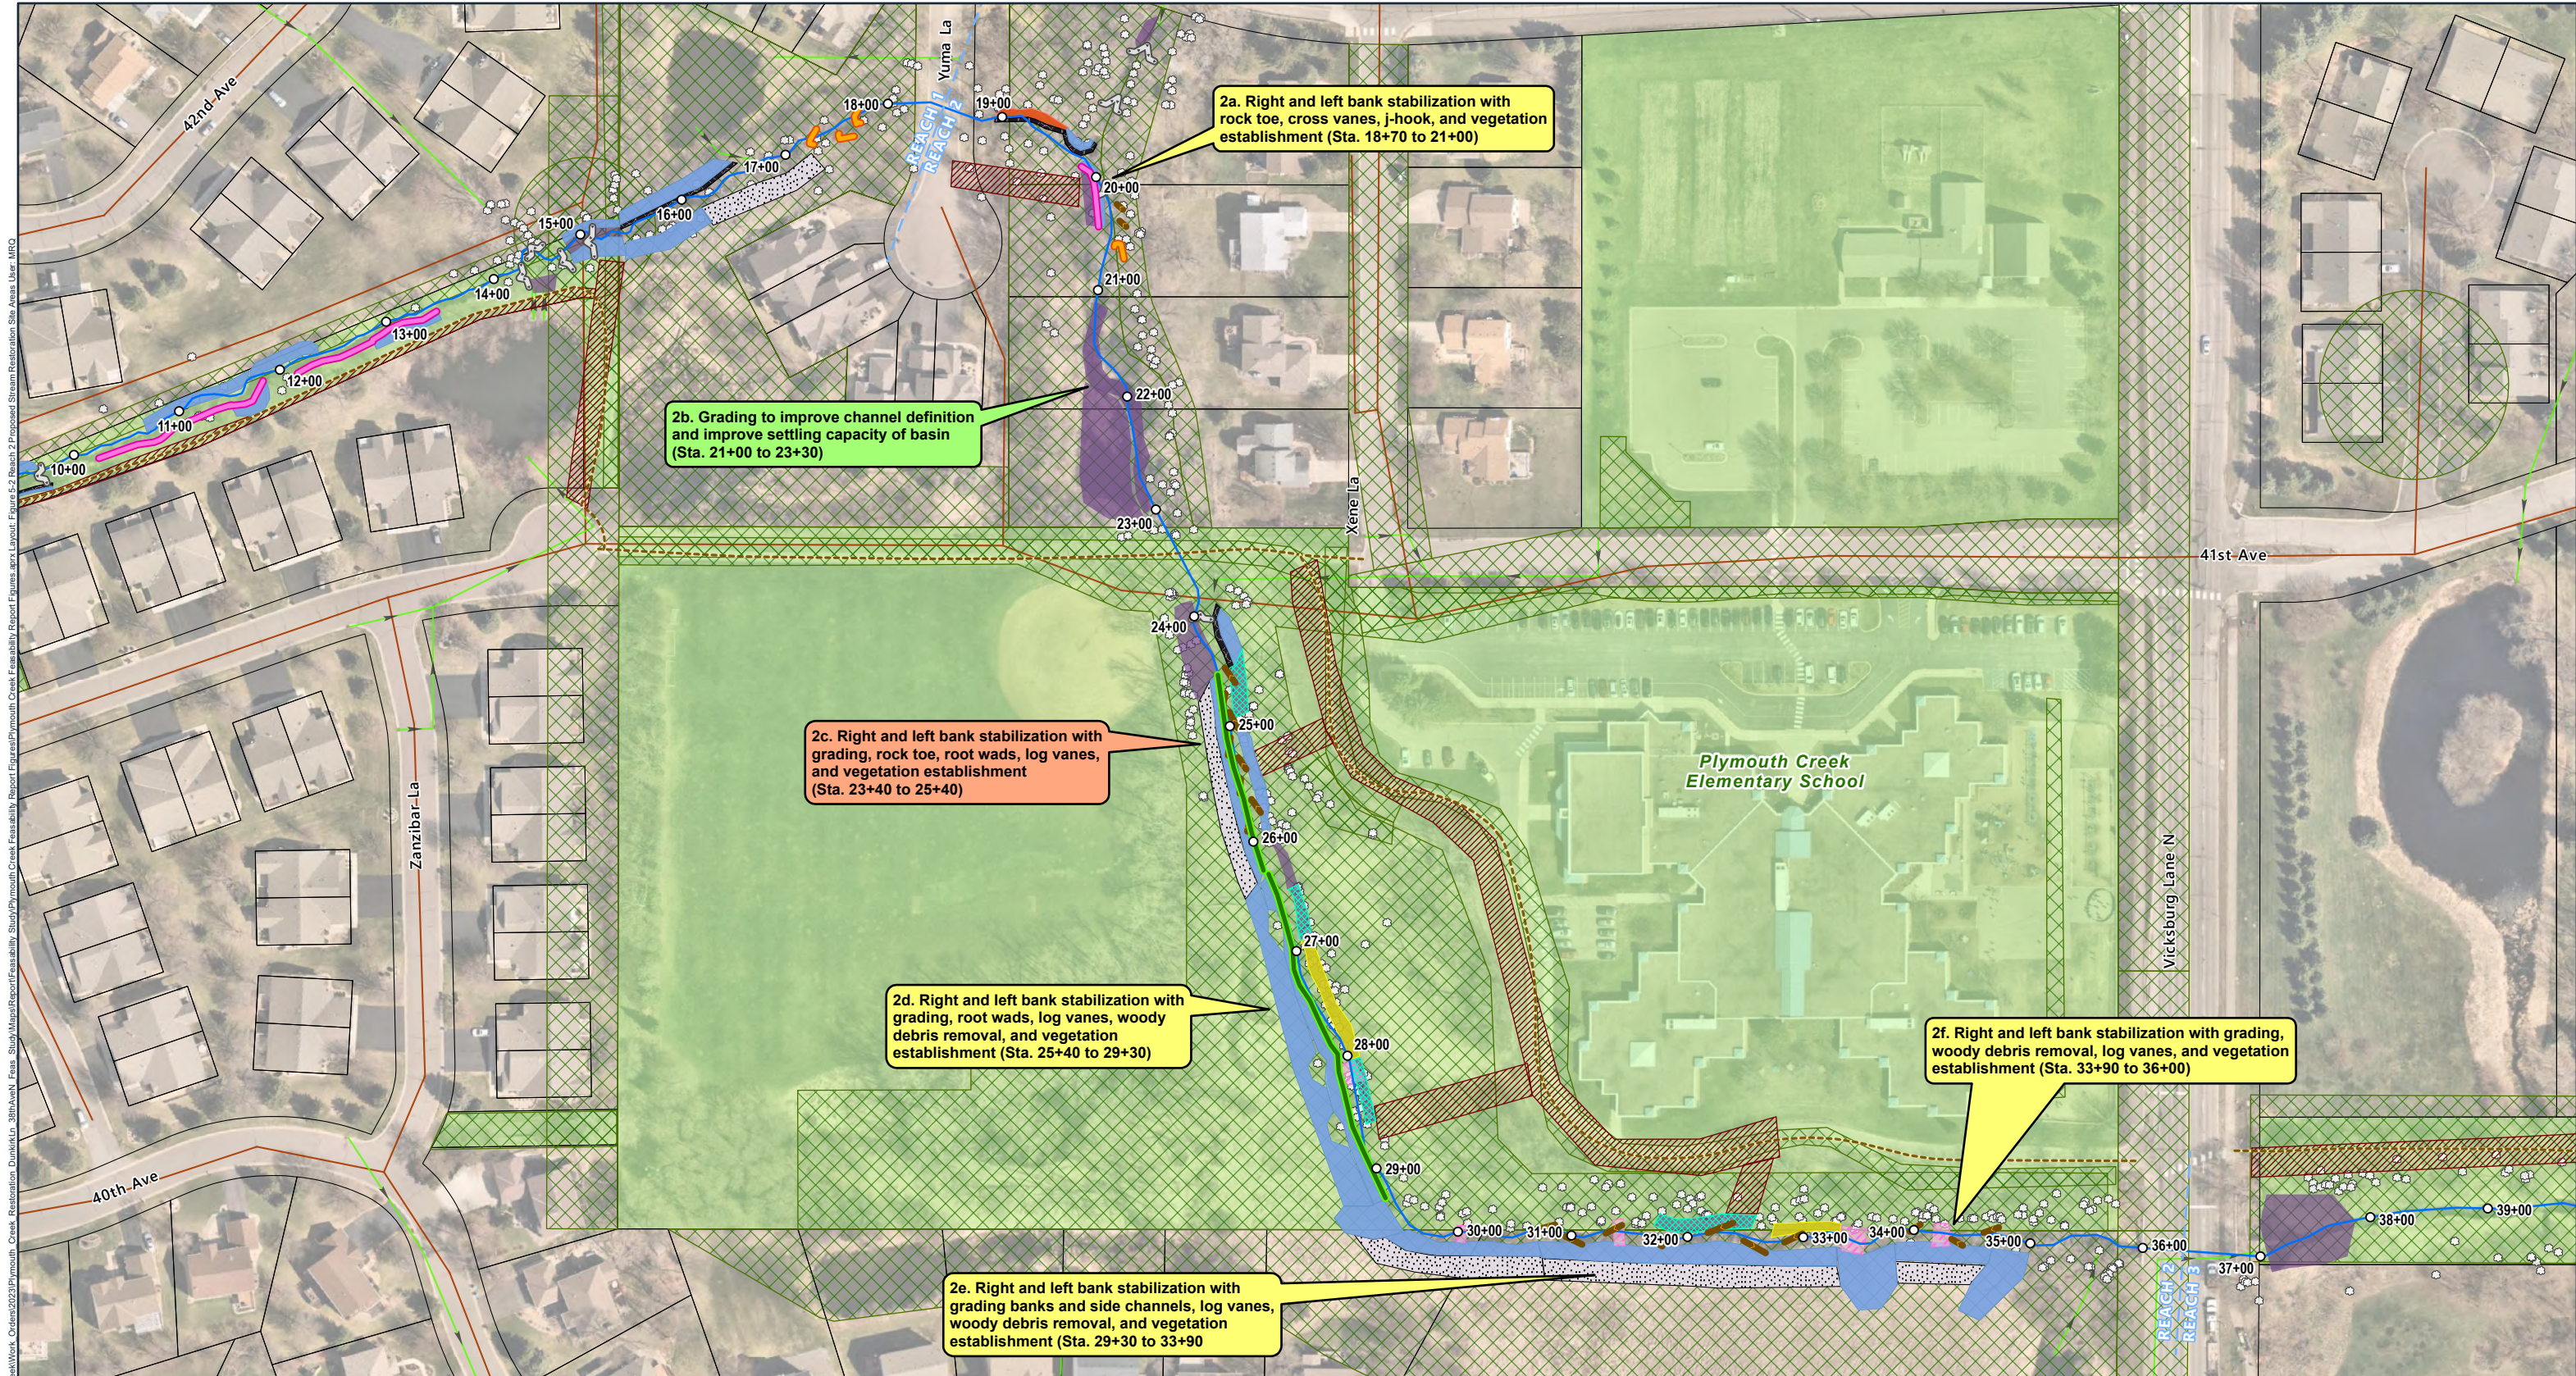
Proposed Stream Restoration Site Areas Reach 1
 Plymouth Creek Stream Restoration Feasibility Study
 BCWMC
 FIGURE 5-1

○ Creek Stationing	□ Parcel Boundary	— Root Wads	■ Plug Planting	■ Priority Level
○ Significant Trees	■ Public Parcel	— Vanes	■ Rock Riprap	■ Low
--- Bike and/or Pedestrian Trail	■ Easements	■ Brush Mattresses	■ Seeding	■ Medium
— Gravity Storm Sewer	Proposed Restoration	■ Construction Access	■ VRSS	■ High
— Sanitary Main	— Coir Log	■ Debris Removal		
— Plymouth Creek	— Cross-Vanes	■ Grading		
--- Reach Breakline	— J-Hook	■ Live Staking

This study identifies 26 restoration areas, defined as areas of similar erosion properties and prioritization metrics, within the approximate 7,000-foot assessed reach. The restoration areas are ranked from low to high priority. Figure 5-1 shows the potential restoration areas, and Table 5-3 details the proposed restoration methods for each area.

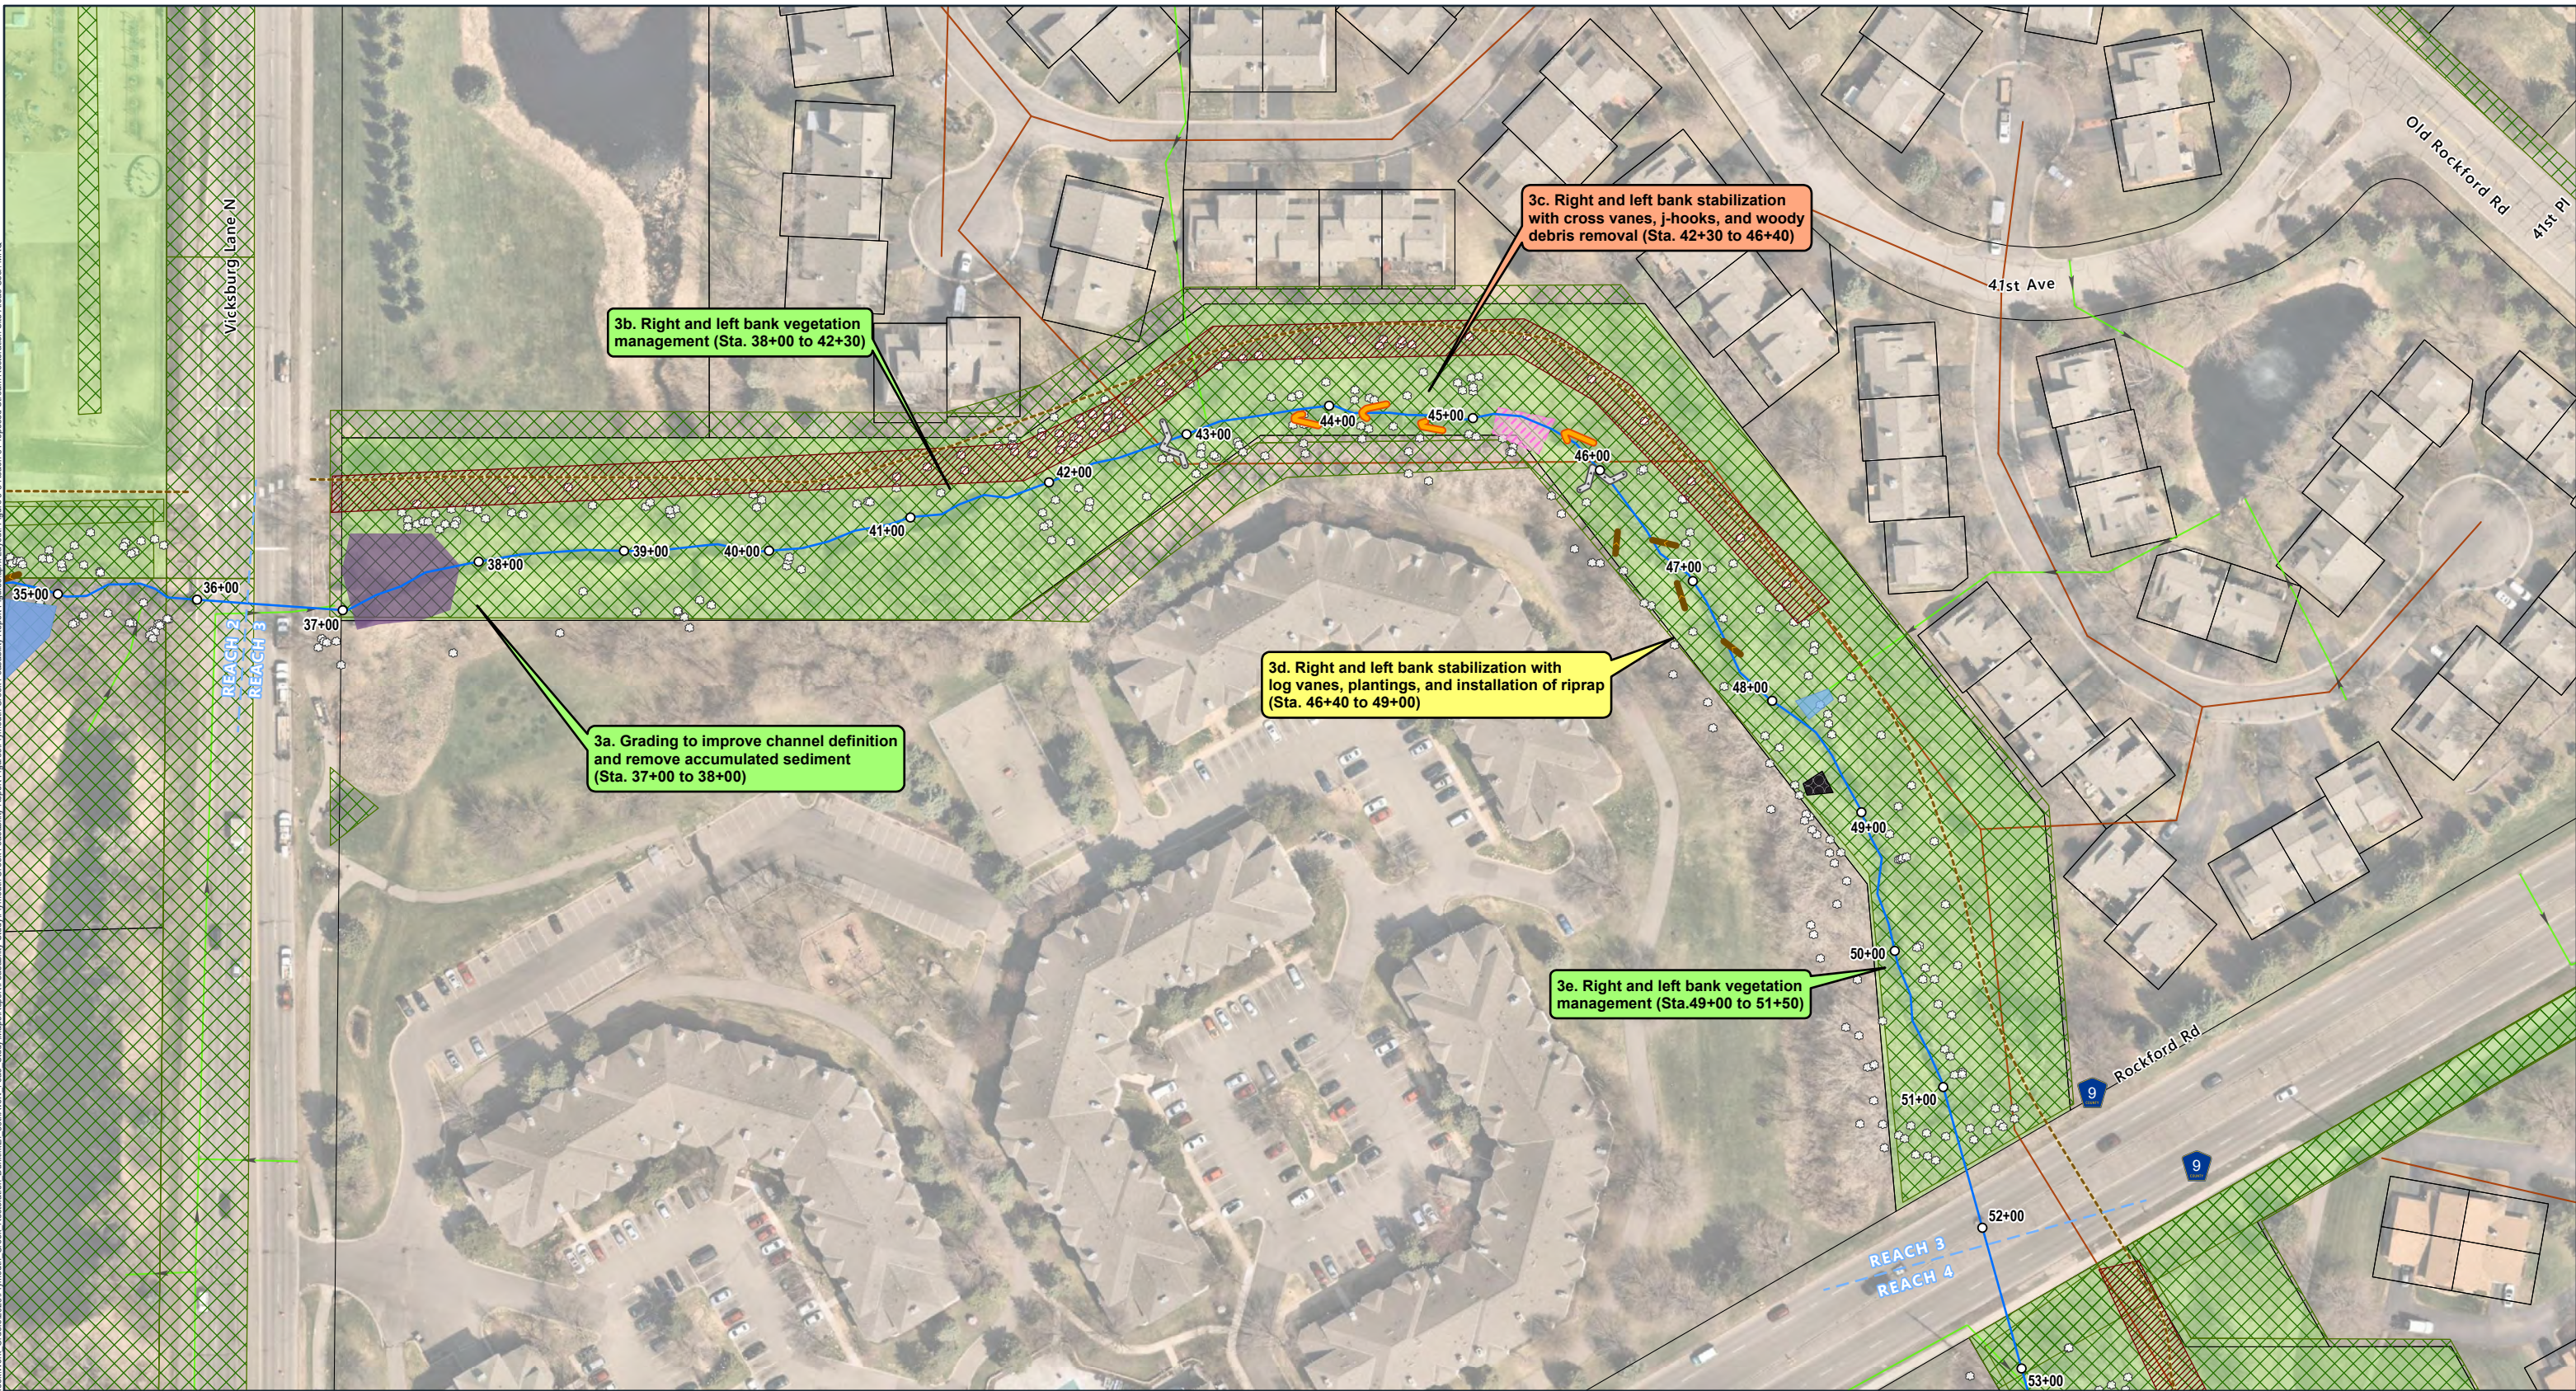
Proposed Stream Restoration Site Areas
Reach 3
 Plymouth Creek Stream Restoration Feasibility Study
 BCWMC
 FIGURE 5-3

- Creek Stationing
- ⊙ Significant Trees
- - - Bike and/or Pedestrian Trail
- Gravity Storm Sewer
- Sanitary Main
- Plymouth Creek
- - - Reach Breakline

- Parcel Boundary
- Public Parcel
- ▧ Easements
- Proposed Restoration
- ⊖ Cross-Vanes
- J-Hook
- Vanes

Table 5-3 Proposed Restoration Areas (areas shown in Figure 5-1 through Figure 5-4)

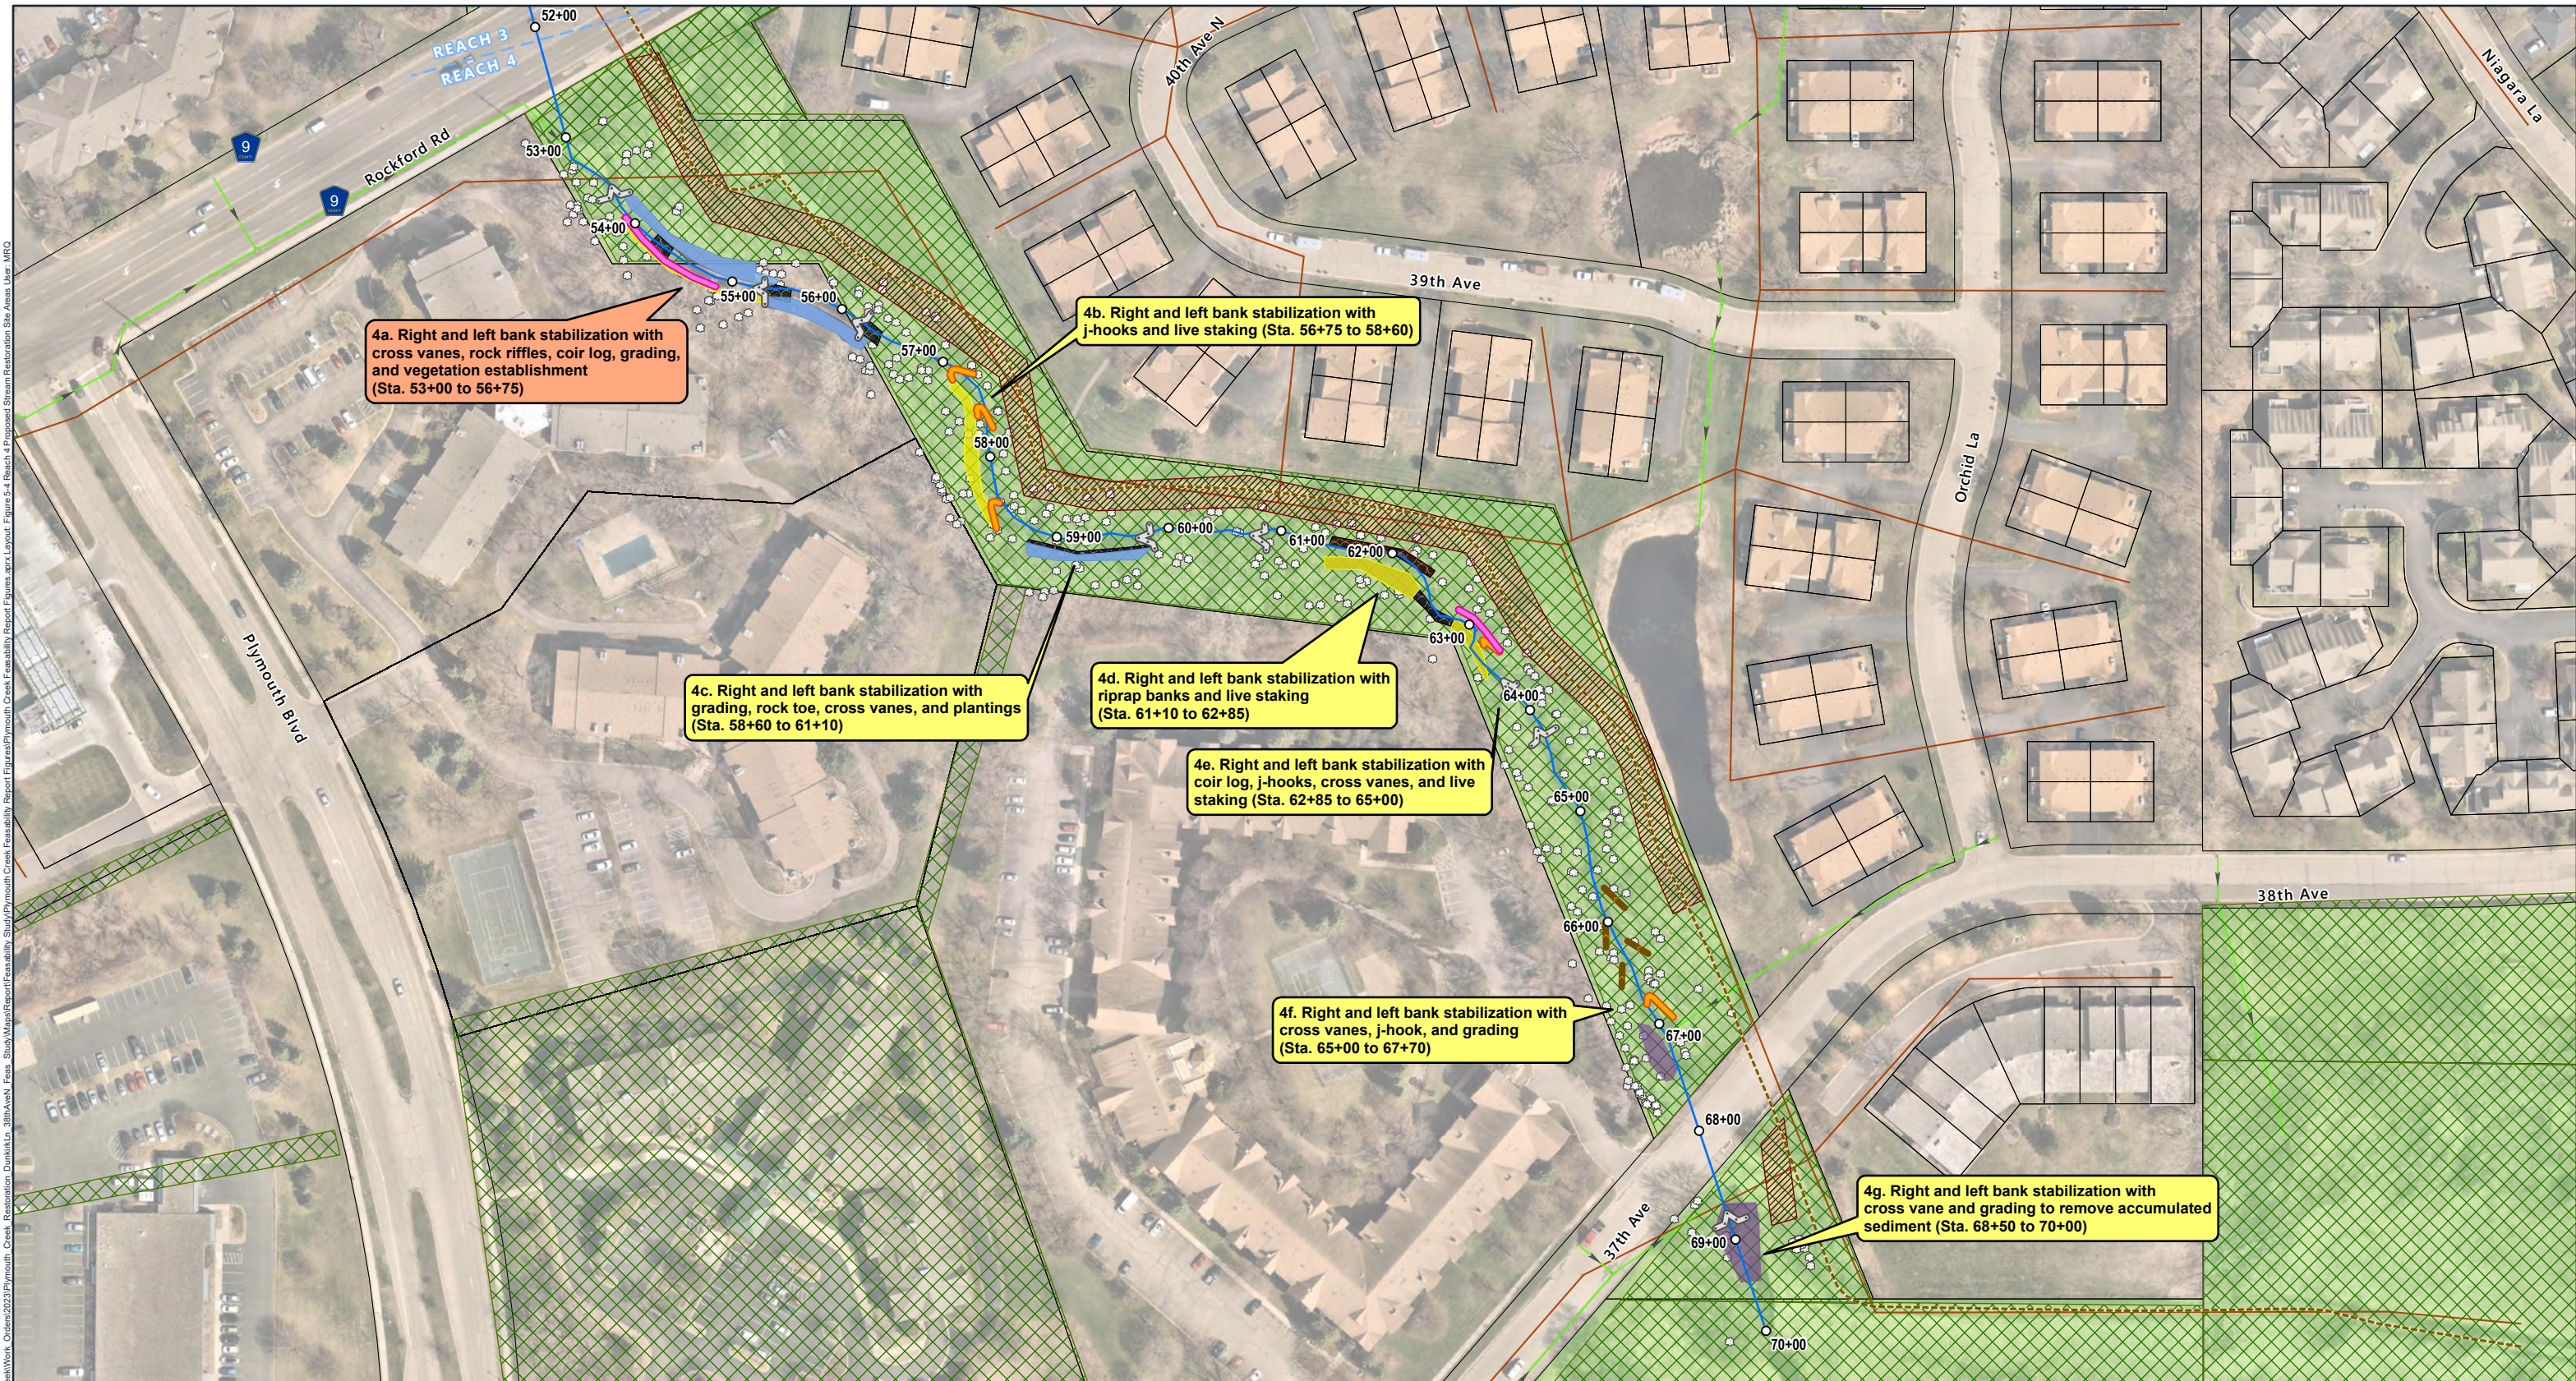
Proposed Stream Restoration Site Areas Reach 4
 Plymouth Creek Stream Restoration Feasibility Study
 BCWMC
 FIGURE 5-4

| ○ Creek Stationing | ▭ Parcel Boundary | ▨ Construction Access | Priority Level |

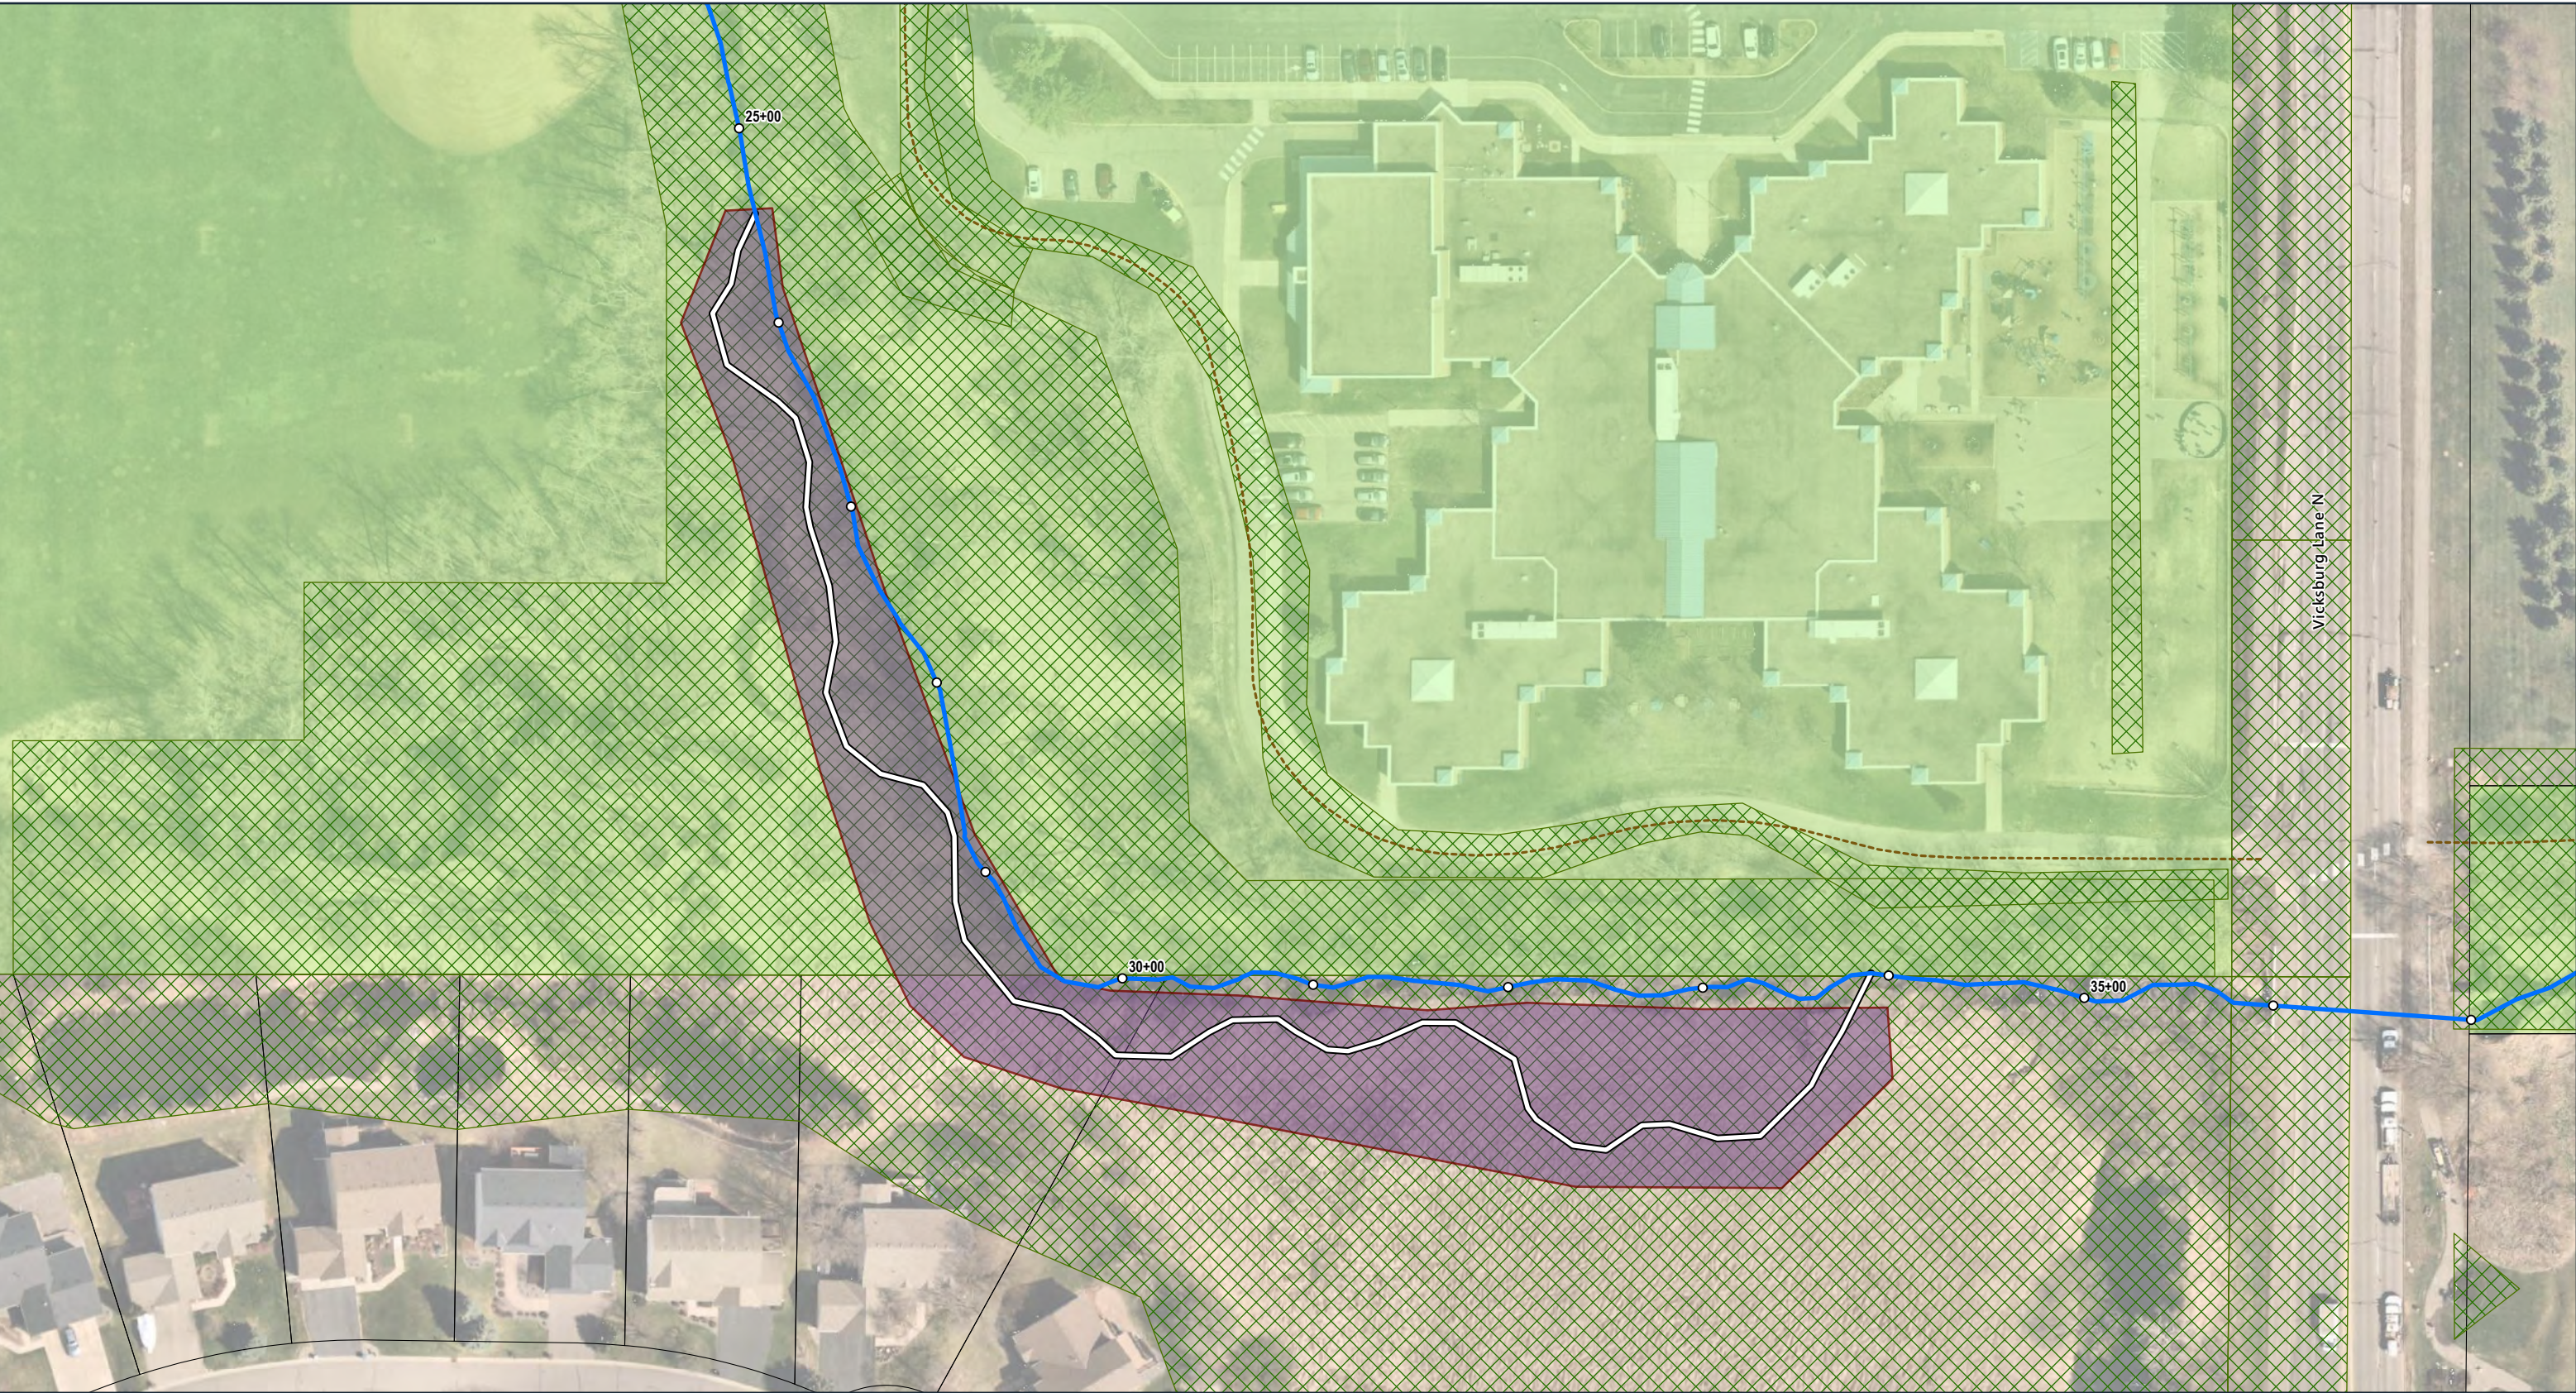
- Creek Stationing
- Plymouth Creek
- Potential Re-meander
- - - Bike and/or Pedestrian Trail
- Grading Extents
- Parcel Boundary
- Public Parcel

- Increasing stream length and sinuosity
- Decreasing velocities and likelihood of bank erosion by allowing flows exceeding the bankfull event to spread out and disperse energy across the wider floodplain
- Increasing resiliency during higher flow storm events
- Enhancing in-stream, and riparian habitat
- Promoting groundwater connectivity if new channel bedding includes void spaces for sub-surface flow
- Enhancing geomorphic processes including sediment transport and deposition
- Enhancing floodplain connectivity if floodplain grading is incorporated into the design

Although reestablishing a meandering pattern could improve the stream as described above, the meander restoration alternative has a higher construction cost, which is discussed further in Section 7.
