Plymouth Creek Stream Restoration Project (2025 CR-P) Feasibility Report

Plymouth, Minnesota

Prepared for
Bassett Creek Watershed Management Commission

May 2024

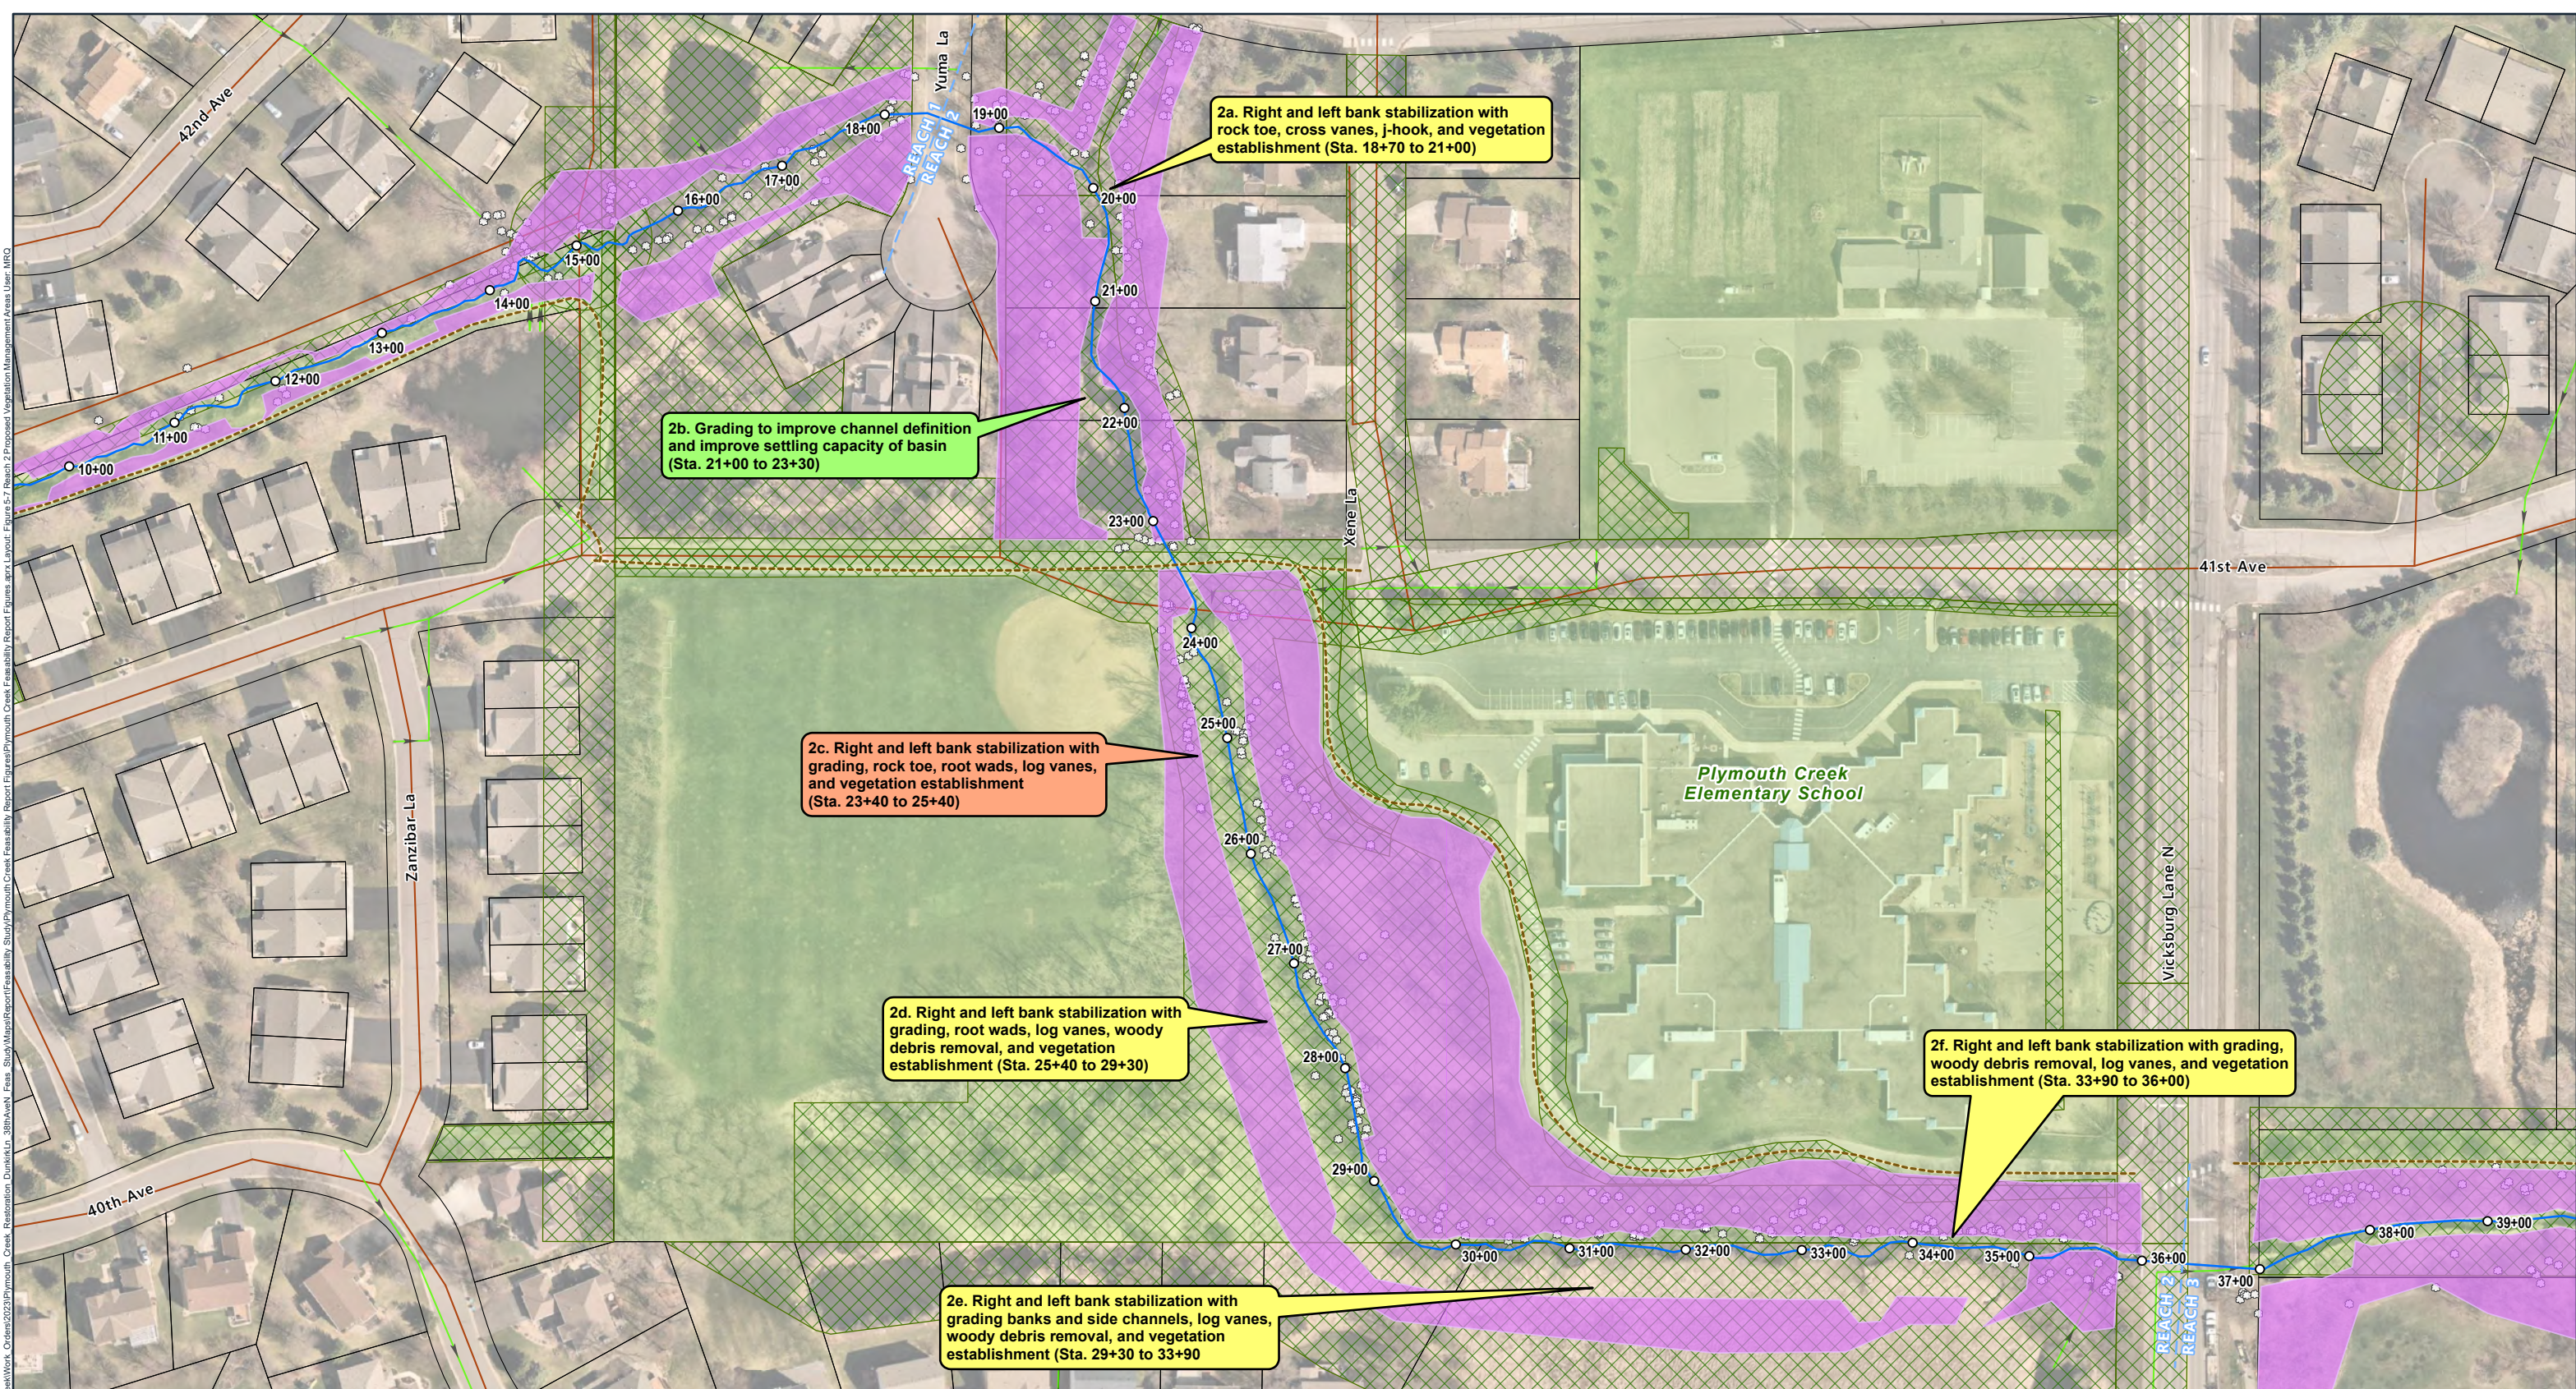
Proposed Vegetation Management Areas
Reach 1
 Plymouth Creek Stream Restoration Feasibility Study
 BCWMC
 FIGURE 5-6

- Creek Stationing
 - Significant Trees
 - - - Bike and/or Pedestrian Trail
 - Gravity Storm Sewer
 - Sanitary Main
 - Plymouth Creek
 - - - Reach Breakline
- Parcel Boundary
 - Public Parcel
 - Easements
 - Proposed Vegetation Management Area
- Priority Level
 - Low
 - Medium
 - High

Riparian vegetation management adjacent to proposed in-stream and streambank restoration areas is a proposed component of every option in this feasibility study. Typically, the proposed vegetation management areas are 25 to 40 feet wide but can be as narrow as 15 feet and as wide as 80 feet. The vegetation management width changes due to the varying proximity of the creek to buildings and the bike/pedestrian trail Figure 5-6 through Figure 5-9.

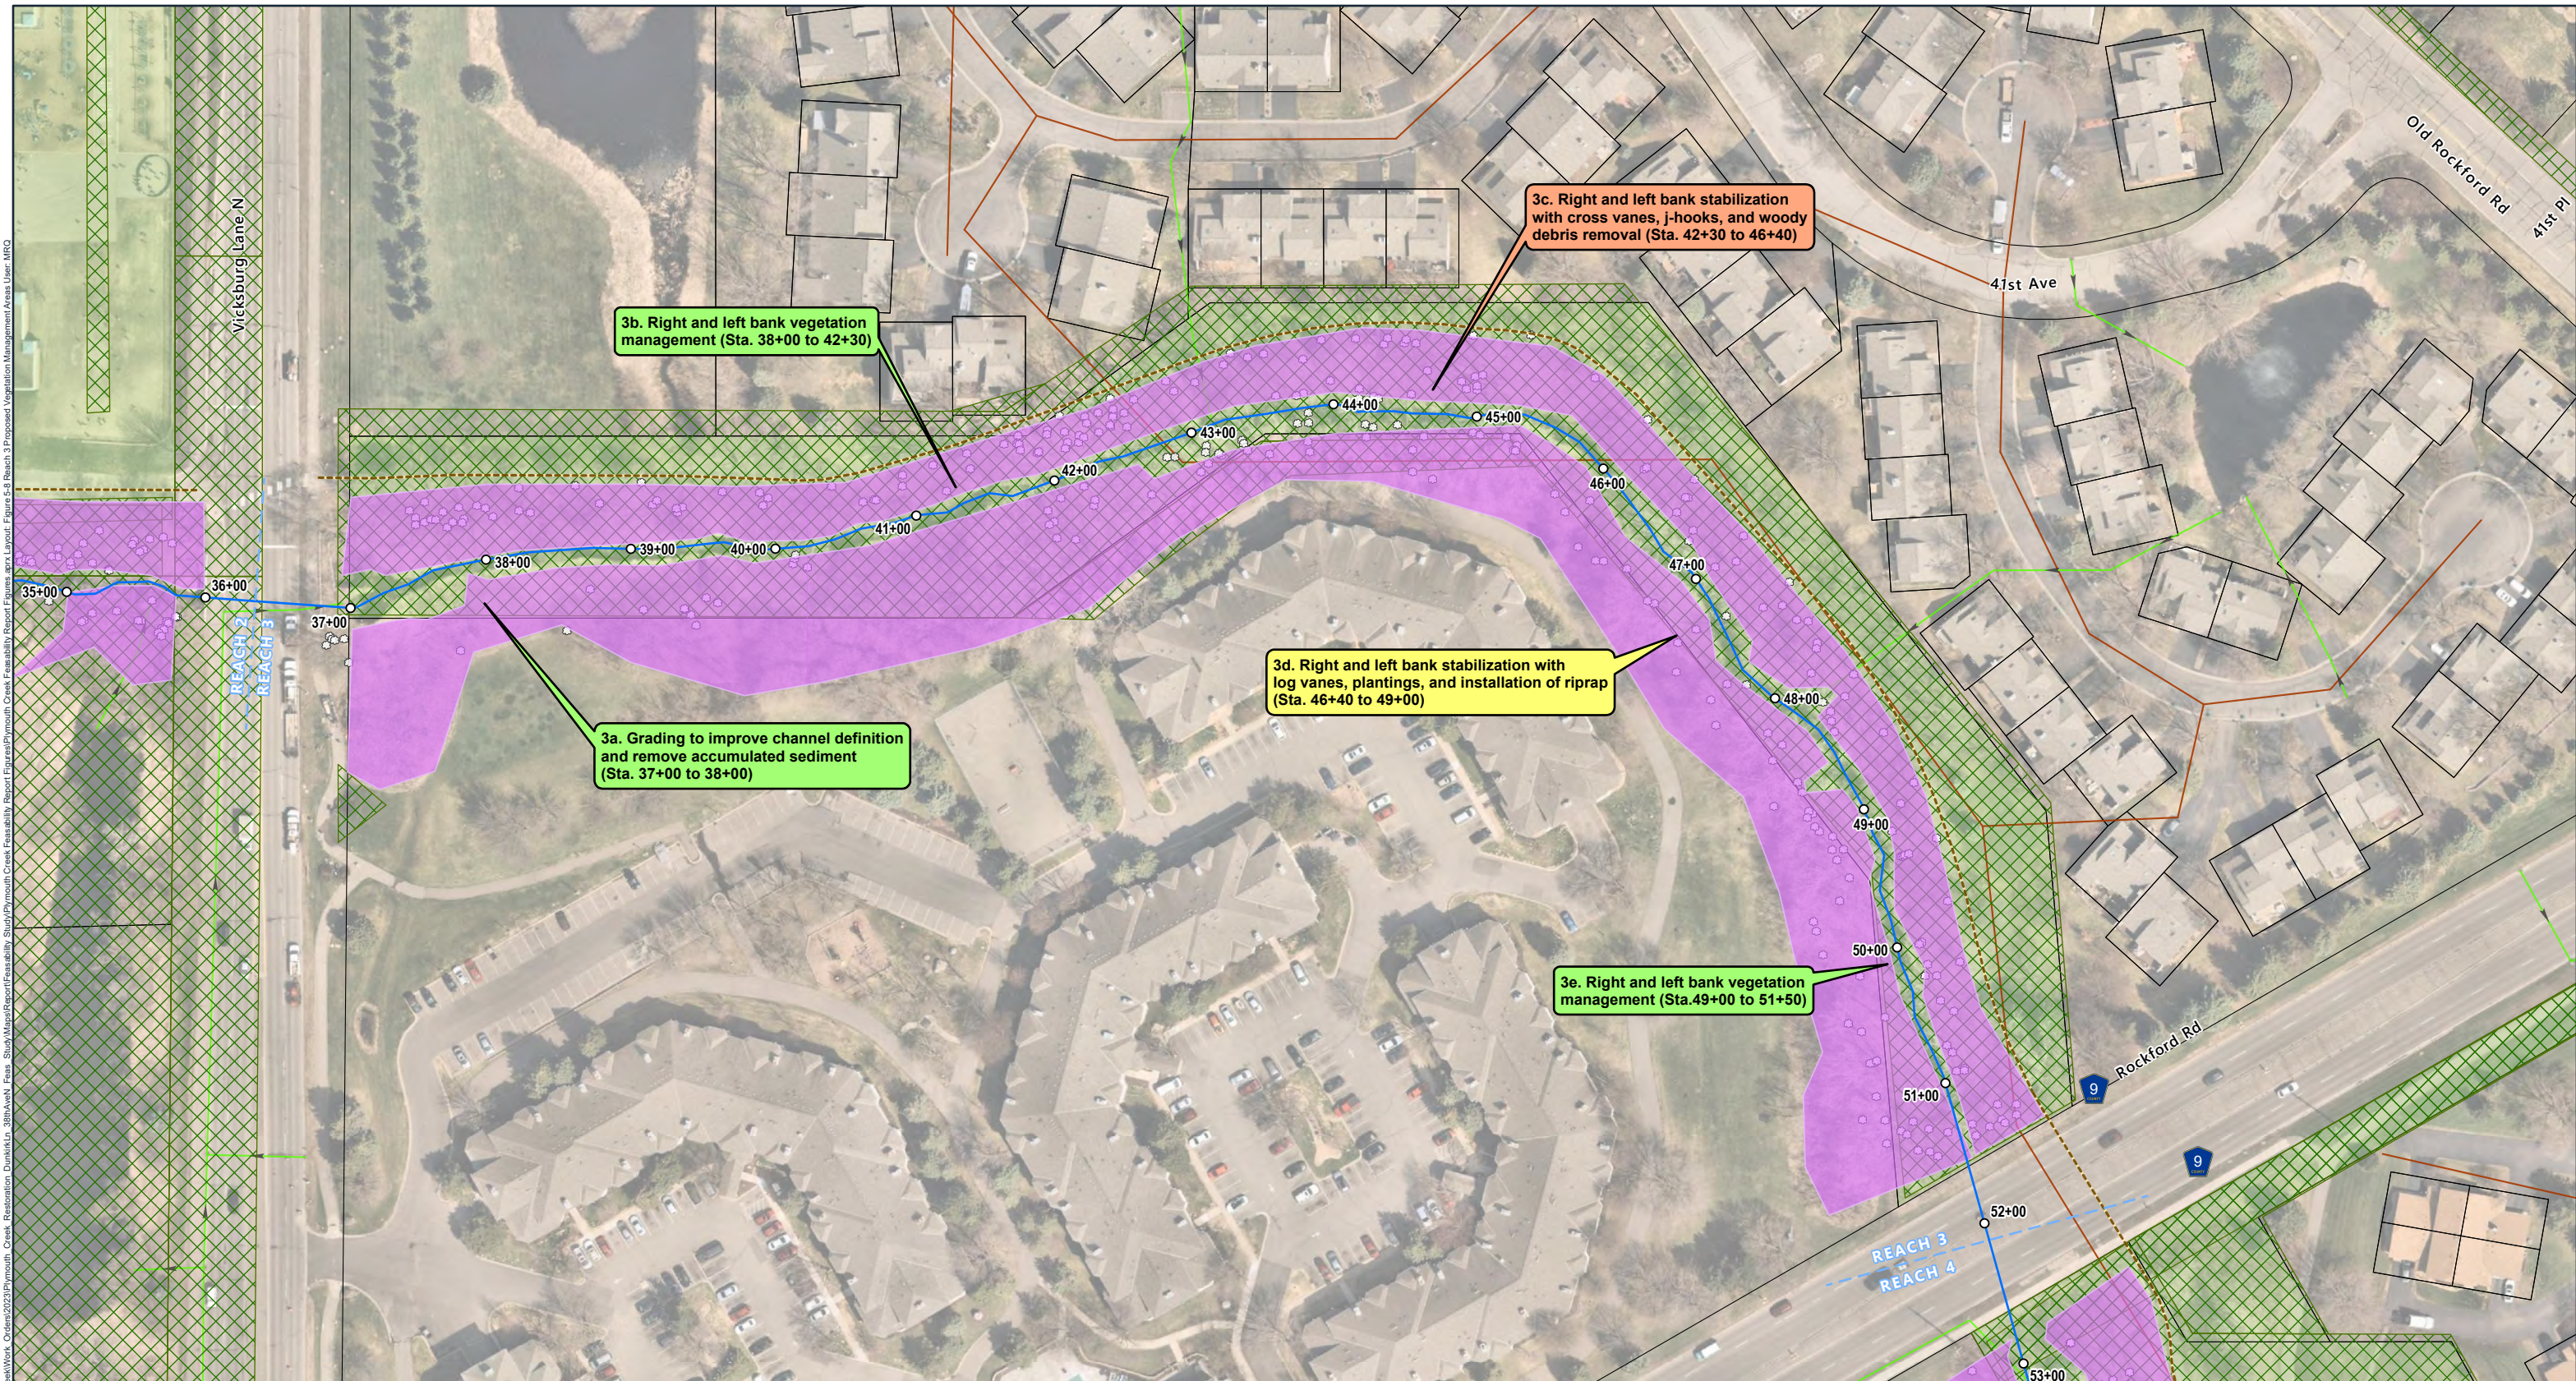
3b. Right and left bank vegetation management (Sta. 38+00 to 42+30)

3c. Right and left bank stabilization with cross vanes, j-hooks, and woody debris removal (Sta. 42+30 to 46+40)

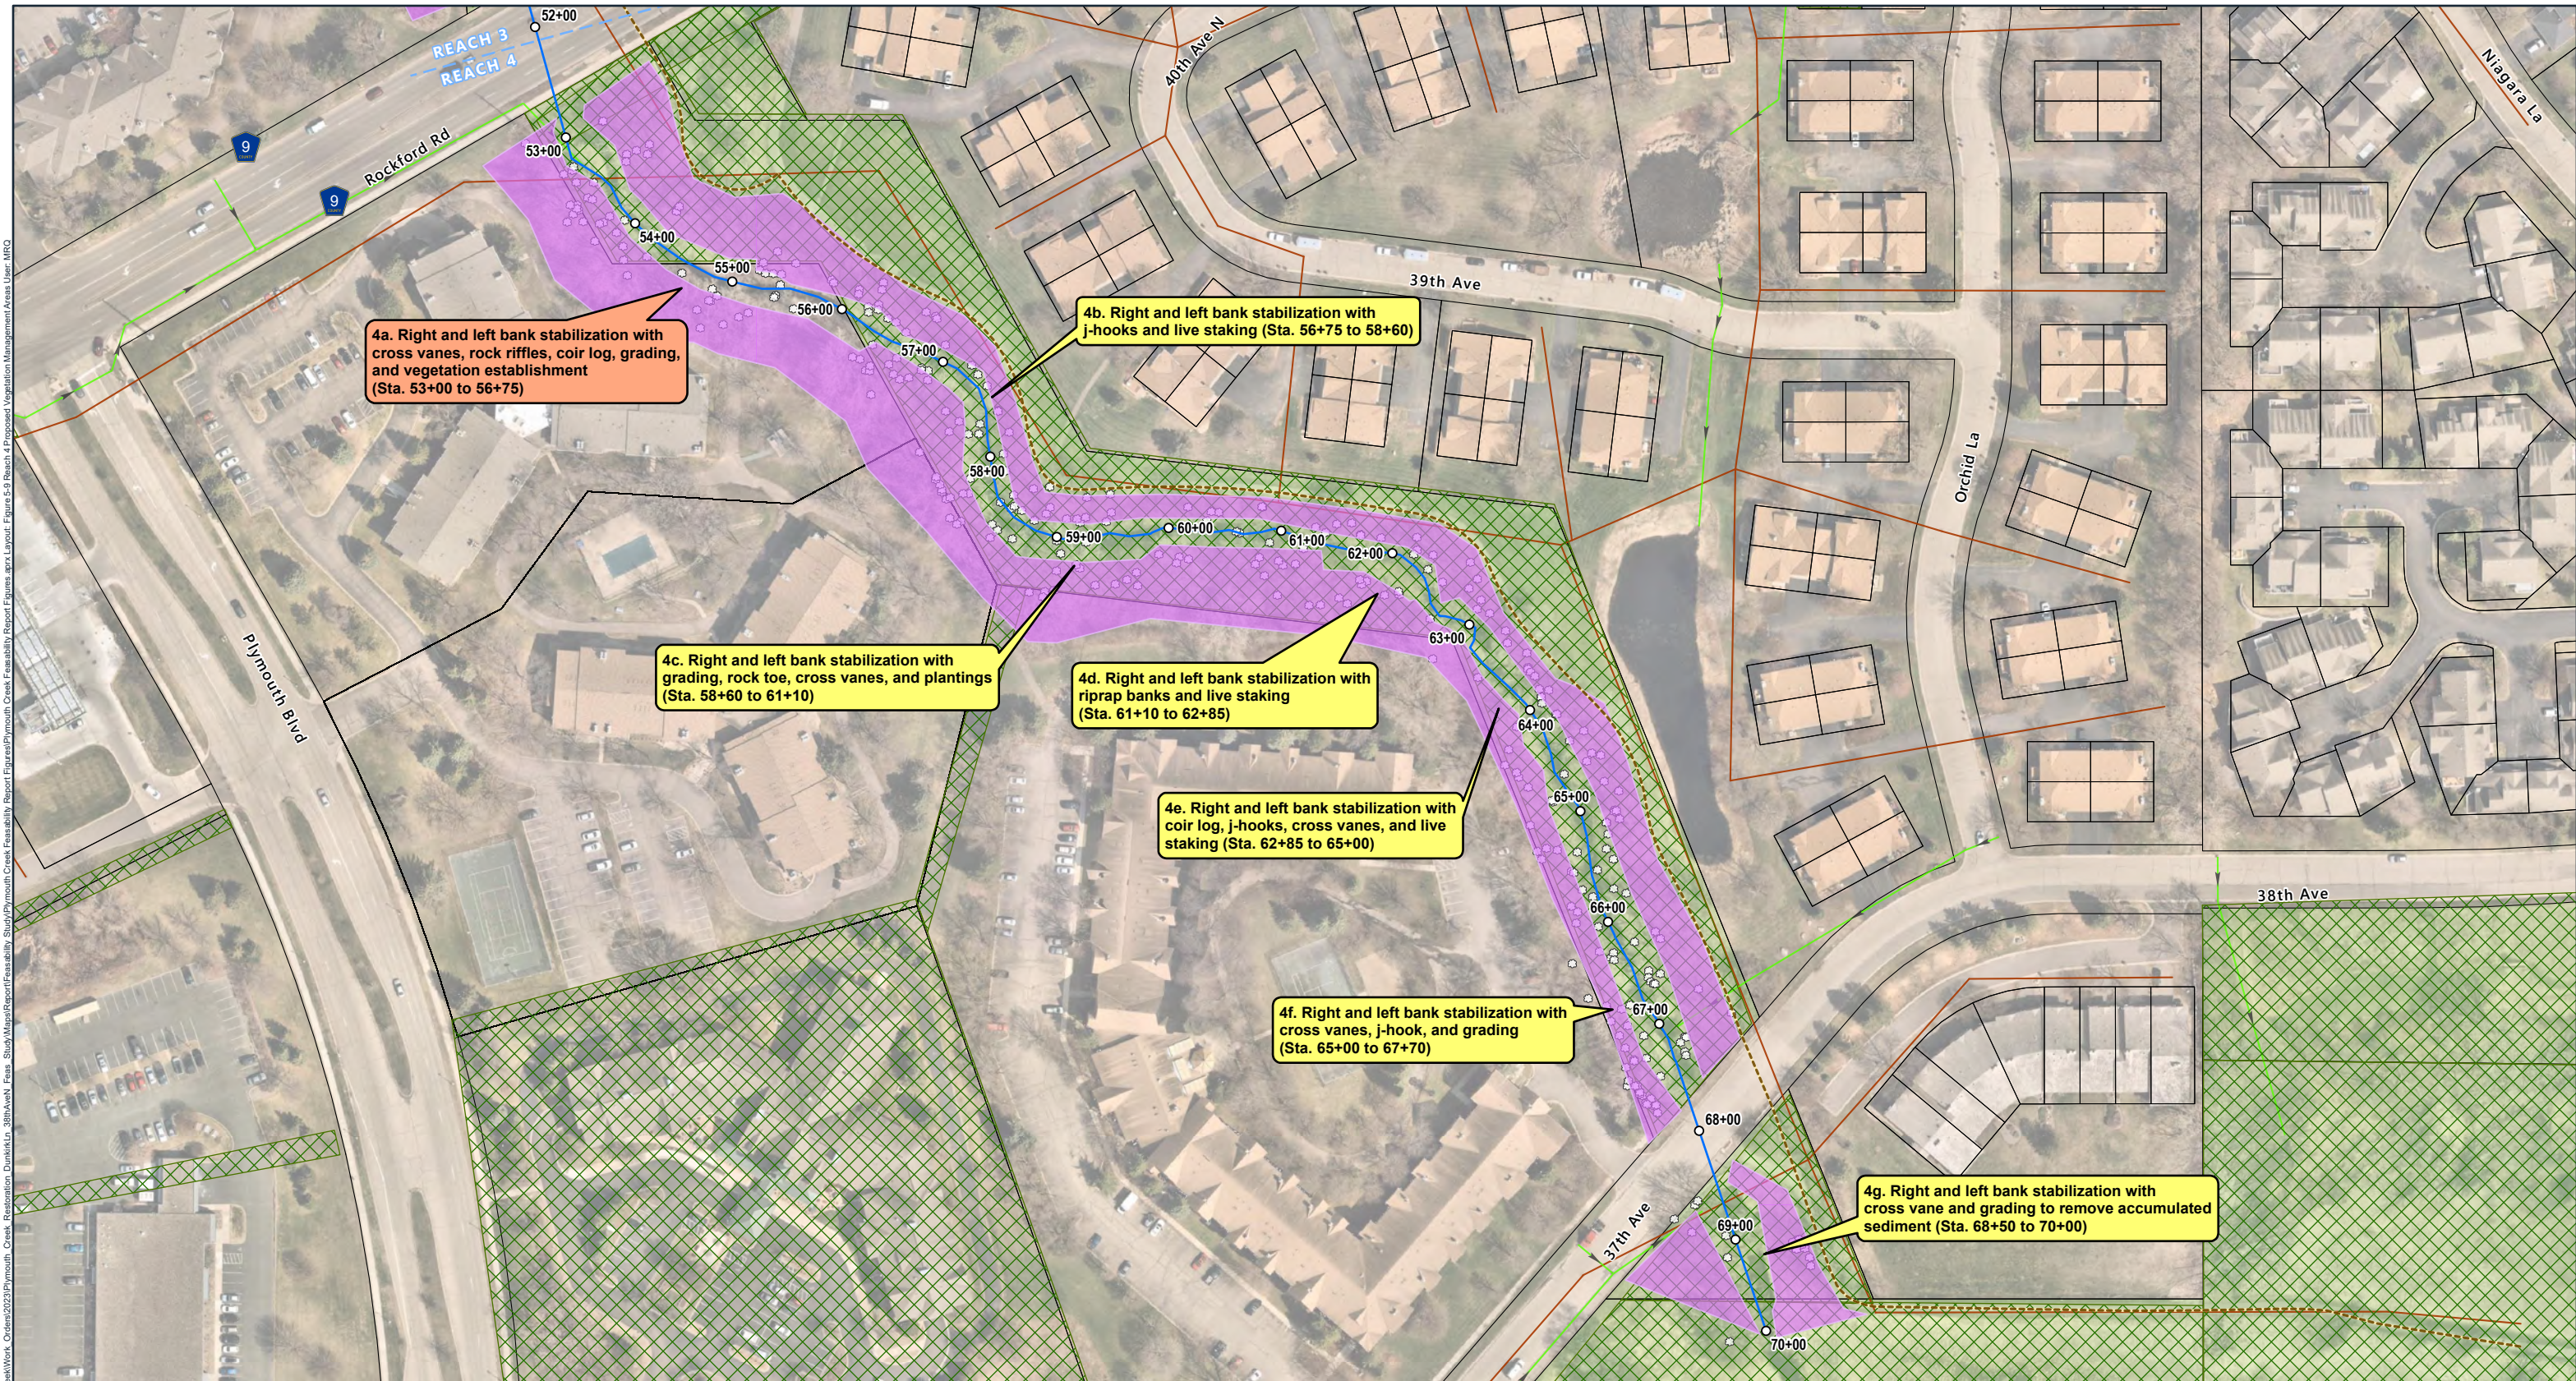
4a. Right and left bank stabilization with cross vanes, rock riffles, coir log, grading, and vegetation establishment (Sta. 53+00 to 56+75)

4b. Right and left bank stabilization with j-hooks and live staking (Sta. 56+75 to 58+60)
