**ARCHAEOLOGICAL INVESTIGATION CONDUCTED FOR THE
PLYMOUTH CREEK STREAM CHANNEL RESTORATION FEASIBILITY STUDY,
CITY OF PLYMOUTH,
HENNEPIN COUNTY, MINNESOTA**

Bassett Creek Watershed Management Commission

**Barr Engineering
4300 MarketPointe Dr
Minneapolis, MN 55435**

January 2016

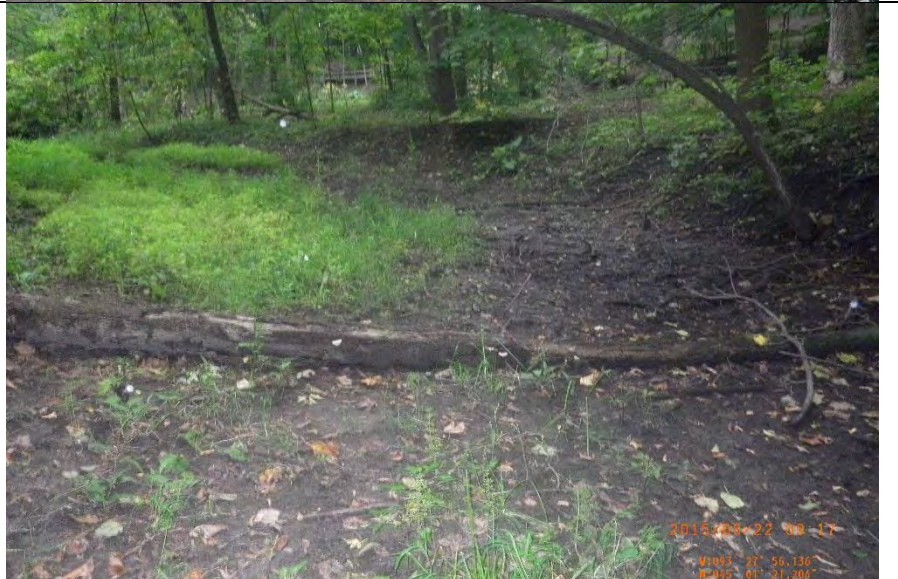
Photo 3 – September 22, 2015

Wetland 1

Facing southeast. This photo
shows the eroded edge of
Wetland 1 and saturated soils.

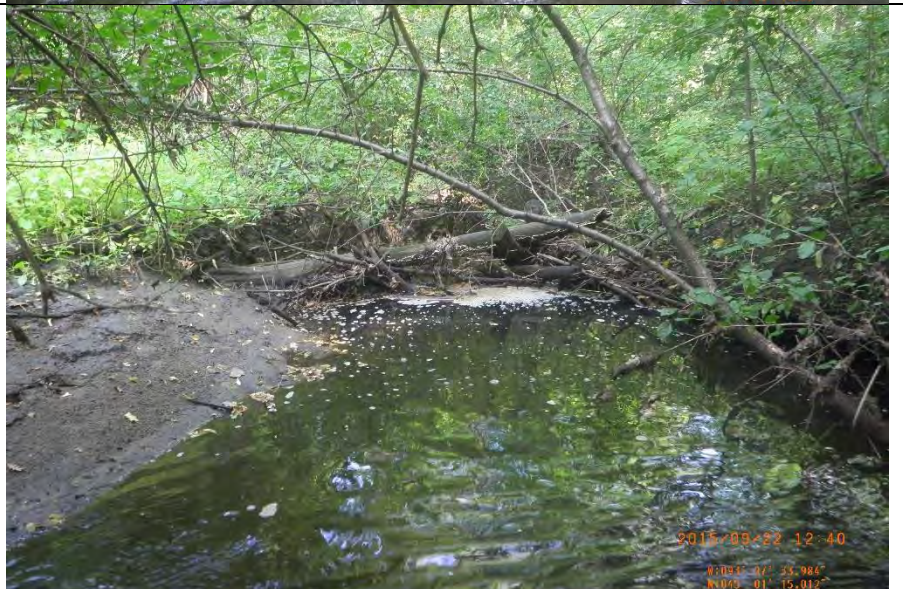
Study Reach
(East of Fernbrook Ln. N)

Many areas within the stream reach east of Fernbrook Lane have snags that obstruct water flow

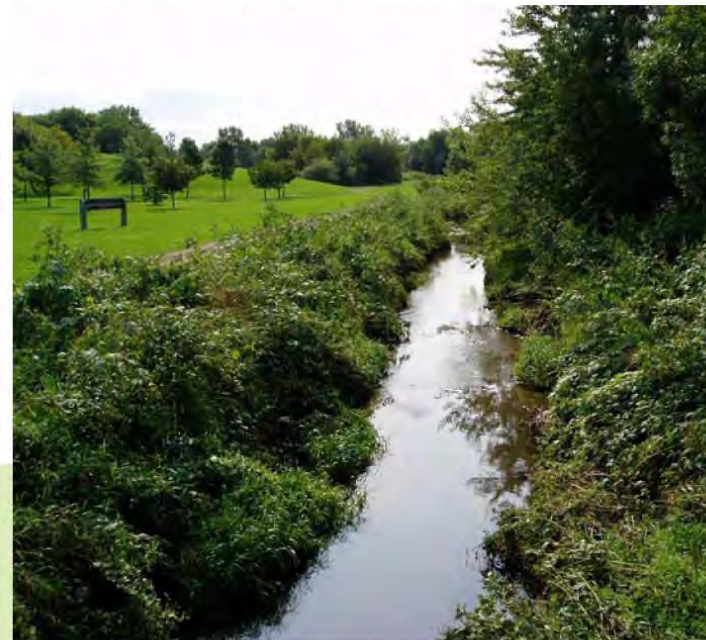
EXISTING CONDITIONS

Channel incision occurs when there is an imbalance between the sediment supply and the sediment carrying capacity of the stream. Erosion will occur when the sediment carrying capacity of a stream exceeds the sediment supply. In streams with cohesive banks and steep channel slope, the erosion will first occur primarily on the channel bottom because that is where the erosive forces are the strongest. As the channel deepens, the stream will gradually become wider as the banks eventually fail. The stream will gradually return to equilibrium; however, the process can take many years and significant amounts of erosion will occur during the process.

Grade control measures are used where channel downcutting has occurred. Various types of weirs are commonly used to provide grade control on streams, particularly in steeper systems. Weirs can be constructed of sheetpile, concrete, or natural materials such as rock. In most cases, natural rock is used to emulate natural riffles. Large boulders would comprise the core of the structure, with smaller rock material placed on the upstream and downstream sides of the boulders to provide a gradual transition to the channel.

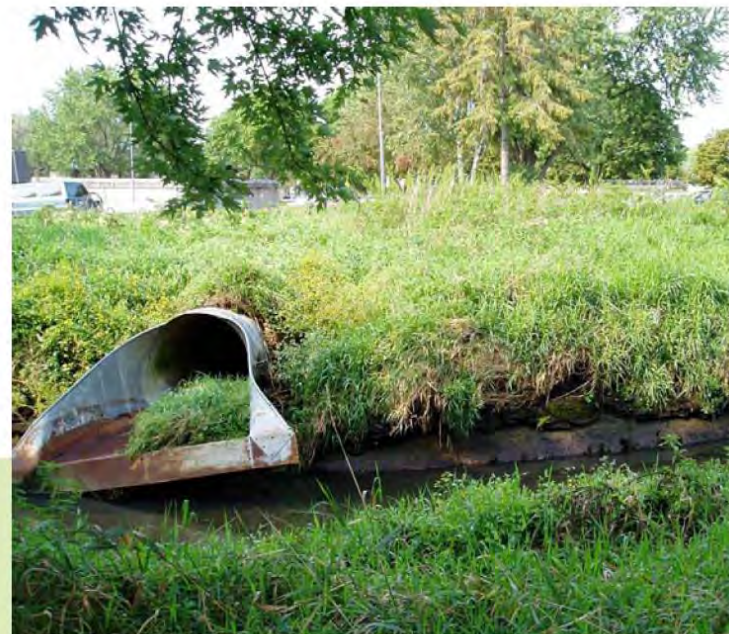
EXISTING CONDITIONS

Erosion is frequently observed at culvert outlets for a variety of reasons, including insufficient erosion protection at the culvert outlet, streambank erosion, and channel downcutting, which leaves the culvert perched above the channel. Filter fabric is often used at culvert outlets to separate riprap protection from underlying soils, however the fabric provides a slippery surface for the riprap, which commonly slides into the channel.

Culvert Stabilization is somewhat unique to each situation, depending on the site circumstances. Most sites require additional rock placement with a granular filter layer (rather than filter fabric). Some cases may require re-alignment and/or lowering of the outlet to better align with the stream channel. Typically, outlets should be aligned in the downstream channel direction so that flow doesn't impinge on the opposite bank. It is usually desirable for the culvert to enter the stream at or just above the normal water level in order to minimize the potential for undercutting.
