Feasibility Report for North Branch Bassett Creek Restoration Project

Crystal, Minnesota

September 2010

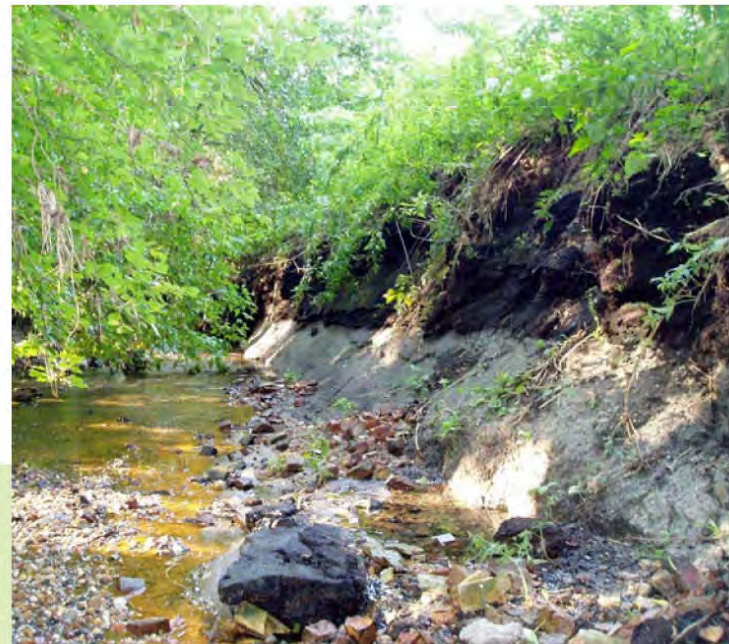
Fluvial bank erosion is caused by water in the stream moving past the streambanks. The shear stress caused by the flow entrains soil particles into the flow, causing the stream bank to erode away. This is the most common type of erosion that occurs in streams. Virtually all streams experience this type of erosion as their flow path evolves over time. However, the rate of fluvial bank erosion can increase when the stream is out of equilibrium with its watershed. Increased flow from a watershed will increase the rate of fluvial bank erosion. In many cases, it appears to be a part of the natural process of stream evolution. In places where the channel is confined by the valley walls, however, fluvial bank erosion can lead to failure of the high banks. It can also undermine storm sewer inlets.

Stone Toe Protection is constructed from cobble-sized rock on the creek edges. It extends to approximately the bankfull level, which will protect the channel banks for flow events that occur every 1 to 2 years or less. The material will extend into the ground to resist scour. Coarse gravel is used to separate the larger rock material from underlying soil. Stone toe protection is typically used in conjunction with revegetation of the upper banks.

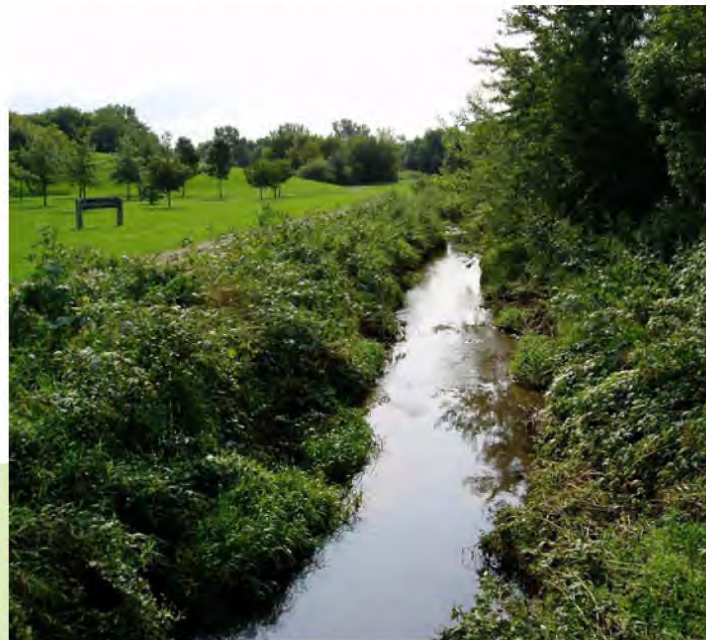
Channel incision occurs when there is an imbalance between the sediment supply and the sediment carrying capacity of the stream. Erosion will occur when the sediment carrying capacity of a stream exceeds the sediment supply. In streams with cohesive banks and steep channel slope, the erosion will first occur primarily on the channel bottom because that is where the erosive forces are the strongest. As the channel deepens, the stream will gradually become wider as the banks eventually fail. The stream will gradually return to equilibrium; however, the process can take many years and significant amounts of erosion will occur during the process.

Grade control measures are used where channel downcutting has occurred. Various types of weirs are commonly used to provide grade control on streams, particularly in steeper systems. Weirs can be constructed of sheetpile, concrete, or natural materials such as rock. In most cases, natural rock is used to emulate natural riffles. Large boulders would comprise the core of the structure, with smaller rock material placed on the upstream and downstream sides of the boulders to provide a gradual transition to the channel.

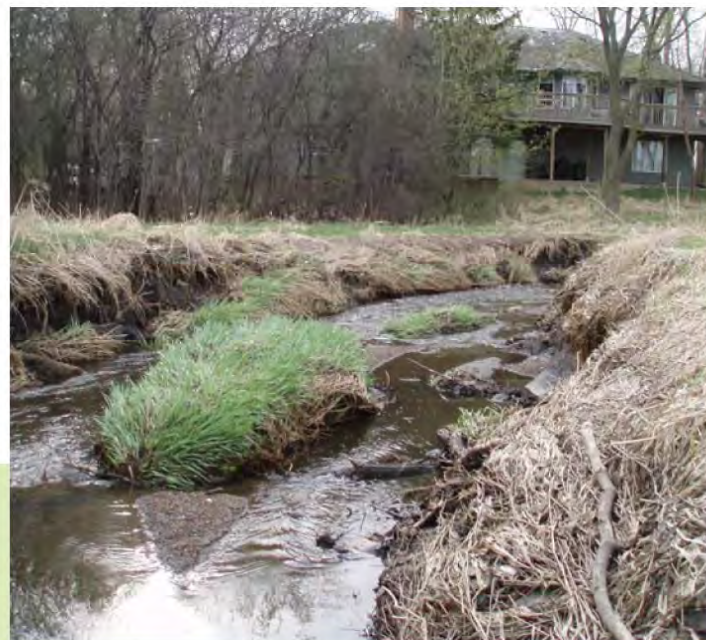
Fluvial bank erosion is caused by water in the stream moving past the streambanks. The shear stress caused by the flow entrains soil particles into the flow, causing the stream bank to erode away. This is the most common type of erosion that occurs in streams. Virtually all streams experience this type of erosion as their flow path evolves over time. However, the rate of fluvial bank erosion can increase when the stream is out of equilibrium with its watershed. Increased flow from a watershed will increase the rate of fluvial bank erosion. In places where the channel is confined by the valley walls, however, fluvial bank erosion can lead to failure of the high banks. It can also undermine storm sewer inlets.

Rock vanes are constructed from boulders on the creek bottom. They function by diverting channel flow toward the center and away from the bank. They are typically oriented in the upstream direction and occupy no more than one third of the channel width. Vanes are largely submerged and inconspicuous. The rocks are chosen such that they will be large enough to resist movement during flood flows or by vandalism, with additional smaller rock material to add stability. Rock vanes function in much the same way as root wads in that they push the stream thalweg (zone of highest velocity) away from the outside bend. They also promote sedimentation behind the vane, which adds to the toe protection.

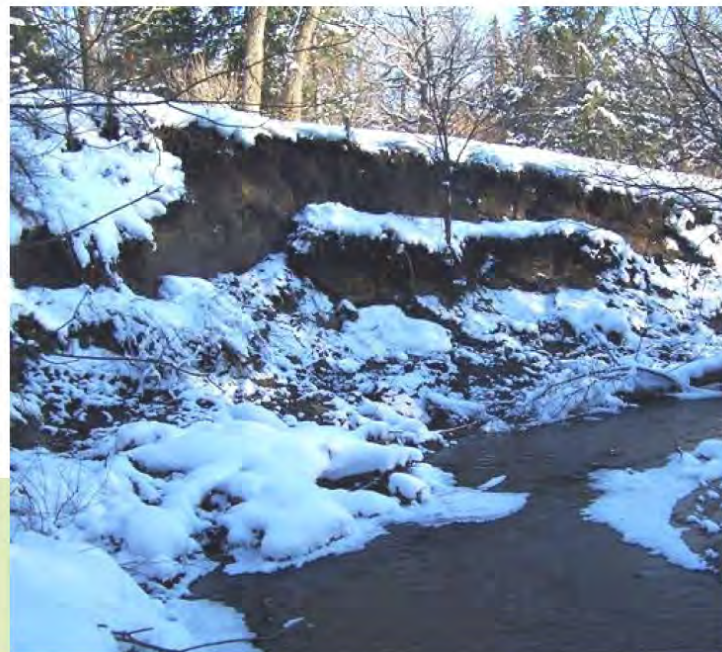
Fluvial bank erosion is caused by water in the stream moving past the streambanks. The shear stress caused by the flow entrains soil particles into the flow, causing the stream bank to erode away. This is the most common type of erosion that occurs in streams.

Virtually all streams experience this type of erosion as their flow path evolves over time. However, the rate of fluvial bank erosion can increase when the stream is out of equilibrium with its watershed. Increased flow from a watershed will increase the rate of fluvial bank erosion.

Soil Pillows are utilized in a bioengineering method known as Vegetated Reinforced Slope Stabilization (VRSS). The method combines rock, geosynthetics, soil and plants to stabilize steep, eroding slopes in a structurally sound manner. VRSS typically involves protecting layers of soils with a blanket or geotextile material (e.g. erosion control blanket) and vegetating the slope by either planting selected species (often willow or dogwood species) between the soil layers or by seeding the soil with desired species before it is covered by the protective material. In either case, with adequate light and moisture, the vegetation grows quickly and provides significant root structure to strengthen the bank. This method tends to be labor intensive and, therefore, relatively expensive.

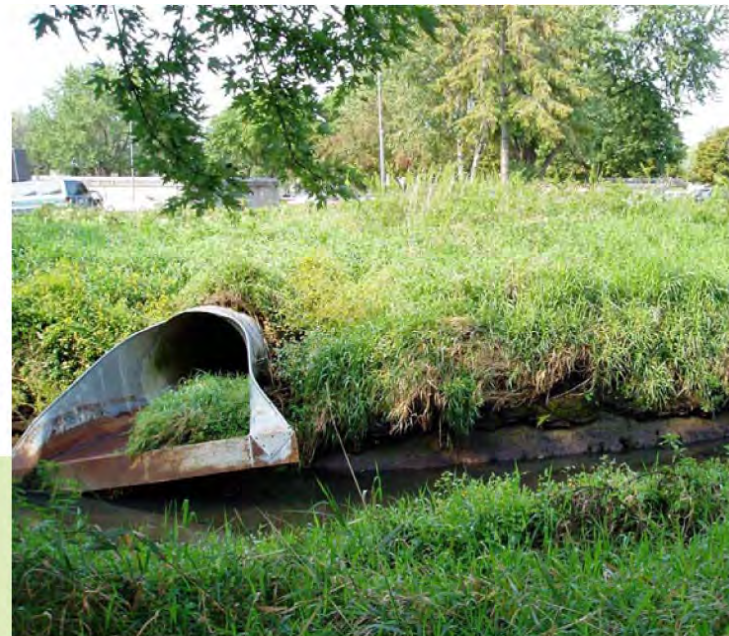
Erosion is frequently observed at culvert outlets for a variety of reasons, including insufficient erosion protection at the culvert outlet, streambank erosion, and channel downcutting, which leaves the culvert perched above the channel. Filter fabric is often used at culvert outlets to separate riprap protection from underlying soils, however the fabric provides a slippery surface for the riprap, which commonly slides into the channel.

Culvert Stabilization is somewhat unique to each situation, depending on the site circumstances. Most sites require additional rock placement with a granular filter layer (rather than filter fabric). Some cases may require re-alignment and/or lowering of the outlet to better align with the stream channel. Typically, outlets should be aligned in the downstream channel direction so that flow doesn't impinge on the opposite bank. It is usually desirable for the culvert to enter the stream at or just above the normal water level in order to minimize the potential for undercutting.
