# Feasibility Report for Bassett Creek Restoration Project - Reach 1

***Golden Valley, Minnesota***

***Prepared for  
Bassett Creek Watershed Management Commission***

***September 2010***

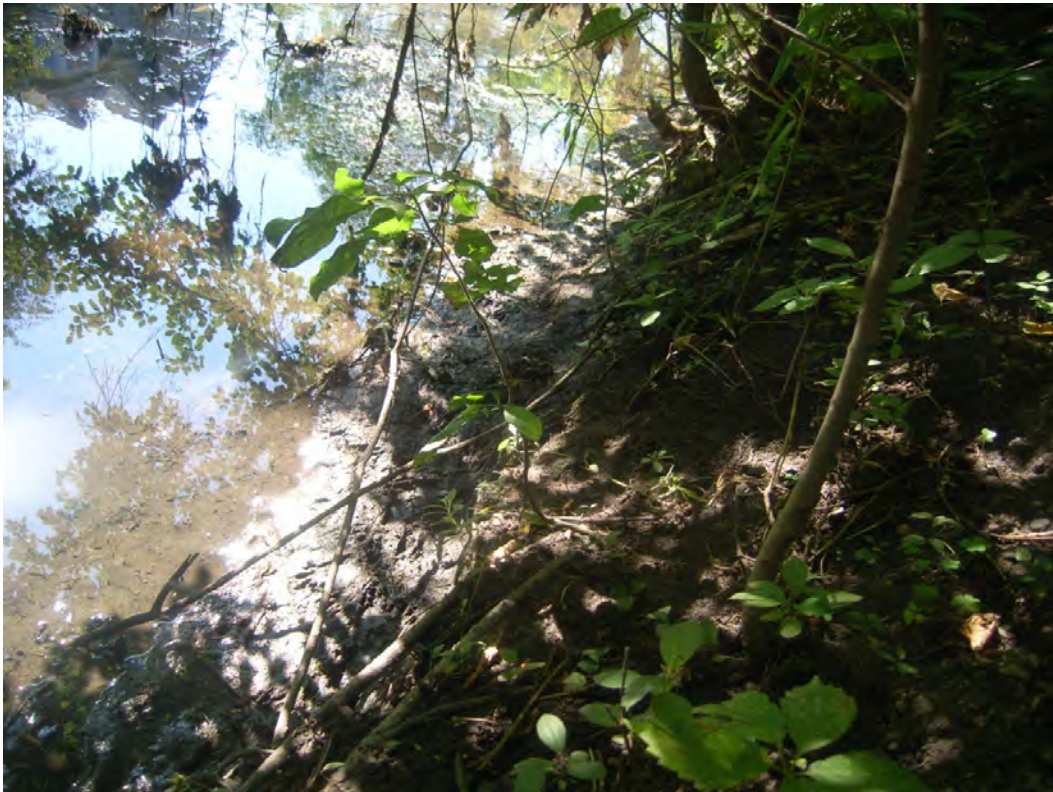
**Photo 2: Wetland A. View of transition from upland to wetland at Data point SB-9.**

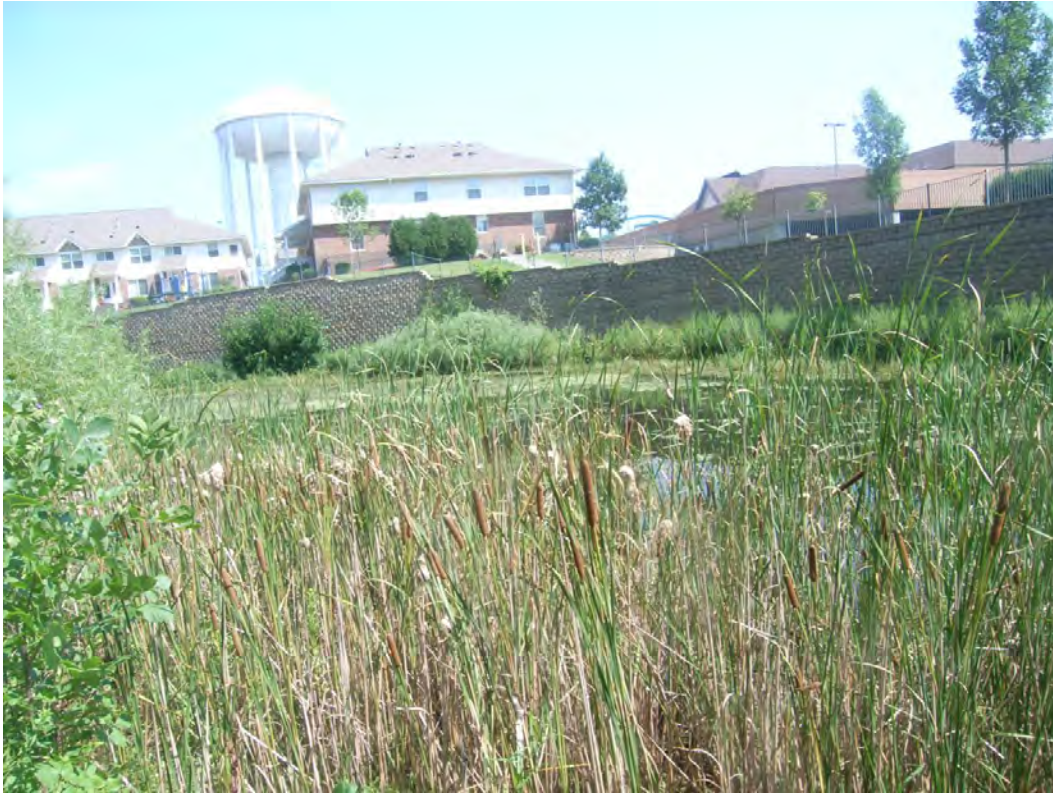
**Photo 3: Surface Water 1. Storm water pond located adjacent to Wetland A.**

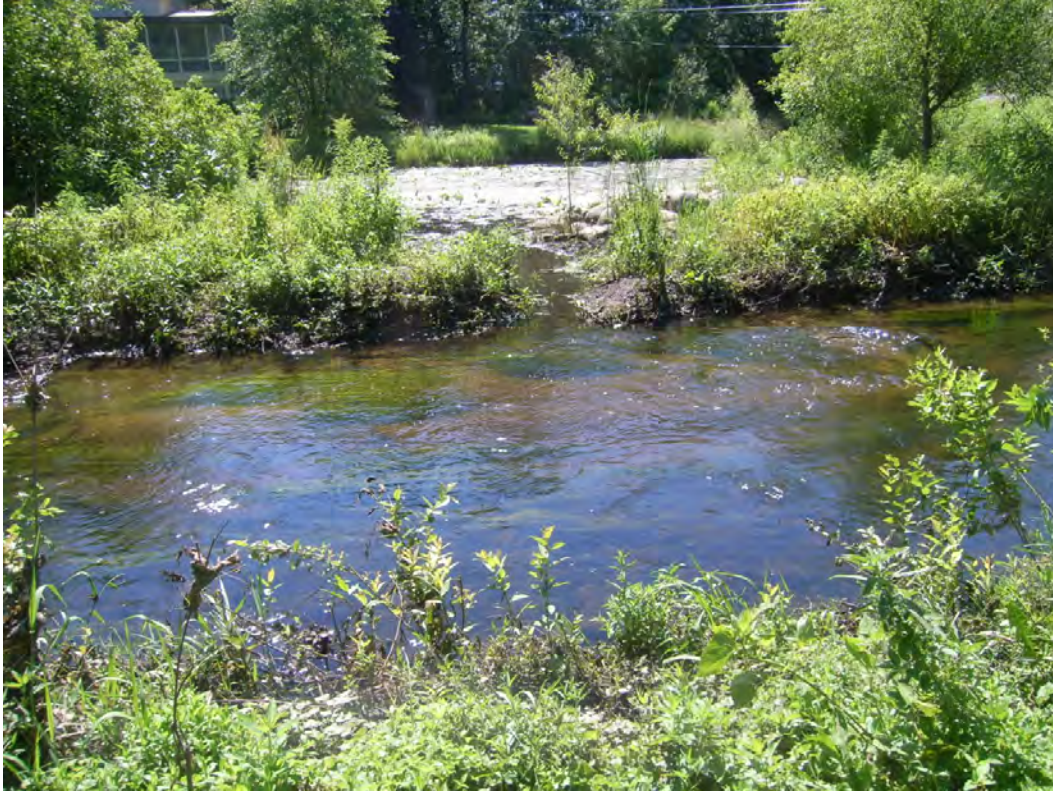
**Photo 5: Wetland C. View of Creek with excavated marsh in background.**

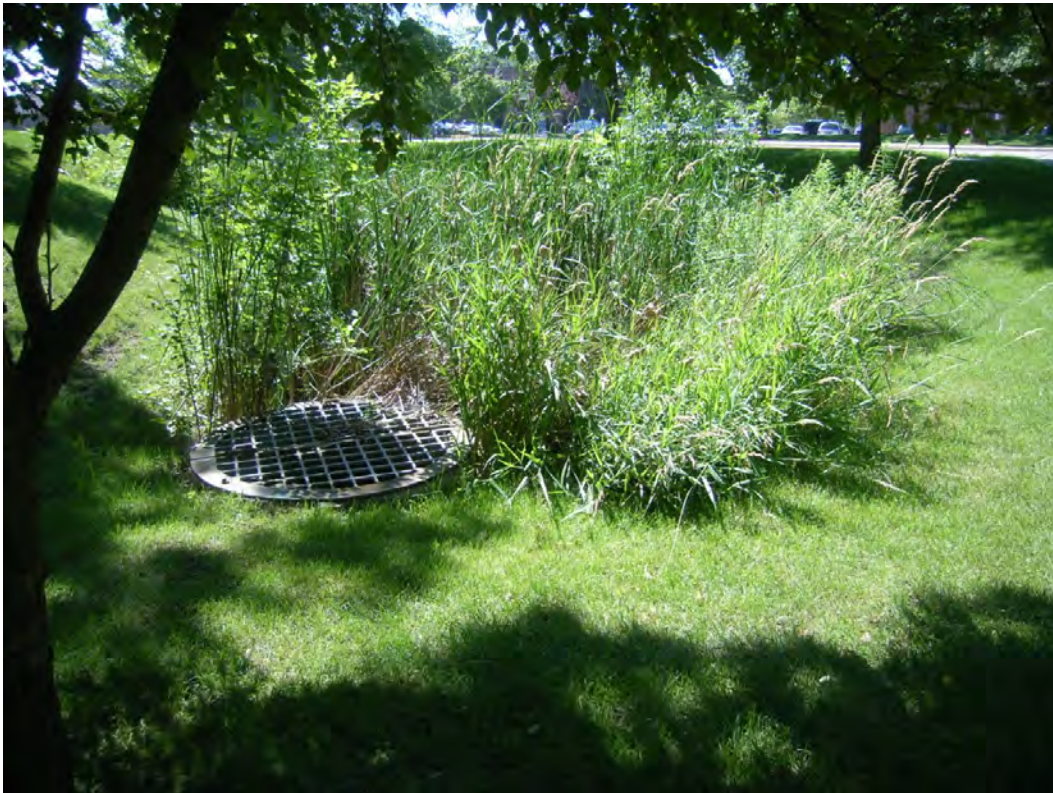
**Photo 7: Surface Water 2. Small storm water pond adjacent to Wetland C.**
