**Feasibility Report for the 2012
Bassett Creek Main Stem Restoration Project
Golden Valley Road to Irving Avenue North**

June 2011

Golden Valley & Minneapolis, Minnesota

***Prepared for
Bassett Creek Watershed Management Commission
June 2011***

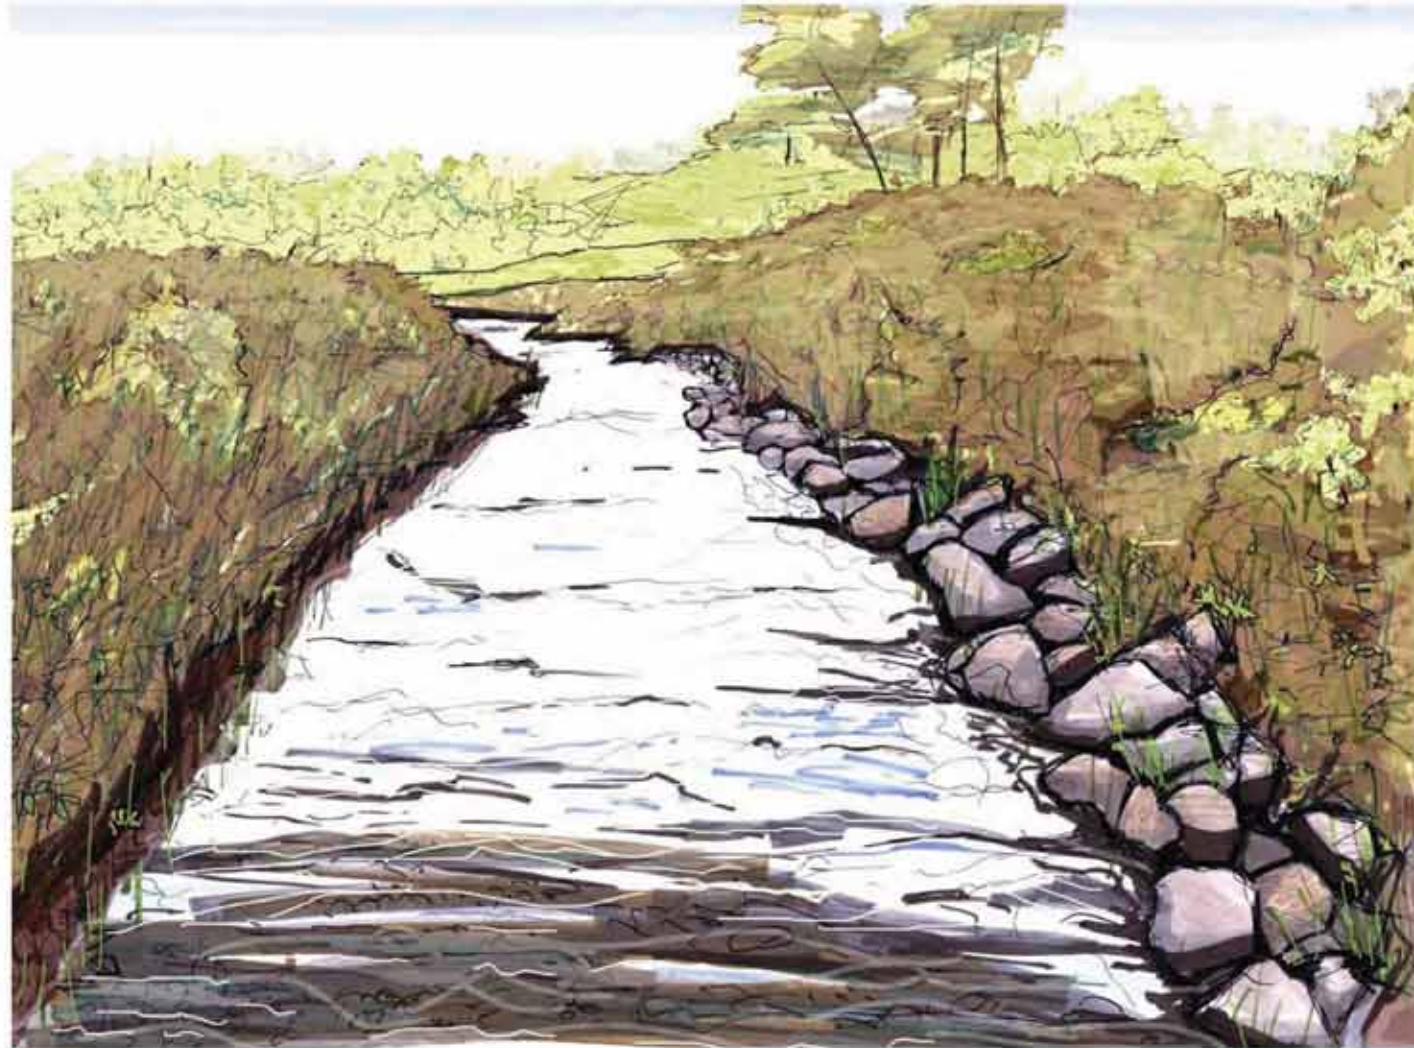
Figure 3

Stone Toe Protection is constructed from cobble-sized rock on the creek edges. It extends to approximately the bankfull level, which will protect the channel banks for flow events that occur every 1 to 2 years or less. The material will extend into the ground to resist scour. Coarse gravel is used to separate the larger rock material from underlying soil. Stone toe protection is typically used in conjunction with revegetation of the upper banks.

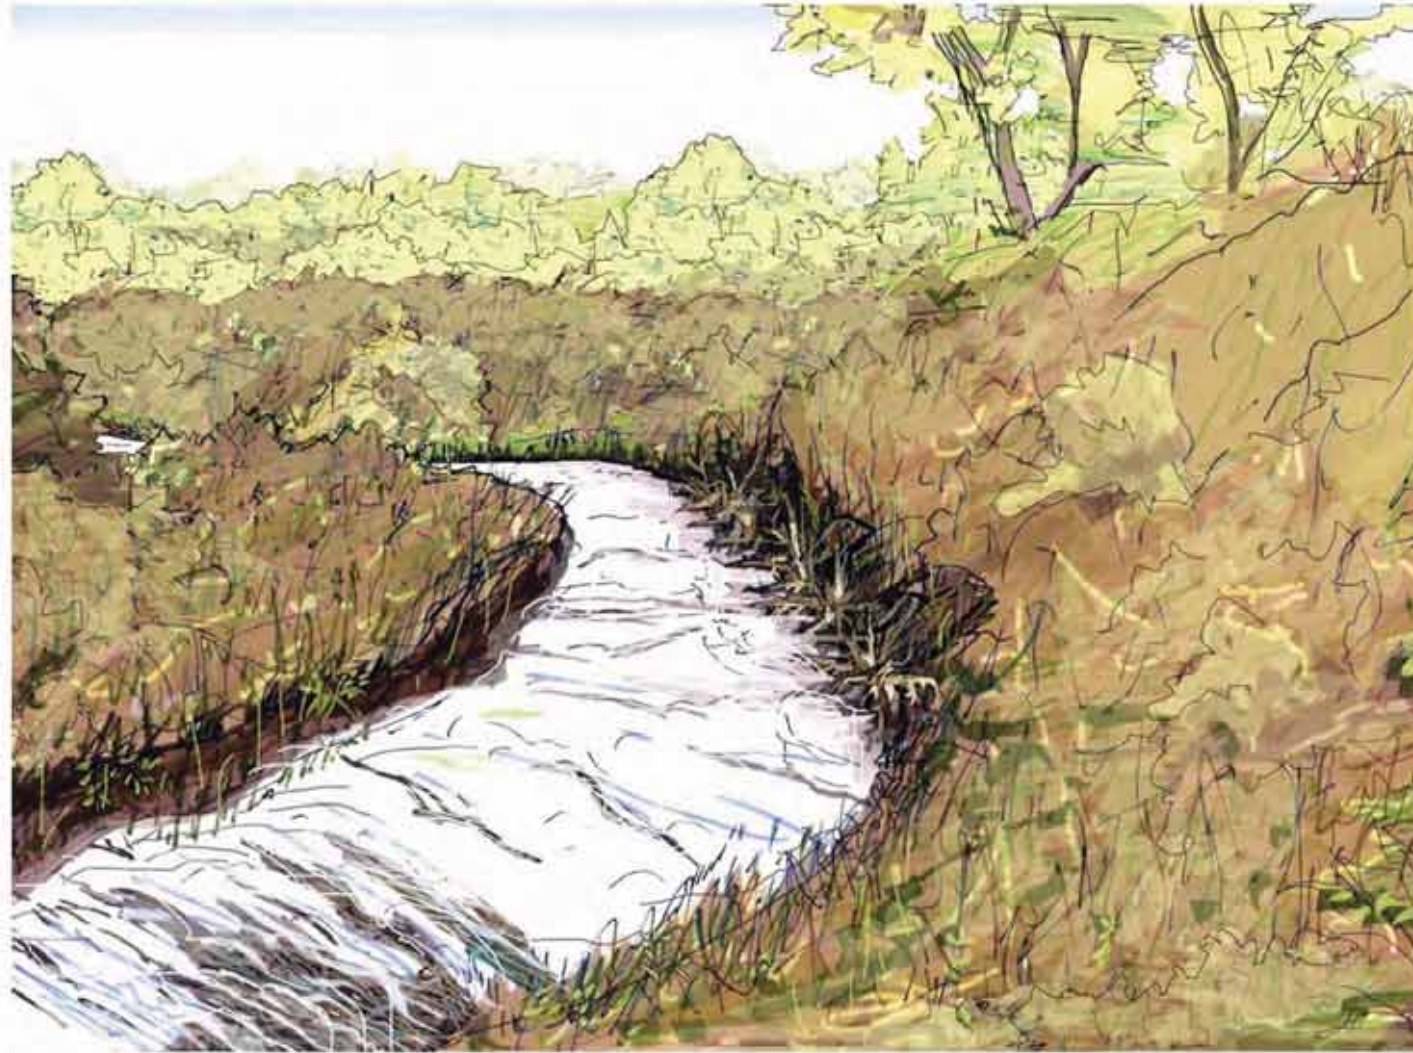
Figure 4

Root wads are constructed using sections of tree trunks with their root balls attached. The trunks extend into the stream bank leaving only the roots exposed, partially submerged. The root wads are spaced to protect a given length of bank. Footer logs and boulders are often used to help stabilize the root wads. Root wads work well where the water is deep, such as on the outside of bends, and where there is adequate sunlight to allow vegetation to grow around the exposed root wads. As the vegetation becomes established, it becomes difficult to distinguish the root wads from their natural surroundings.

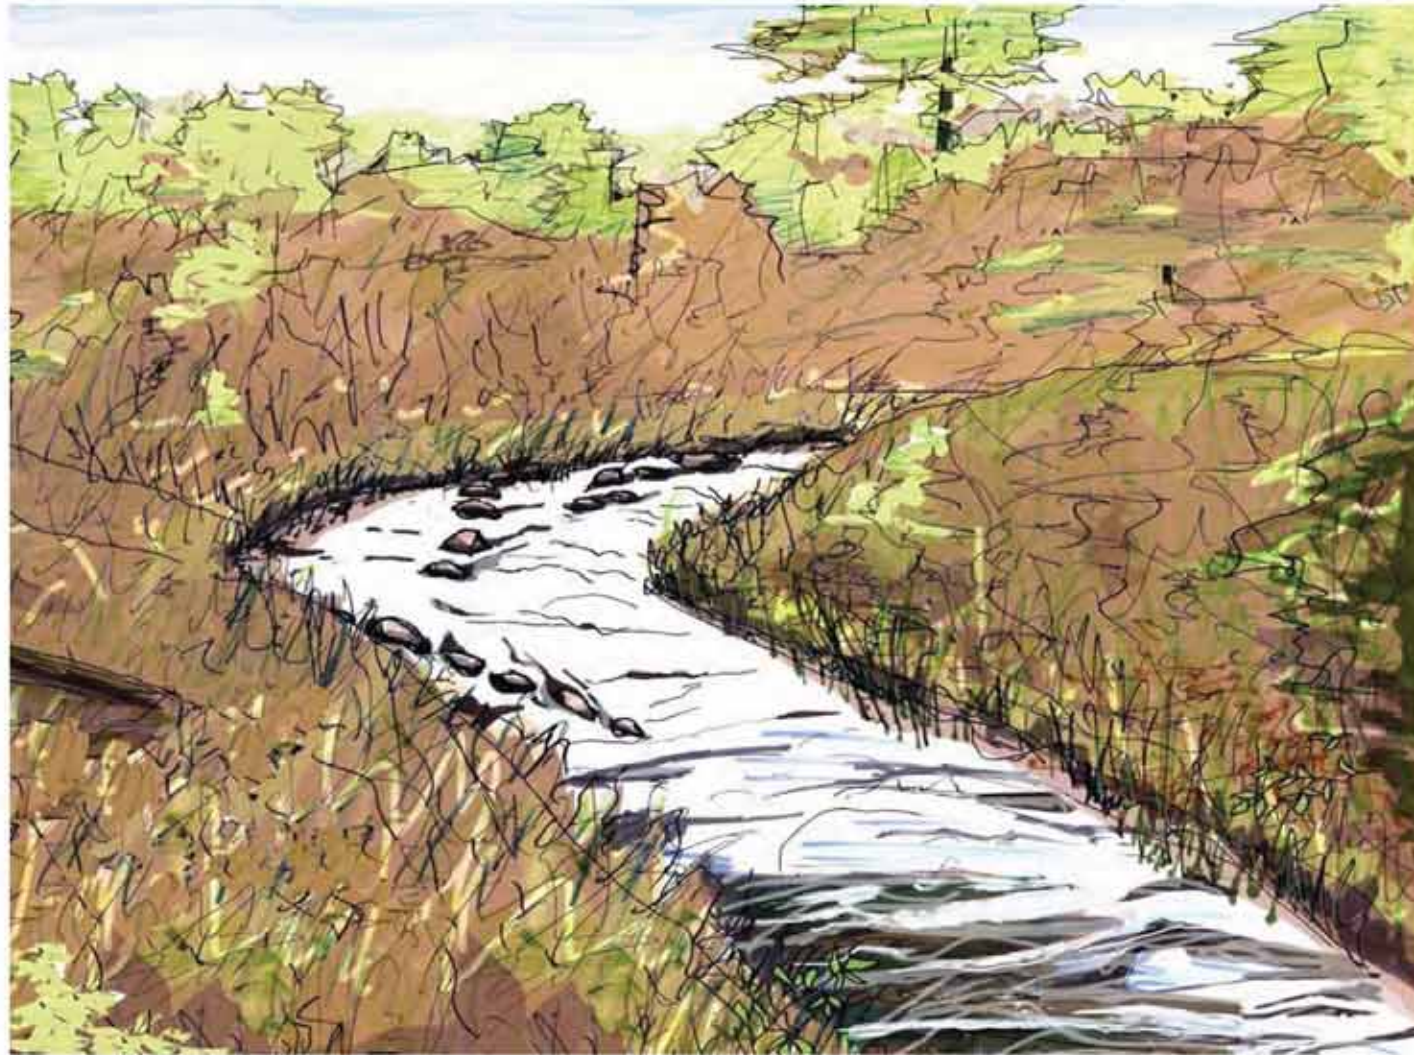
Figure 6

Fluvial bank erosion is caused by water in the stream moving past the streambanks. The shear stress caused by the flow entrains soil particles into the flow, causing the stream bank to erode away. This is the most common type of erosion that occurs in streams. Virtually all streams experience this type of erosion as their flow path evolves over time. However, the rate of fluvial bank erosion can increase when the stream is out of equilibrium with its watershed. Increased flow from a watershed will increase the rate of fluvial bank erosion. In places where the channel is confined by the valley walls, however, fluvial bank erosion can lead to failure of the high banks. It can also undermine storm sewer inlets.

Rock vanes are constructed from boulders on the creek bottom. They function by diverting channel flow toward the center and away from the bank. They are typically oriented in the upstream direction and occupy no more than one third of the channel width. Vanes are largely submerged and inconspicuous. The rocks are chosen such that they will be large enough to resist movement during flood flows or by vandalism, with additional smaller rock material to add stability. Rock vanes function in much the same way as root wads in that they push the stream thalweg (zone of highest velocity) away from the outside bend. They also promote sedimentation behind the vane, which adds to the toe protection.
