Memorandum

To: Bassett Creek Watershed Management Commission (BCWMC)
From: Barr Engineering Co.
Subject: Bassett Creek 2019 Flood Control Project Inspection
Date: December 11, 2019
Project: 23/27-0051.45 2019 4065

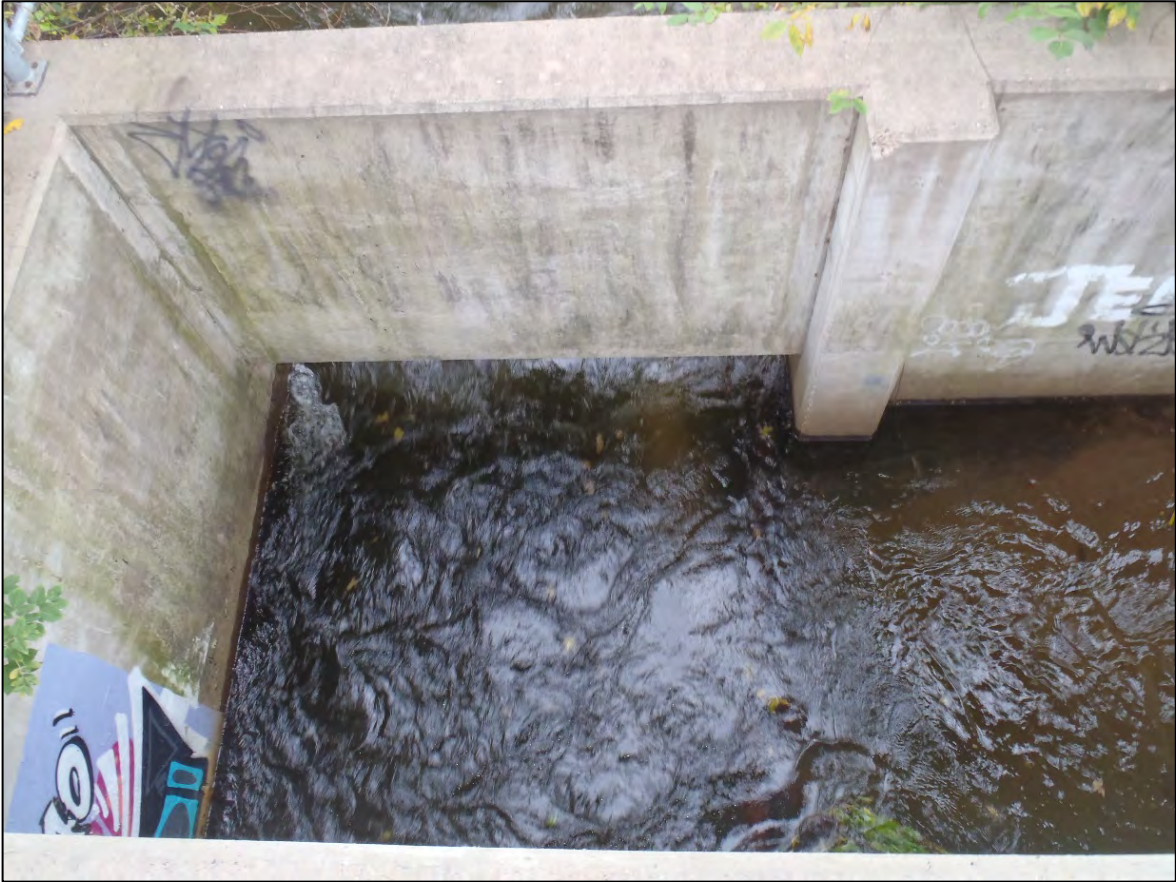
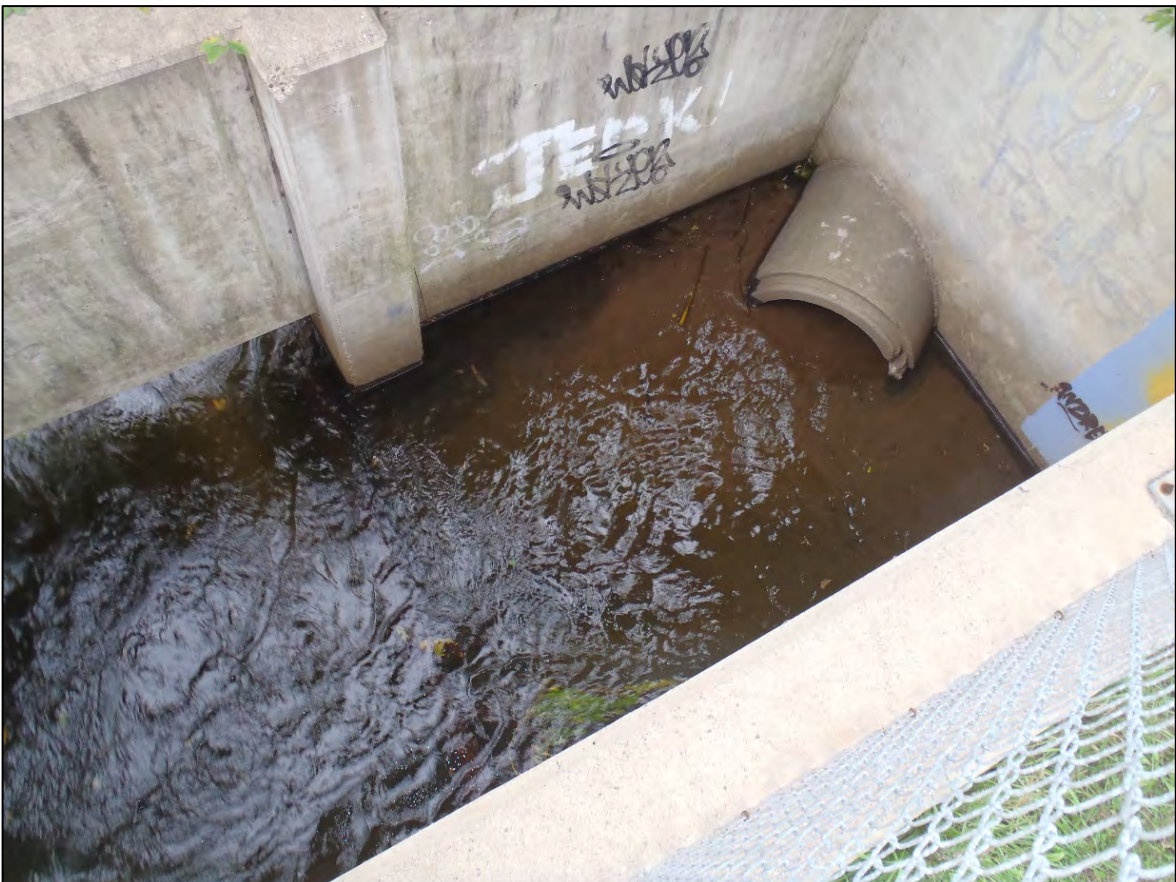
Highway 100 Double Box Culverts (Crystal/Golden Valley)

- c. Deposited sediment was observed in the north (left) box culvert, generally ranging from 8 to 12 inches deep. High flows in 2019 appeared to have more evenly redistributed sediment throughout the north (left) box culvert. This is consistent with previous inspections and 6-24 inches of deposited sediment has been observed in the north (left) box culvert since 2002.

- d. A large branch was stuck on the wall between the double box culverts in the inlet structure.
- e. The outlet portion of the structure appeared to be in satisfactory condition.

- Remove the large branch between the double box culverts in the inlet structure (Recommended by Crystal due to location of debris).
- Monitor accumulated sediment in north (left) box culvert and consider future removal.
- Monitor cracking and spalling concrete in the south (right) box culvert.

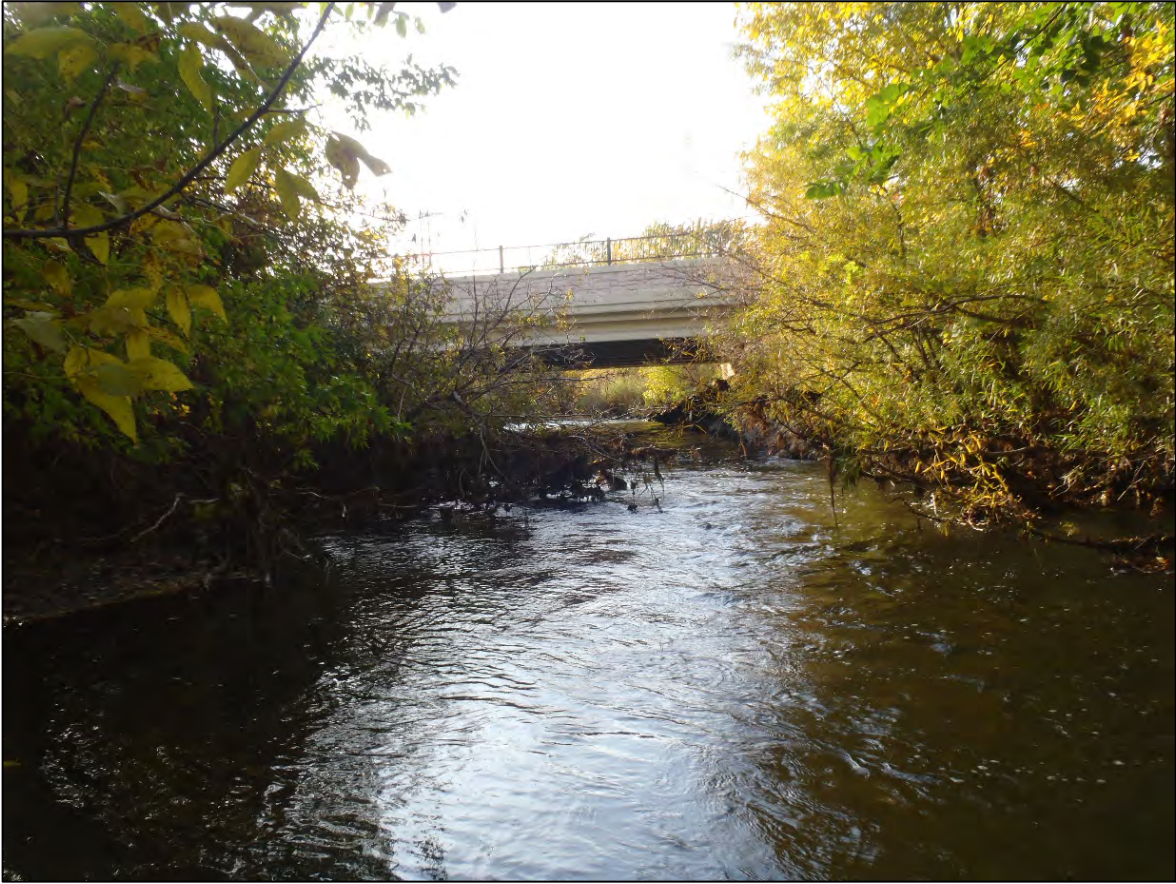
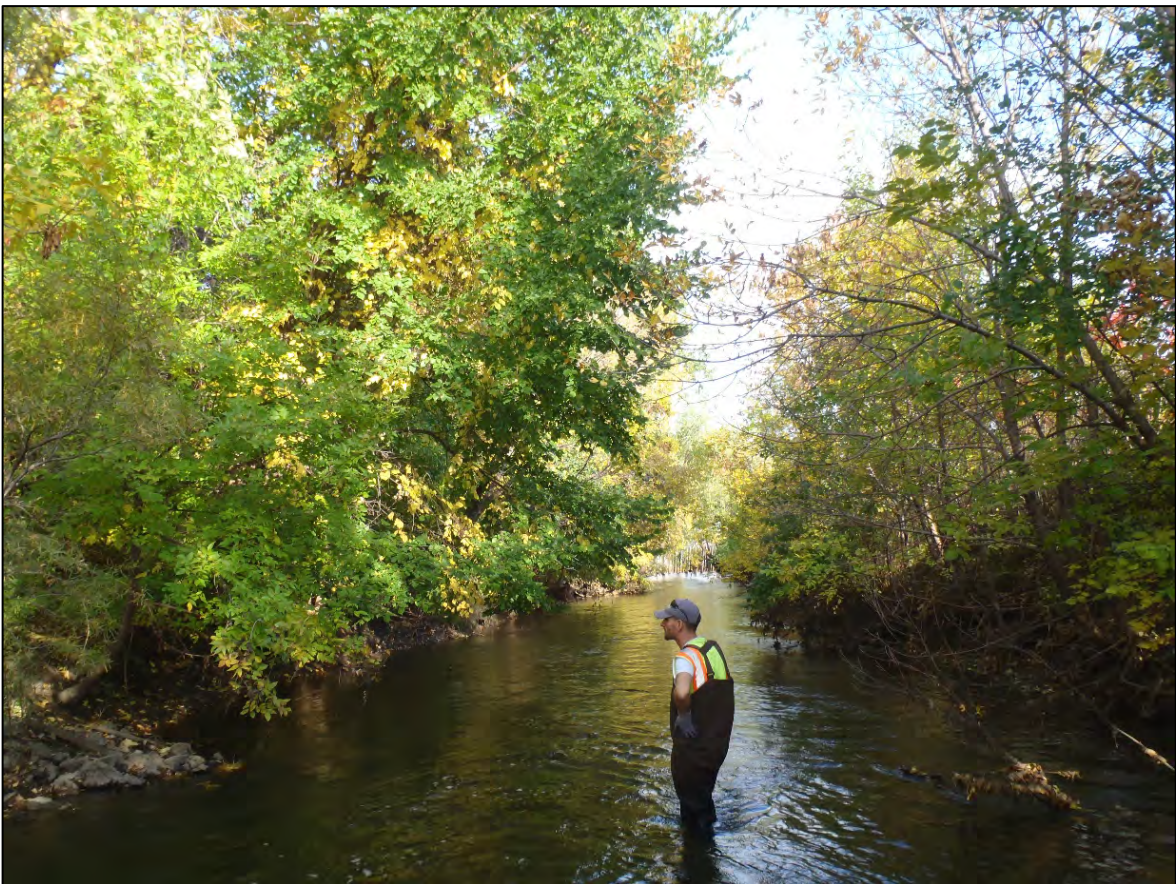
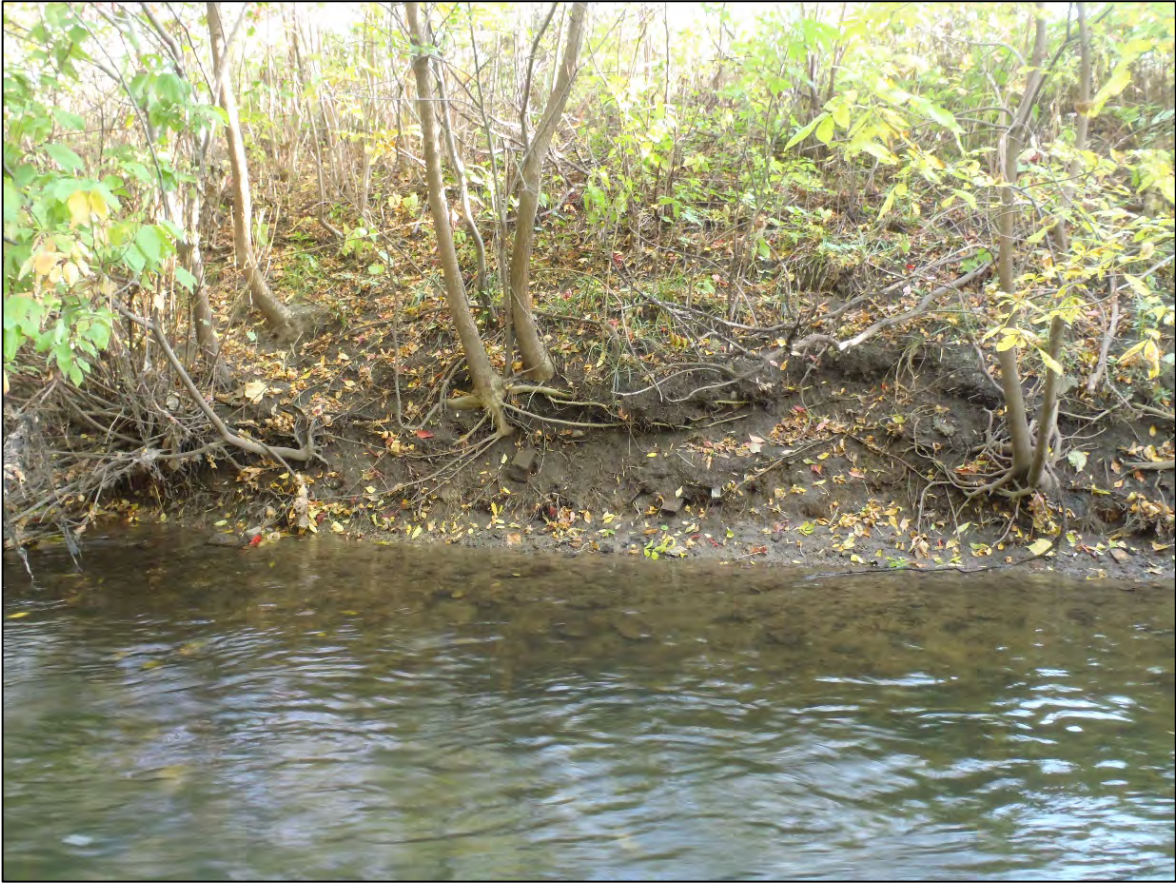
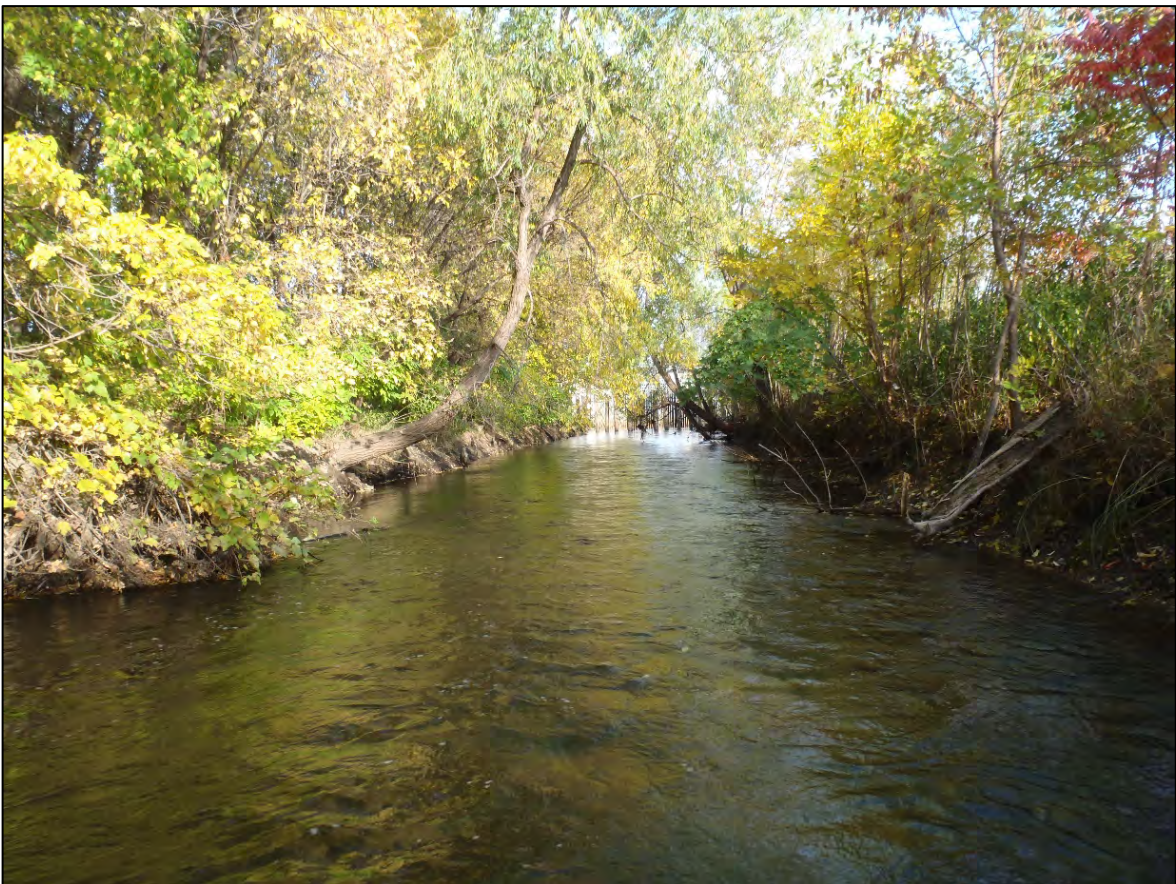
Open Channel (Minneapolis)

- a. The open channel, from Van White Memorial Boulevard to the inlet structure, appeared to be in satisfactory condition.
- b. The banks were generally covered with brush and trees about 3-4 feet above the channel bottom. Below the level of the trees and brush, the banks were bare soil on both sides for most of the length of the channel, however no obvious signs of bank erosion were noted.
- c. A dead tree had partially fallen into the channel just downstream of Van White Memorial Boulevard and was collecting debris.
- d. Sediment has deposited and formed a delta on the south (right) side of the channel between the debris barrier and inlet structure. Vegetation was growing on the delta and approximately one-quarter of the channel was blocked by the sediment, debris, and vegetation.

- Remove accumulated sediment and debris on the south (right) side of the channel between the inlet structure and debris barrier.
- Monitor downed tree(s) and debris and remove as needed.
- Bassett Creek Main Stem Erosion Repair Project (CIP 2017 CR-M) is included in the BCWMC CIP Table 5-3. The BCWMC completed a feasibility study for the project in May 2016, and ordered construction of the project at their September, 2016 meeting. The project was originally scheduled for construction during the summer of 2018, but due to permitting issues with the US Army Corps of Engineers and the State Historic Preservation Office, it was postponed to the winter of 2019/2020. The resultant construction project should minimize future erosion concerns at some sections of the creek and reduce the amount of sediment depositing near the inlet structure.

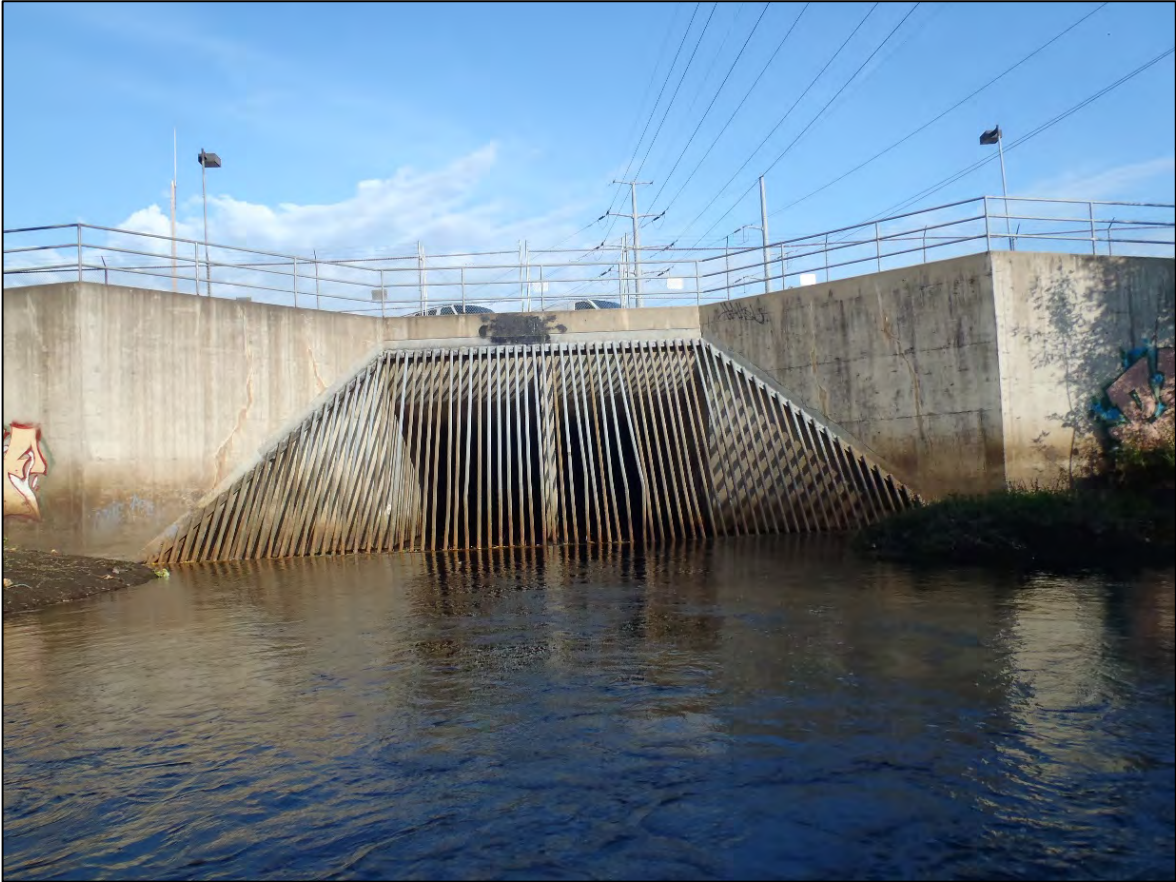
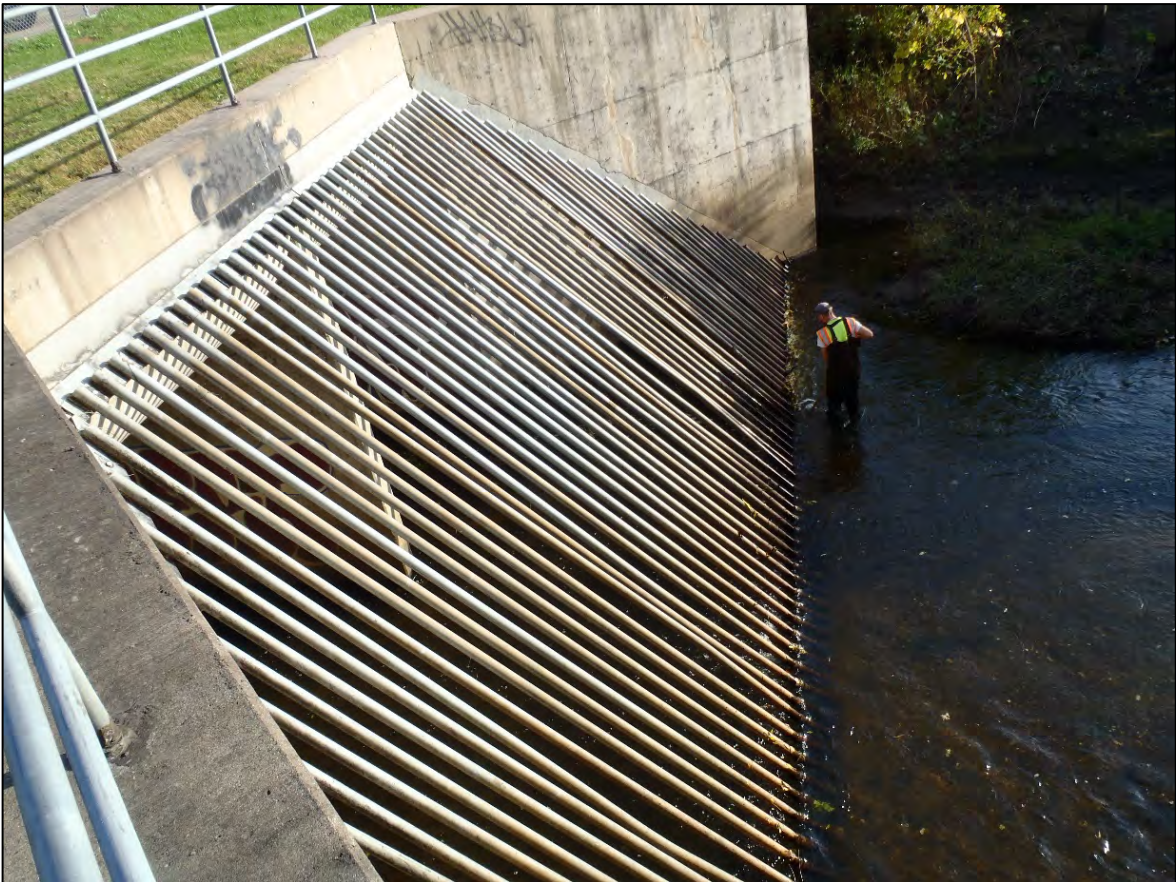
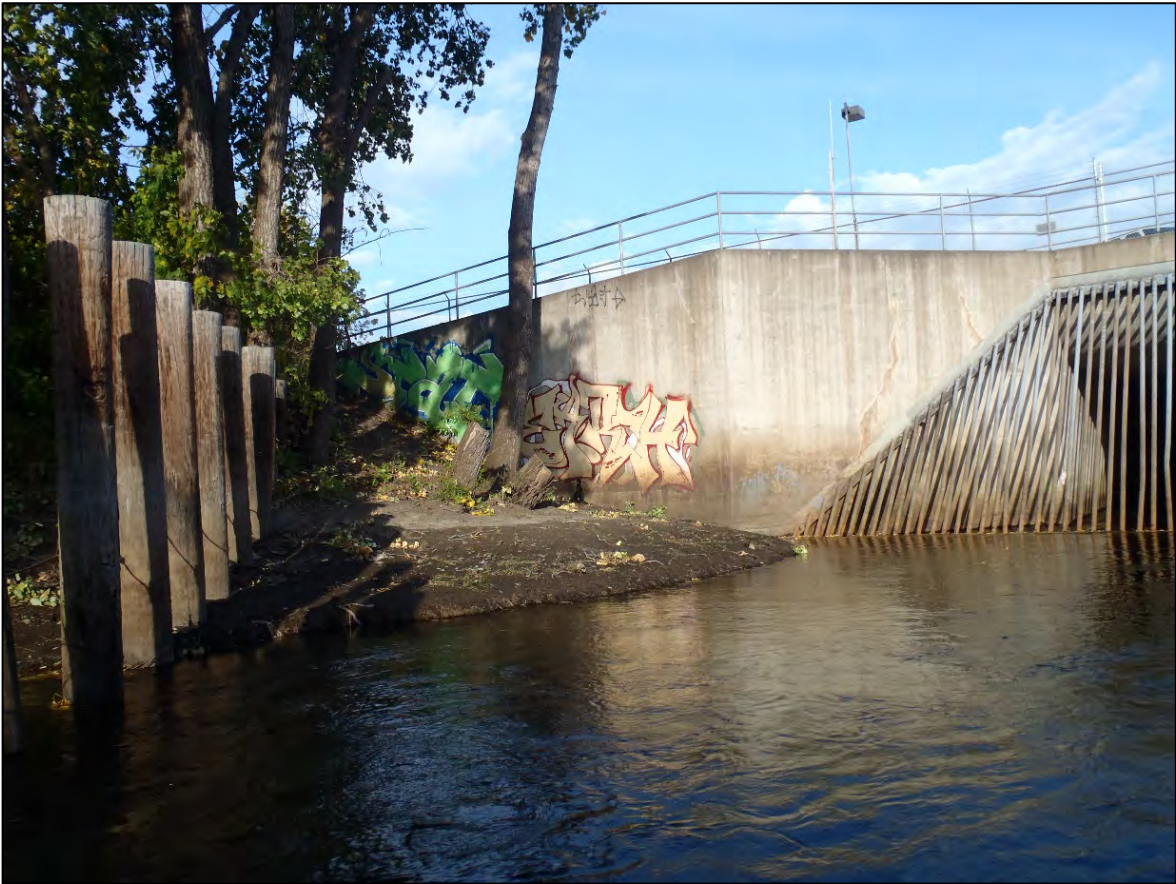
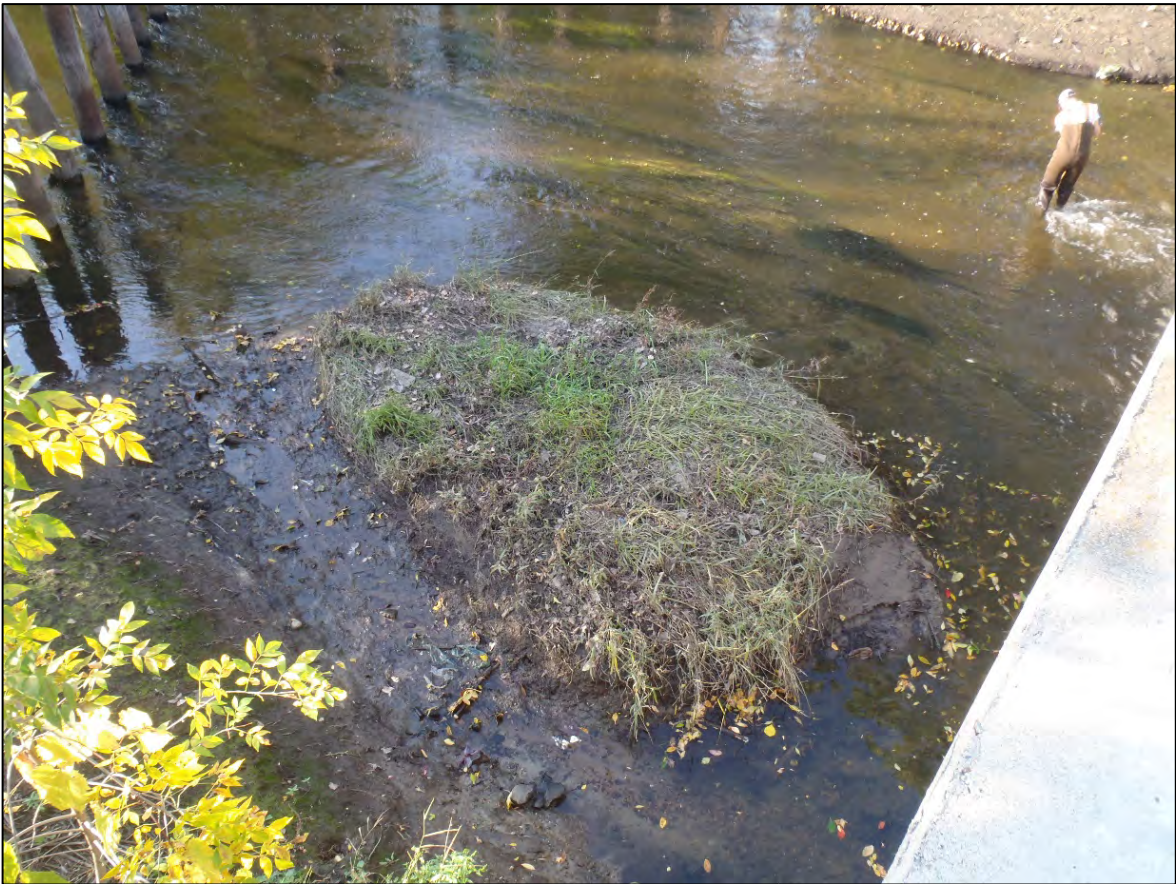
Inlet Structure (Minneapolis)

- a. The concrete inlet structure appeared to be in satisfactory condition.
- b. Vertical cracks were observed in the concrete on either side of the structure.
- c. Cracks were observed near where the handrail posts are embedded.
- d. The railings and vertical bars appeared to be in satisfactory condition.
- e. The inlet structure had recently been cleared of debris.

- Monitor for debris and clear as needed.
- Monitor cracks in the concrete inlet structure.
