Bassett Creek 3rd Avenue and 2nd Street Tunnel Inspection Report

Prepared for
Bassett Creek Watershed Management Commission

3rd Avenue and 2nd Street Tunnel Inspection Report

Inspection Date: October 2020

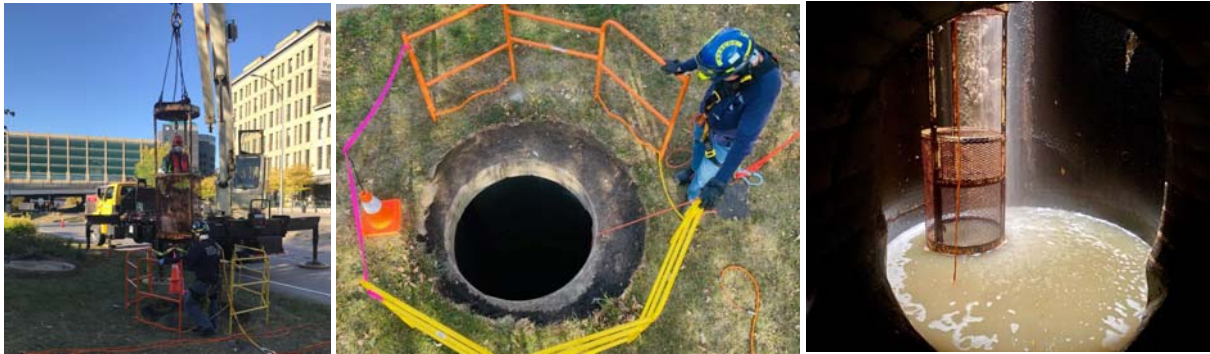
Figure 3-2 Washington Avenue Shaft

The Washington Avenue shaft was the primary access and egress point for the second day of inspection. Access was achieved by crane and basket through an 8-foot-diameter, 70-foot-deep shaft. At the bottom of the shaft, there is a 4-foot-deep sump that prevents the basket from having a dry landing, so the basket must stay suspended, and swing towards a 6-foot-diameter drift tunnel for the inspector to exit the basket. Photos of the shaft entry are included in Figure 3-2.

Washington Avenue Shaft Modification: The Washington Avenue Shaft is one of the primary access points to enter the Bassett Creek and the I-94/2nd Street tunnel system. The 8-foot-diameter shaft is approximately 70 feet deep and has an approximately 4-foot-deep sump at the bottom that is typically filled with water. This configuration adds challenges for access as well as safety hazards (i.e. submergence of inspectors). Barr recommends that a grated landing be installed to improve this access point for future inspections and maintenance..
