Memorandum

To: Bassett Creek Watershed Management Commission (BCWMC)
From: Barr Engineering Co.
Subject: Bassett Creek 2021 Flood Control Project Inspection
Date: October 14, 2021
Project: 23270051.52 2021 4065

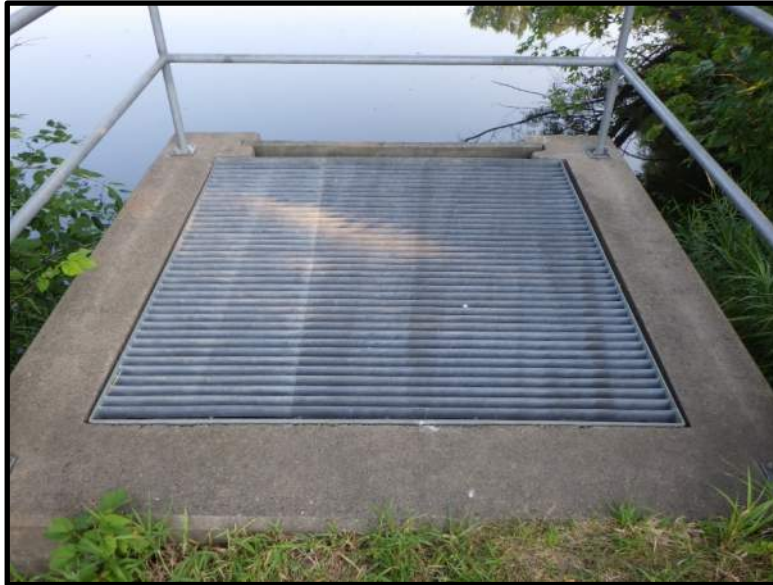
Detention Pond and Outlet Structure (Crystal)

- a. The outlet structure appeared to be in satisfactory condition.
- b. The detention pond appeared to be in satisfactory condition, but a survey is needed to assess accumulated sediment.

Recommended Action:

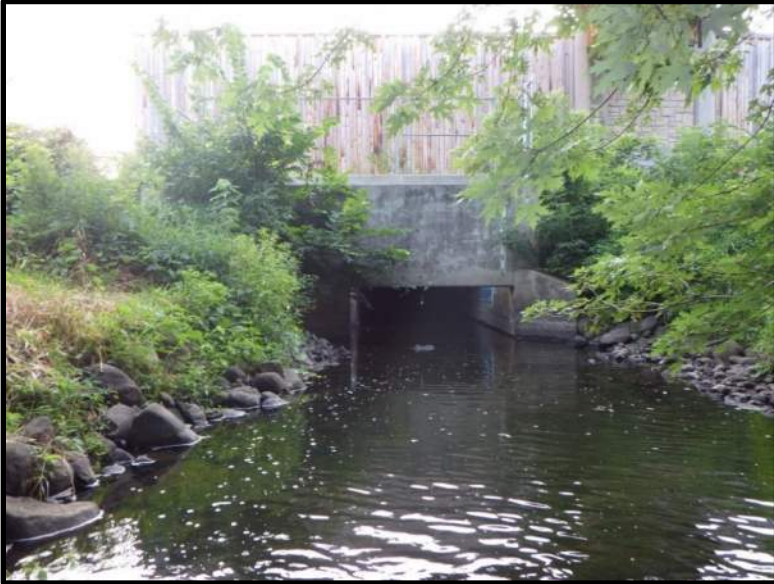
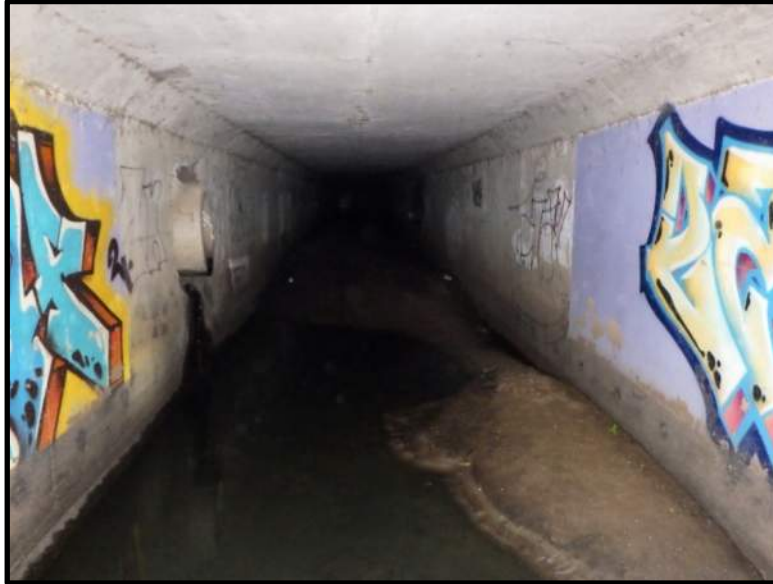
Highway 100 Double Box Culverts (Crystal/Golden Valley)

- a. The concrete box culverts and concrete inlet structure appeared to be in satisfactory condition.
- b. Circumferential cracks and areas of spalled concrete were observed in the north (left) box culvert.
- c. Longitudinal cracks, circumferential cracks, and areas of spalled concrete were observed along the top of the south (right) box culvert. MnDOT performed repairs to the culverts in 2007, but cracks have been noted since 2008 and areas of concrete spalling have been noted since 2014.
- d. Deposited sediment was observed in the north (left) box culvert, generally ranging from 6-24 inches deep. This is consistent with previous inspections and 6-24 inches of deposited sediment has been observed in the north (left) box culvert since 2002.
- e. The outlet portion of the structure appeared to be in satisfactory condition.

- Monitor accumulated sediment in north (left) box culvert and consider future removal.
- Monitor cracking and spalling concrete in both box culverts.

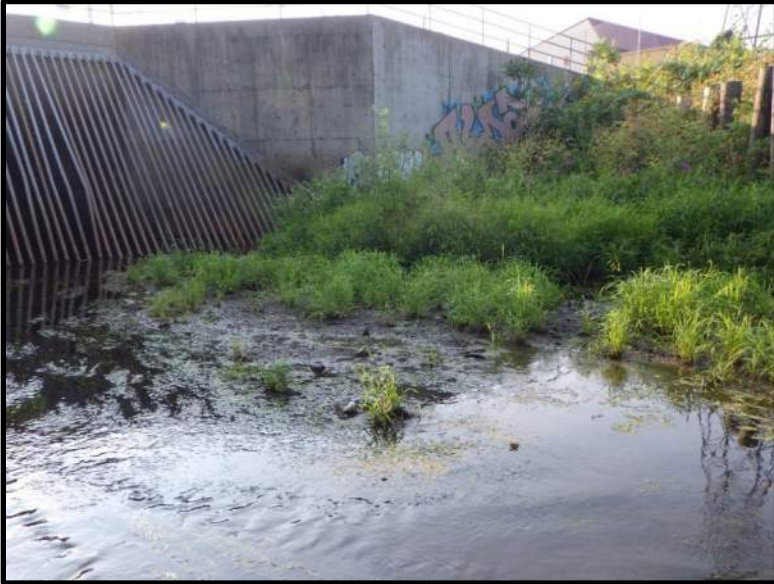
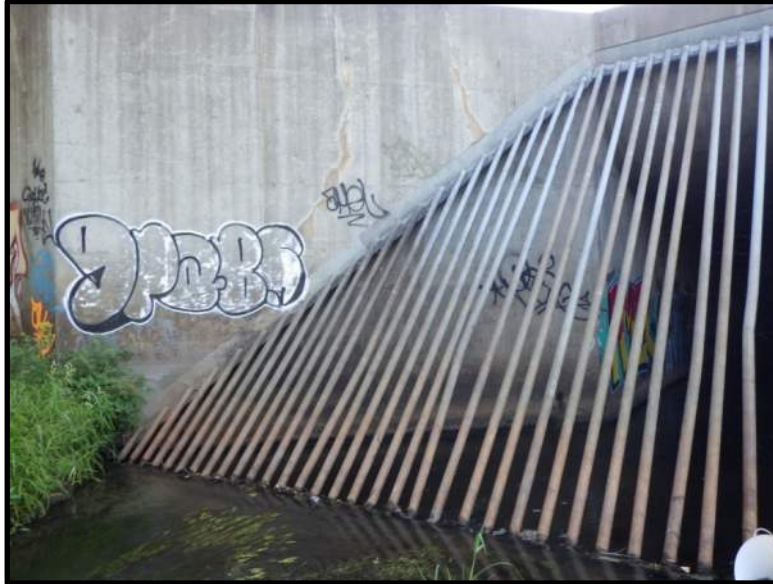
Inlet Structure (Minneapolis)

- a. The concrete inlet structure appeared to be in satisfactory condition.
- b. Vertical cracks were observed in the concrete on either side of the structure.
- c. Cracks were observed near where the handrail posts are embedded.
- d. The railings appeared to be in satisfactory condition.
- e. Some of the vertical bars have been bent and projecting a slight bow but generally appeared to be in satisfactory condition.
- f. The inlet structure was clear of debris.

- Monitor for debris and clear as needed.
- Monitor cracks in the concrete inlet structure.
