## Memorandum

**To:** Bassett Creek Watershed Management Commission (BCWMC)  
**From:** Barr Engineering Co.  
**Subject:** Bassett Creek 2022 Flood Control Project Inspection  
**Date:** November 9, 2022  
**Project:** 23270051.53 2022 4065

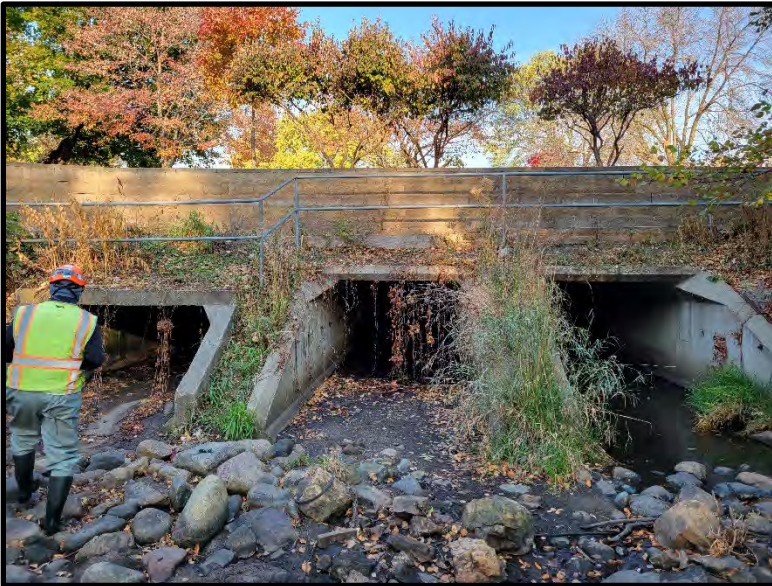
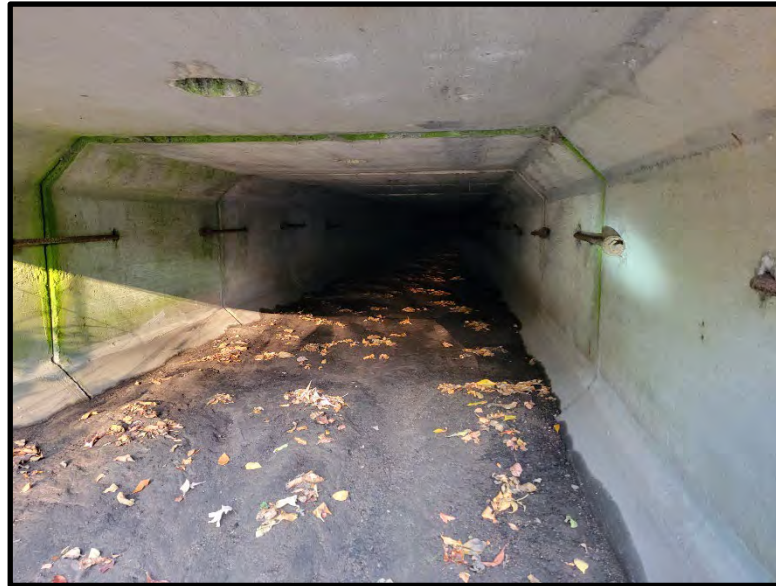
## Markwood 8 feet x 4 feet Box Culvert (Crystal)

- b. Circumferential cracks and areas of spalled concrete with exposed reinforcement were observed in the north (left) box culvert.
- c. Longitudinal cracks, circumferential cracks, and areas of spalled concrete with exposed reinforcement were observed along the top of the south (right) box culvert. MnDOT performed repairs to the culverts in 2007, but cracks have been noted since 2008 and areas of concrete spalling have been noted since 2014.
- d. Deposited sediment was observed in the north (left) box culvert, generally ranging from 6-24 inches deep. This is consistent with previous inspections and 6-24 inches of deposited sediment has been observed in the north (left) box culvert since 2002.
- e. The outlet portion of the structure appeared to be in satisfactory condition.

- Monitor accumulated sediment in north (left) box culvert and consider future removal.
- Monitor cracking, spalling concrete, and exposed reinforcement in both box culverts.
- MnDOT should assess the defects and repair, as necessary.

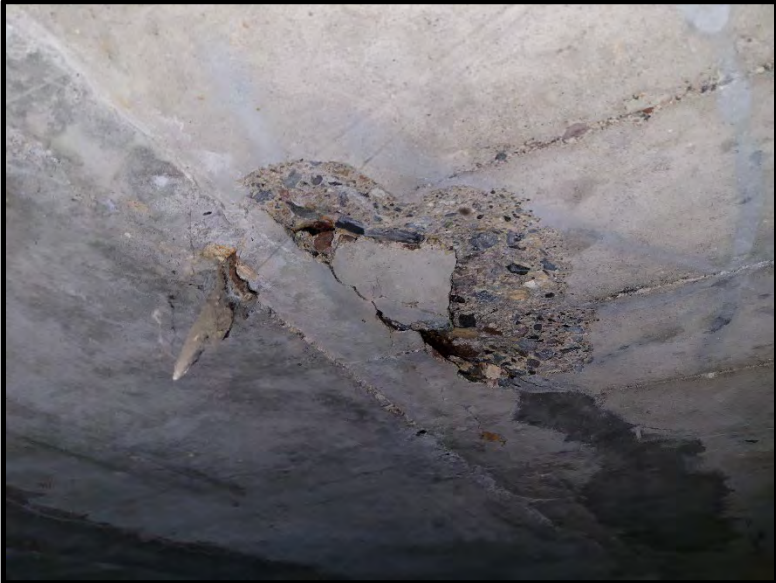
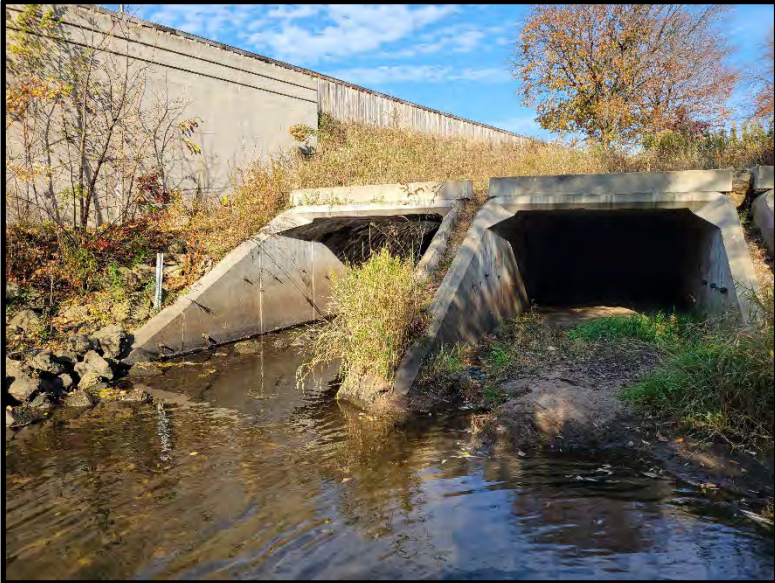
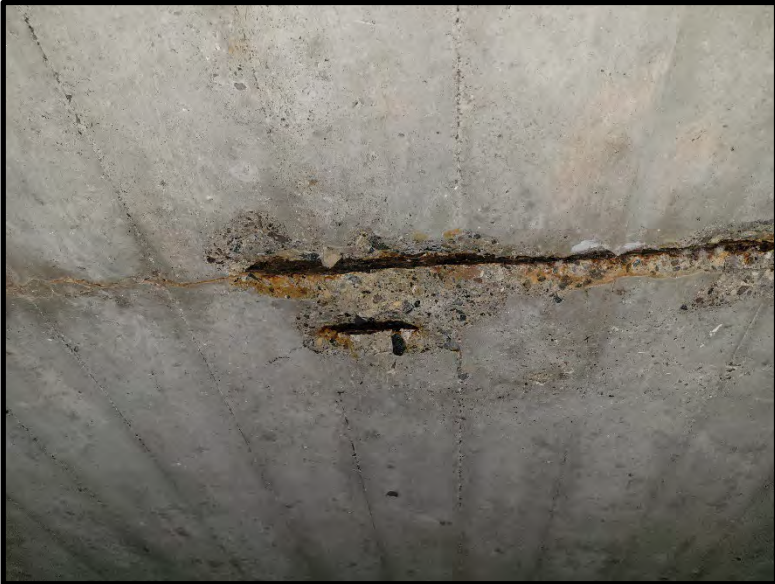
Highway 100 Double Box Culverts, continued

- a. The concrete inlet structure appeared to be in satisfactory condition.

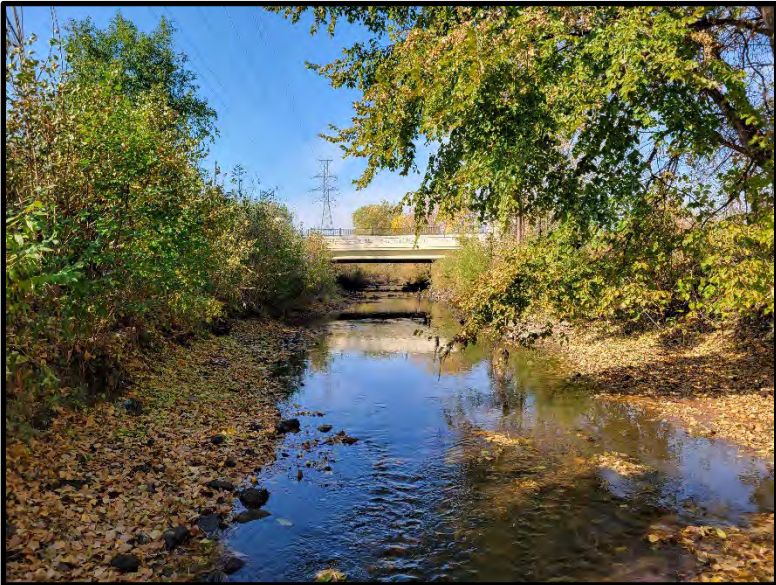
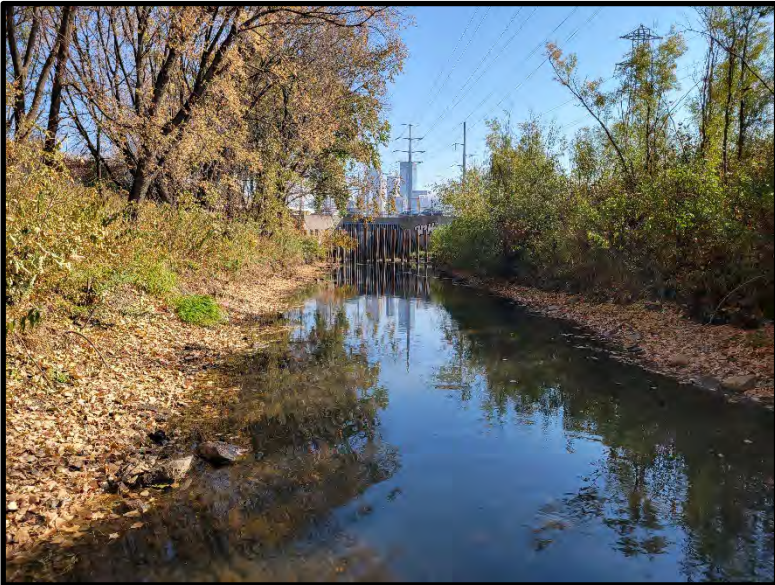
Open Channel (Minneapolis)

- a. The open channel, from Van White Memorial Boulevard to the inlet structure, appeared to be in satisfactory condition.
- b. The banks were generally vegetated. Some areas had exposed soil and steep slopes but seemed stable and no obvious signs of bank erosion were noted.
- c. Sediment has deposited and formed a delta on the south (right) side of the channel between the debris barrier and inlet structure. Vegetation was growing on the delta and approximately one-quarter of the channel was blocked by the sediment, debris, and vegetation. This is consistent with previous years' observation.
