Feasibility Report for Bassett Creek Main Stem Restoration, Regent Avenue to Golden Valley Road (2024 CR-M)—DRAFT

Golden Valley, Minnesota

Prepared for
Bassett Creek Watershed Management Commission

Appendix A
Site Visit Photos

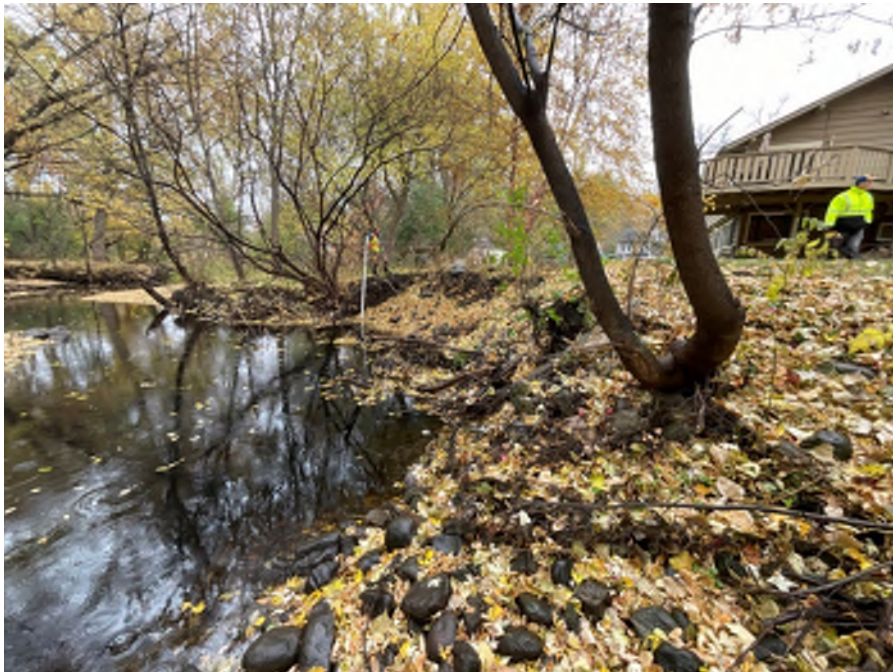
Photo 26: Site 2m. Soil exposure and deposition at the right bank of station 35+60 (facing downstream).

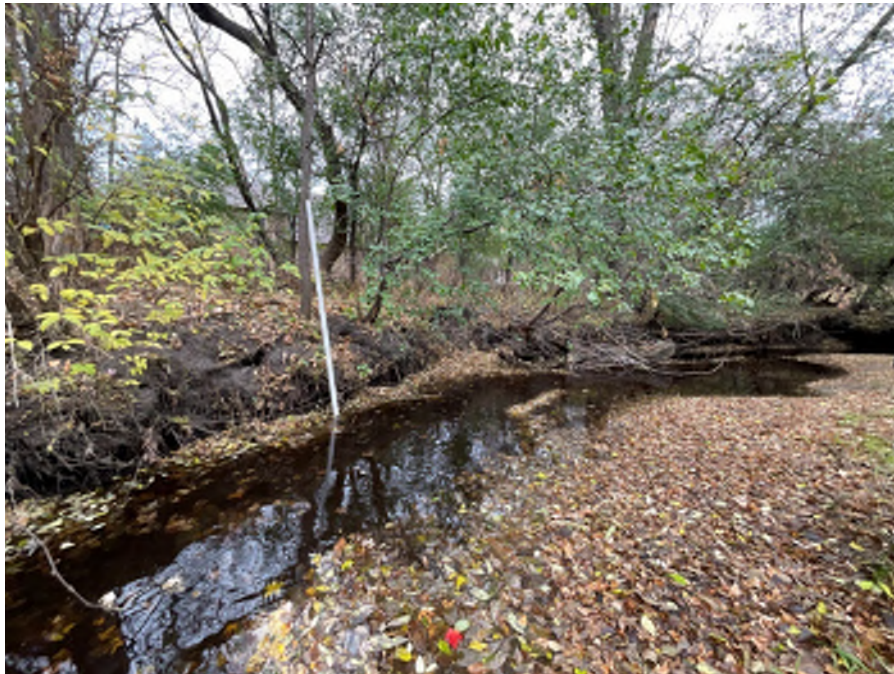
Photo 28: Site 2n. Undercut on the left bank of station 37+90; deposition on the right bank (facing downstream).

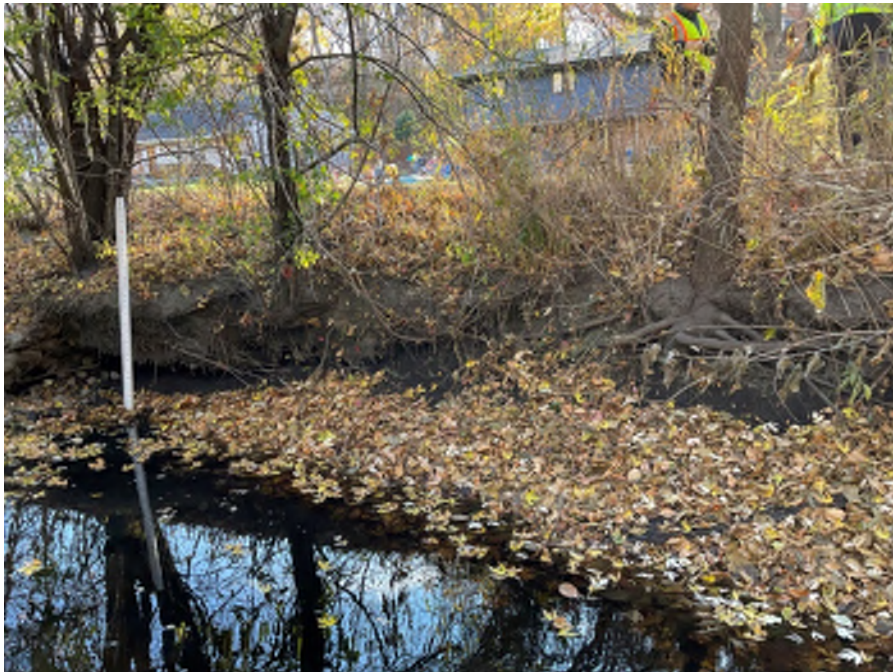
Photo 36: Site 3h. BEHI measurement at right bank of station 51+00 with undercut and deposition.
