Appendices

Appendix A
Site Visit Photos

Bassett Creek Main Stem Erosion Issues and Restoration Prioritization

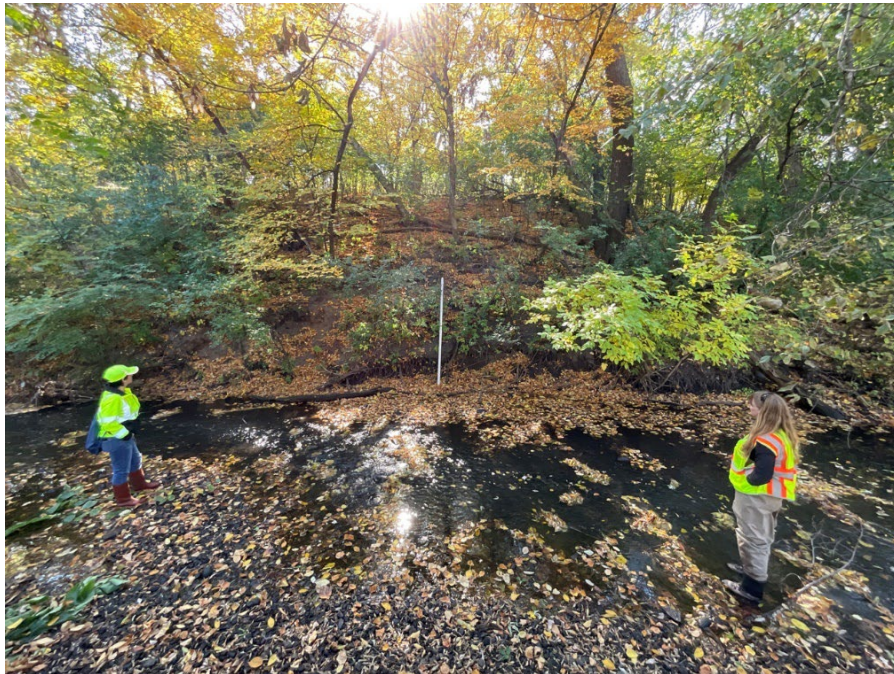
Photo 4: Site 1c. BEHI measurement at the right bank of station 7+20.

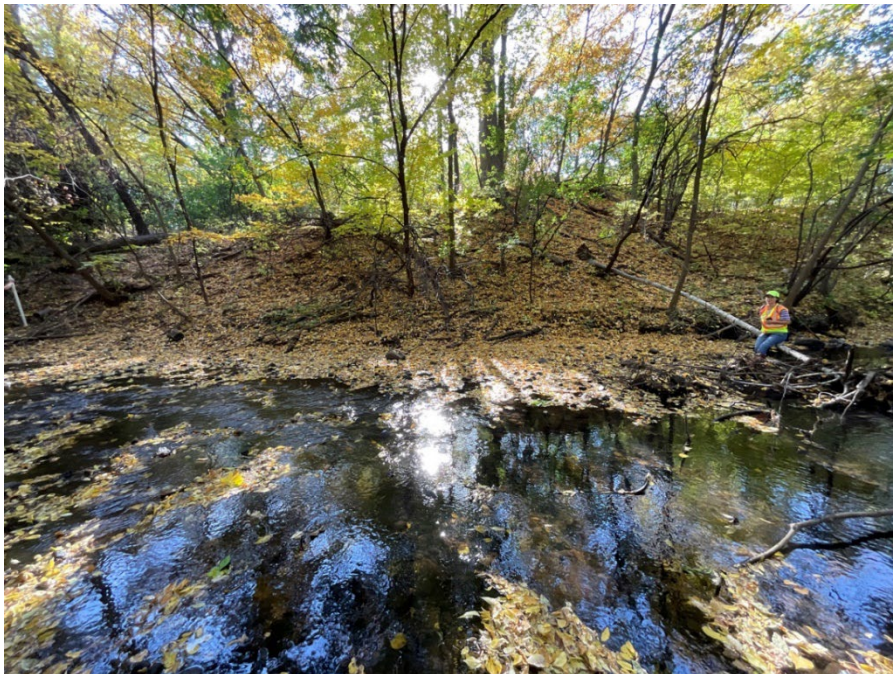
Photo 10: Site 2a. Left bank of station 16+80.

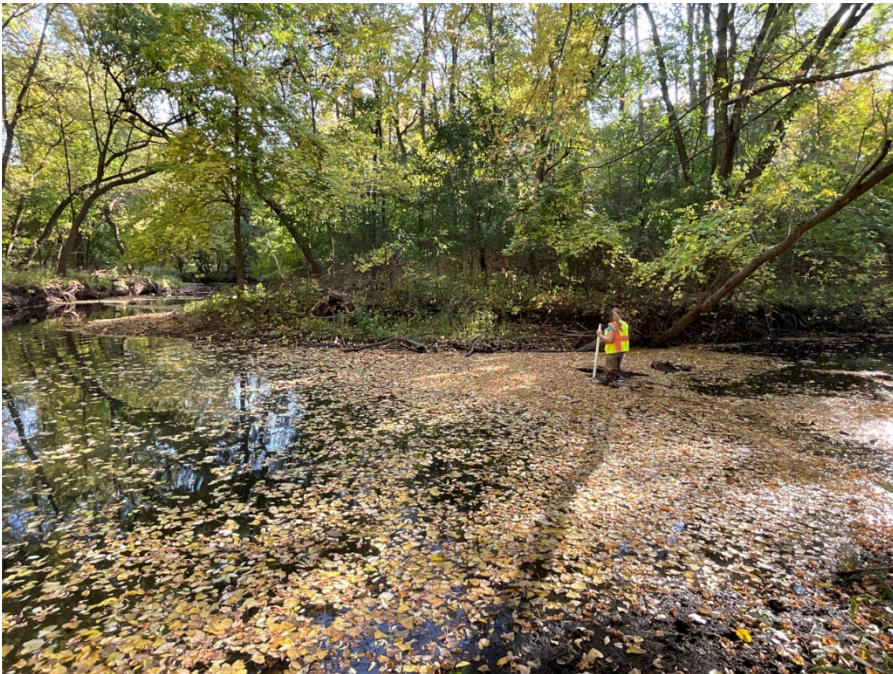
Photo 12: Site 2c. Large deposition at the right bank of station 19+50 (facing downstream).

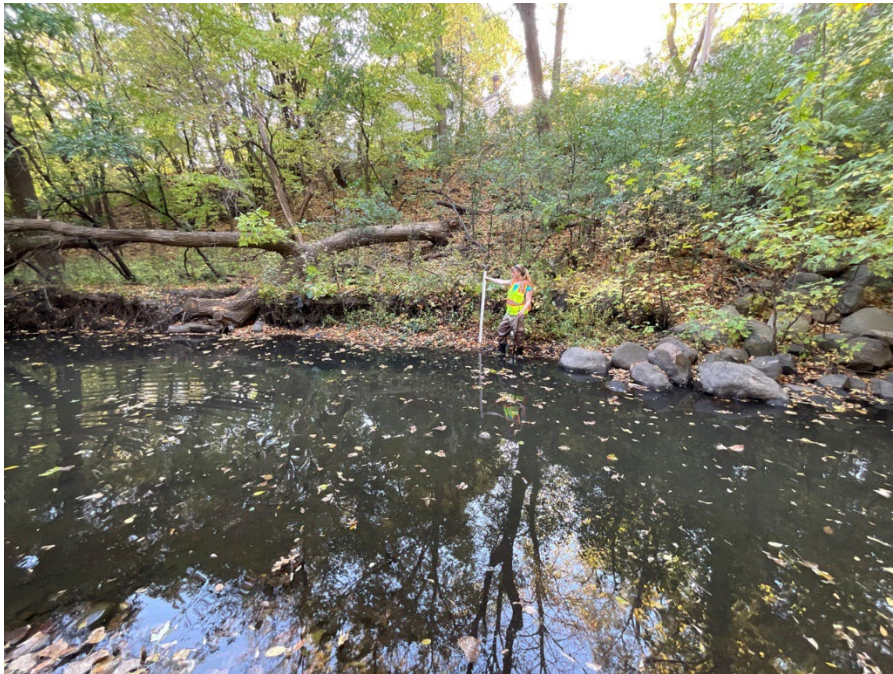
Photo 14: Site 2d. BEHI measurement at the right bank of station 21+10.

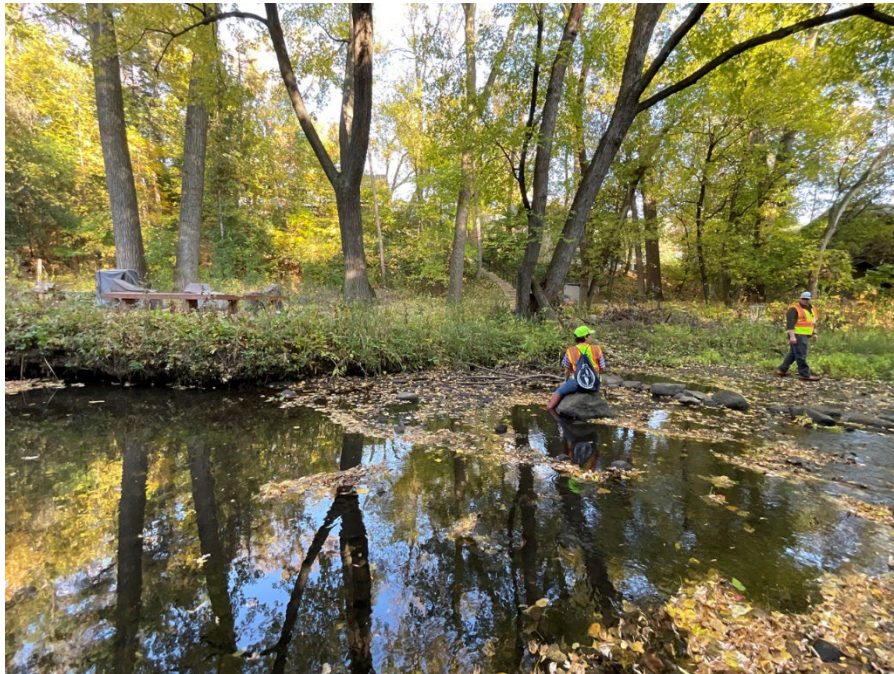
Photo 18: Site 2f. Left bank undercutting at station 23+10.

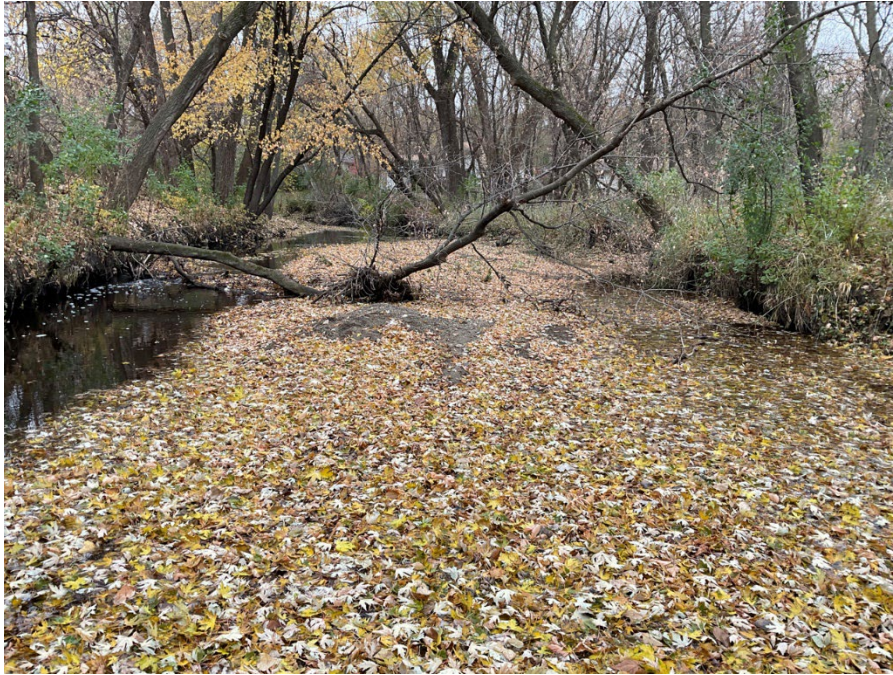
Photo 31: Site 3c. Undercut at the upstream section at station 46+50.

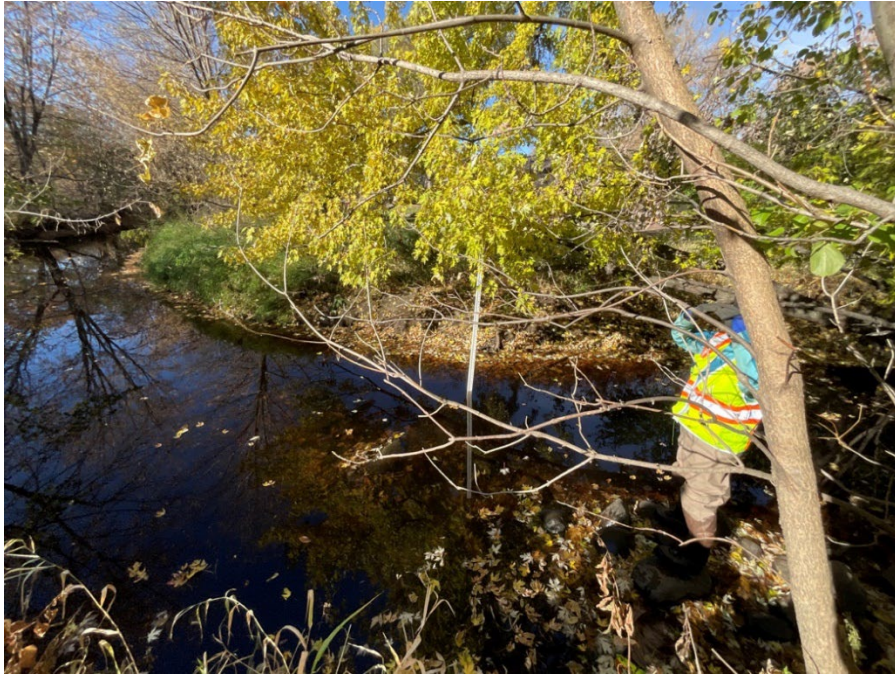
Photo 37: Site 3i. Left bank of station 52+30.

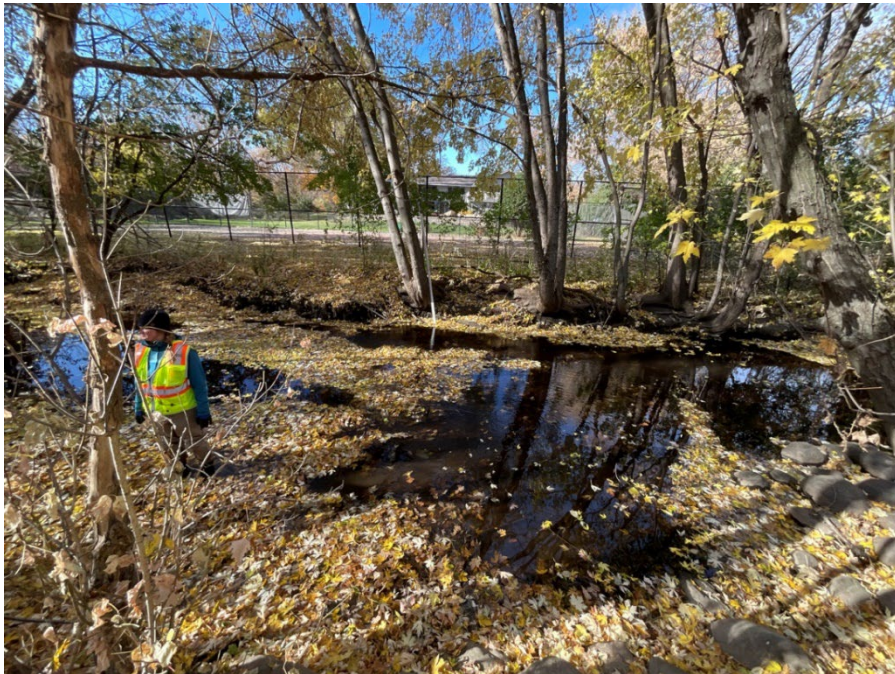
Photo 38: Site 3i. Left bank of station 53+50.

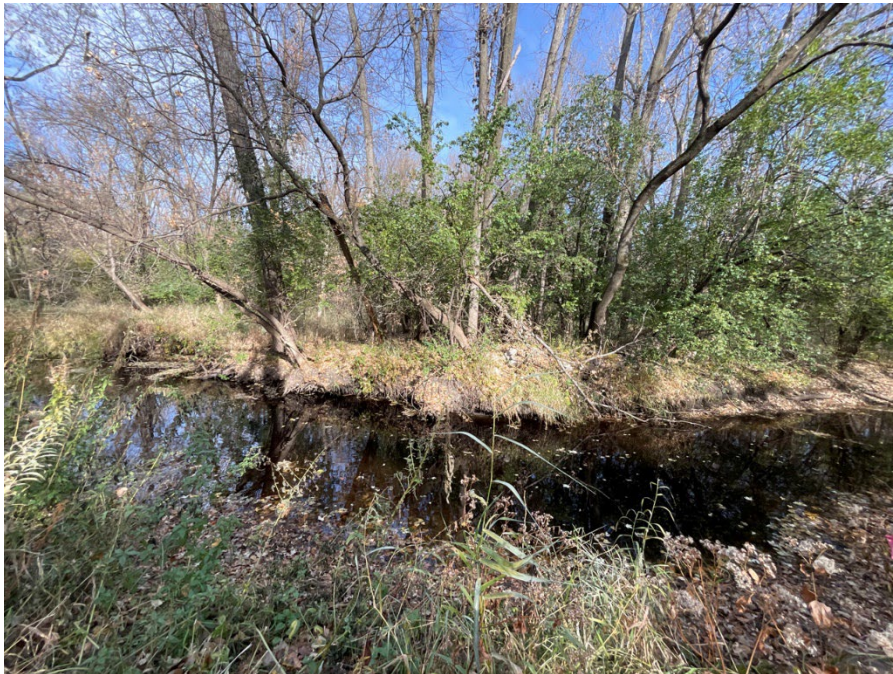
Photo 40: Site 3j. Undercut at the left bank of station 55+20.

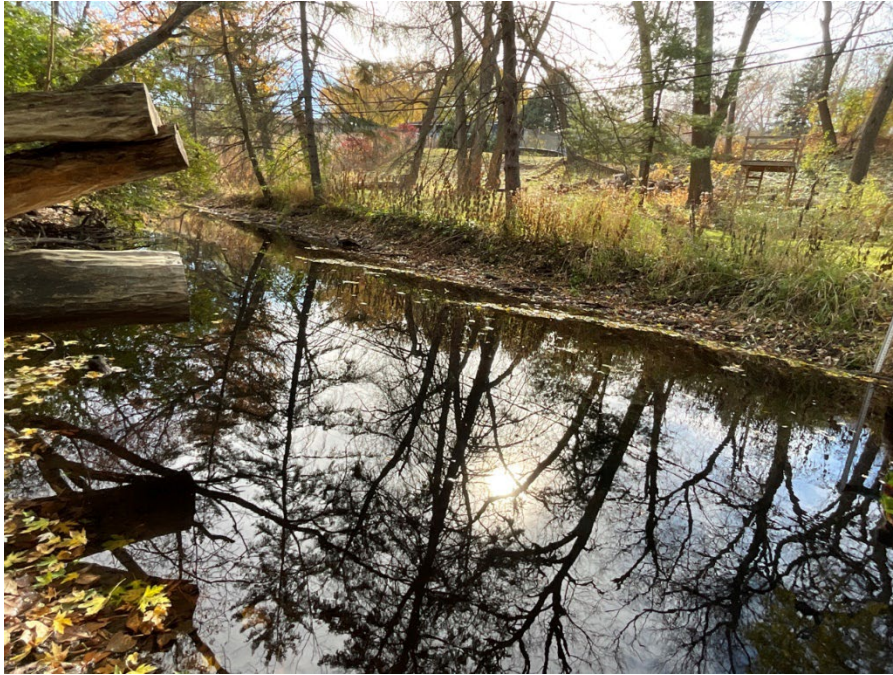
Photo 41: Site 4a. Right bank of station 57+80.

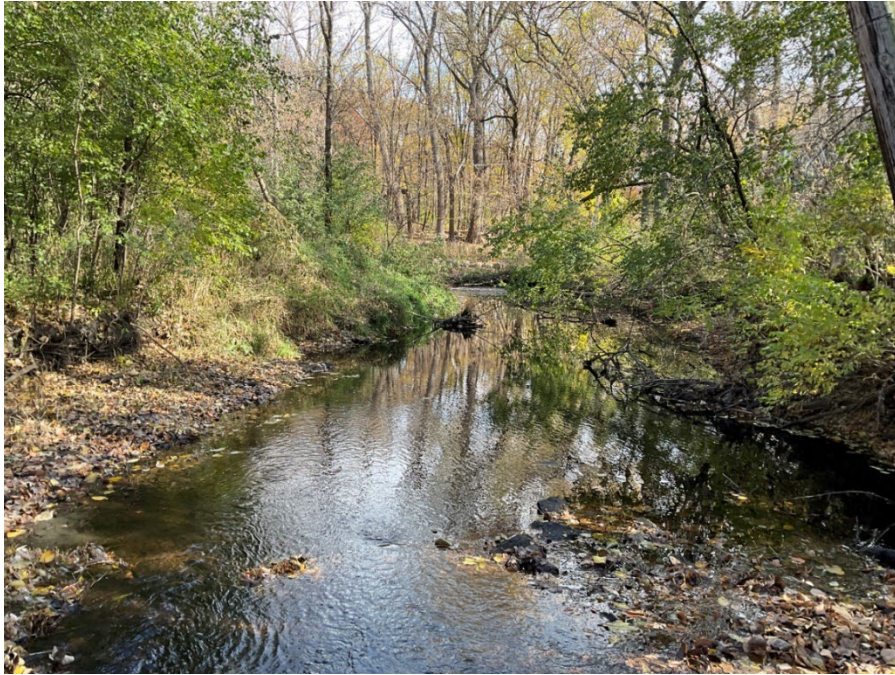
Photo 43: Site 4c. Downstream section before oxbow at station 61+40.

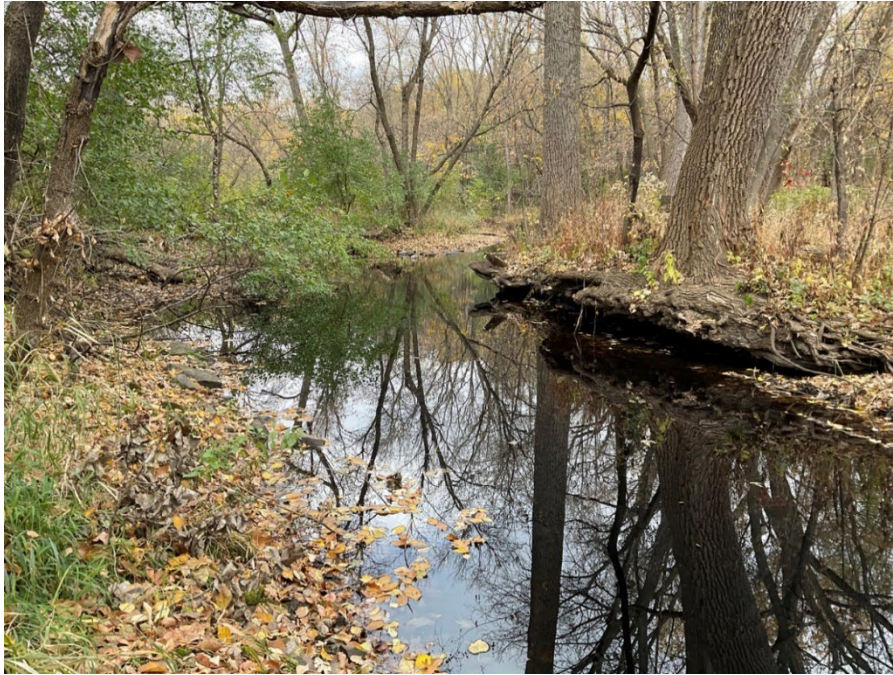
Photo 45: Site 4e. Undercut at station 65+50 (facing upstream).

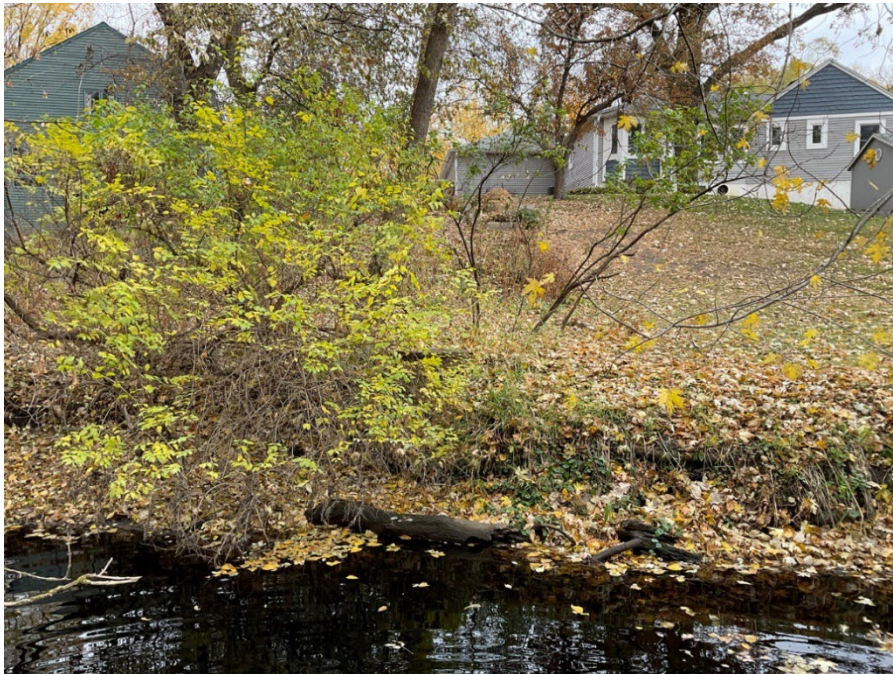
Photo 46: Site 4f. Sanitary manhole at the left bank of station 65+90.

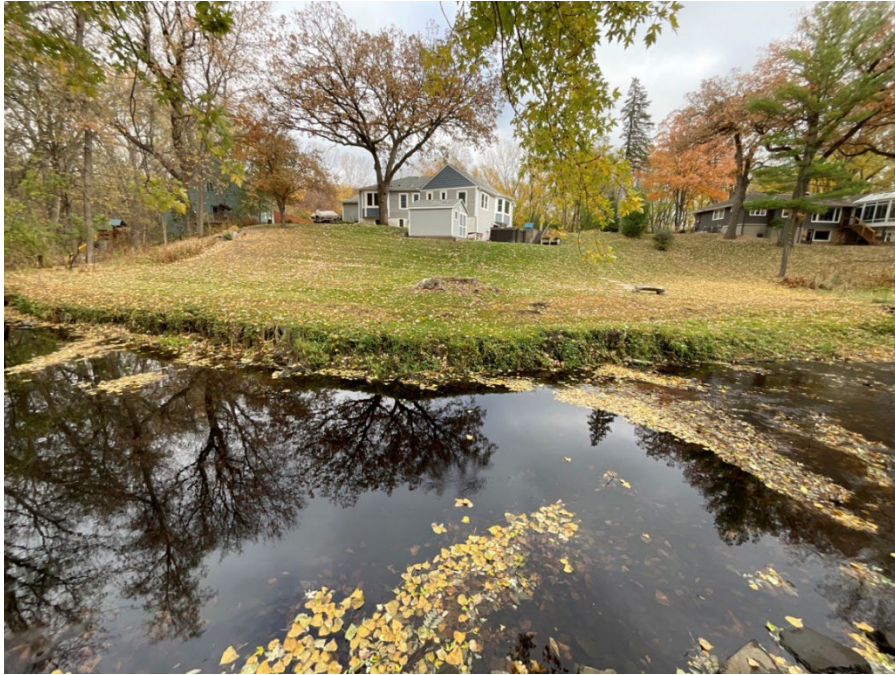
Photo 47: Site 4f. Left bank of station 66+70.

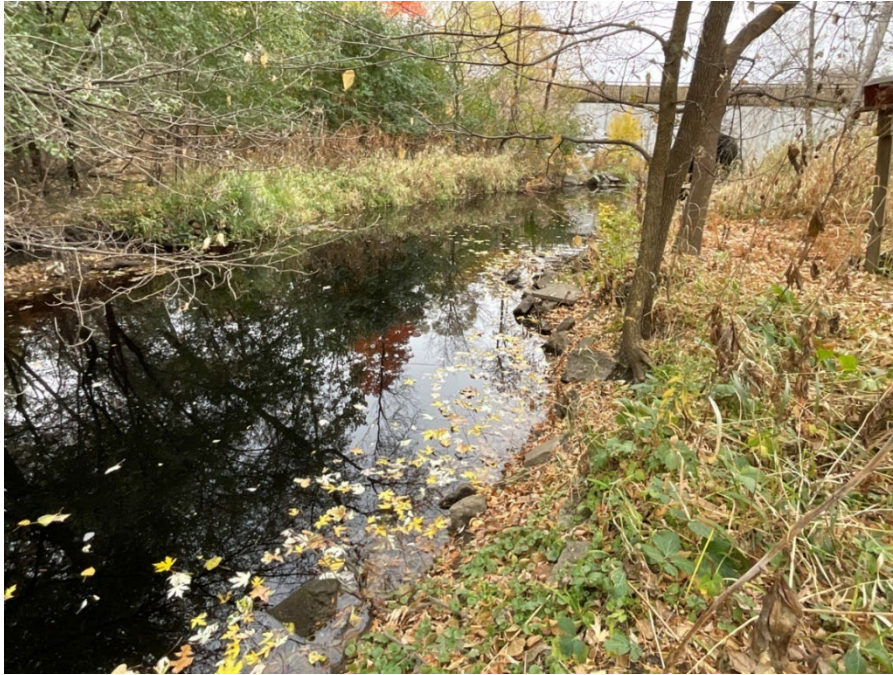
Photo 51: Site 4i. Poor riprap at the right bank of station 70+80 (facing downstream).
