Appendices

Appendix A
Site Visit Photos

Bassett Creek Main Stem Restoration (2024 CR-M)

Bassett Creek Main Stem Erosion Issues and Restoration Prioritization

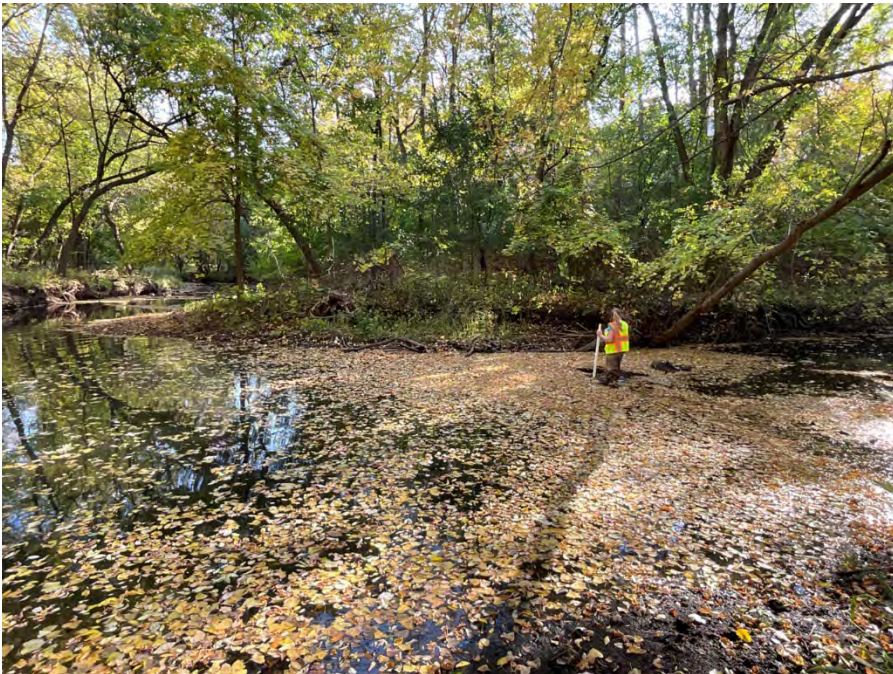
Photo 12: Site 2c. Large deposition at the right bank of station 19+50 (facing downstream).

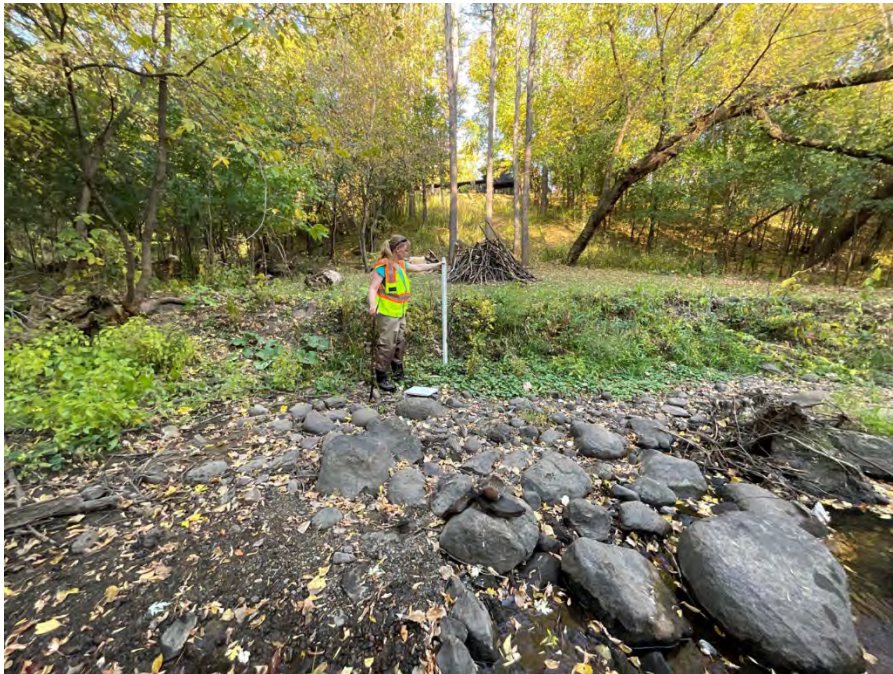
Photo 16: Site 2e. BEHI measurement at the left bank of station 22+50.

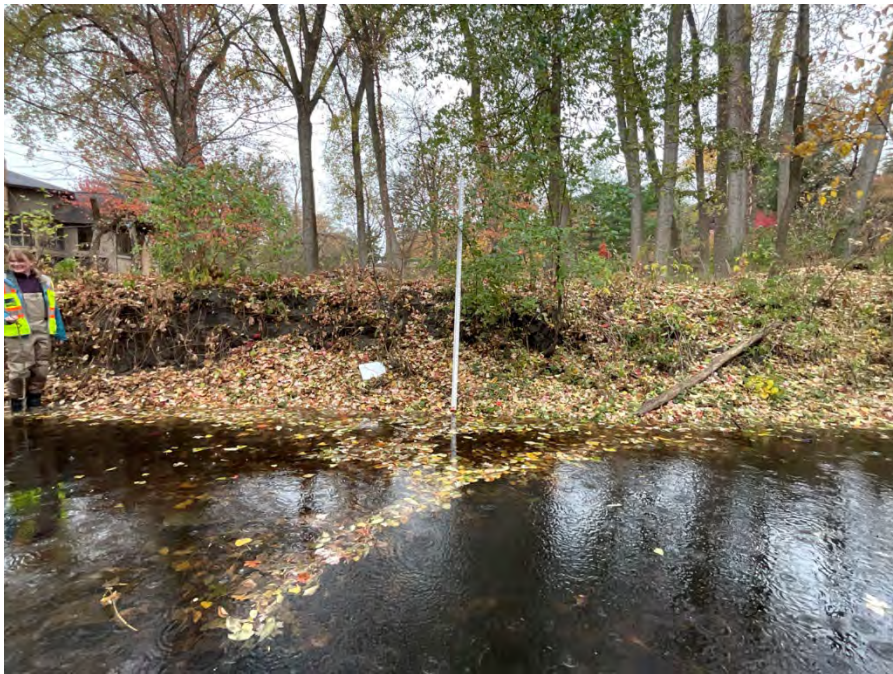
Photo 20: Site 2h. BEHI measurement at the right bank of station 29+00.

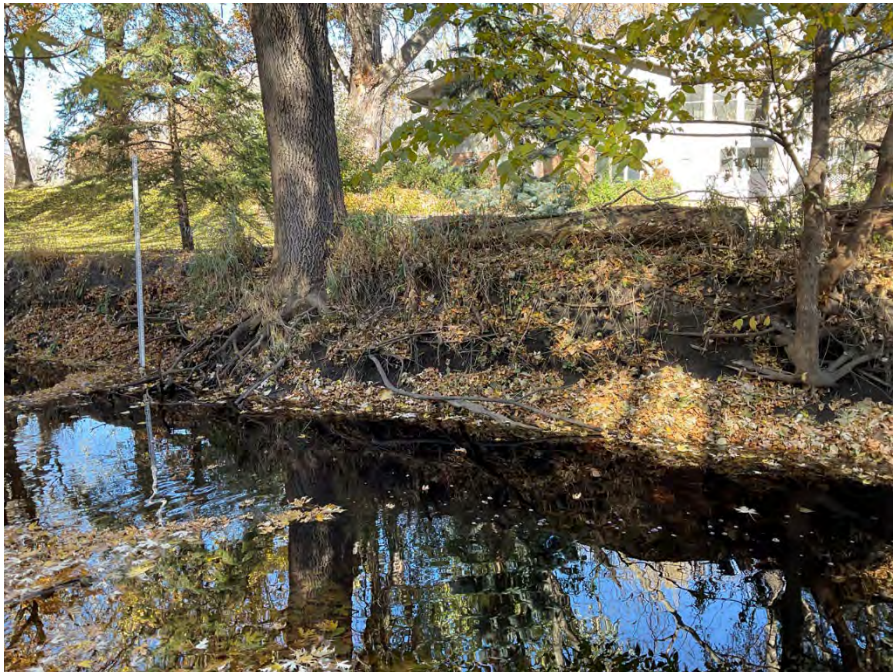
Photo 34: Site 3f. Bare soil at the upstream section at station 50+90.

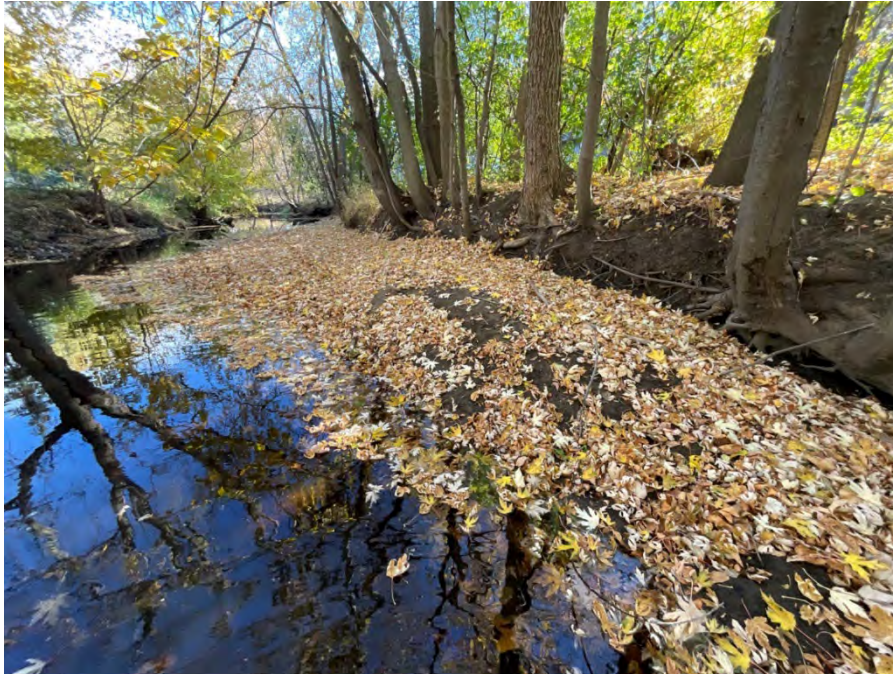
Photo 35: Site 3g. Undercut and deposition at right bank of station 50+20.

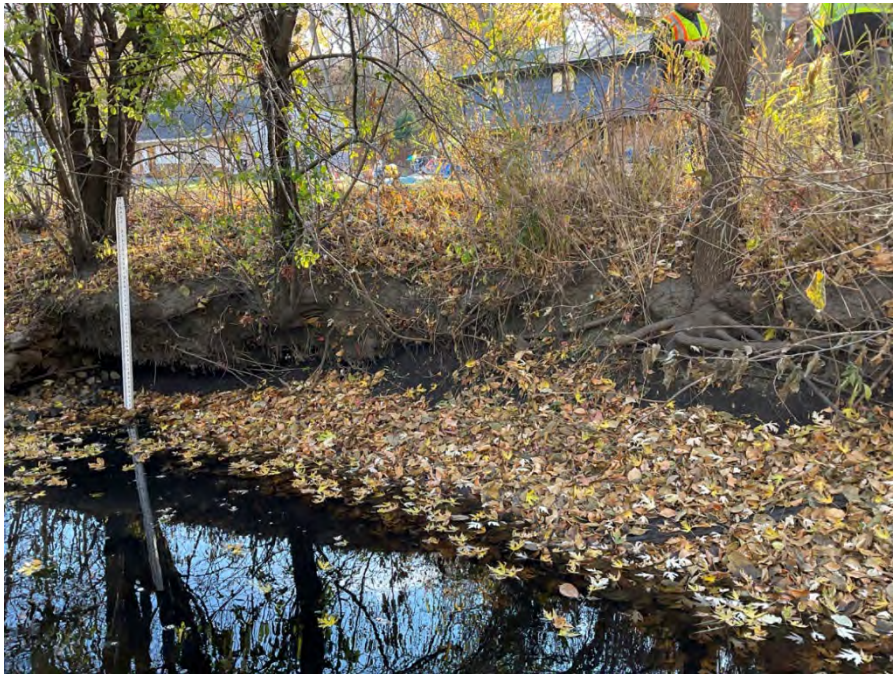
Photo 36: Site 3h. BEHI measurement at right bank of station 51+00 with undercut and deposition.

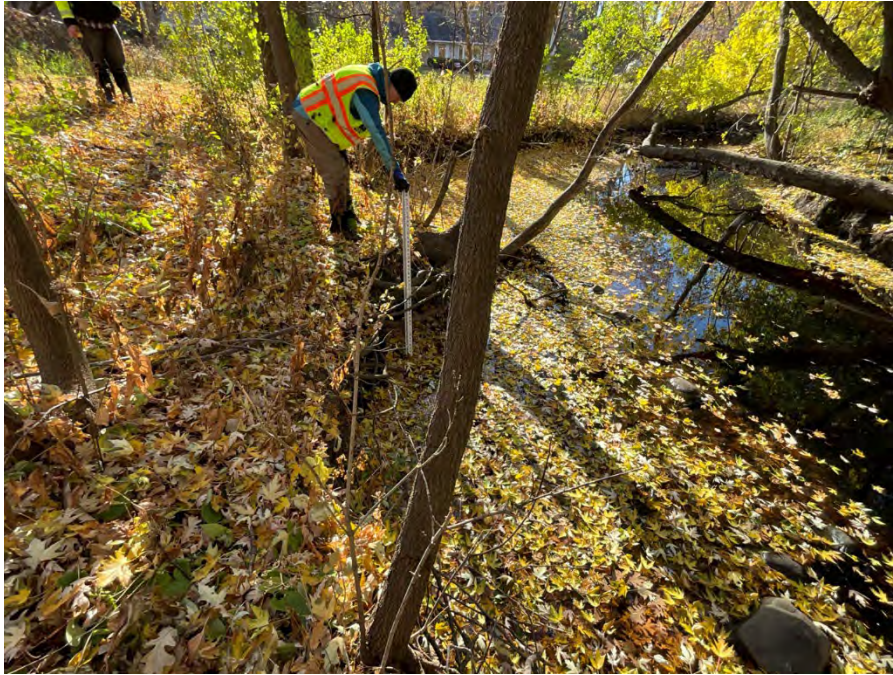
Photo 39: Site 3i. BEHI measurement at the right bank of station 53+00 (facing upstream).

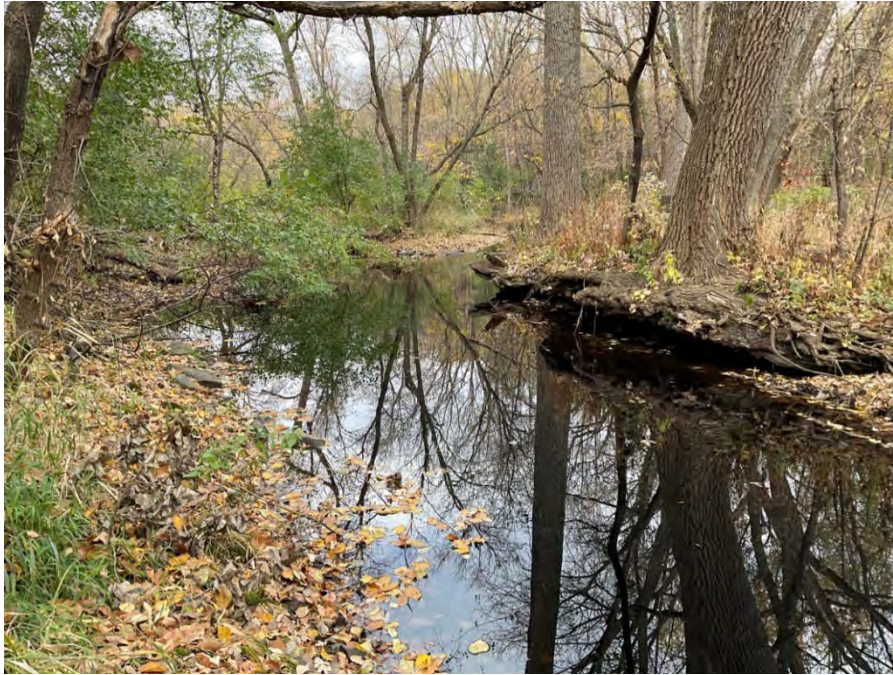
Photo 45: Site 4e. Undercut at station 65+50 (facing upstream).
