Memorandum

To: Bassett Creek Watershed Management Commission (BCWMC)
From: Barr Engineering Co. (Josh Phillips, Gabby Campagnola, Jim Herbert)
Subject: Bassett Creek 2023 Flood Control Project Inspection
Date: December 13, 2023
Project: 23270051.58 2023 4065

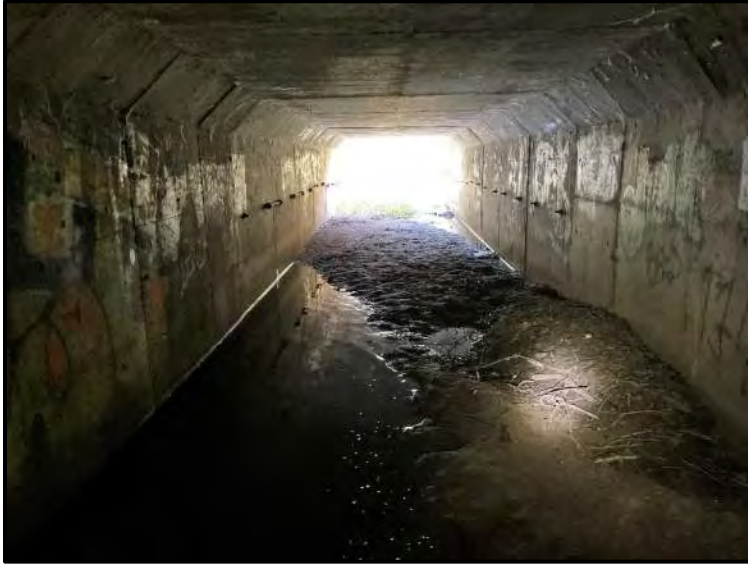
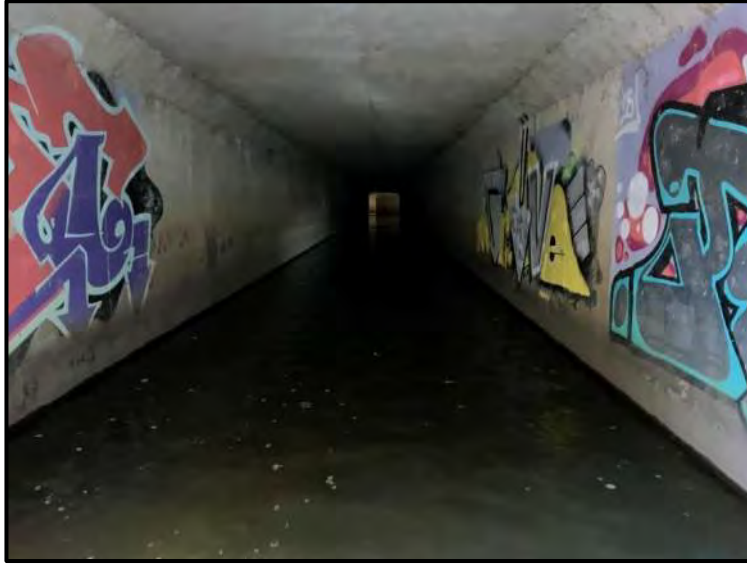
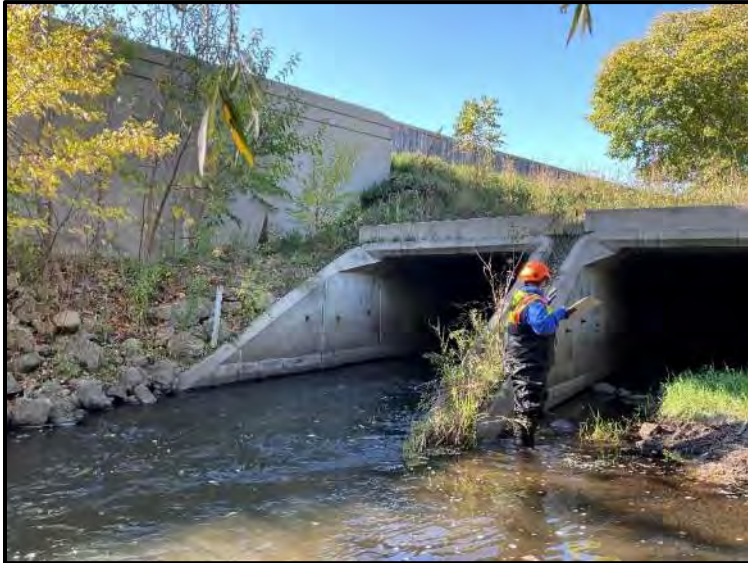
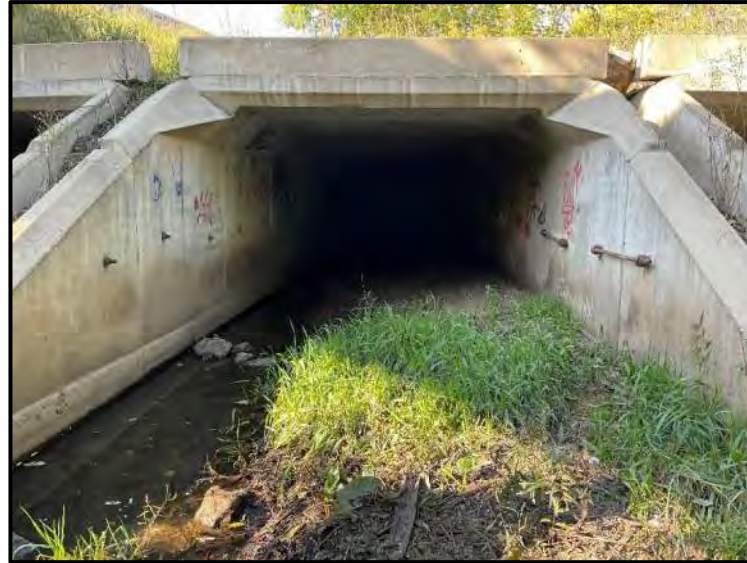
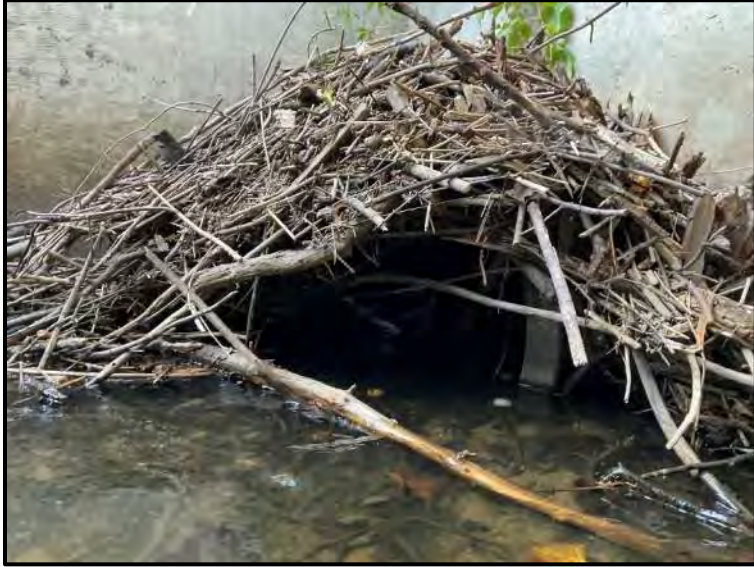
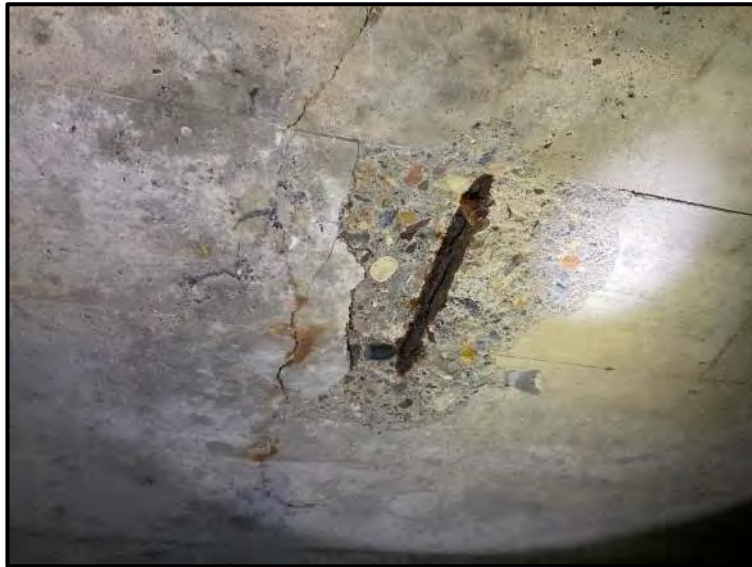
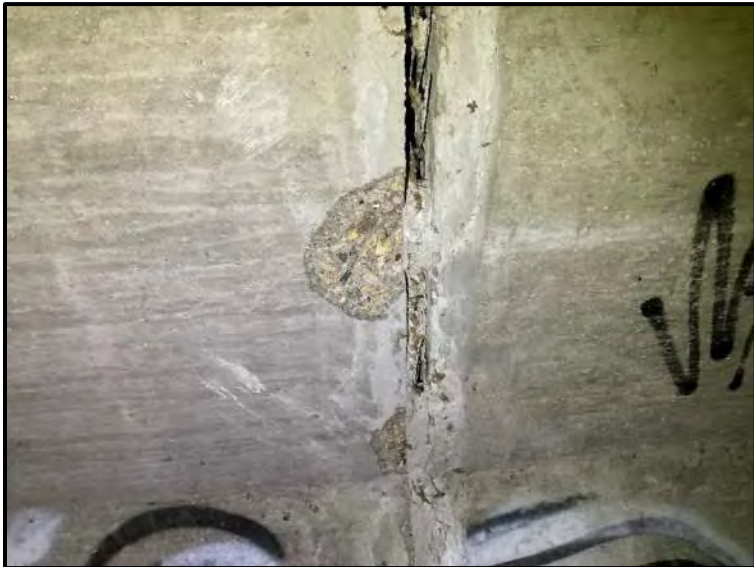
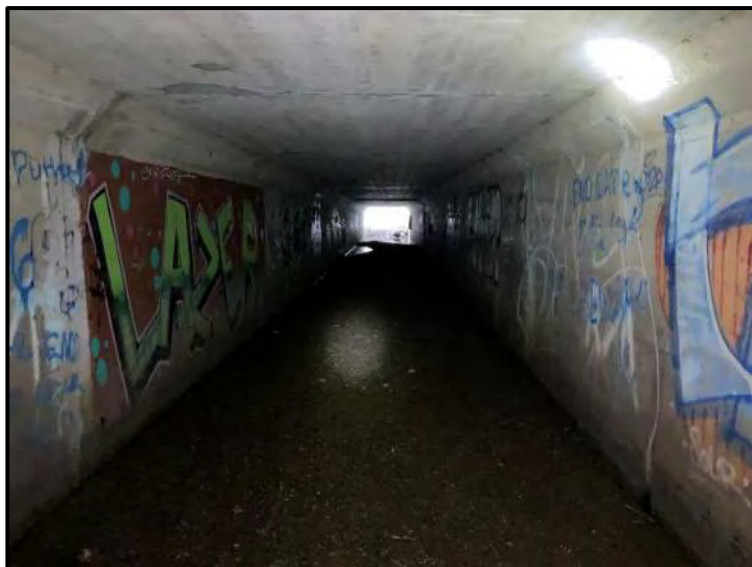
Highway 100 Double Box Culverts (MnDOT Responsibility, Located in Crystal/Golden Valley)

- a. The concrete inlet structure appeared to be in satisfactory condition.
- b. Circumferential cracks and approximately 12 locations of spalled concrete, nine of which had exposed reinforcement, were observed in the north (left) box culvert.

- c. Two areas of spalled concrete on the right wall of the south (right) box culvert were observed.
- d. Four longitudinal cracks, circumferential cracks, and areas of spalled concrete with exposed reinforcement were observed along the top of the south (right) box culvert. MnDOT performed repairs to the culverts in 2007, but cracks have been noted since 2008 and areas of concrete spalling have been noted since 2014.

- e. Deposited sediment was observed in the north (left) box culvert, generally ranging from 6-36 inches deep. This is similar to previous inspections that noted 6-24 inches of deposited sediment has been observed in the north (left) box culvert since 2002.

- f. The outlet portion of the structure appeared to be in satisfactory condition.
- g. Riprap was observed in the inlet structure near entrance to the south (right) box culvert.

- Remove deposited riprap in the inlet structure near the entrance to the south (right) box culvert.
- Monitor accumulated sediment in north (left) box culvert and consider future removal.
- Monitor cracking, spalling concrete, and exposed reinforcement in both box culverts.
- MnDOT should assess the defects and repair, as necessary.

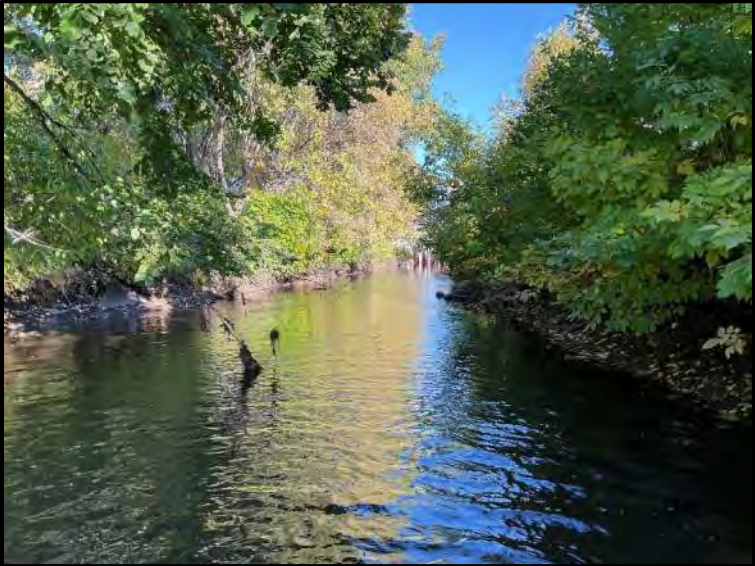
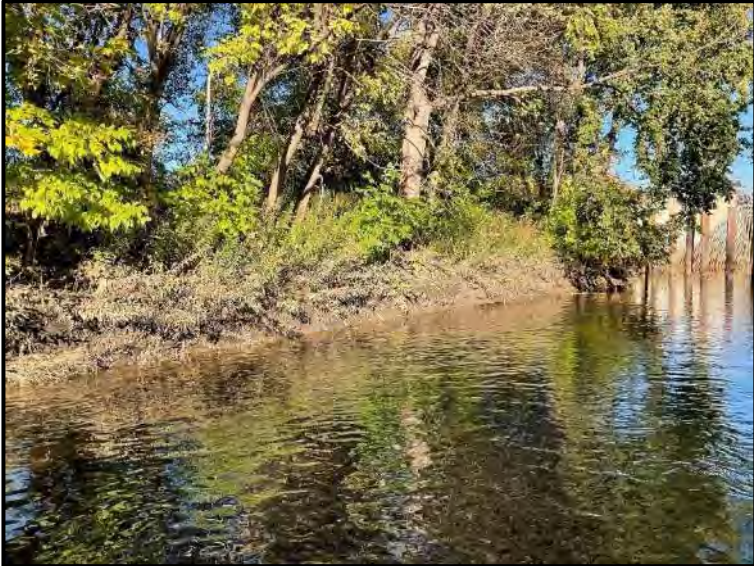
Open Channel (Minneapolis)

- a. The open channel, from Van White Memorial Boulevard to the inlet structure, appeared to be in satisfactory condition.
- b. The banks were generally vegetated. Some areas had exposed soil and steep slopes but seemed stable and no obvious signs of bank erosion were noted.
- c. Sediment has deposited and formed a delta on the south (right) side of the channel between the debris barrier and inlet structure, extending approximately 20% of the channel width. Vegetation was growing on the delta. This is consistent with previous years' observation.

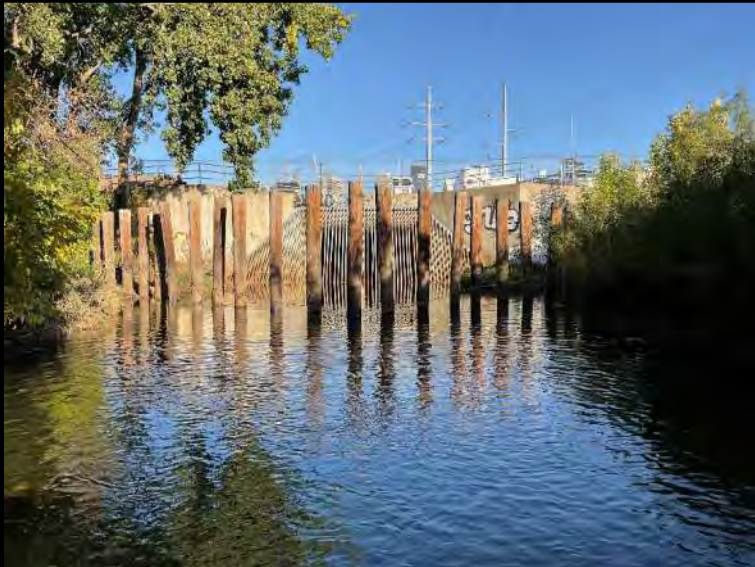
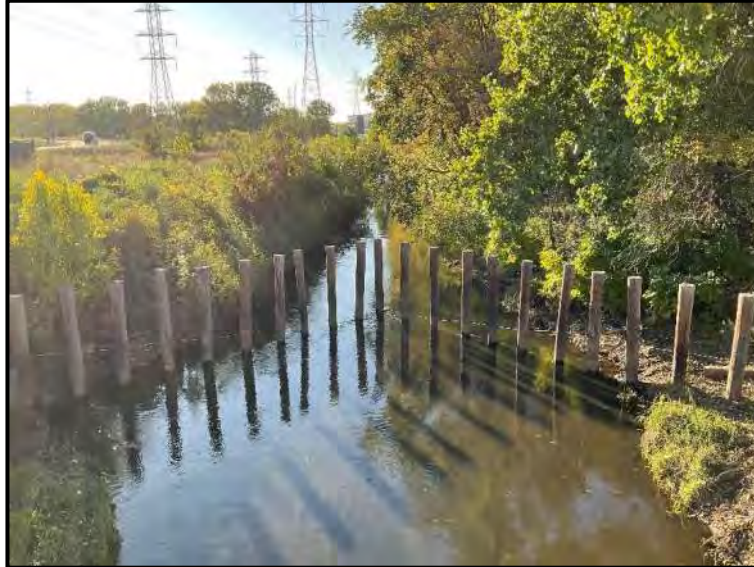
Debris Barrier (Minneapolis)

- a. The debris barrier piles appeared to be in satisfactory condition.
- b. The steel cable was repaired by the City since the last inspection and extended across the channel, attached at each post.

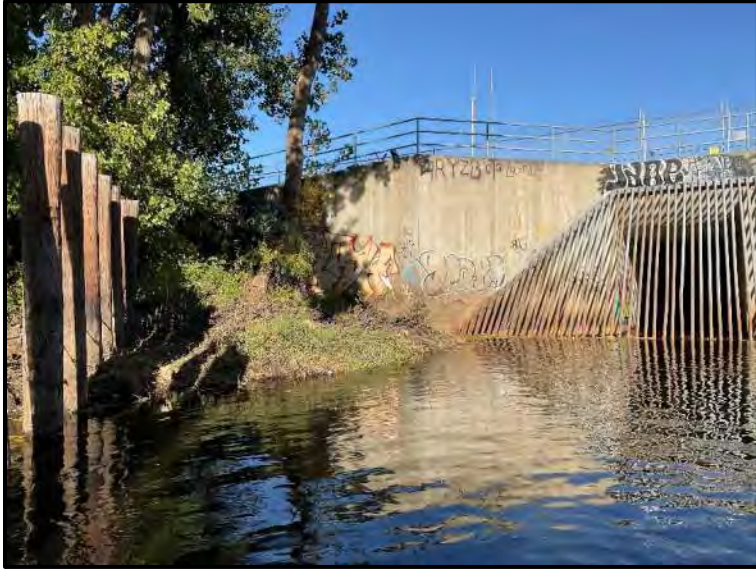
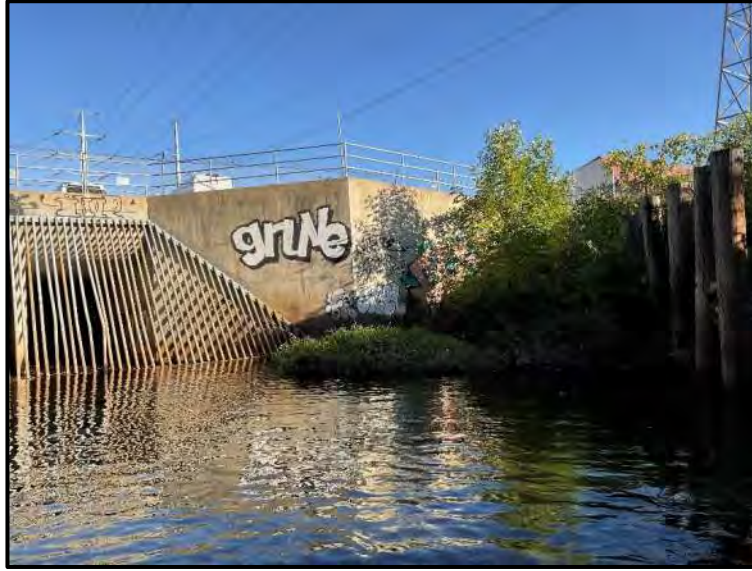
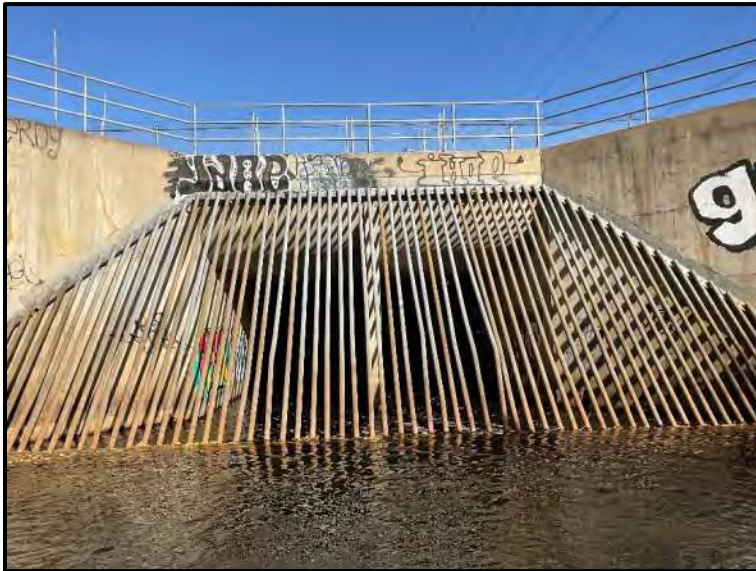
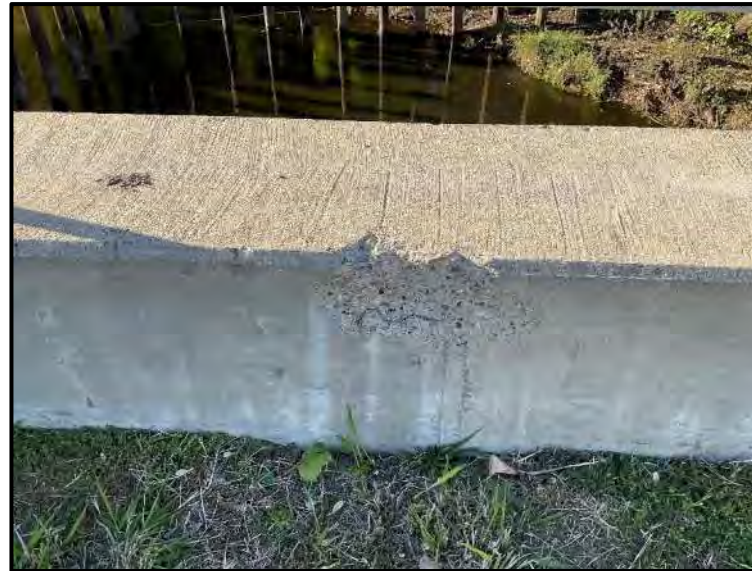
Inlet Structure (Minneapolis)

- a. The concrete inlet structure appeared to be in satisfactory condition.
- b. Vertical cracks were observed in the concrete on either side of the structure.
- c. Cracks were observed near where the handrail posts are embedded.
- d. The railings appeared to be in satisfactory condition.
- e. Some of the vertical bars have been bent and projecting a slight bow but generally appeared to be in satisfactory condition.

- f. The inlet structure was clear of debris.
- g. Spalled concrete was observed behind the railings on the right side of the structure.

- Monitor for debris and clear as needed.
- Monitor cracks in the concrete inlet structure.
- Monitor concrete spalling behind the railings.
