I. Detailed alternatives for stabilization

**BASSETT CREEK POTENTIAL
STABILIZATION SITES**
Bassett Creek Erosion Repair Feasibility Report
Bassett Creek Watershed
Management Commission

FIGURE I-2
BASSETT CREEK REACH 1 ALTERNATIVES
REACH 1 - FRUEN MILL SITE
 Bassett Creek Erosion Repair Feasibility Report
 Bassett Creek Watershed Management Commission

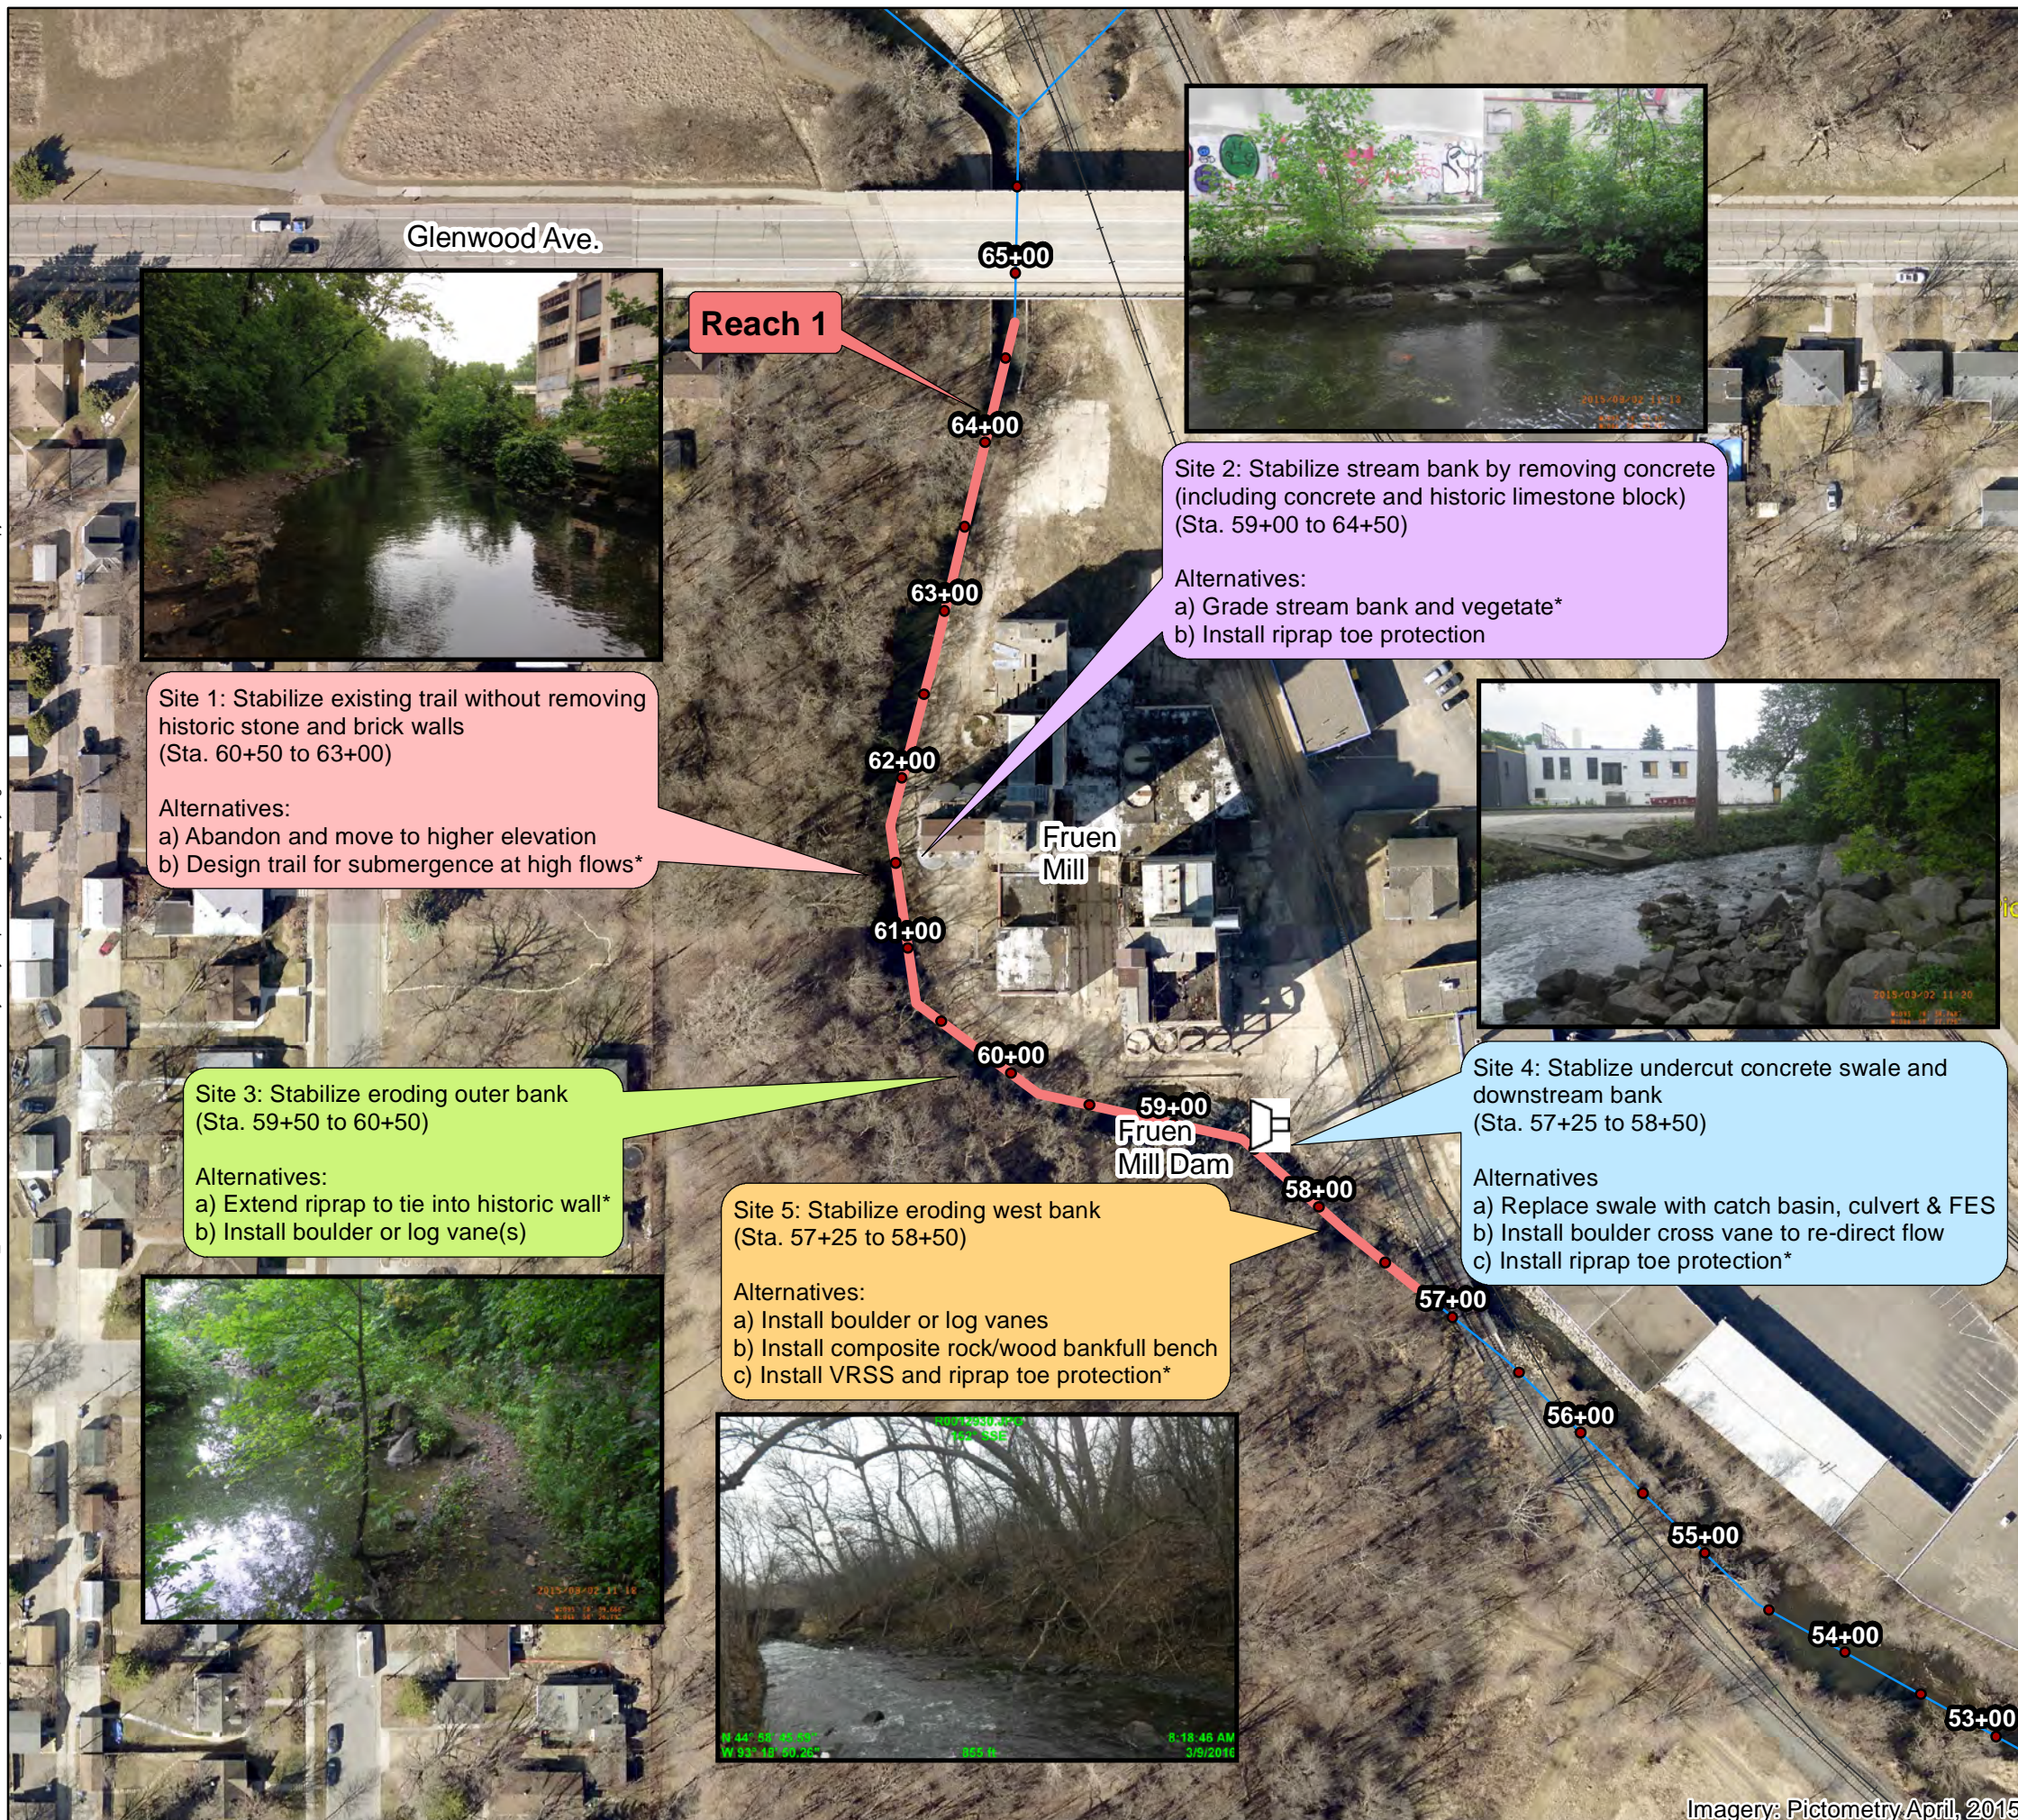
Reach 1

Issues: Concrete and limestone armoring on east bank in varying states of repair. Foot path on west bank being eroded in places, submerged at high flows.

Constraints: Water level control must remain at the historic dam site. Historic rock and brick walls must remain. Narrow valley and infrastructure limits meandering potential. Potential soil contamination due to history of industrial use.

Note: Individual alternatives are defined as a, b, or c for many of the sites. One or more alternatives will be chosen for each site.

The entire eastern bank of Bassett Creek through the Fruen Mill complex is identified as Site 2 (Station 59+00 to 64+50 on Figure I-2). The eastern stream bank through this site is fully armored with a combination of historical limestone blocks and concrete; some of the armoring materials are failing or have collapsed into the stream. Photo 2 in Appendix A shows a typical portion of this site.

Site 5 is located downstream of the Fruen Mill Dam and upstream of the railroad bridge, along the west bank of Bassett Creek (Station 57+25 to 58+50 on Figure I-2). Photo 5 in Appendix A shows a typical portion of this site. The majority of the stream flow is along the opposite (east) bank, but the downstream railroad bridge causes a flow constriction and backwater along the west bank. Highly turbulent flows have eroded the toe of the west bank and created a cut bank up to 7 feet tall in places.

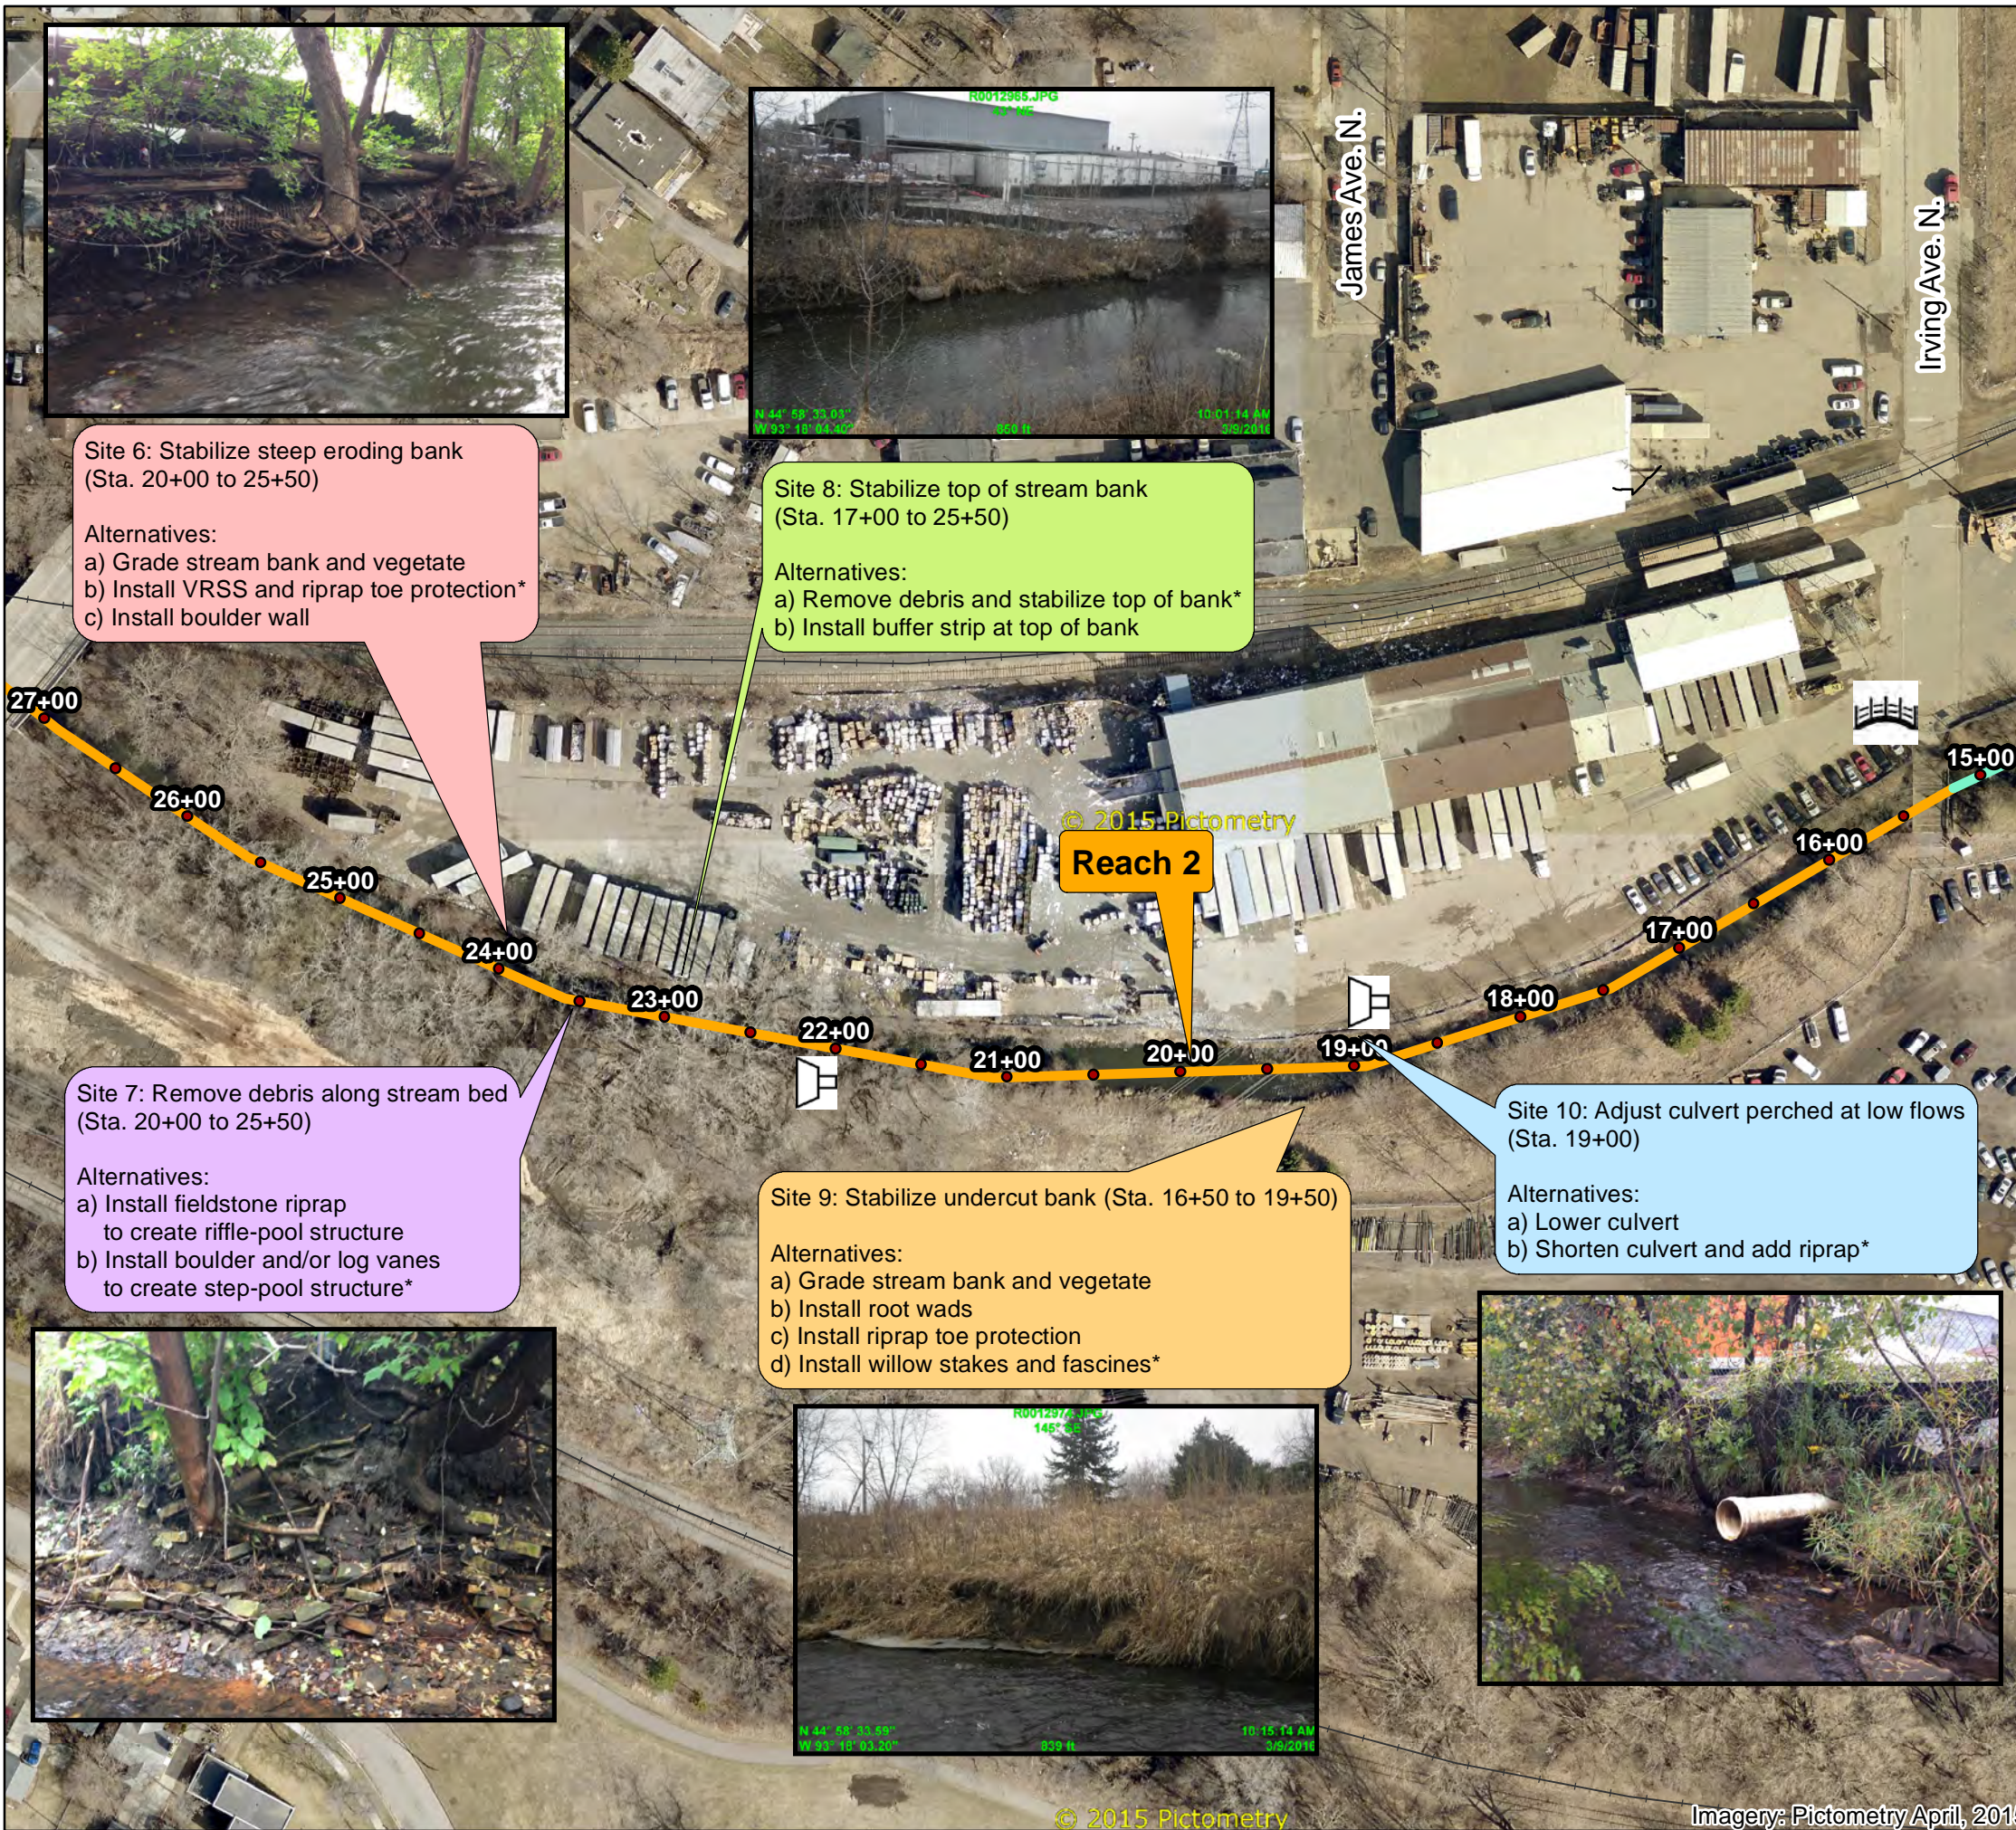
FIGURE I-3
BASSETT CREEK REACH 2 ALTERNATIVES
 Bassett Creek Erosion Repair Feasibility Report
 Bassett Creek Watershed Management Commission

Reach 2

Issues: Historically straightened and brick-lined; banks are steep and eroding in places. Stream bed is a mixture of native and imported materials
