Memorandum

Project: Plymouth Creek Restoration Phase 1

Subject: Plymouth Creek Restoration Design Memo

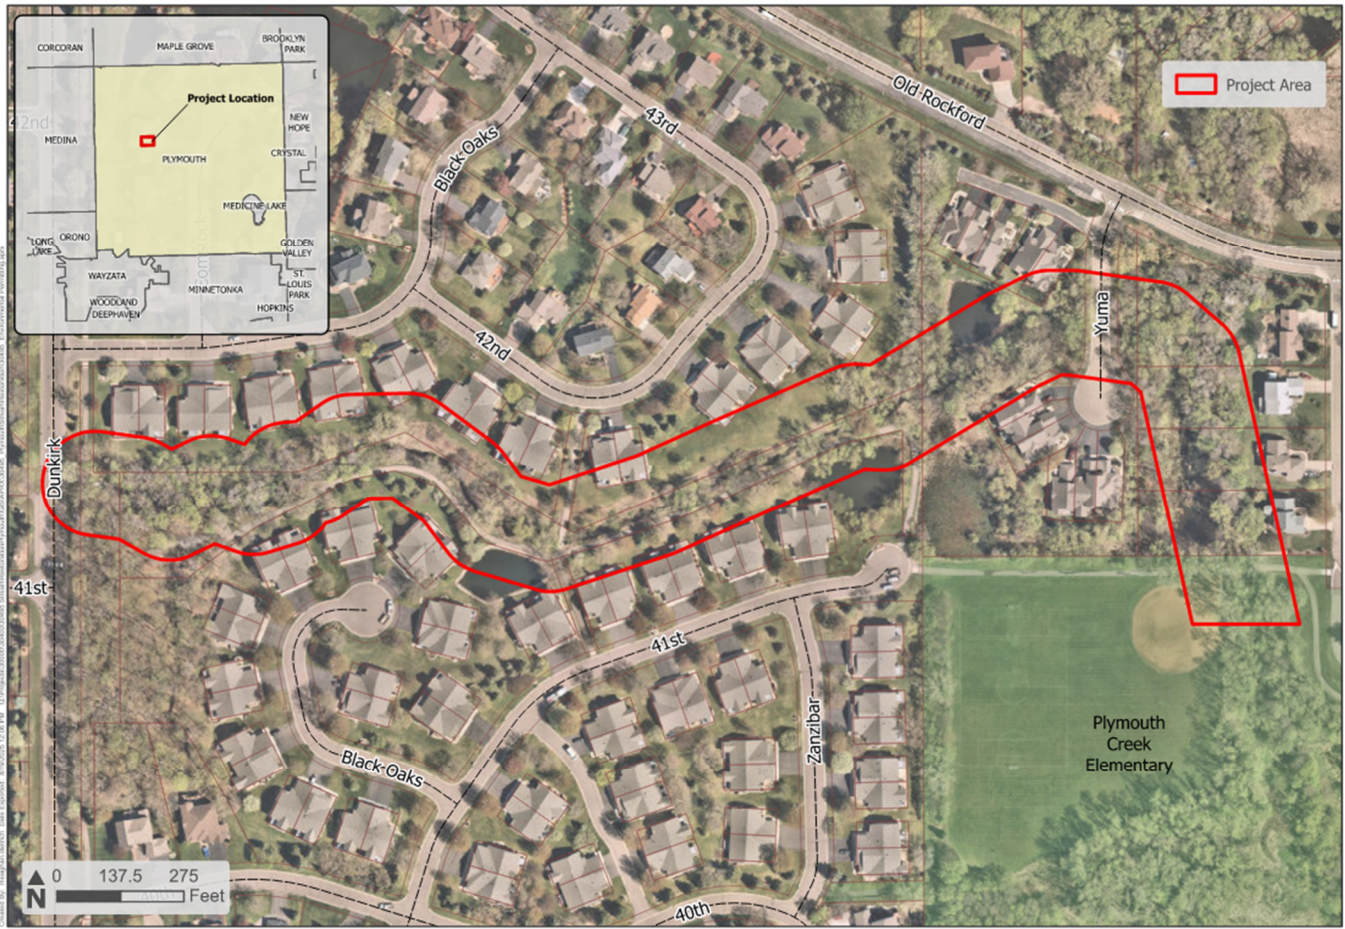
Figure 1: Project Location – Phase 1 Restoration from Dunkirk Ln to 41st Avenue Trail

Upon review of the entire proposed project and the level of effort needed to complete the full Option 3 design, the City decided to then break out the creek restoration into two phases. The first phase will focus on the stream from Dunkirk Lane to the trail crossing near 41st Avenue, see Figure 1 below. The second phase will then start where the first phase ends and continue until 38th Avenue. The goal is to design and permit the first phase of the project in fall and winter of 2025 and construct the project in early winter and spring of 2026. Phase two would then be designed and permitted starting in spring of 2026 and constructed over the 2026/2027 winter.
