### Erosion Sites

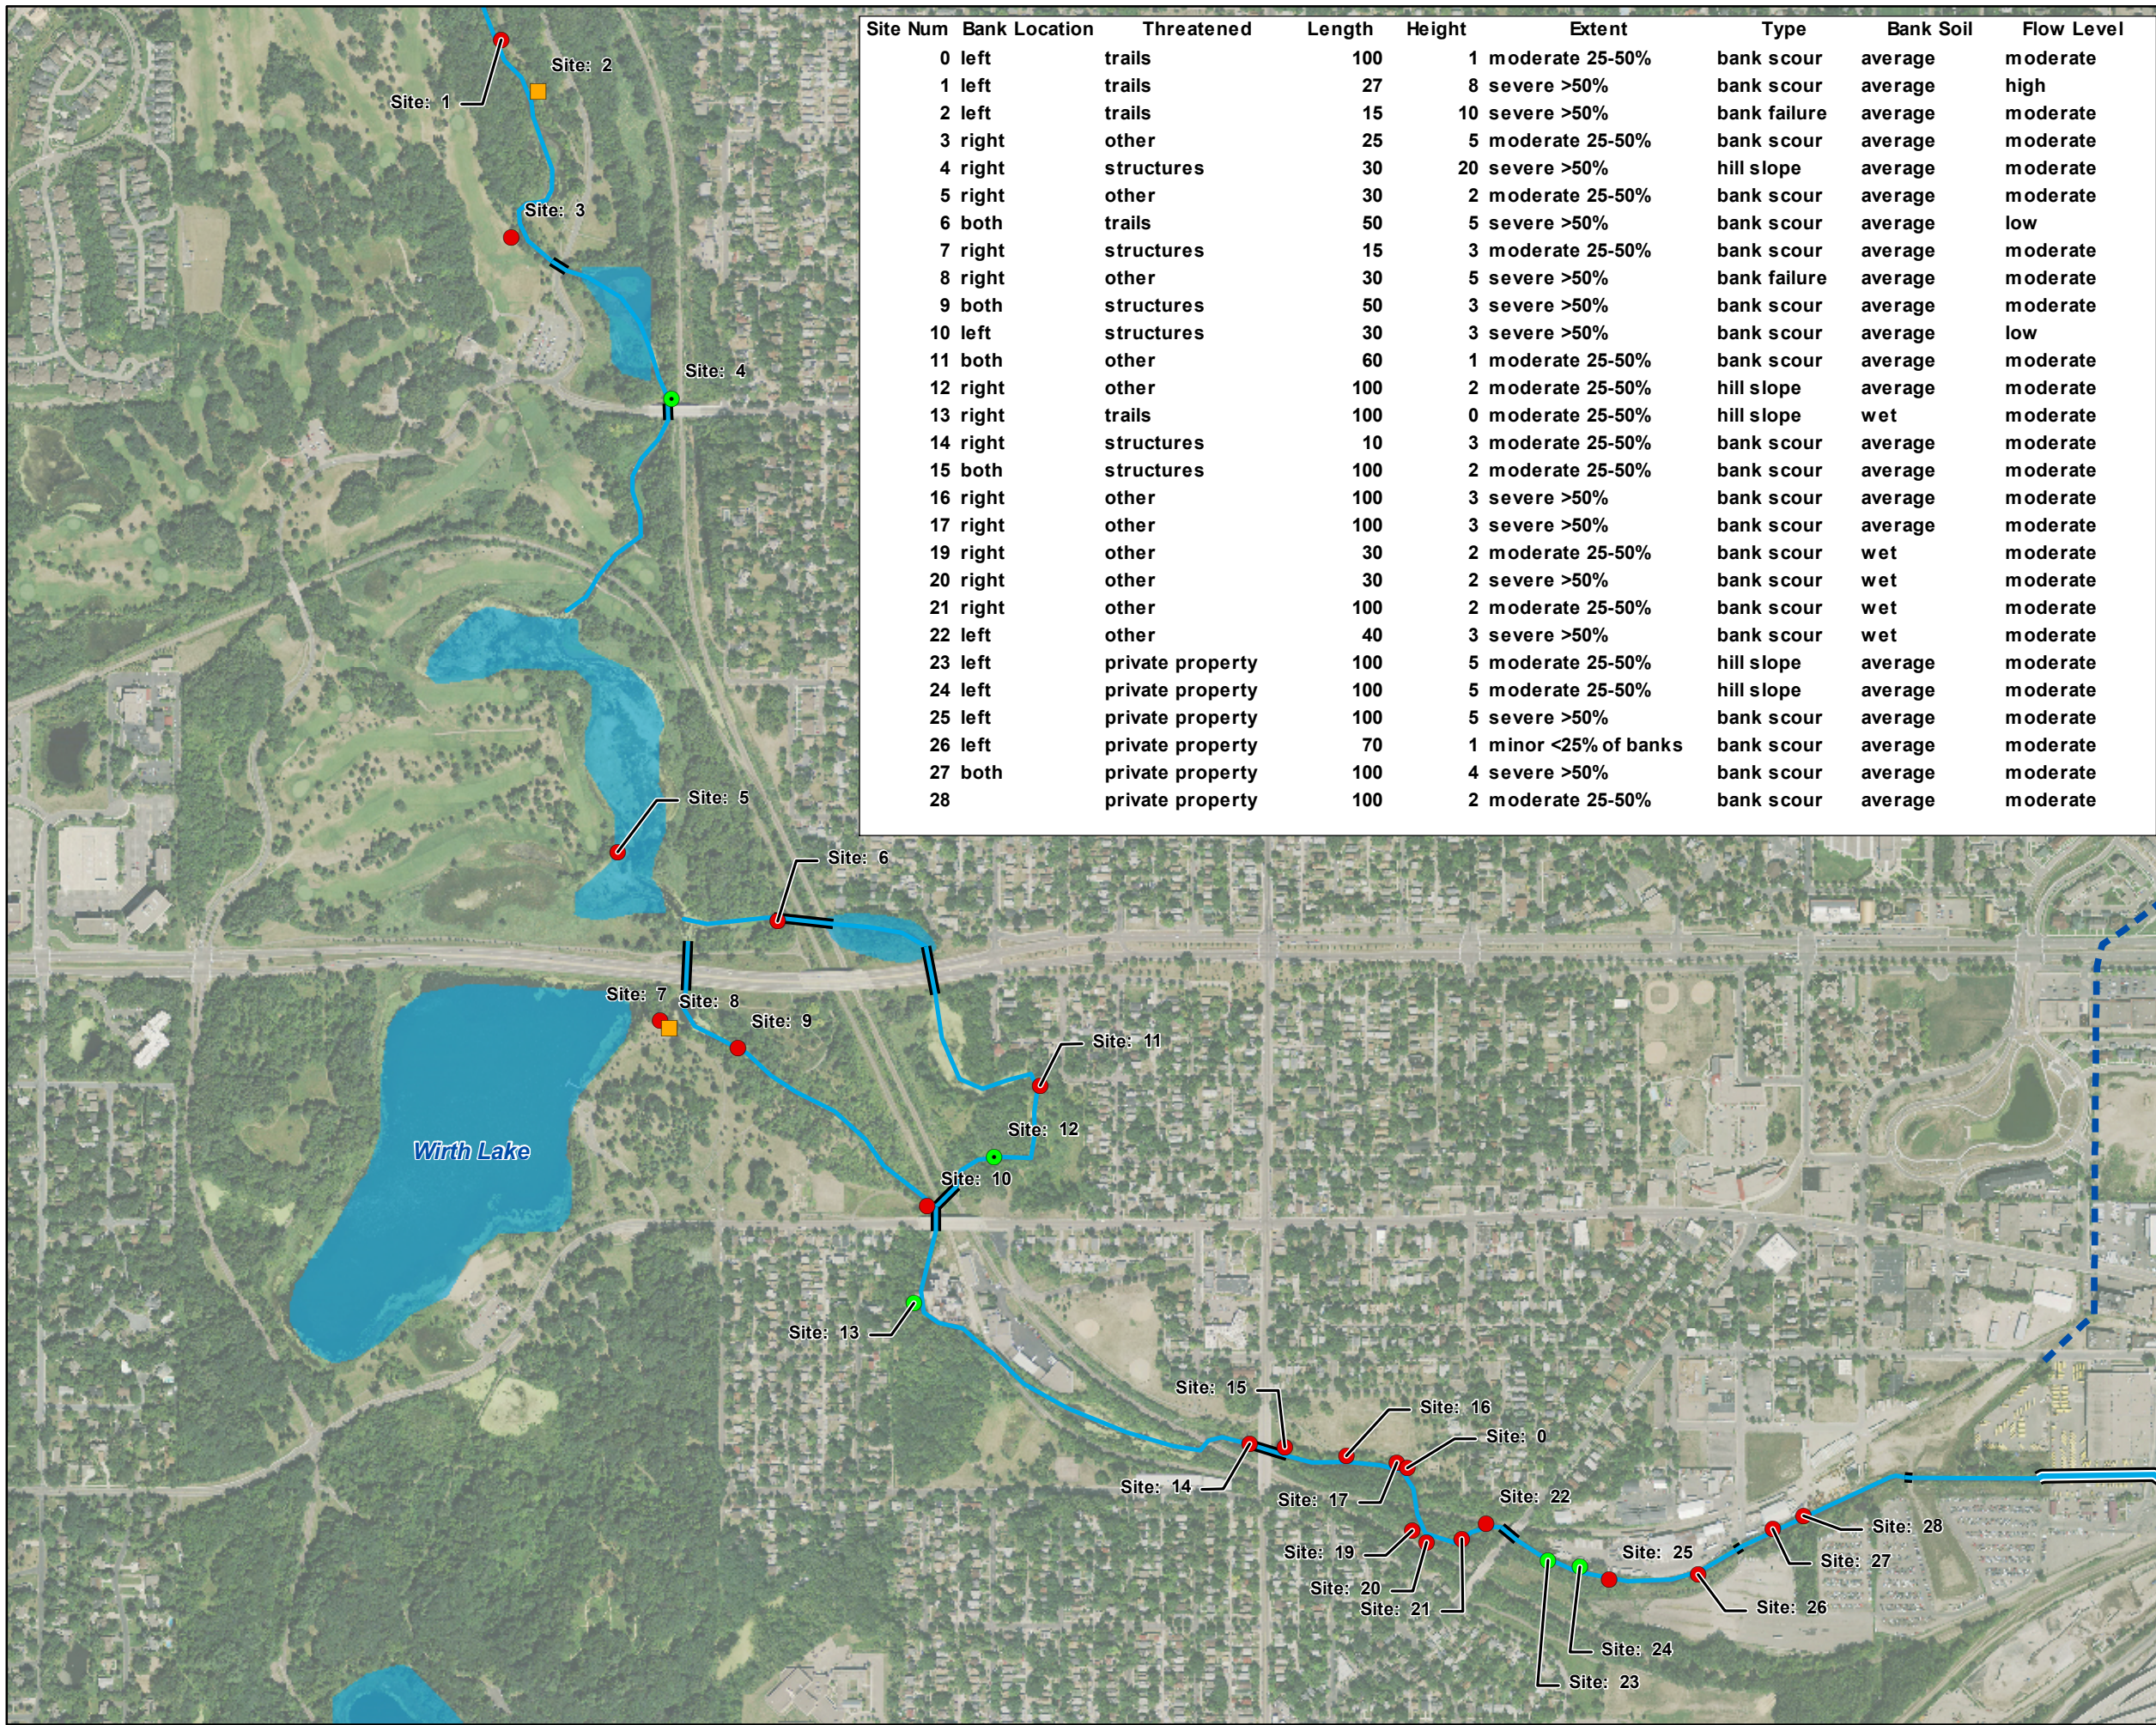
- Bank Failure
- Bank Scour
- Hill Slope

Site Num	Bank Location	Threatened	Length	Height	Extent	Type	Bank Soil	Flow Level
0	left	trails	100	1	moderate 25-50%	bank scour	average	moderate
1	left	trails	27	8	severe >50%	bank scour	average	high
2	left	trails	15	10	severe >50%	bank failure	average	moderate
3	right	other	25	5	moderate 25-50%	bank scour	average	moderate
4	right	structures	30	20	severe >50%	hill slope	average	moderate
5	right	other	30	2	moderate 25-50%	bank scour	average	moderate
6	both	trails	50	5	severe >50%	bank scour	average	low
7	right	structures	15	3	moderate 25-50%	bank scour	average	moderate
8	right	other	30	5	severe >50%	bank failure	average	moderate
9	both	structures	50	3	severe >50%	bank scour	average	moderate
10	left	structures	30	3	severe >50%	bank scour	average	low
11	both	other	60	1	moderate 25-50%	bank scour	average	moderate
12	right	other	100	2	moderate 25-50%	hill slope	average	moderate
13	right	trails	100	0	moderate 25-50%	hill slope	wet	moderate

14	right	structures	10	3	moderate 25-50%	bank scour	average	moderate
15	both	structures	100	2	moderate 25-50%	bank scour	average	moderate
16	right	other	100	3	severe >50%	bank scour	average	moderate
17	right	other	100	3	severe >50%	bank scour	average	moderate
19	right	other	30	2	moderate 25-50%	bank scour	wet	moderate
20	right	other	30	2	severe >50%	bank scour	wet	moderate
21	right	other	100	2	moderate 25-50%	bank scour	wet	moderate
22	left	other	40	3	severe >50%	bank scour	wet	moderate
23	left	private property	100	5	moderate 25-50%	hill slope	average	moderate
24	left	private property	100	5	moderate 25-50%	hill slope	average	moderate
25	left	private property	100	5	severe >50%	bank scour	average	moderate
26	left	private property	70	1	minor <25% of banks	bank scour	average	moderate
27	both	private property	100	4	severe >50%	bank scour	average	moderate
28		private property	100	2	moderate 25-50%	bank scour	average	moderate
