I. Detailed alternatives for stabilization

BASSETT CREEK POTENTIAL STABILIZATION SITES
 Bassett Creek Erosion Repair Feasibility Report
 Bassett Creek Watershed Management Commission

FIGURE I-2
BASSETT CREEK REACH 1 ALTERNATIVES
REACH 1 - FRUEN MILL SITE
 Bassett Creek Erosion Repair Feasibility Report
 Bassett Creek Watershed Management Commission

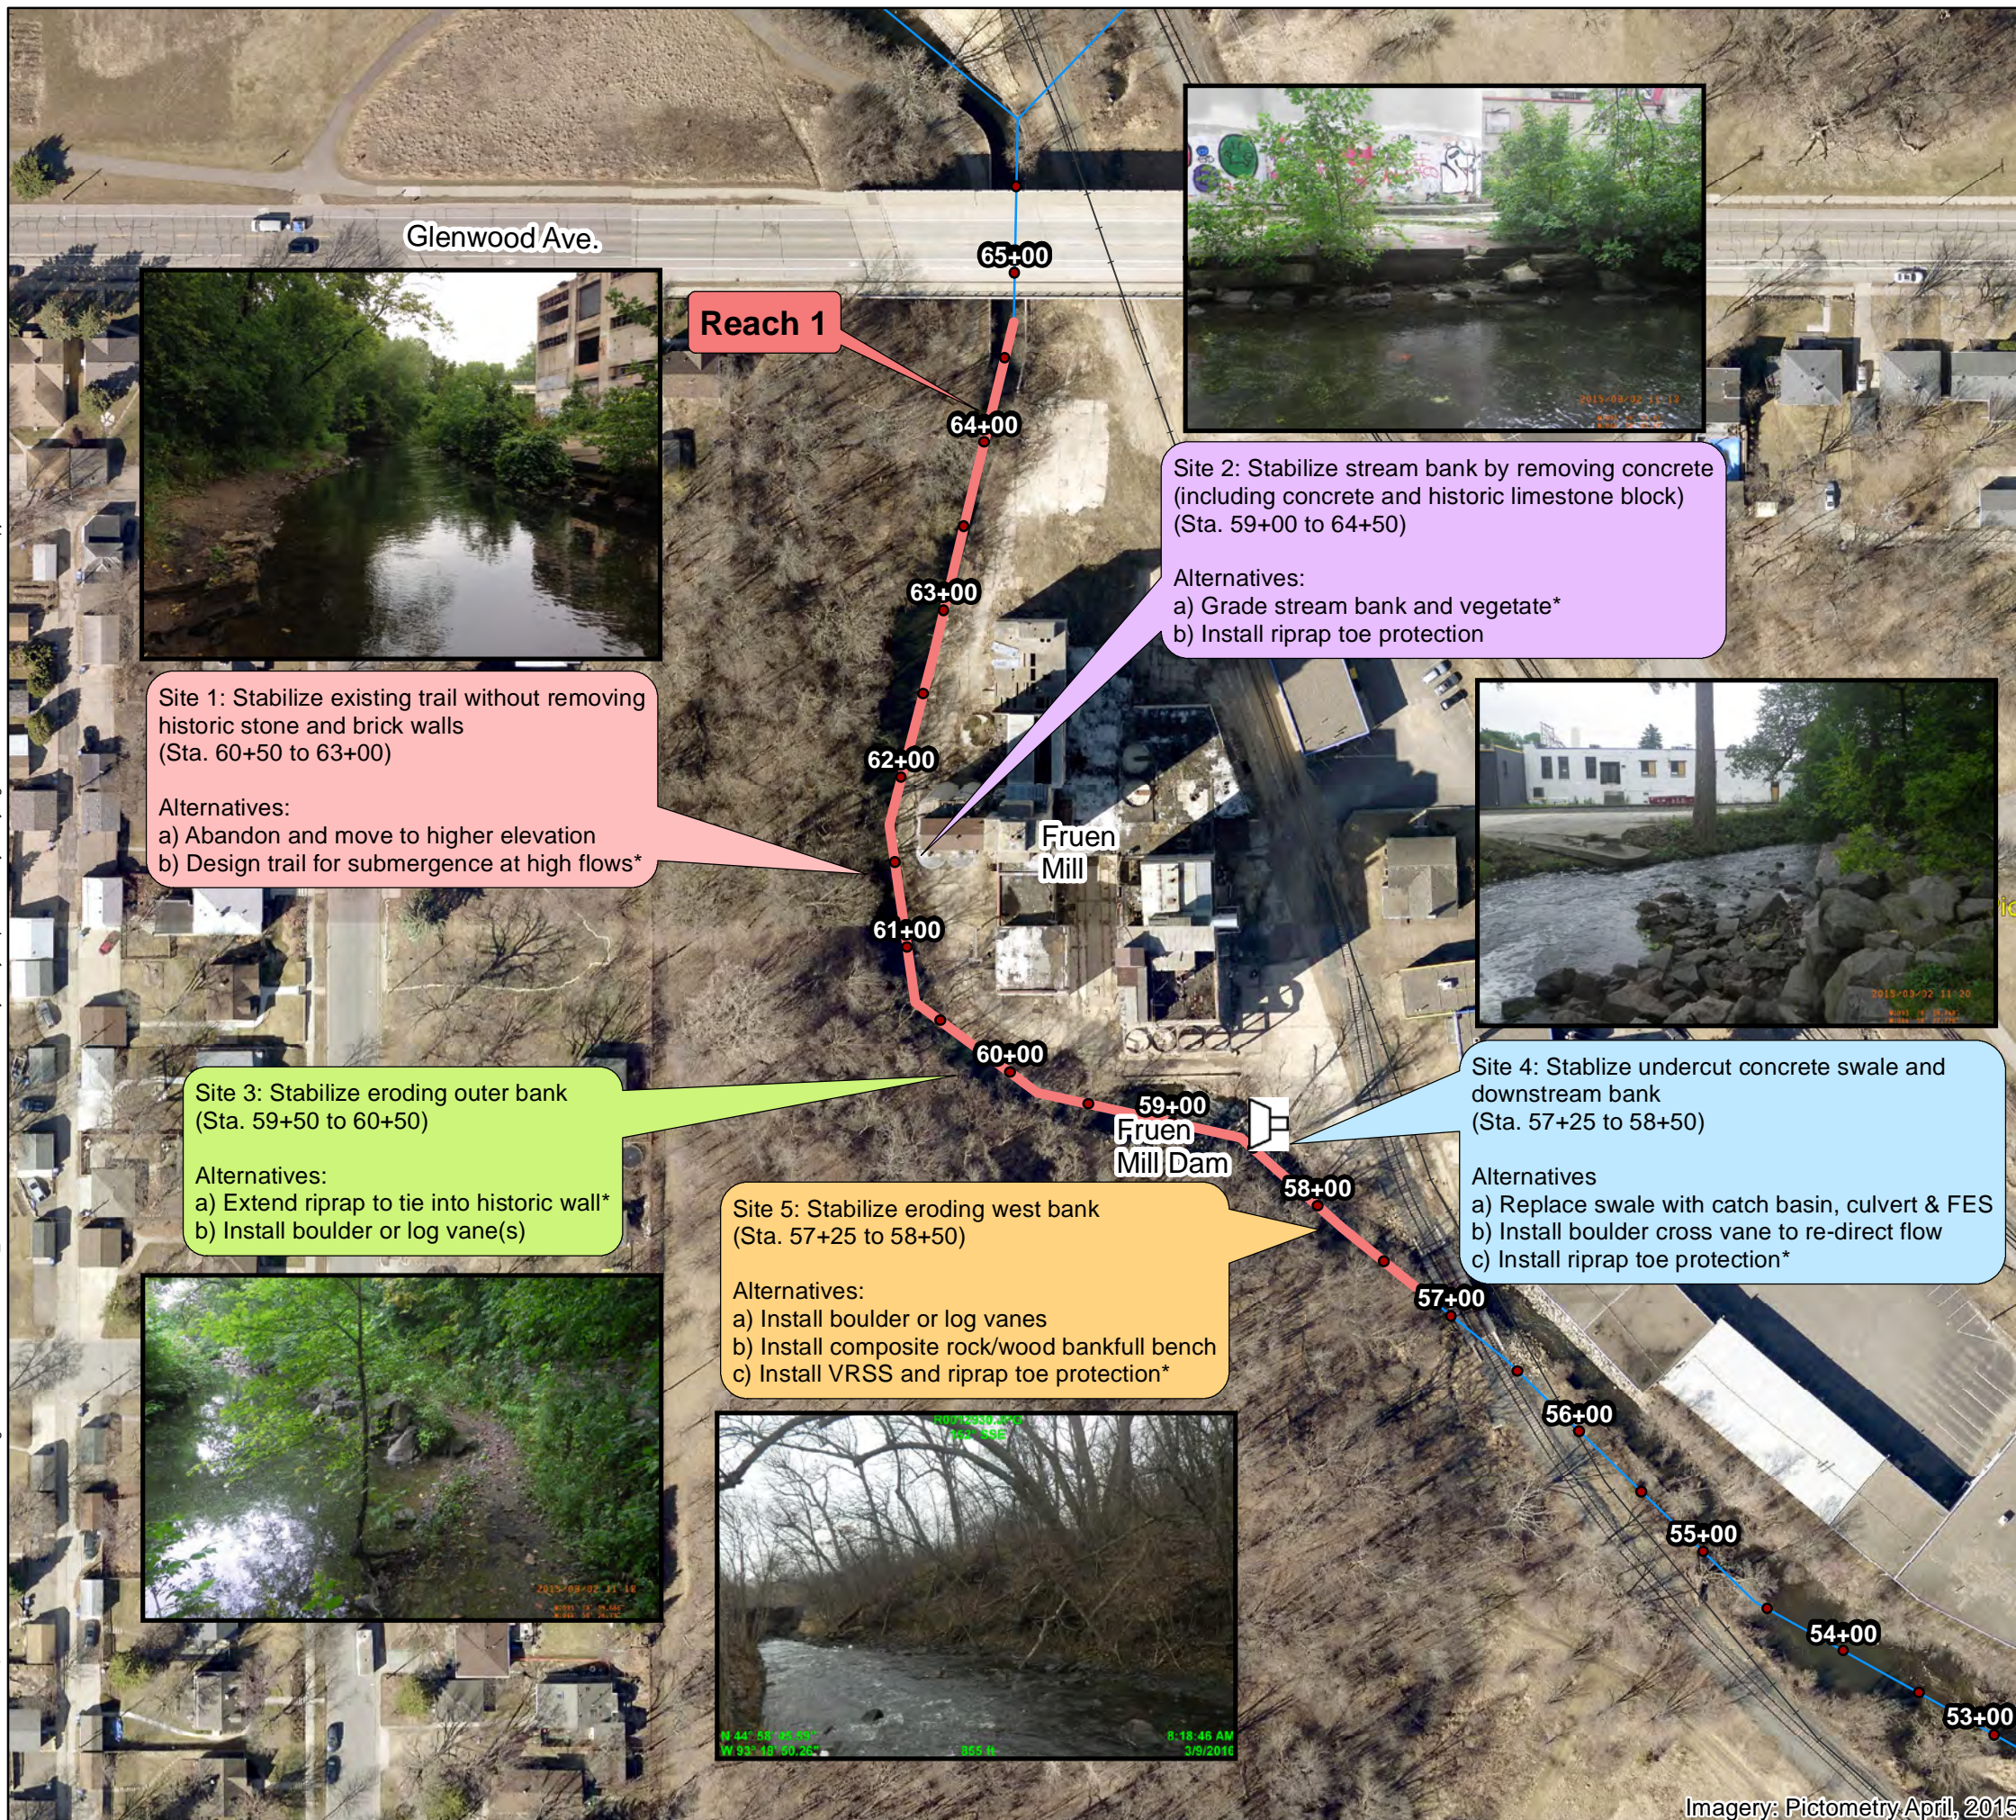
Reach 1

Issues: Concrete and limestone armoring on east bank in varying states of repair. Foot path on west bank being eroded in places, submerged at high flows.

Constraints: Water level control must remain at the historic dam site. Historic rock and brick walls must remain. Narrow valley and infrastructure limits meandering potential. Potential soil contamination due to history of industrial use.

Note: Individual alternatives are defined as a, b, or c for many of the sites. One or more alternatives will be chosen for each site.

(*) Indicates recommended alternative

The entire eastern bank of Bassett Creek through the Fruen Mill complex is identified as Site 2 (Station 59+00 to 64+50 on Figure I-2). The eastern stream bank through this site is fully armored with a combination of historical limestone blocks and concrete; some of the armoring materials are failing or have collapsed into the stream. Photo 2 in Appendix A shows a typical portion of this site.

Site 5 is located downstream of the Fruen Mill Dam and upstream of the railroad bridge, along the west bank of Bassett Creek (Station 57+25 to 58+50 on Figure I-2). Photo 5 in Appendix A shows a typical portion of this site. The majority of the stream flow is along the opposite (east) bank, but the downstream railroad bridge causes a flow constriction and backwater along the west bank. Highly turbulent flows have eroded the toe of the west bank and created a cut bank up to 7 feet tall in places.

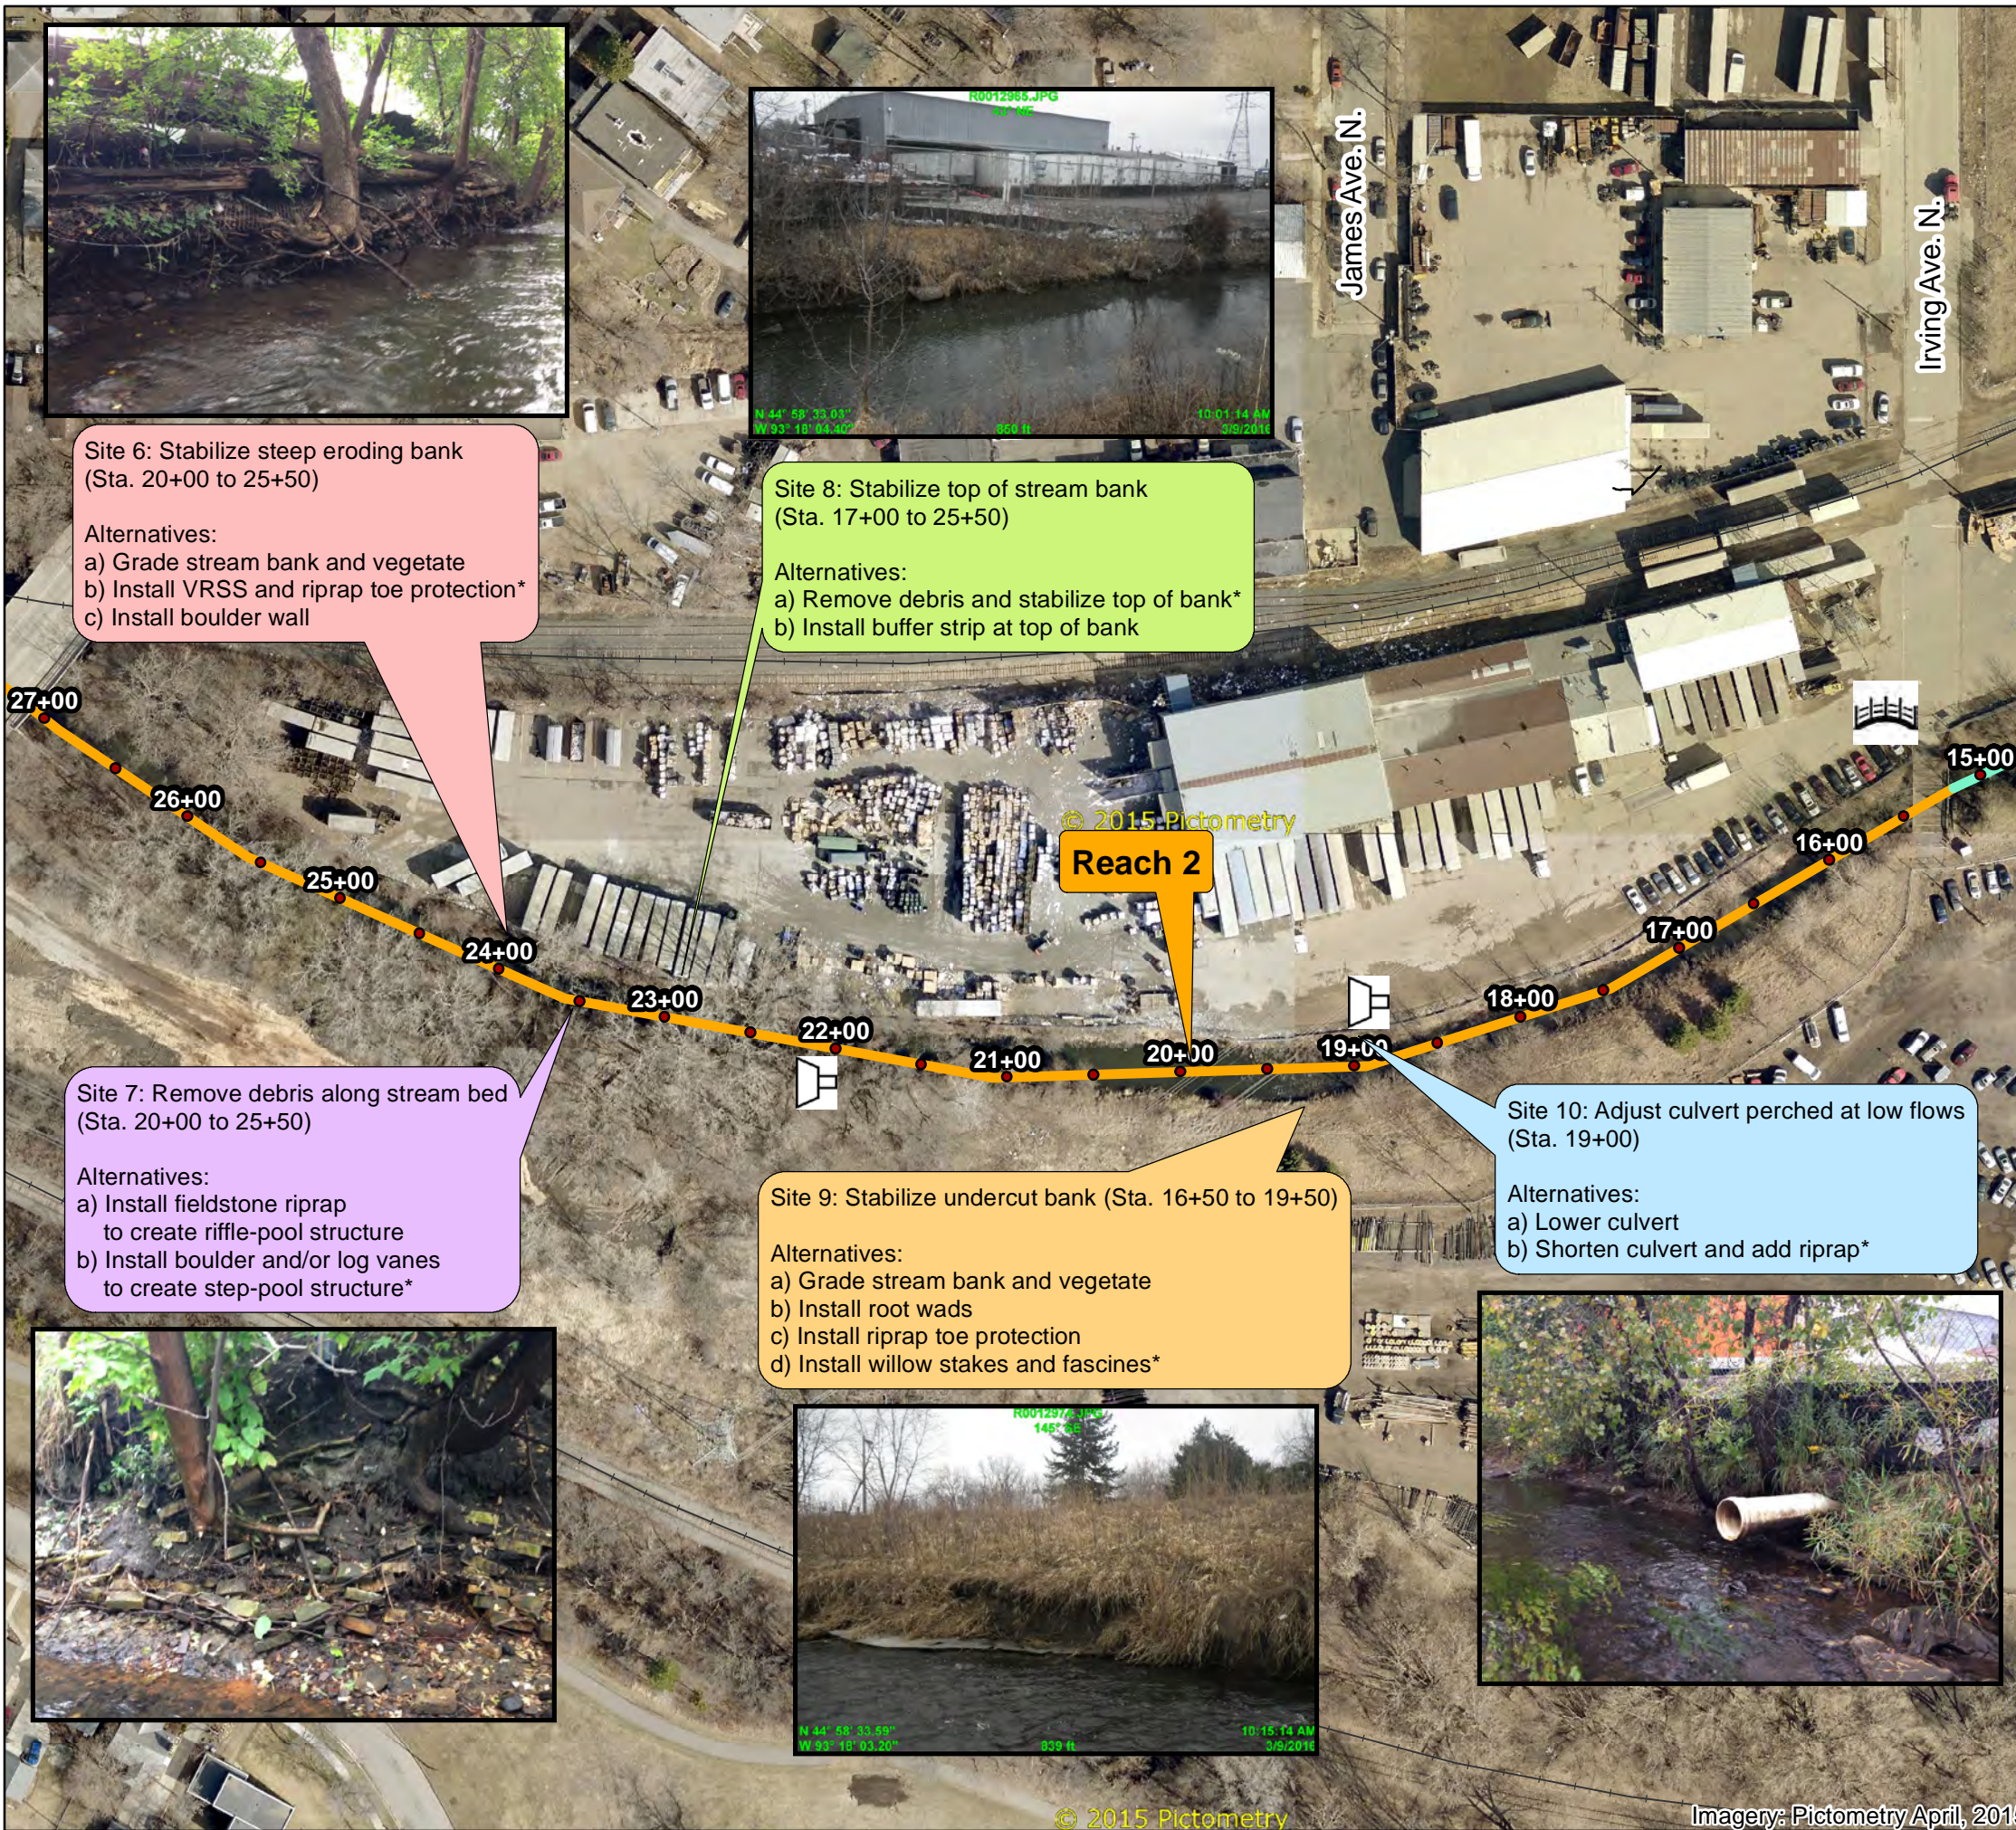
Reach 2

Issues: Historically straightened and brick-lined; banks are steep and eroding in places. Stream bed is a mixture of native and imported materials
