Feasibility Report for Ponderosa Woods Stream Restoration Project—**D R A F T**

Plymouth, Minnesota

Prepared for
Bassett Creek Watershed Management Commission

May 2023

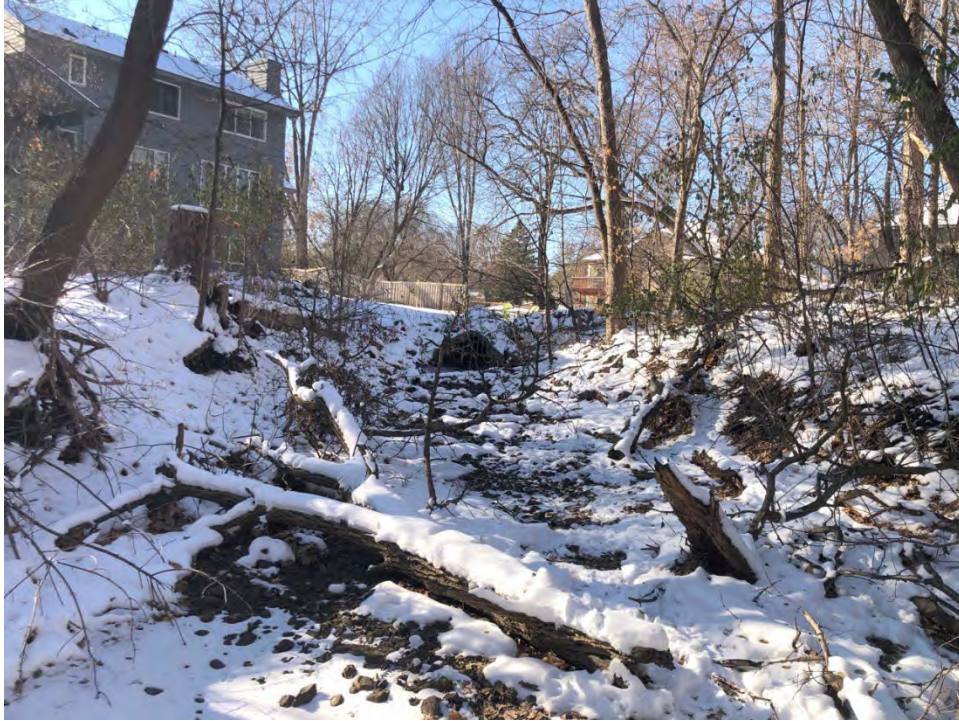
Figure 3-2 Upstream Section with Channel Debris and Bank Erosion (Reach 1)

Figure 3-2 through Figure 3-5 show a few examples of erosion and general conditions along the stream.

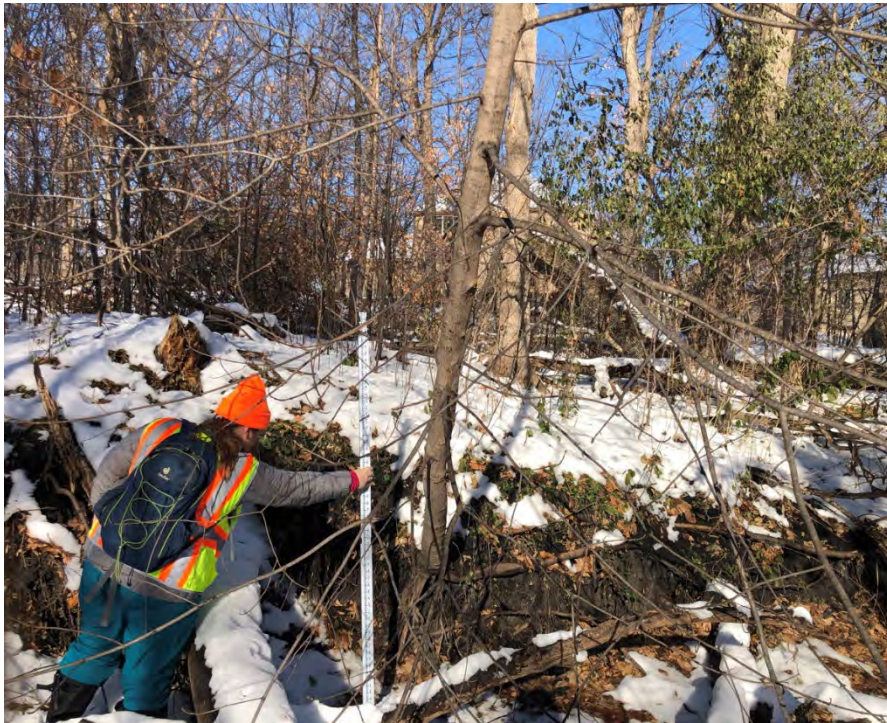
Figure 3-3 Left Bank Erosion (Reach 1)

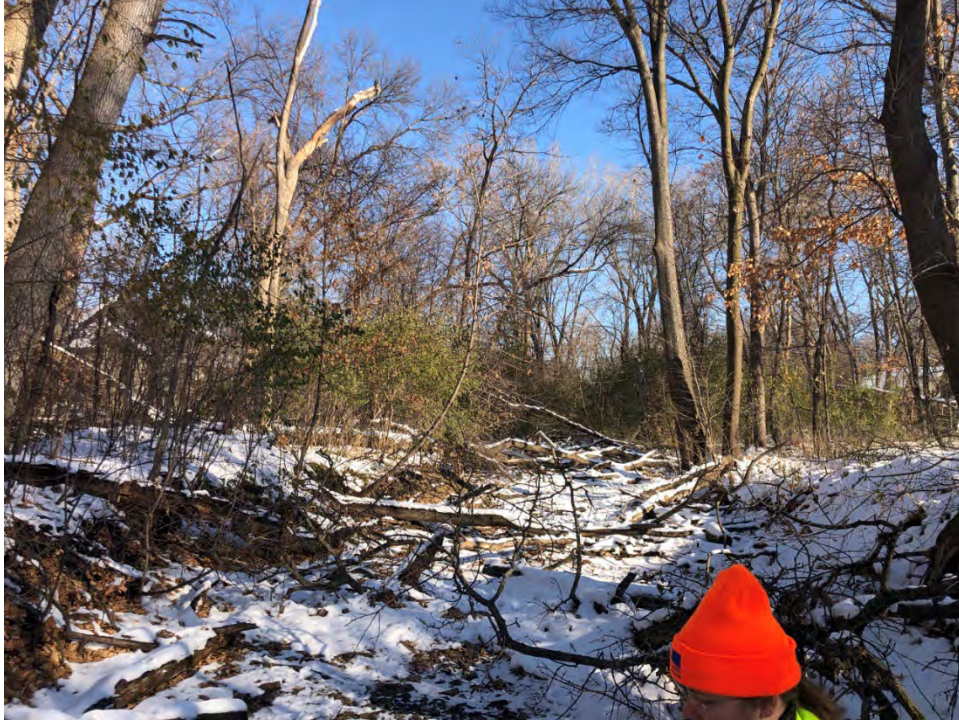
Figure 3-4 Debris and Left Bank Erosion (Reaches 1 and 2, downstream of upstream flared end section)

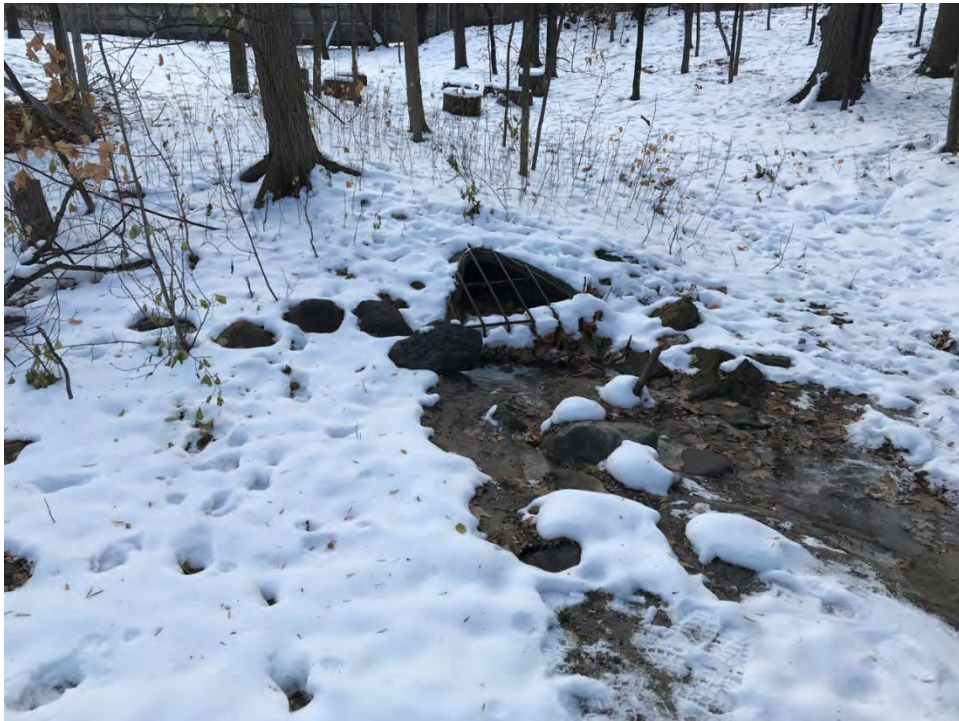
Figure 3-5 Erosion and Sediment Deposition at a Stormwater Side-channel

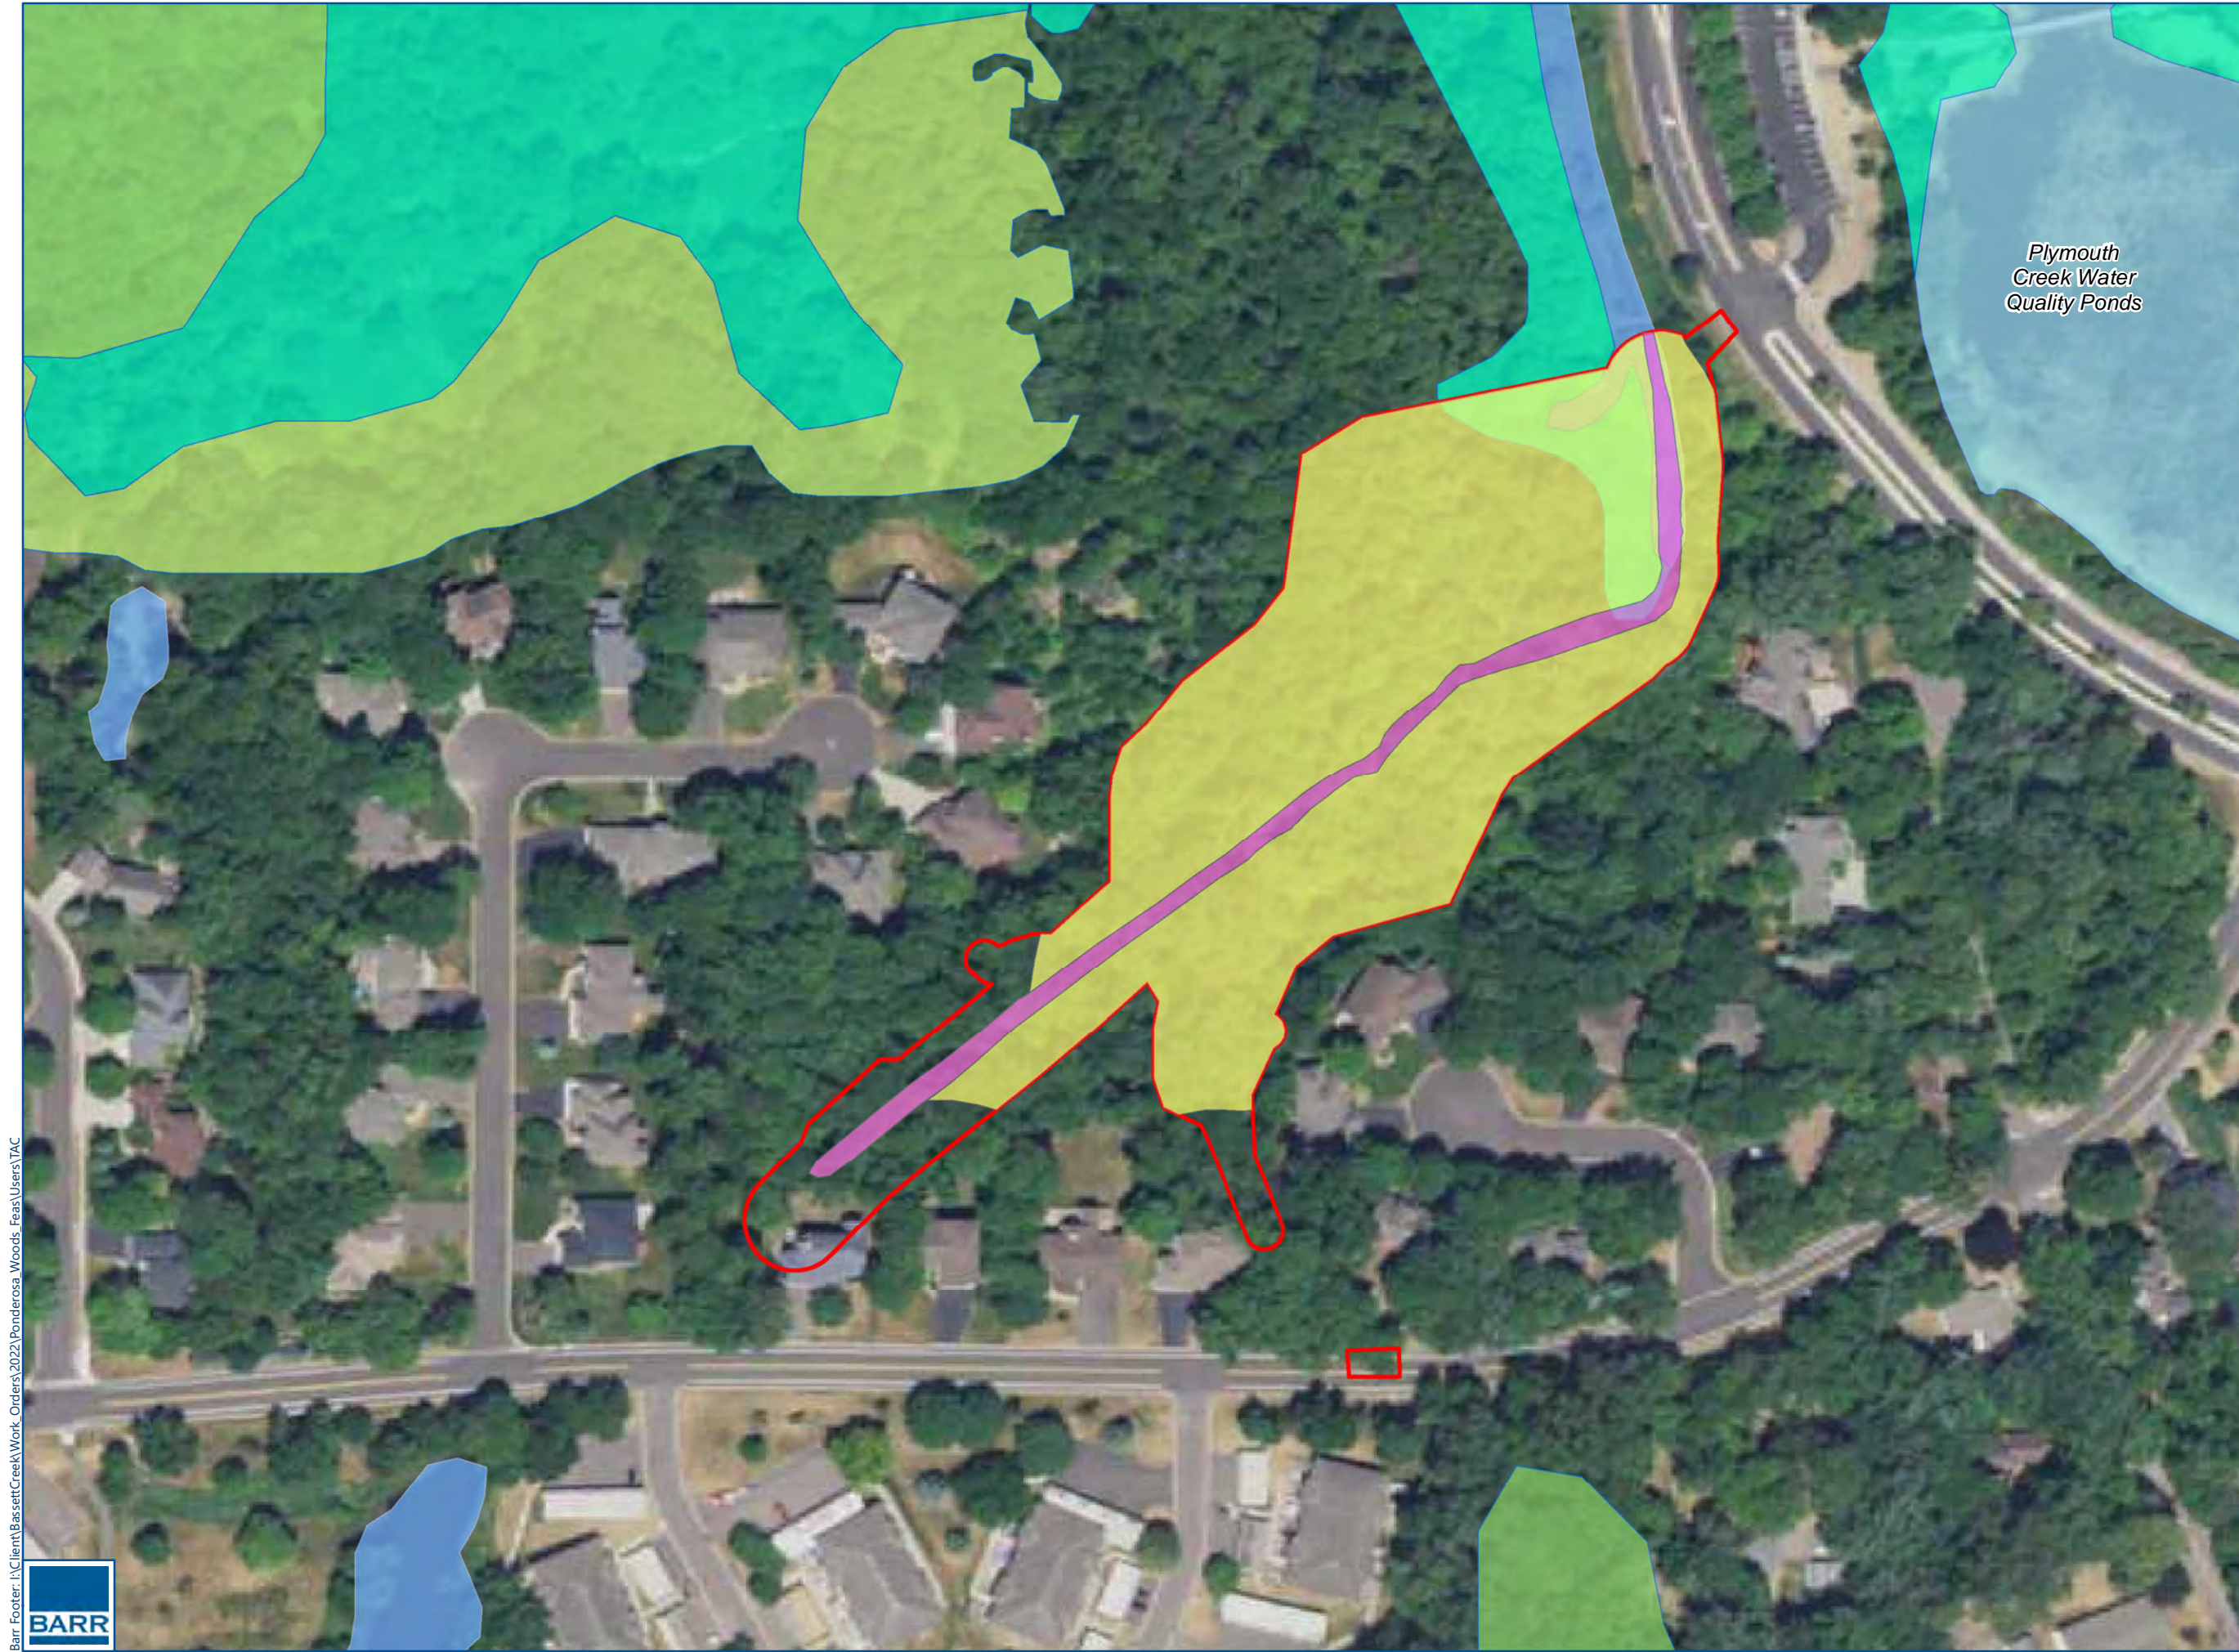
FIGURE 3-8

- Largest Proposed Project Area
 - Floodplain
 - Forest Wetland
 - Riverine/Stream Bed
- NWI Minnesota**
- Emergent Wetland
 - Forested Wetland
 - Forested/E... Wetland
 - Forested/S... Wetland
 - Pond
 - Lake

Figure 3-8 shows the desktop aquatic resources delineation.

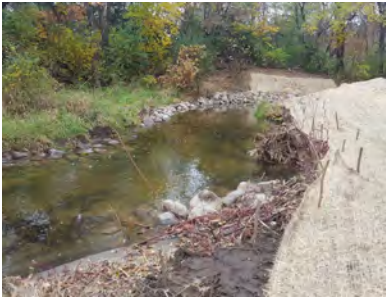
Design Element	Purpose	Ecological Benefits
<p>Rock Toe Bank Stabilization (hard armoring element)</p>

<p>Boulders buried and extending partially up the toe of the bank to protect the bank from high velocity flows and bank erosion.</p>	<p>Prevents sediment deposition into the stream channel, improving water quality for aquatic species.</p>

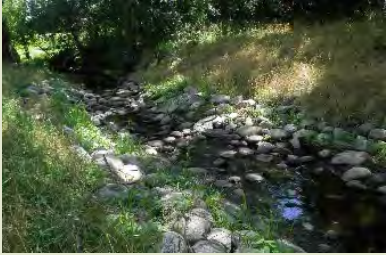
Design Element	Purpose	Ecological Benefits
<p>Rock Riffles (bioengineering element)</p>

<p>Gravel or cobble-sized material installed in the stream bed to create natural flow patterns and to control stream bed elevations.</p>	<p>The variety in flow and channel substrate size provides habitat diversity for aquatic species.</p>
<p>Cross Vanes (bioengineering element)</p>

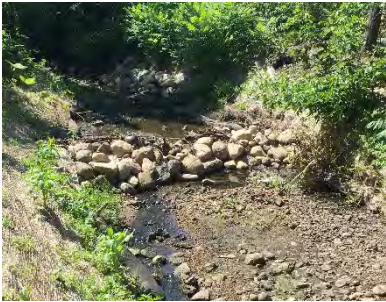
<p>Boulders buried in the stream bed and extending partially (“vanes”) or entirely across the stream (“cross vanes”) to achieve one or more of the following goals: re-direct flows away from banks, encourage sediment deposition in selected areas, and control stream bed elevations</p>	<p>Scour pools develop over time near the vane, which provide habitat diversity for species that prefer pools to faster flowing in-channel habitat.</p>
<p>Coir Blanket/Live Stakes Bank Stabilization (bioengineering element)</p>

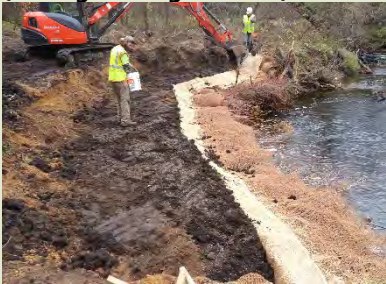
<p>Long-lasting, biodegradable fabric with seeding and live stakes to stabilize slopes and encourage establishment of root systems for further stabilization</p>	<p>The vegetation, once established, will increase the diversity of the riparian habitat, and improve aquatic habitat.</p>

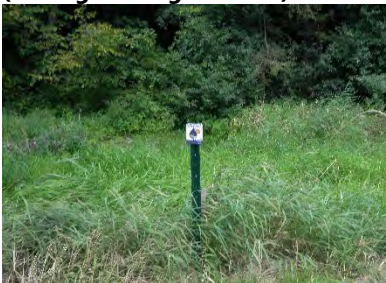
<p>Vegetated Buffer (includes removal of trees, invasive buckthorn, and in-channel debris) (bioengineering element)</p>

<p>Establish vegetation along a stream bank or overbank area to stabilize bare soils and increase resistance to fluvial erosion. Remove unhealthy trees and invasive species, including buckthorn, to open the tree canopy to allow understory vegetation to grow and stabilize the banks. Remove in-channel debris to stabilize banks and prevent additional erosion.</p>	<p>Using trees, shrubs, and a seed mix of grass and forbs provides a diverse array of vegetation and habitat types. Allows for more naturalized aesthetics, with emphasis on native species. Removal of in-channel debris prevents erosive flows from being routed into the bank and also eliminates locations for sediment accumulation, improving water quality for aquatic species.</p>
