Memorandum

Project: Plymouth Creek Restoration Phase 1

Subject: Plymouth Creek Restoration Design Memo

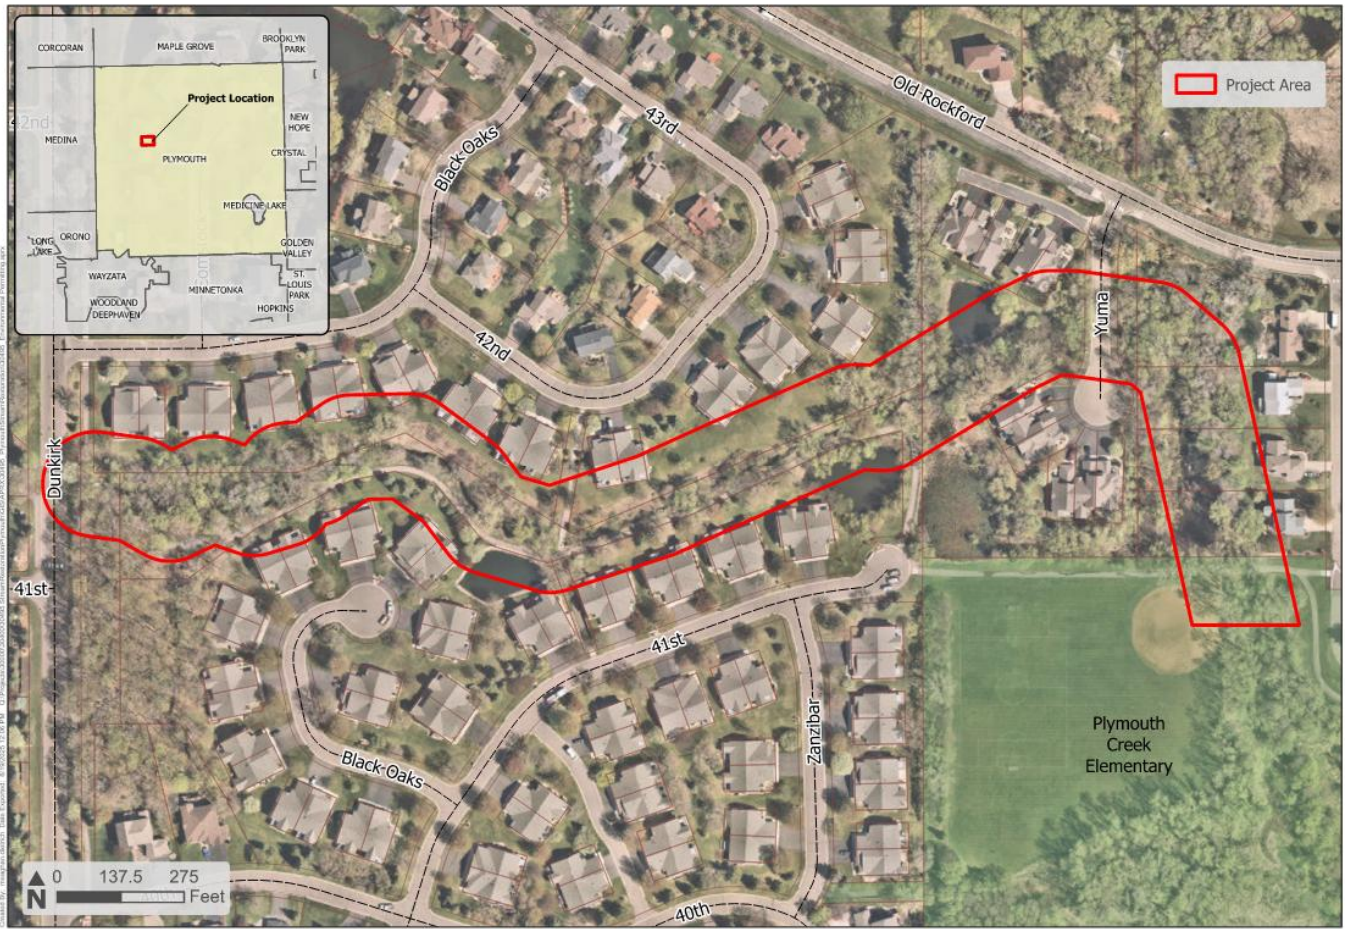
Figure 1: Project Location – Phase 1 Restoration from Dunkirk Ln to 41st Avenue Trail

Upon review of the entire proposed project and the level of effort needed to complete the full Option 3 design, the City decided to break out the creek restoration into two phases. The first phase will focus on the stream from Dunkirk Lane to the trail crossing near 41st Avenue, see Figure 1 below. The second phase will start where the first phase ends and continue until 38th Avenue. The goal is to design and permit the first phase of the project in fall and winter of 2025 and construct the project in 2026. Currently the project manual and contract is structured to offer the contractor flexibility to construct in Winter 2026, or late Summer 2026, depending on weather conditions. Phase two would then be designed and permitted starting in spring of 2026 and constructed over the 2026/2027 winter.
