Main Stem Channel Restoration Project

Golden Valley road to Irving Avenue North, Minneapolis

BCWMC Project Number 2012CR-M

FINAL REPORT
November 2015

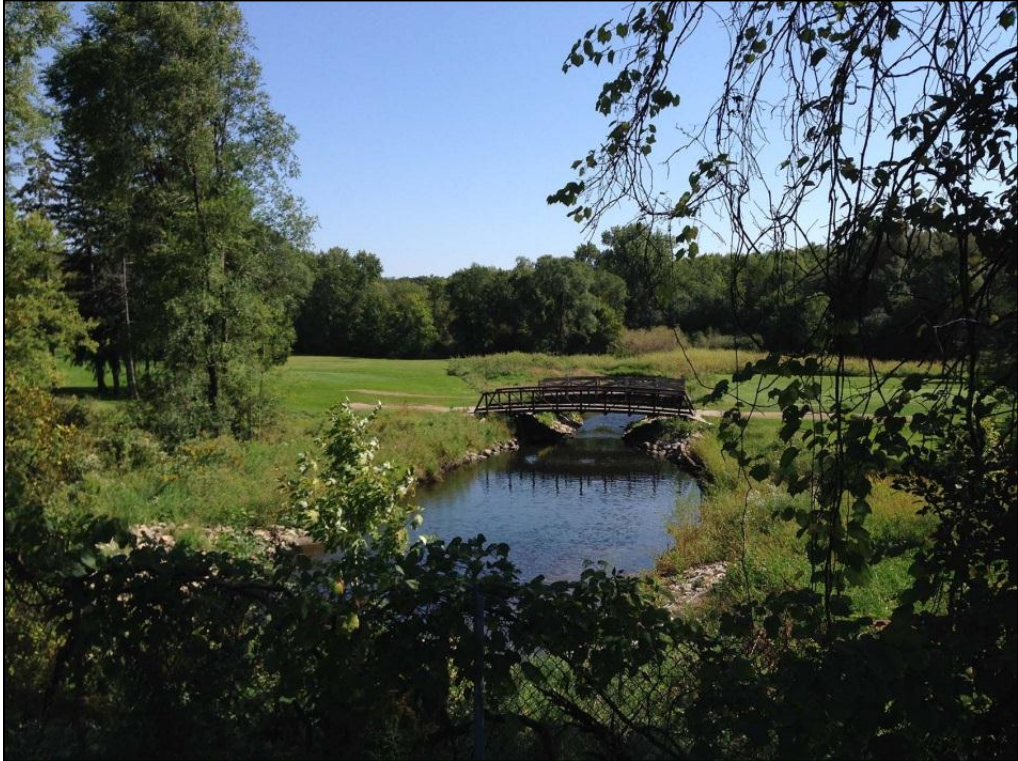
Bassett Creek Side Channel and Trail Work (work paid for by MPRB and city of Minneapolis) - BEFORE

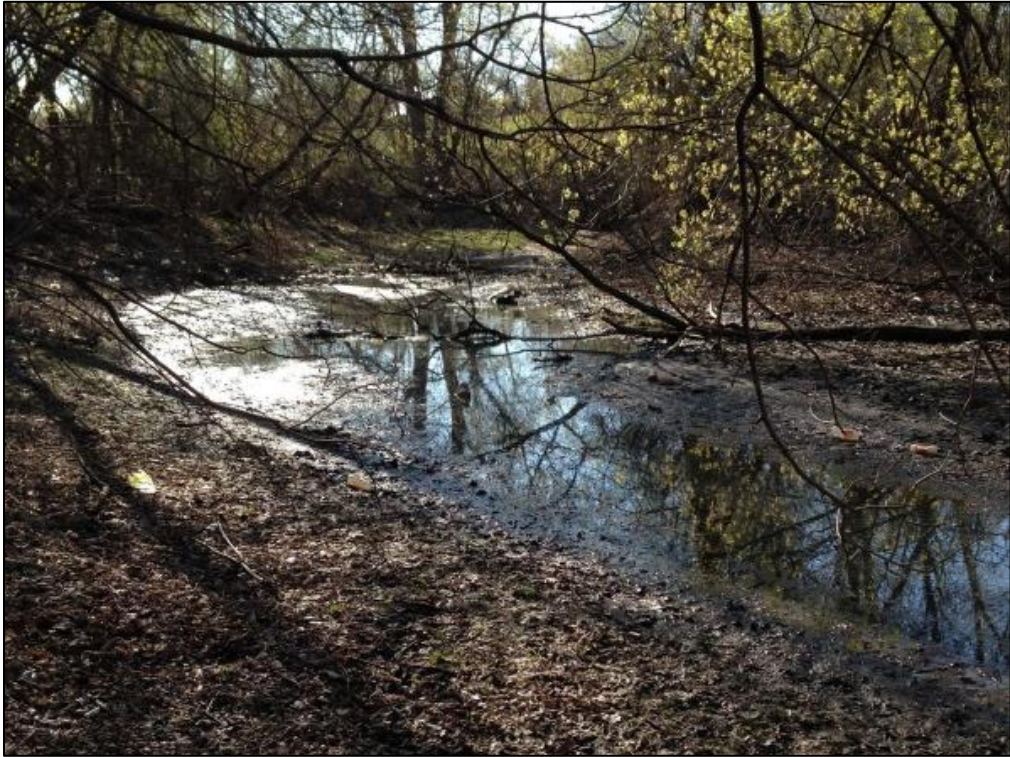
Bassett Creek Side Channel and Trail Work (work paid for by MPRB and city of Minneapolis) – AFTER

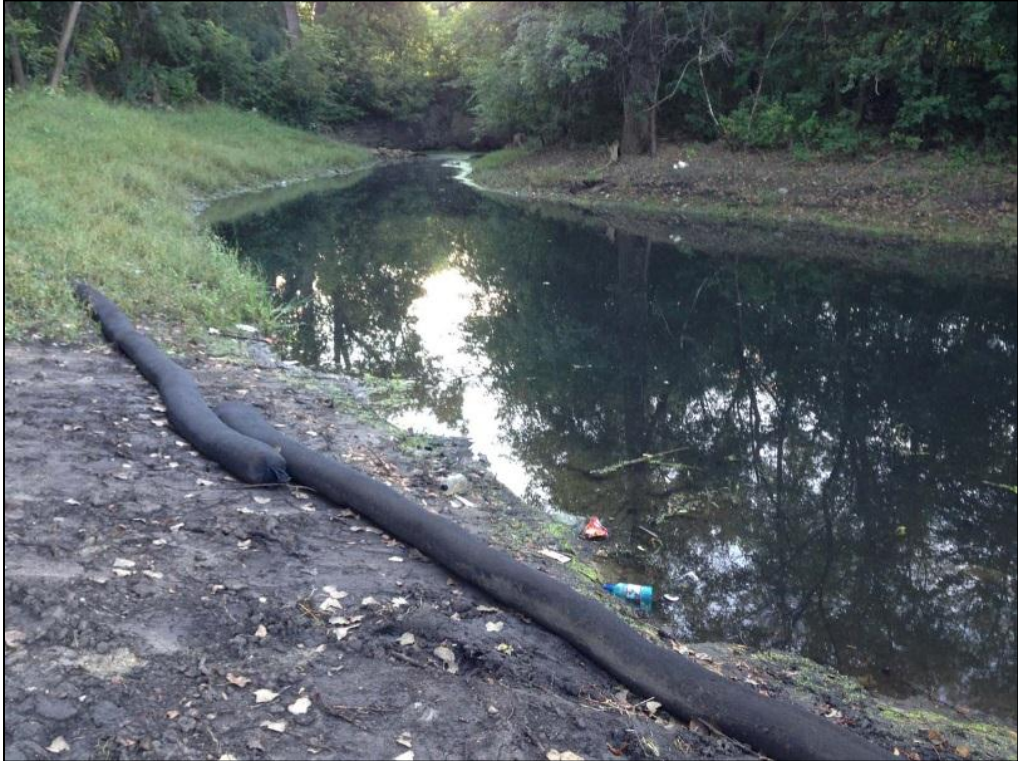
Bassett Creek Side Channel and Trail Work (work paid for by MPRB and city of Minneapolis) - BEFORE

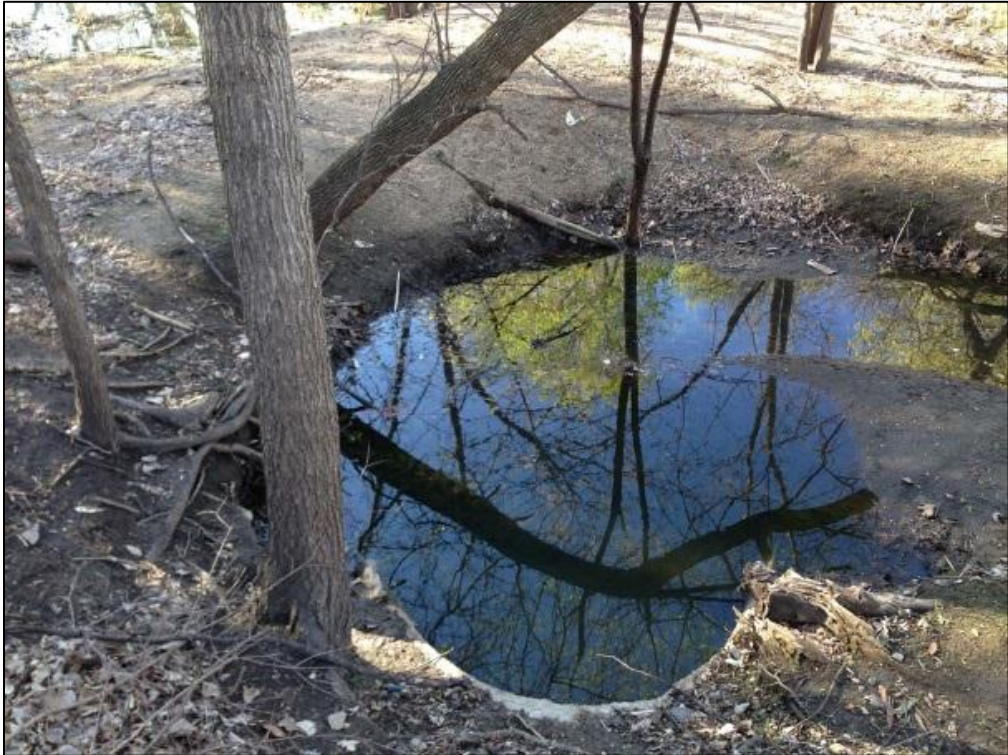
Bassett Creek Side Channel and Trail Work (work paid for by MPRB and city of Minneapolis) – AFTER
