1:45 Wirth Lake Outlet Structure – Stop #2

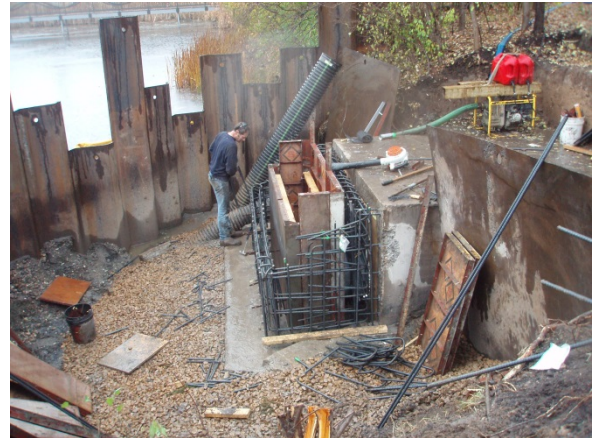
During construction, fall 2012

The outlet modification was estimated to reduce phosphorus loading to the lake by an average of 55 pounds per year (*Wirth Lake Excess Nutrients Total Maximum Daily Load Report*, MPCA, 2010). The existing stone-faced concrete culvert that once served as a roadway crossing in addition to the Wirth Lake outlet was constructed several decades ago. Although the roadway was removed, the culvert was left in place. A timber weir was built onto this concrete culvert in the 1970's to help maintain lake elevations and to help prevent rough fish from entering the lake. On behalf of the BCWMC, the City of Golden Valley replaced the outlet structure during the fall of 2012. The project included replacing the timber weir with a new concrete weir structure that incorporates two check valves to prevent the flow of Bassett Creek into Wirth Lake. The valves were placed inside the existing culvert to be out of sight of park users. The project was constructed by G.F. Jedlicki Inc. for approximately \$90,000.

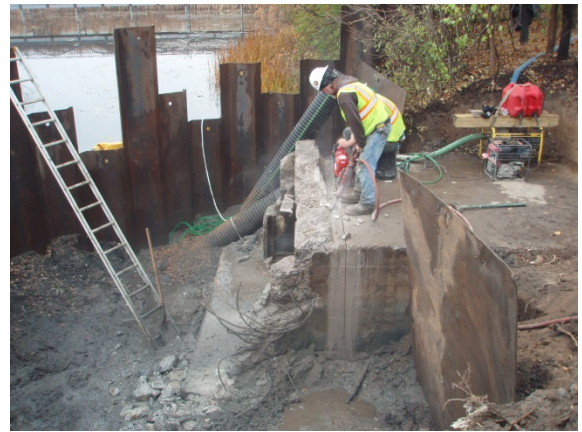
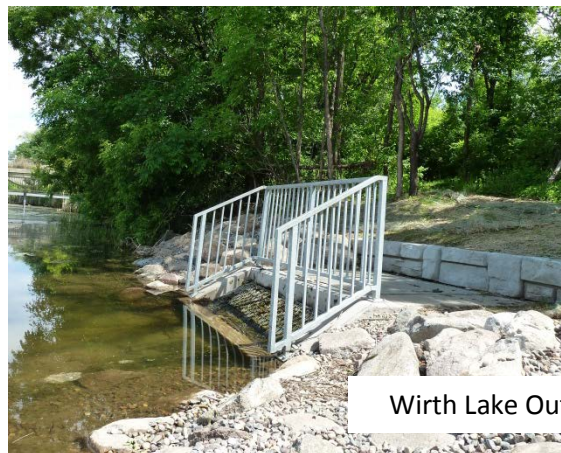
Wirth Lake Outlet Structure, June 2013
