Stream Stabilization Plan

Stone Toe Protection

Bank Protection

TOE WOOD
 EXAMPLE DETAIL

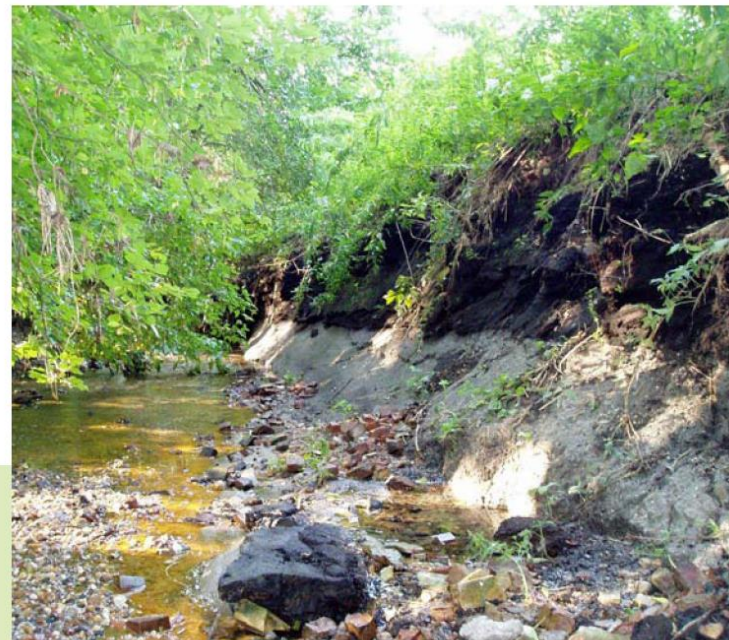
EXISTING CONDITIONS

Fluvial bank erosion is caused by water in the stream moving past the streambanks. The shear stress caused by the flow entrains soil particles into the flow, causing the stream bank to erode away. This is the most common type of erosion that occurs in streams. Virtually all streams experience this type of erosion as their flow path evolves over time. However, the rate of fluvial bank erosion can increase when the stream is out of equilibrium with its watershed. Increased flow from a watershed will increase the rate of fluvial bank erosion. In many cases, it appears to be a part of the natural process of stream evolution. In places where the channel is confined by the valley walls, however, fluvial bank erosion can lead to failure of the high banks. It can also undermine storm sewer inlets.

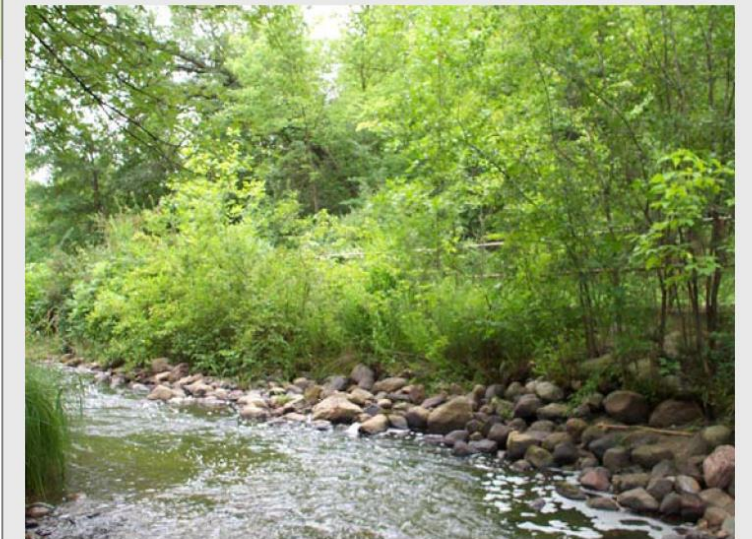
SIMILAR PROJECTS

Stone toe protection has been used extensively in Nine Mile Creek's Lower Valley, in conjunction with deflector dikes, grade control measures and stabilization of large bank failures. Following the 1987 "super storm," the proposed design allowed the stream to continue its course while taking measures to protect areas where water flow was eroding valley walls. The resulting measures have stabilized the stream channel and valley walls while blending seamlessly with the natural environment.

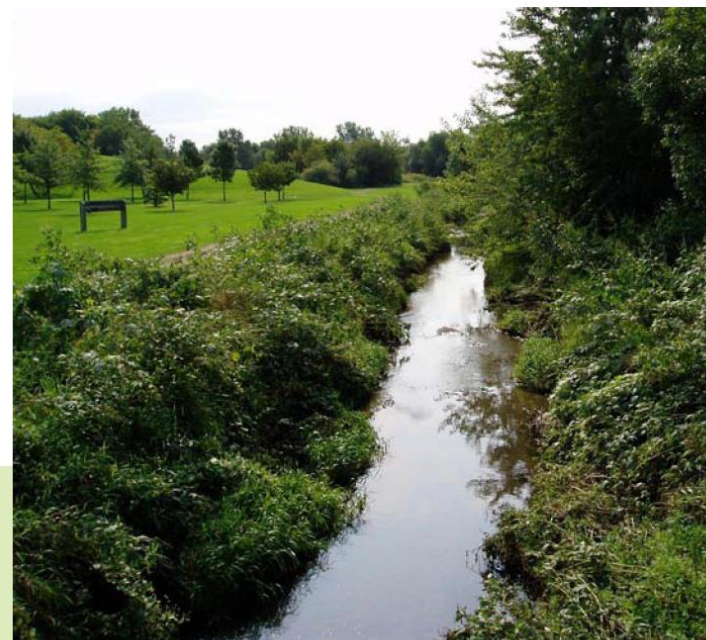
EXISTING CONDITIONS

Channel incision occurs when there is an imbalance between the sediment supply and the sediment carrying capacity of the stream. Erosion will occur when the sediment carrying capacity of a stream exceeds the sediment supply. In streams with cohesive banks and steep channel slope, the erosion will first occur primarily on the channel bottom because that is where the erosive forces are the strongest. As the channel deepens, the stream will gradually become wider as the banks eventually fail. The stream will gradually return to equilibrium; however, the process can take many years and significant amounts of erosion will occur during the process.

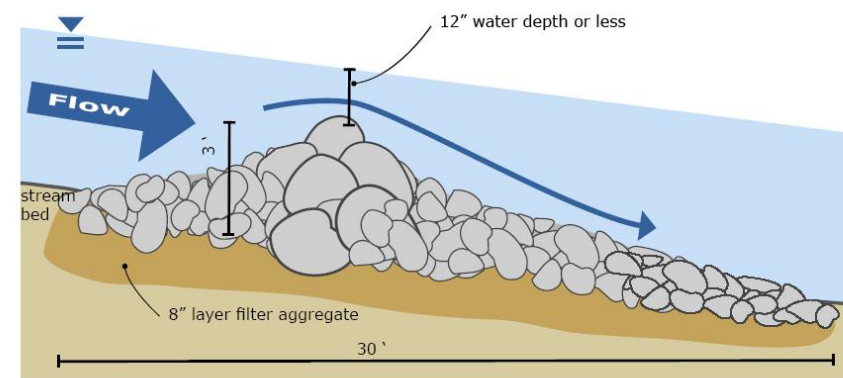
SECTION/PLAN RENDERING

Grade control measures are used where channel downcutting has occurred. Various types of weirs are commonly used to provide grade control on streams, particularly in steeper systems. Weirs can be constructed of sheetpile, concrete, or natural materials such as rock. In most cases, natural rock is used to emulate natural riffles. Large boulders would comprise the core of the structure, with smaller rock material placed on the upstream and downstream sides of the boulders to provide a gradual transition to the channel.

The riffles will serve to raise the surface of the water profile, and will reconnect the stream to its floodplain areas. Following the installation of the riffles, pools will be created upstream of the riffles. However, these pools will fill with sediment over time, which will in effect raise the channel bottom to the desired elevation.

Materials will consist of various gradations of rock, ranging from large, 3-foot boulders to coarse gravel.

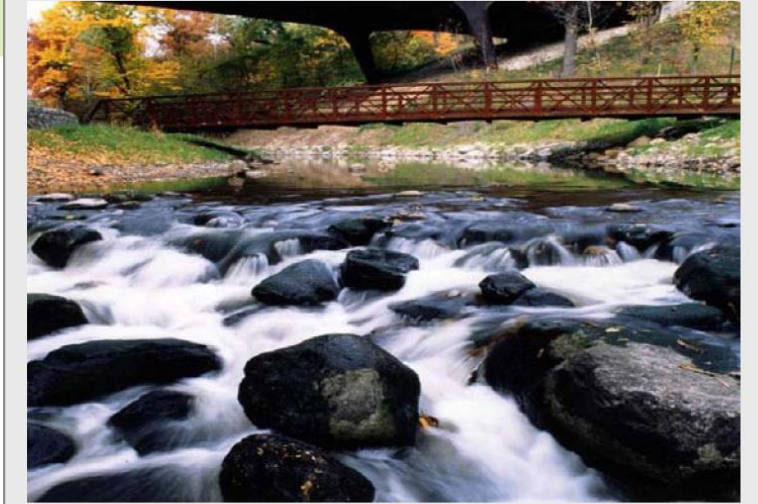
SIMILAR PROJECTS

Following the 1987 "super storm," a rapids was constructed on Nine Mile Creek downstream of the 106th Street Bridge. The rapids was one of several grade-control structures that were installed on a three-mile stretch of creek in the lower valley. The proposal allowed the stream to continue its course while taking measures to protect areas where water flow was eroding valley walls. Protection measures included applying porous deflector dikes, burying sheetpile walls parallel to the creek to prevent undercutting of slopes, installing weirs (rock or capped sheetpile) to limit stream-bed degradation, and improving storm-sewer outlets.

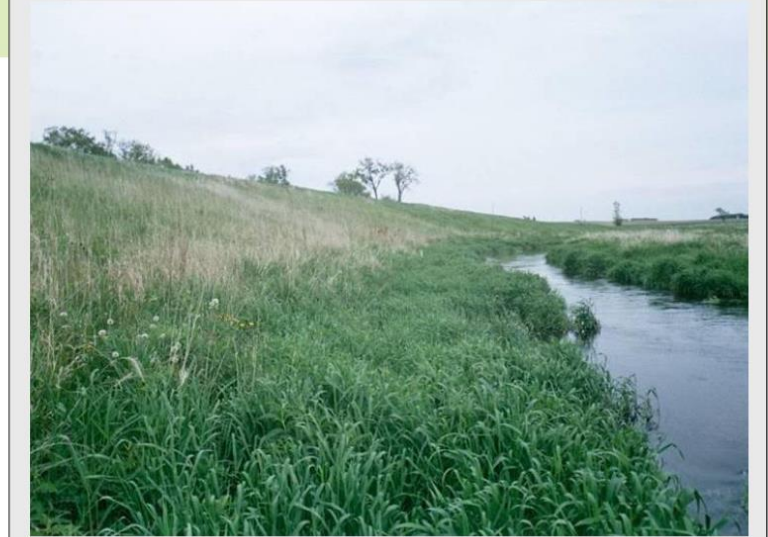
SIMILAR PROJECTS

Here is an example of a stabilization project designed for a 1,000-foot long, 20-foot high streambank that was severely eroded. The channel was directed away from the bank toe by installing six rock vanes. The bank was planted with native vegetation and protected with erosion control blanket, while the terrace above the bank was graded to redirect surface runoff to a less vulnerable area. The restored streambank withstood significant flooding during 2001, and has become nicely vegetated (see picture above).

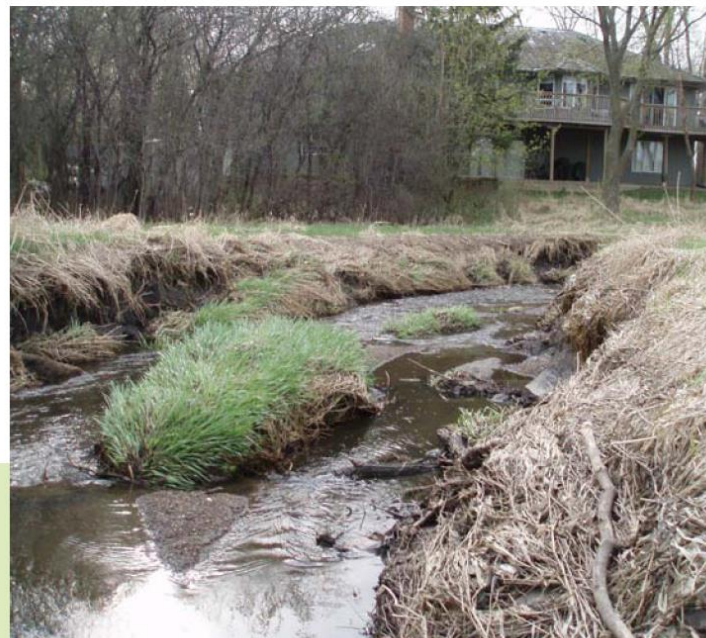
EXISTING CONDITIONS

Fluvial bank erosion is caused by water in the stream moving past the streambanks. The shear stress caused by the flow entrains soil particles into the flow, causing the stream bank to erode away. This is the most common type of erosion that occurs in streams. Virtually all streams experience this type of erosion as their flow path evolves over time. However, the rate of fluvial bank erosion can increase when the stream is out of equilibrium with its watershed. Increased flow from a watershed will increase the rate of fluvial bank erosion. In places where the channel is confined by the valley walls, however, fluvial bank erosion can lead to failure of the high banks. It can also undermine storm sewer inlets.

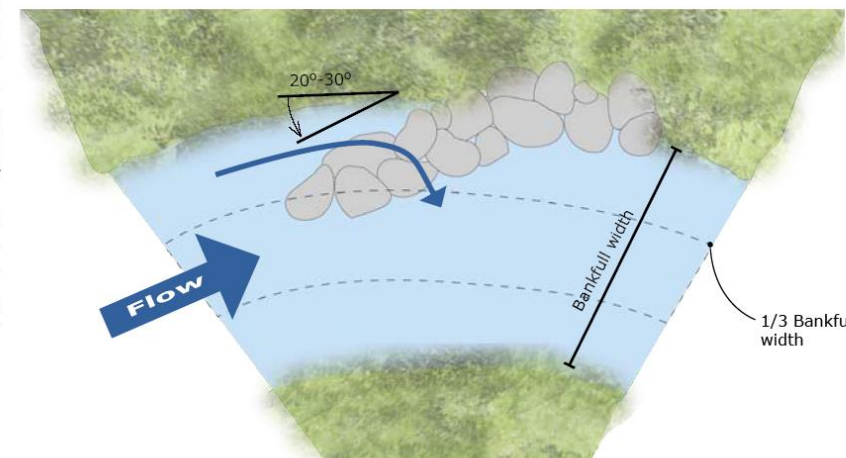
PLAN/SECTION RENDERING

Rock vanes are constructed from boulders on the creek bottom. They function by diverting channel flow toward the center and away from the bank. They are typically oriented in the upstream direction and occupy no more than one third of the channel width. Vanes are largely submerged and inconspicuous. The rocks are chosen such that they will be large enough to resist movement during flood flows or by vandalism, with additional smaller rock material to add stability. Rock vanes function in much the same way as root wads in that they push the stream thalweg (zone of highest velocity) away from the outside bend. They also promote sedimentation behind the vane, which adds to the toe protection.

Vanes can also be constructed from both banks, forming an upstream-pointing "V." In this configuration, the vane protects both banks and also provides grade control.

Materials will consist of various gradations of rock, ranging from large, 3-foot boulders to coarse gravel.

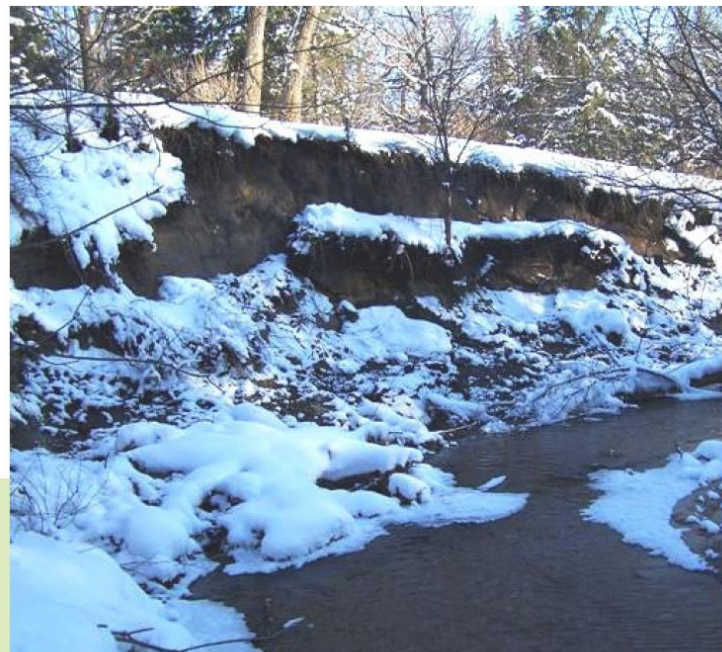
EXISTING CONDITIONS

Fluvial bank erosion is caused by water in the stream moving past the streambanks. The shear stress caused by the flow entrains soil particles into the flow, causing the stream bank to erode away. This is the most common type of erosion that occurs in streams.

Virtually all streams experience this type of erosion as their flow path evolves over time. However, the rate of fluvial bank erosion can increase when the stream is out of equilibrium with its watershed. Increased flow from a watershed will increase the rate of fluvial bank erosion.

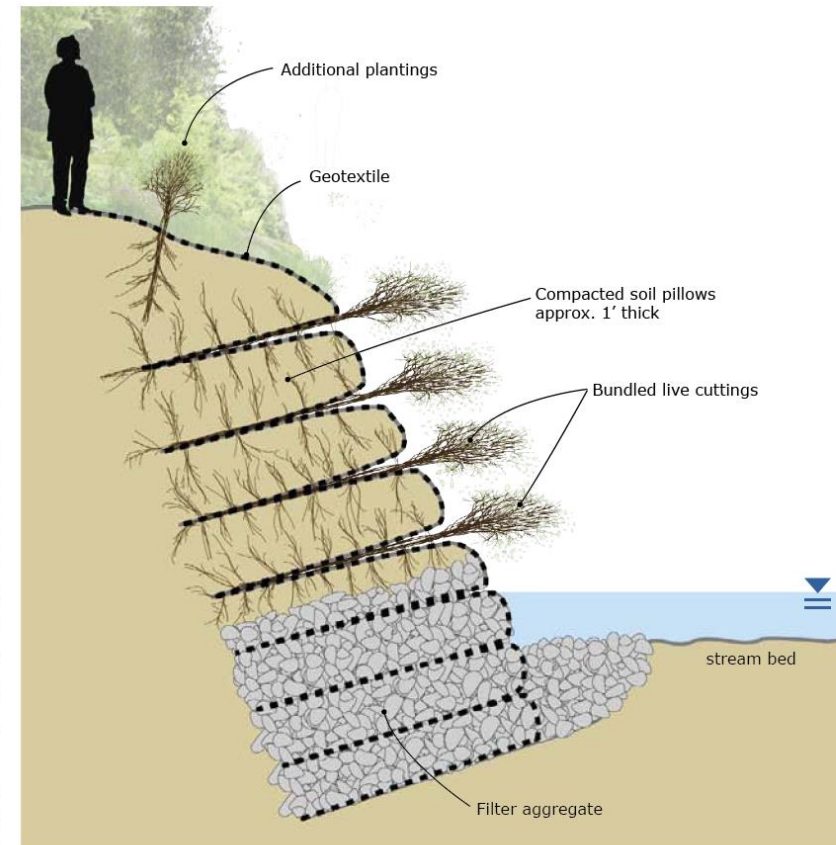
SECTION RENDERING

Soil Pillows are utilized in a bioengineering method known as Vegetated Reinforced Slope Stabilization (VRSS). The method combines rock, geosynthetics, soil and plants to stabilize steep, eroding slopes in a structurally sound manner. VRSS typically involves protecting layers of soils with a blanket or geotextile material (e.g. erosion control blanket) and vegetating the slope by either planting selected species (often willow or dogwood species) between the soil layers or by seeding the soil with desired species before it is covered by the protective material. In either case, with adequate light and moisture, the vegetation grows quickly and provides significant root structure to strengthen the bank. This method tends to be labor intensive and, therefore, relatively expensive.

In places where the channel is confined by the steep valley walls, however, fluvial bank erosion can lead to failure of the high banks. It can also undermine storm sewer inlets. For sites where groundwater seepage is a problem and where it is desirable to maintain steep banks, soil pillows are a feasible solution.

Materials consist of graded rock for the lower layers of the structure and for internal drainage, if necessary. Geotextile fabric is used to wrap the soil. Plants, such as willow or dogwood, or seed mixture is used for planting in and between the soil pillows.

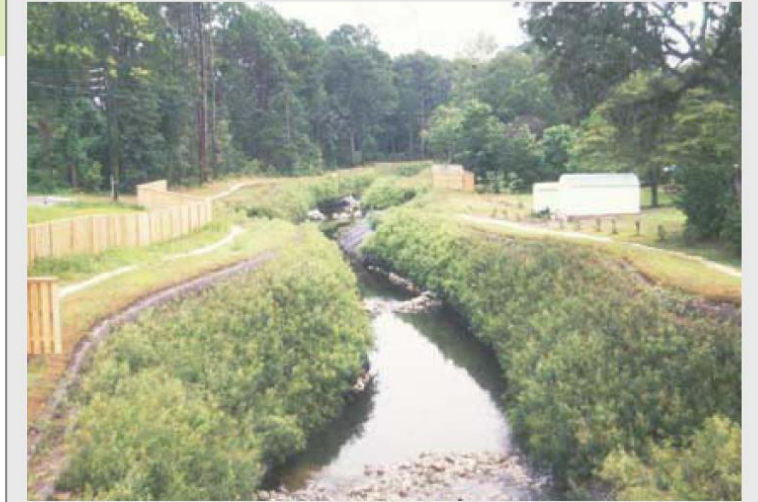
SIMILAR PROJECTS

The Mill Creek Restoration Project utilized soil bioengineering design to stabilize 175 linear feet of severely eroding streambanks within the Caldwell Recreation Park in southeastern Ohio. The work included two 25-foot vegetated reinforced soil slope (VRSS) sections, two 50-foot fill bank sections protected with woven coir and direct woody plantings, and a 12.5-foot tie-in on the upstream and downstream end of streambank work area.

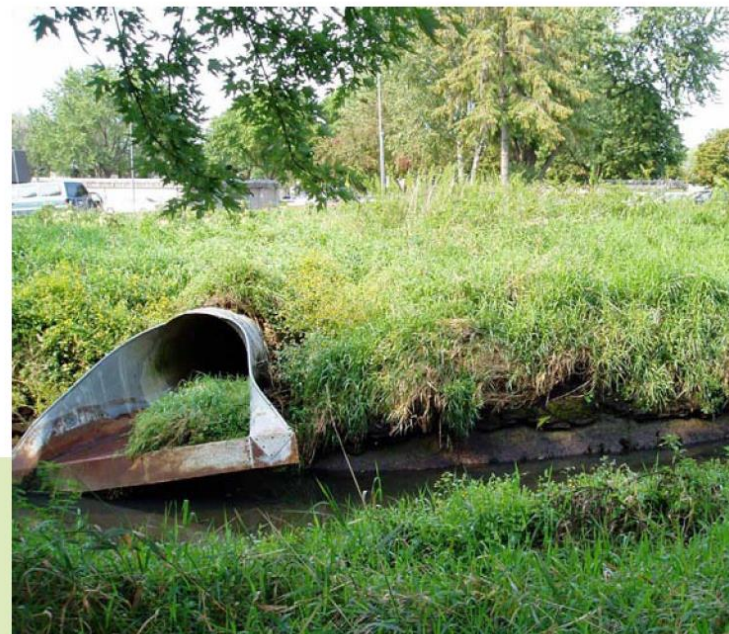
EXISTING CONDITIONS

Erosion is frequently observed at culvert outlets for a variety of reasons, including insufficient erosion protection at the culvert outlet, streambank erosion, and channel downcutting, which leaves the culvert perched above the channel. Filter fabric is often used at culvert outlets to separate riprap protection from underlying soils, however the fabric provides a slippery surface for the riprap, which commonly slides into the channel.

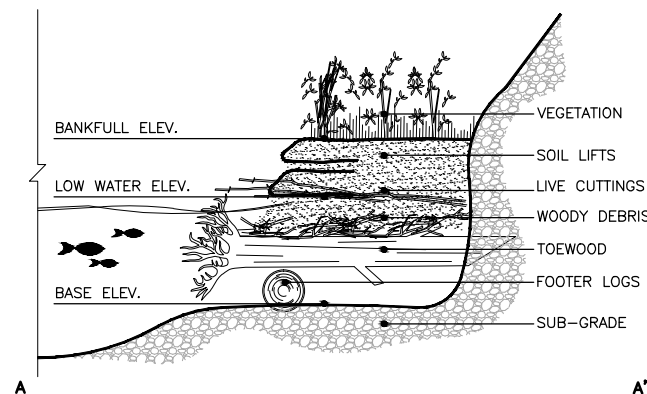
1. INSTALLATION SUMMARY

TOEWOOD BENCH CONSTRUCTION WILL BE DONE IN DRY WEATHER CONDITIONS AFTER STREAM HAS BEEN DIVERTED AND SITE DEWATERED.

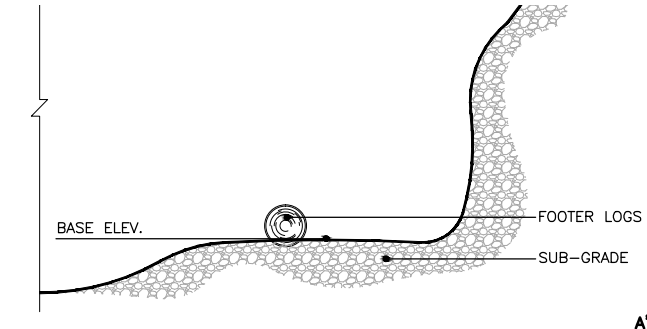
2. SUBGRADE AND FOOTER LOGS

SPECIFICATION:
 -8" TO 1' DIAMETER
 -LIMBS REMOVED
 -APPROX 10' LENGTH

PLACEMENT:
 -EXCAVATE TO BASE ELEVATION - CONTRACTOR SHALL MAKE EFFORT TO SEPARATE GRANULAR AND FINE FILL NATIVE MATERIAL FOR USE IN STEPS 4 AND 6.
 -PLACE FOOTER LOGS 30 DEGREES FROM PARALLEL TO STREAM FLOW WITH ENDS STACKED CREATING A ZIG ZAG PATTERN (PLAN VIEW BELOW)
 -MAINTAIN AVERAGE ELEV. OF 1' ABOVE BASE ELEV.

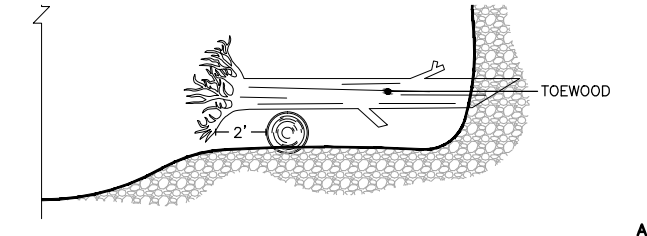
3. ROOT WADS & LRG WOODY DEBRIS

ROOT WAD SPECIFICATION:
 -10" MIN DIAMETER
 -LENGTH INDICATED IN DESIGN CROSS SECTION OR 10' MIN.
 -LIMBS REMOVED
 -ROOT WADS LEFT INTACT
 -ENDS SHARPENED TO A POINT

LARGE WOODY DEBRIS SPECIFICATION:
 -8" MIN DIAMETER

PLACEMENT:
 -PLACE ROOT WADS HORIZONTALLY ON TOP OF FOOTER LOGS, OVERHANG ROOT WAD LOGS 2'
 -ANGLE ROOTWADS UPSTREAM
 -DRIVE SHARPENED TRUNKS MIN. 3' INTO BANK OR DIG IN
 -PLACE 1 ROOT WAD PER FOOTER LOG
 -PLACE 5 TO 7 LARGE WOODY DEBRIS LOGS BETWEEN ROOT WADS

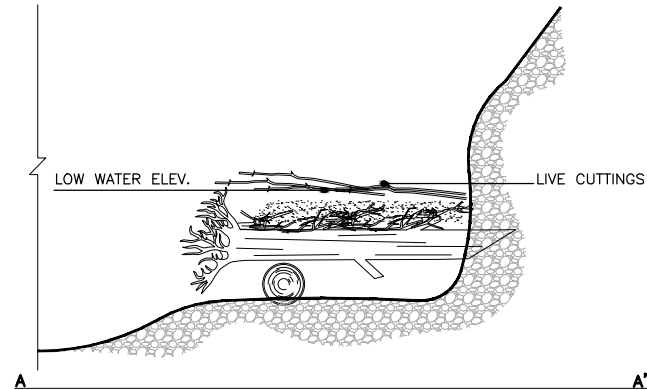
5. LIVE CUTTINGS

PLACEMENT:
 -LAY CUTTINGS WITH A DENSITY OF 10 CUTTINGS PER LINEAL FOOT
 -TOPS OF CUTTING WILL POINT TOWARD CHANNEL
 -TRIM EXPOSED ENDS OF CUTTINGS, LEAVE NO MORE THAN 6" EXPOSED
 -DEPOSIT NATIVE FILL OVER CUTTINGS AND WATER LIBERALLY, COMPRESS FILL TO 2"- 4"

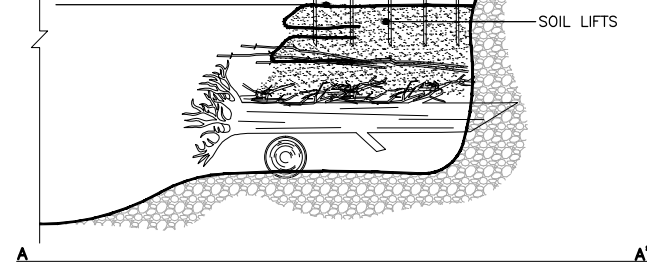
6. SOIL LIFTS

SPECIFICATION:
 -NATIVE FILL (FINE)
 -1' FORMS
 -MIN 6.5' WIDE ROLANKA BIOD-MAT 70, GEOCOIR 700, OR EQUAL LINED WITH MNDOT CAT II EROSION CONTROL BLANKET WITH NATURAL NETTING
 -18" WOODEN STAKES (2X4 CUT AT ANGLE), PLACED AT 3' SPACING

PLACEMENT:
 -PLACE FORM
 -LAY MIN 2.5' OF FABRIC (COCONUT BLANKET AND LINER) ALONG BENCH
 -PLACE 1' OF FILL ON TOP OF MAT AND COMPACT
 -WRAP FILL WITH REMAINING BLANKET AND SECURE WITH STAKES
 -REPEAT UNTIL BANKFUL ELEVATION IS MET, STEP EACH LIFT BACK 1'
 -FOR TOP SOIL LIFT, EXTEND BLANKET TO EXISTING GRADE/BANK

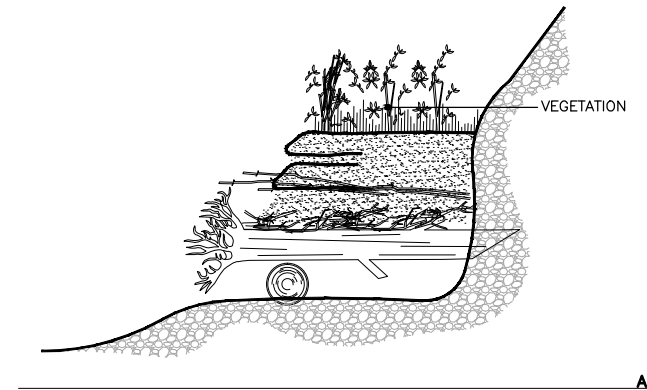
7. VEGETATION

IF SEED IS CALLED FOR:
 -PLANT SEED INSIDE OF SOIL LIFT PRIOR TO COVERING IN FABRIC
 -PLANT SEED ON THE FACE OF EACH SOIL LIFT AS WELL AS ACROSS THE TOP SOIL LIFT
