Crane Lake Improvement Project (CL-3)

FINAL REPORT December 4, 2020

I. Project Overview

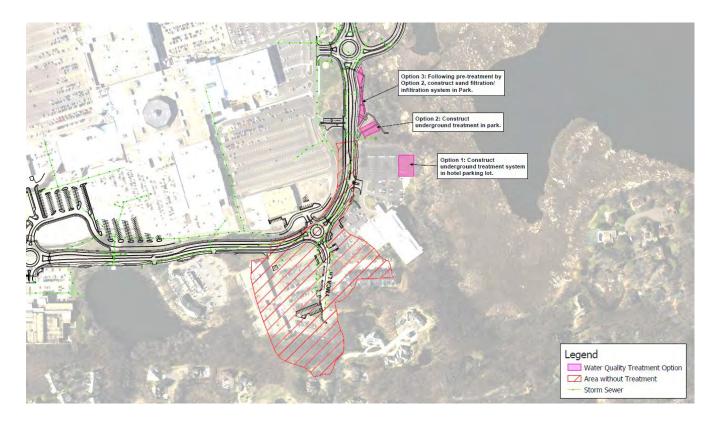
The project area map shown below from the Feasibility Report is located on Ridgedale Drive from YMCA Lane to Wayzata Boulevard. A storm sewer network was installed to collect the untreated drainage area and direct storm water to the underground tank and filtration basins (Option 2 and 3 below). During the feasibility study, it was determined to no longer explore Option 1 which was not constructed.

The Crane Lake Improvements included the installation of a 12,250 cubic-foot underground storage tank, a wet well with a 30 gallon per minute pump, and a series of rain garden filtration basins. The untreated drainage area of 13.3 acres as shown in the above image is collected and directed to the tank, where it is then pumped and filtered through the rain gardens prior to outlet into Crane Lake.

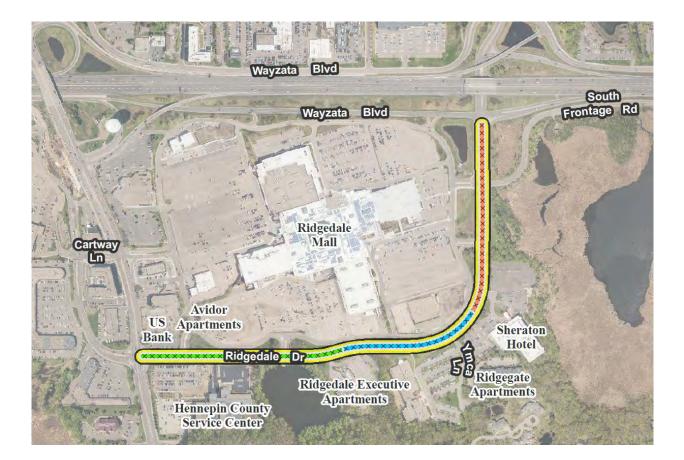
xxxxx	Stage 1 (2019 Construction)	
xxxxx	Stage 2 (2020 Construction)	
×××××	Stage 3 (2020 Construction)	
Project Area

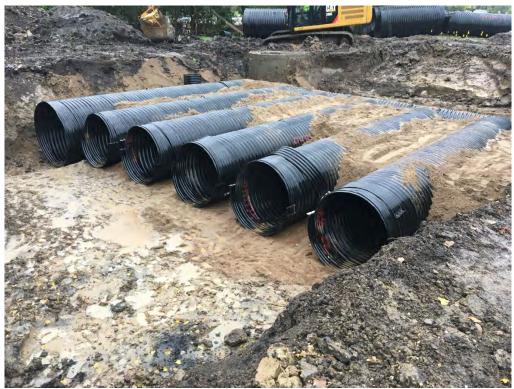
Underground Storm Water Tank Construction at Crane Lake Park – South View

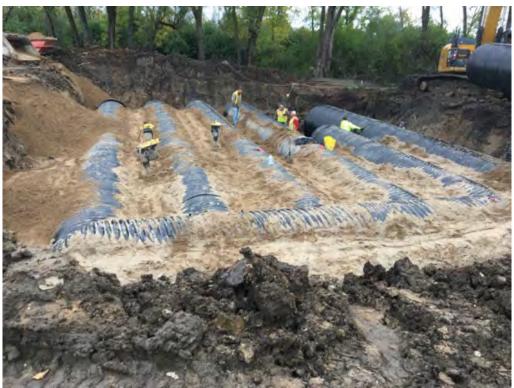
Underground Storm Water Tank Construction at Crane Lake Park – East View

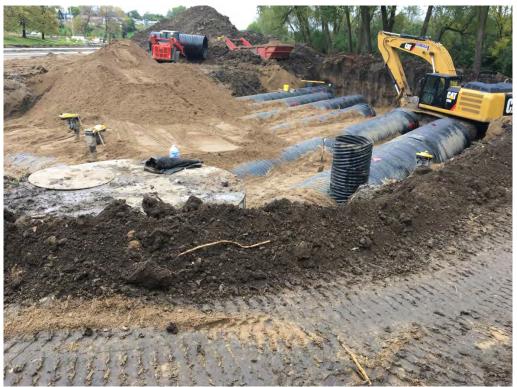
Underground Storm Water Tank Construction at Crane Lake Park – North View

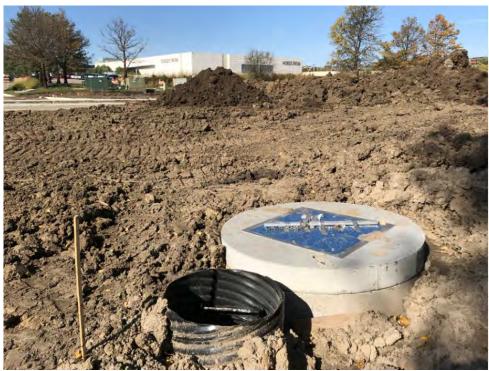
Storm Water Lift Station Access Structures at Crane Lake Park – West View

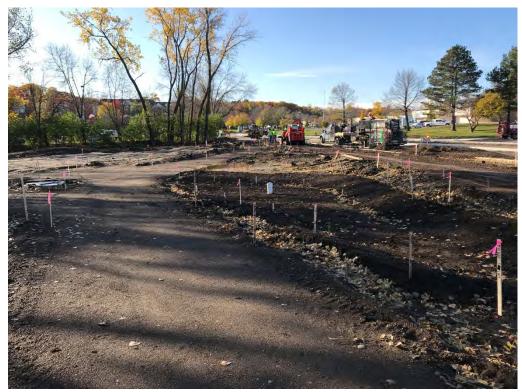
South Rain Garden – South View

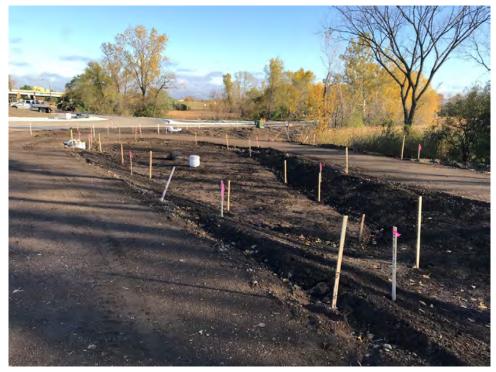
North Rain Garden – North View

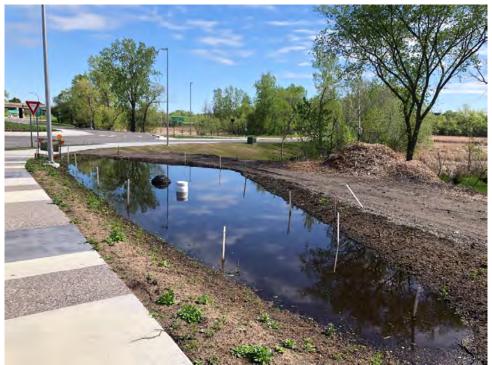
North Rain Garden (Valve Closed – Filtration Needed) – North View

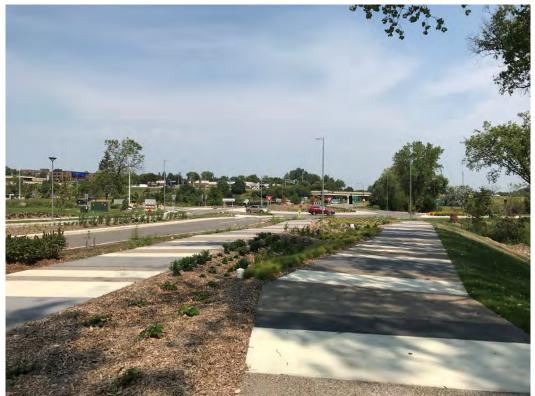
South Rain Garden Plantings Installed – North View

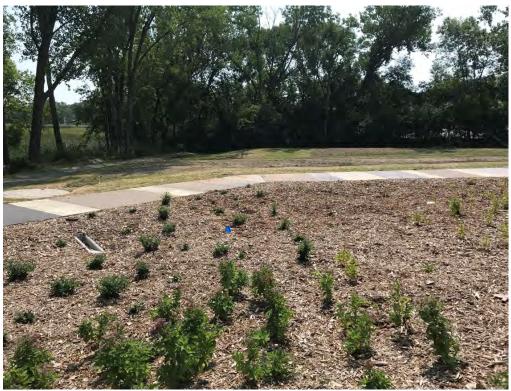
North Rain Garden Plantings Installed (Lift Station Outlet Left Side of Photo) – SE View

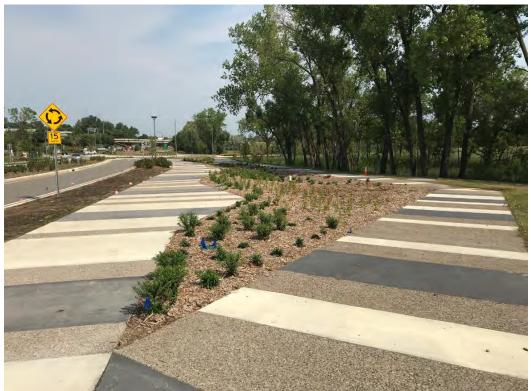
North Rain Garden Plantings Installed – North View

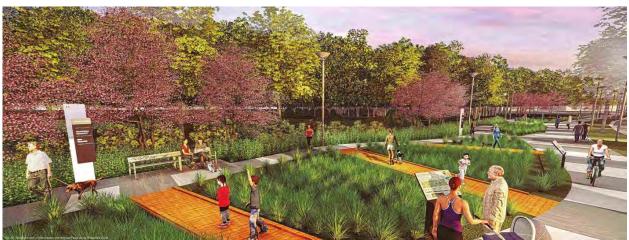
Graphic Depiction of Rain Garden Areas at Crane Lake Park
