About the Bassett Creek Watershed Management Commission (BCWMC)

Bassett Creek Main Stem Restoration (2024 CR-M)

Bassett Creek Main Stem Erosion Issues and Restoration Prioritization

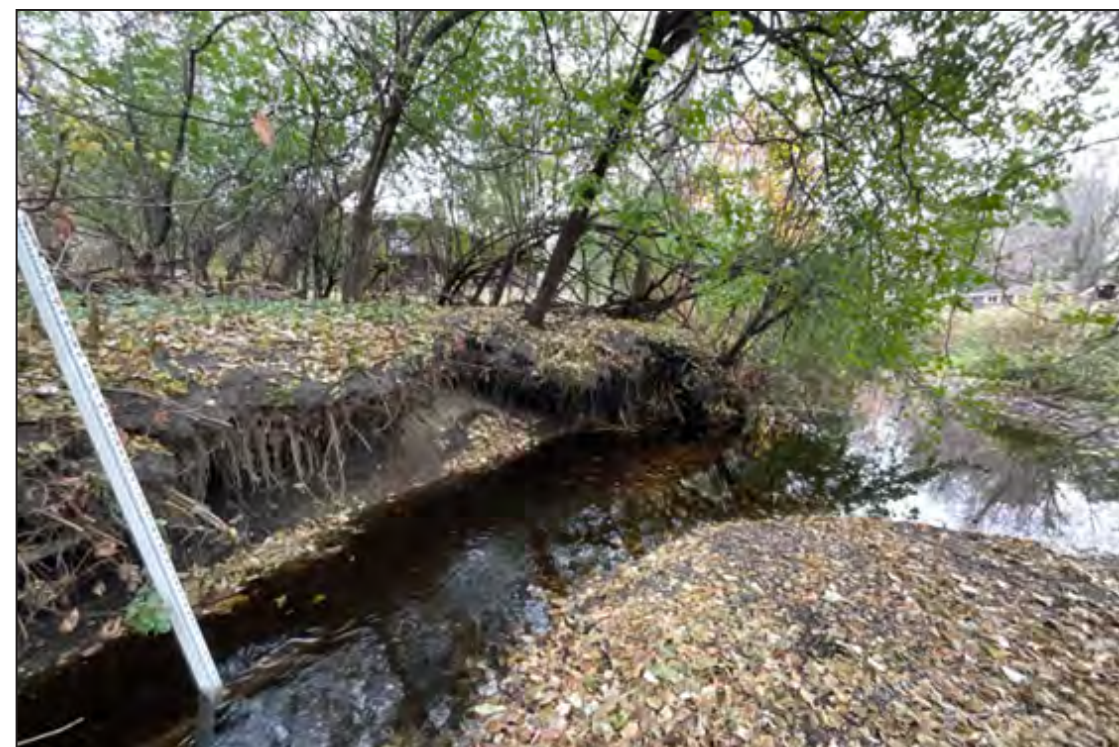
Streambank undercutting

Any type of erosion comes with the associated issues:

- Introduction of sediment to stream and downstream water bodies
- Degradation of bank vegetation and reduced potential for re-growth
- Degradation of in-stream and bank habitats
- Increased risk of continued erosion
- Changing of the stream shape and size overtime

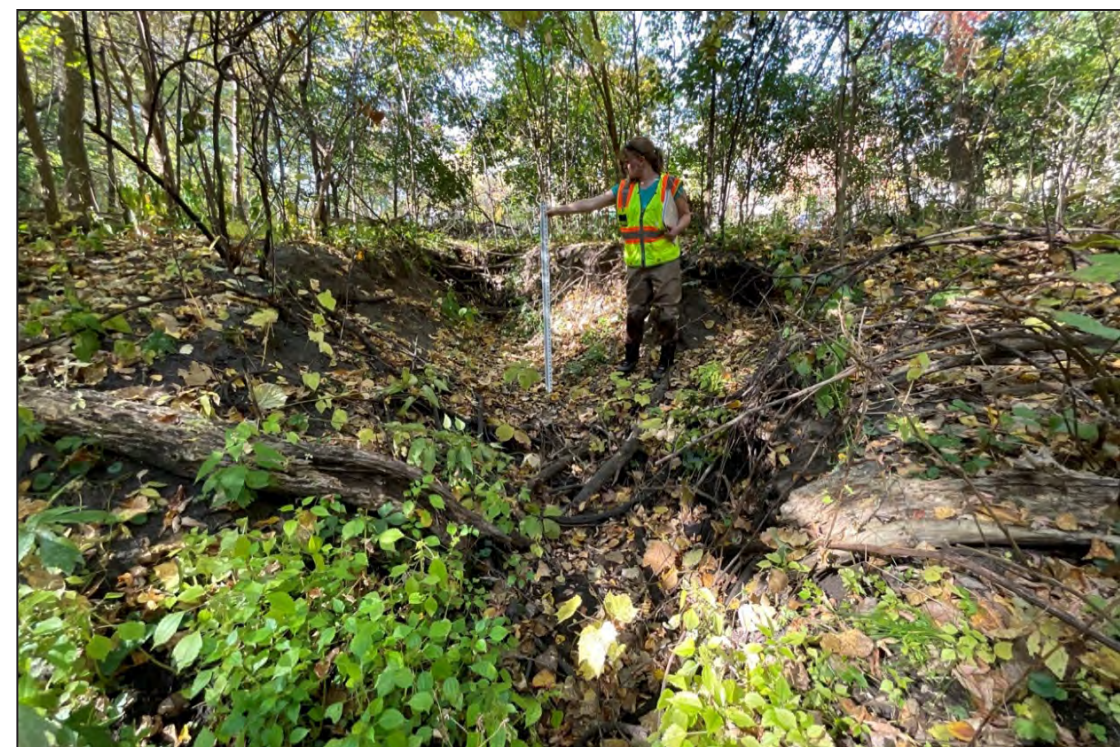
Tributary erosion

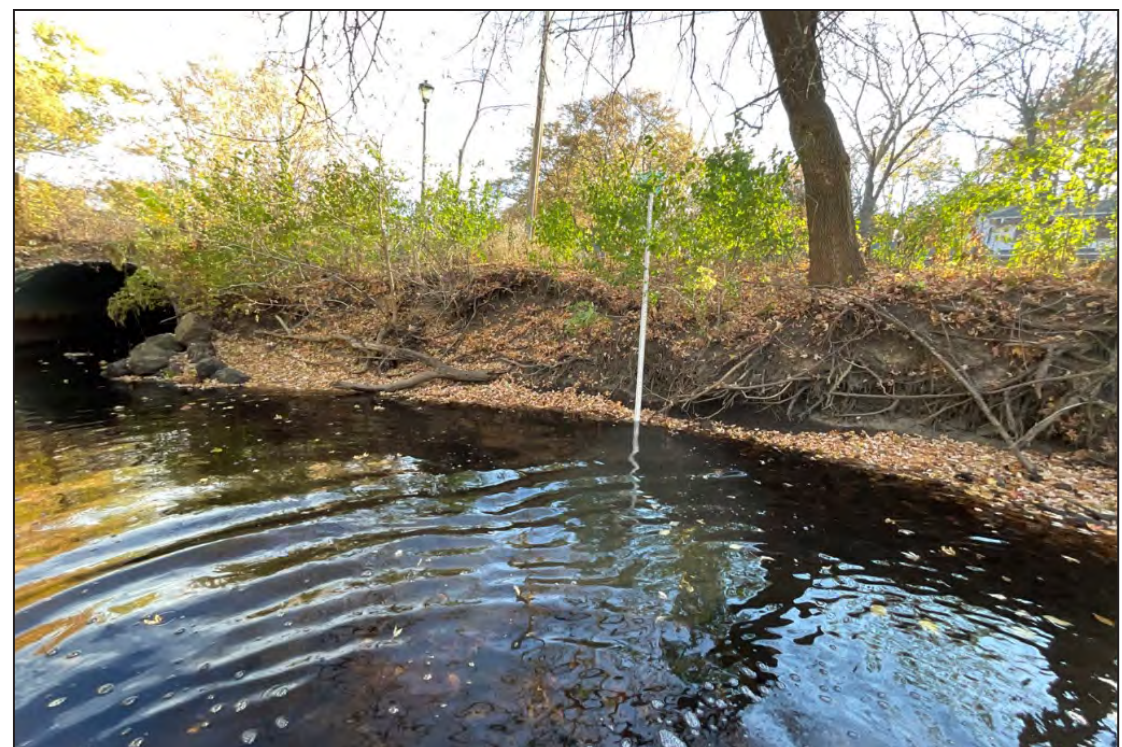
Scour near culverts

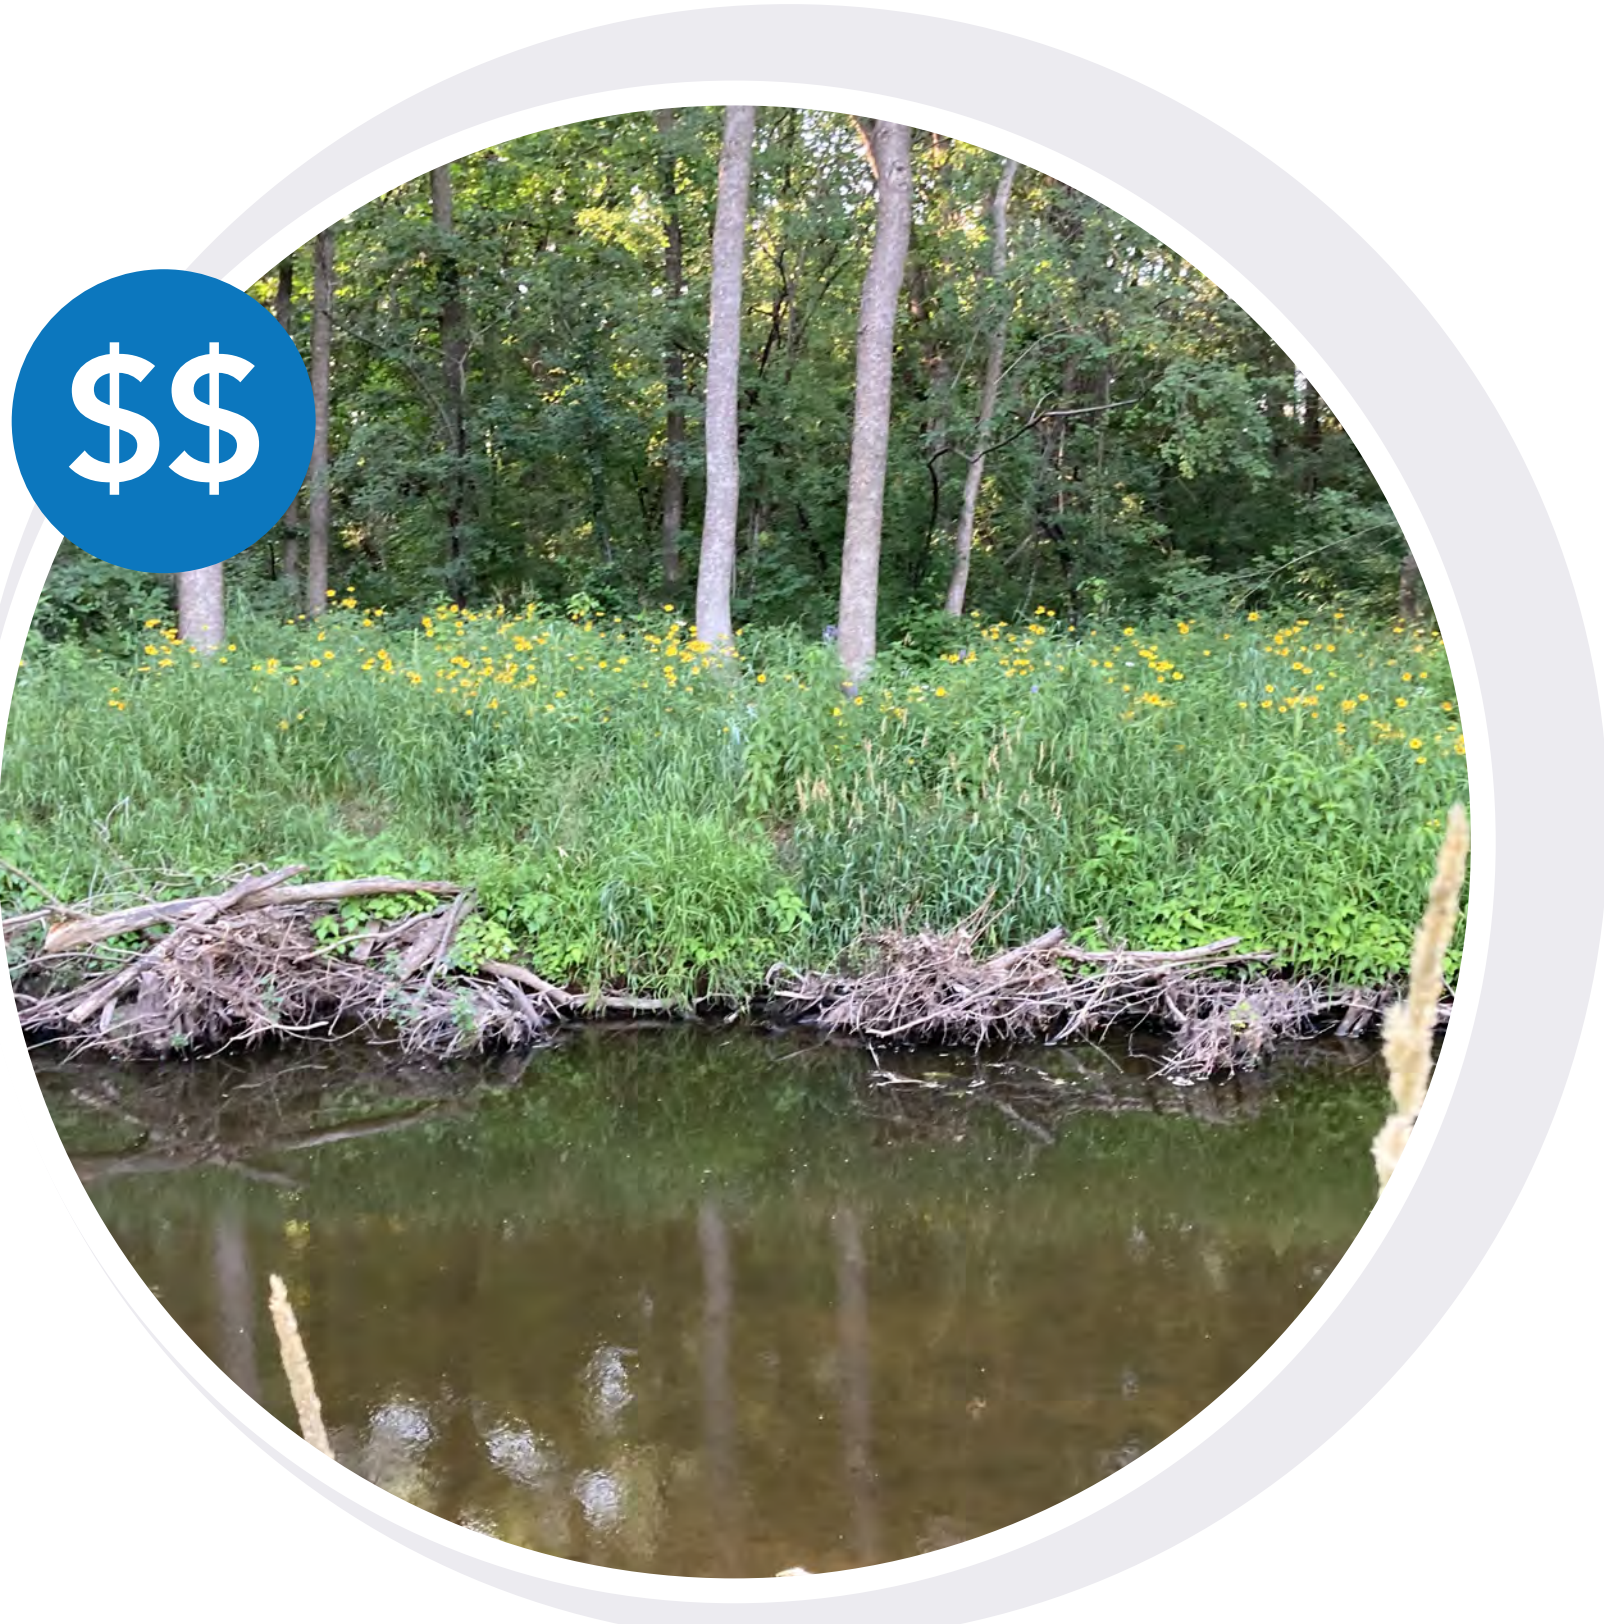
Restoration Design Concept

2 Toe stabilization with bioengineering methods with minimal in-stream structures and riprap, as well as moderate grading and vegetation establishment

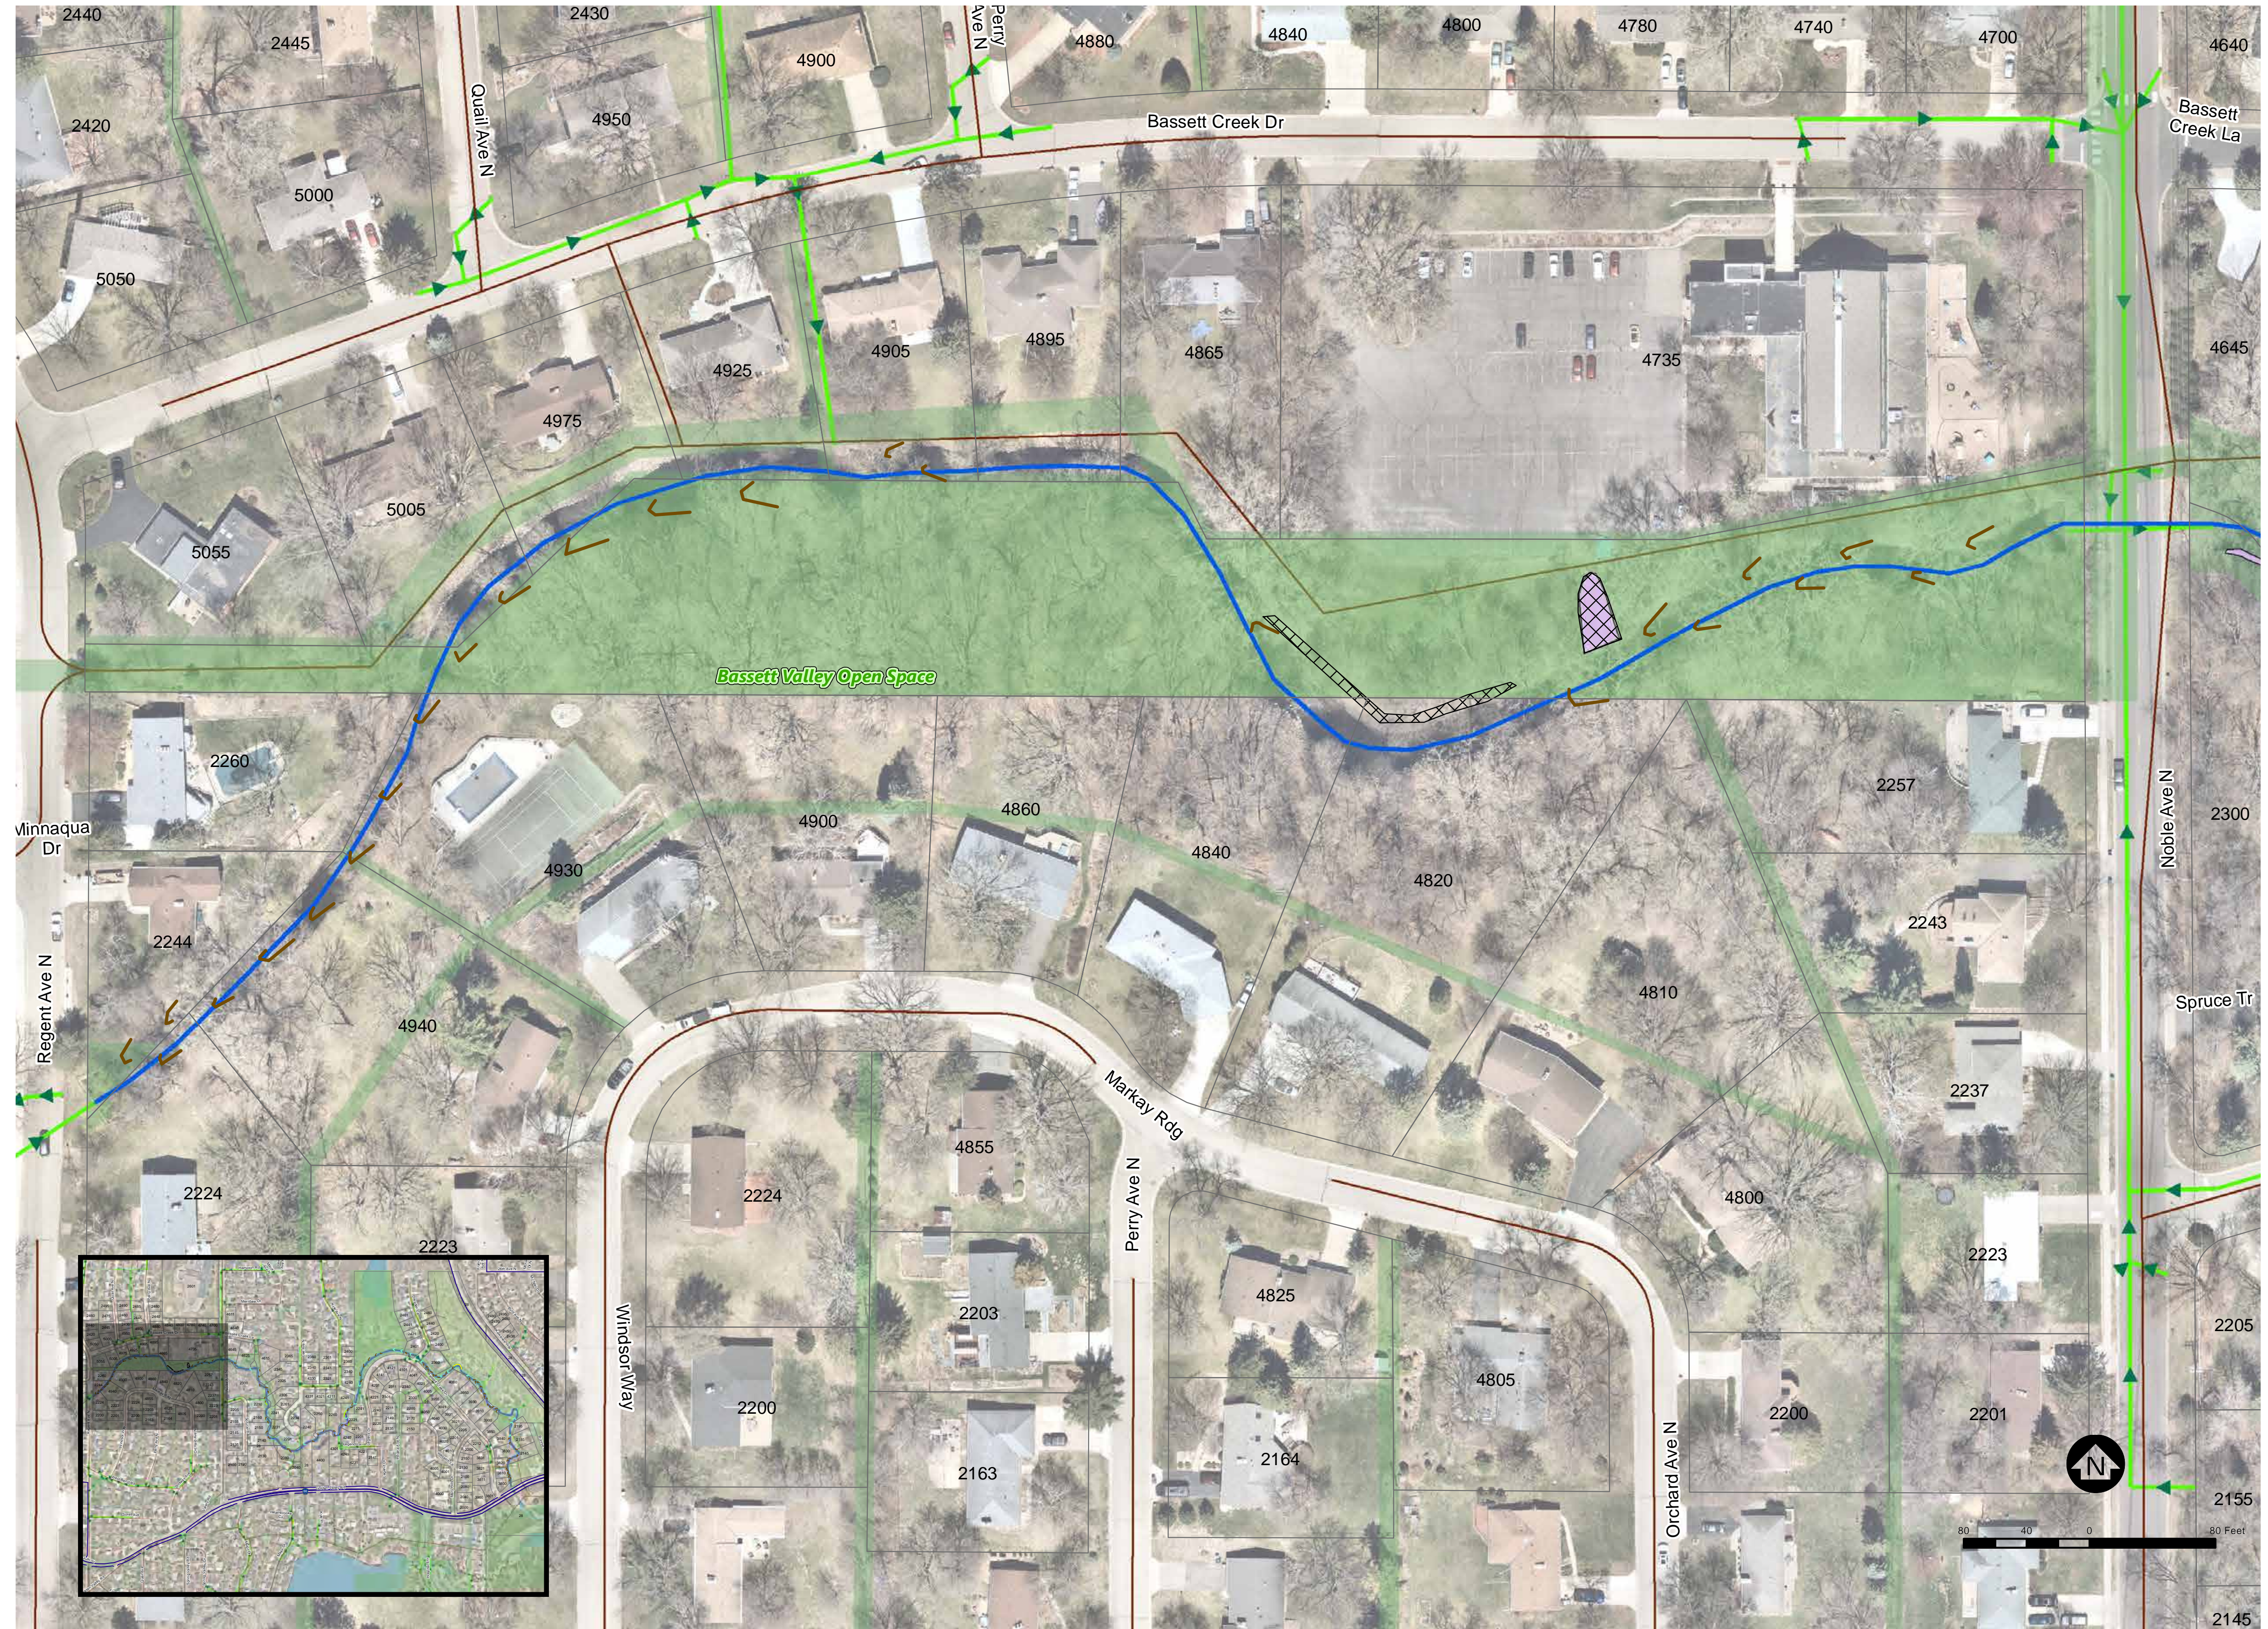
Restoration Design Concept

1 In-stream structures with minimal grading, riprap, and vegetation establishment

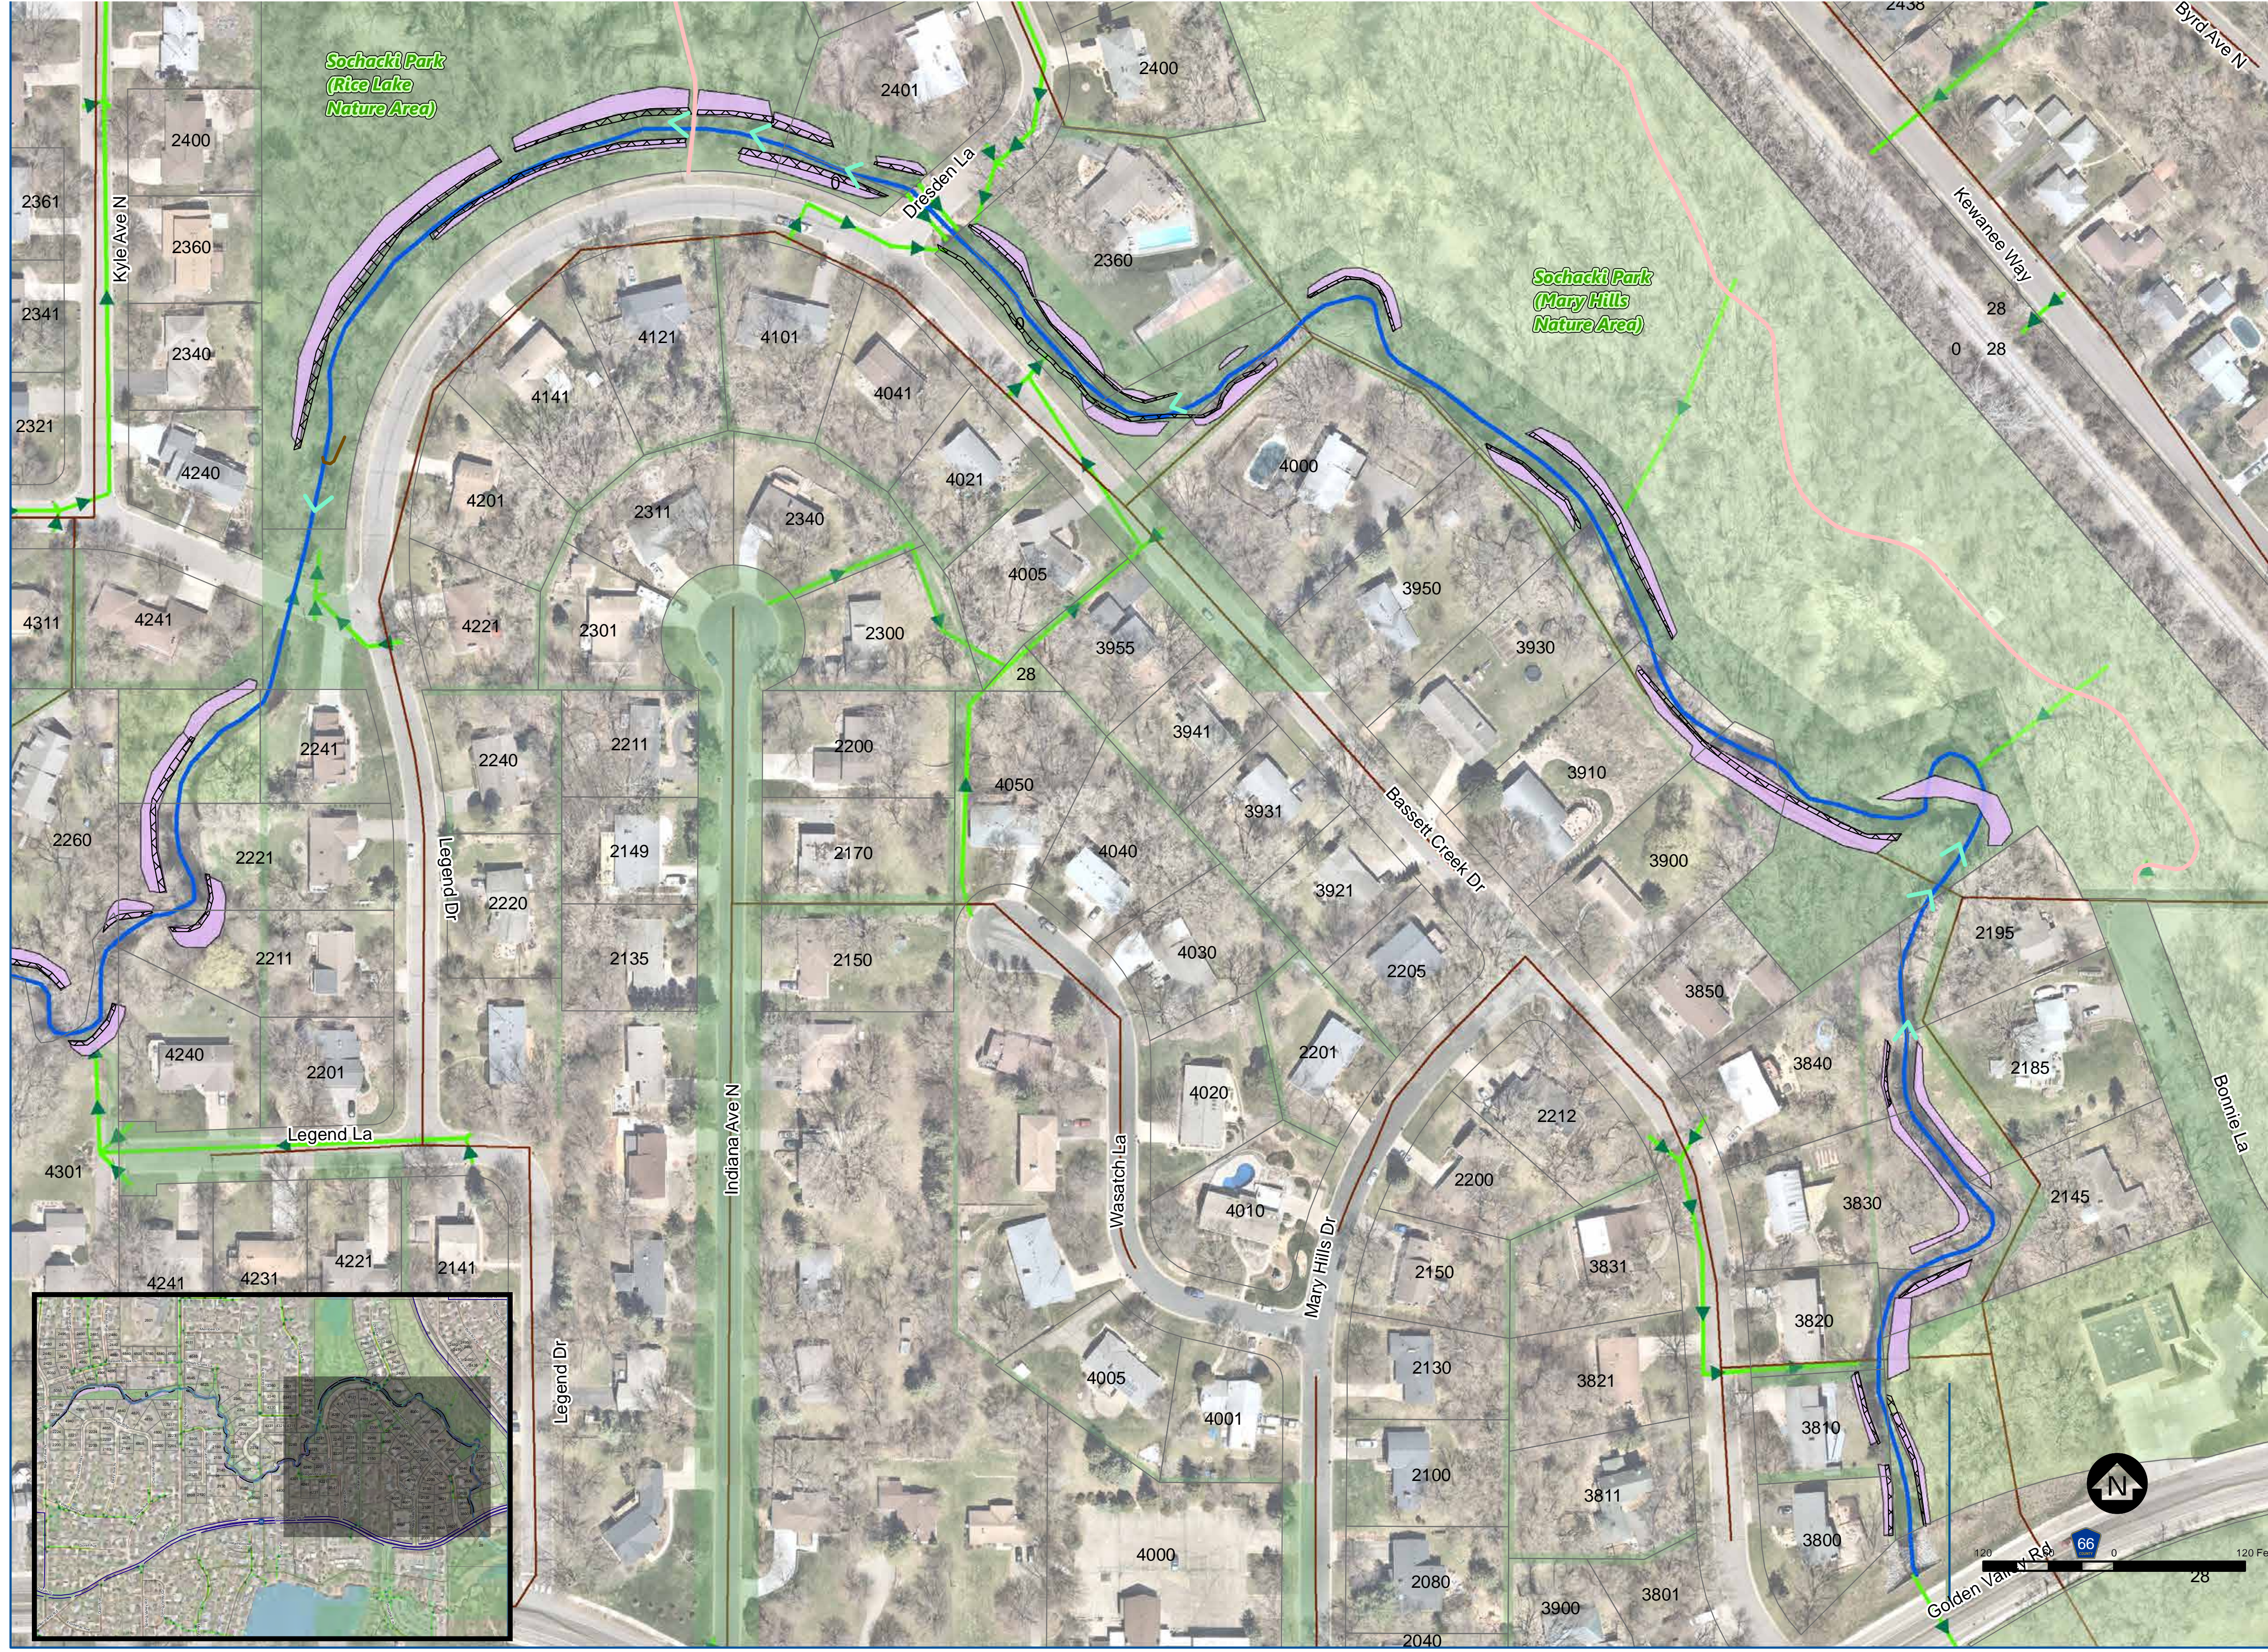
Restoration Design Concept

3 Bank grading with riprap and vegetation establishment with minimal in-stream structures and bioengineering
