# **Feasibility Report for Bassett Creek Main Stem Restoration, Regent Avenue to Golden Valley Road (2024 CR-M)**

***Golden Valley, Minnesota***

Prepared for  
Bassett Creek Watershed Management Commission

June 2023

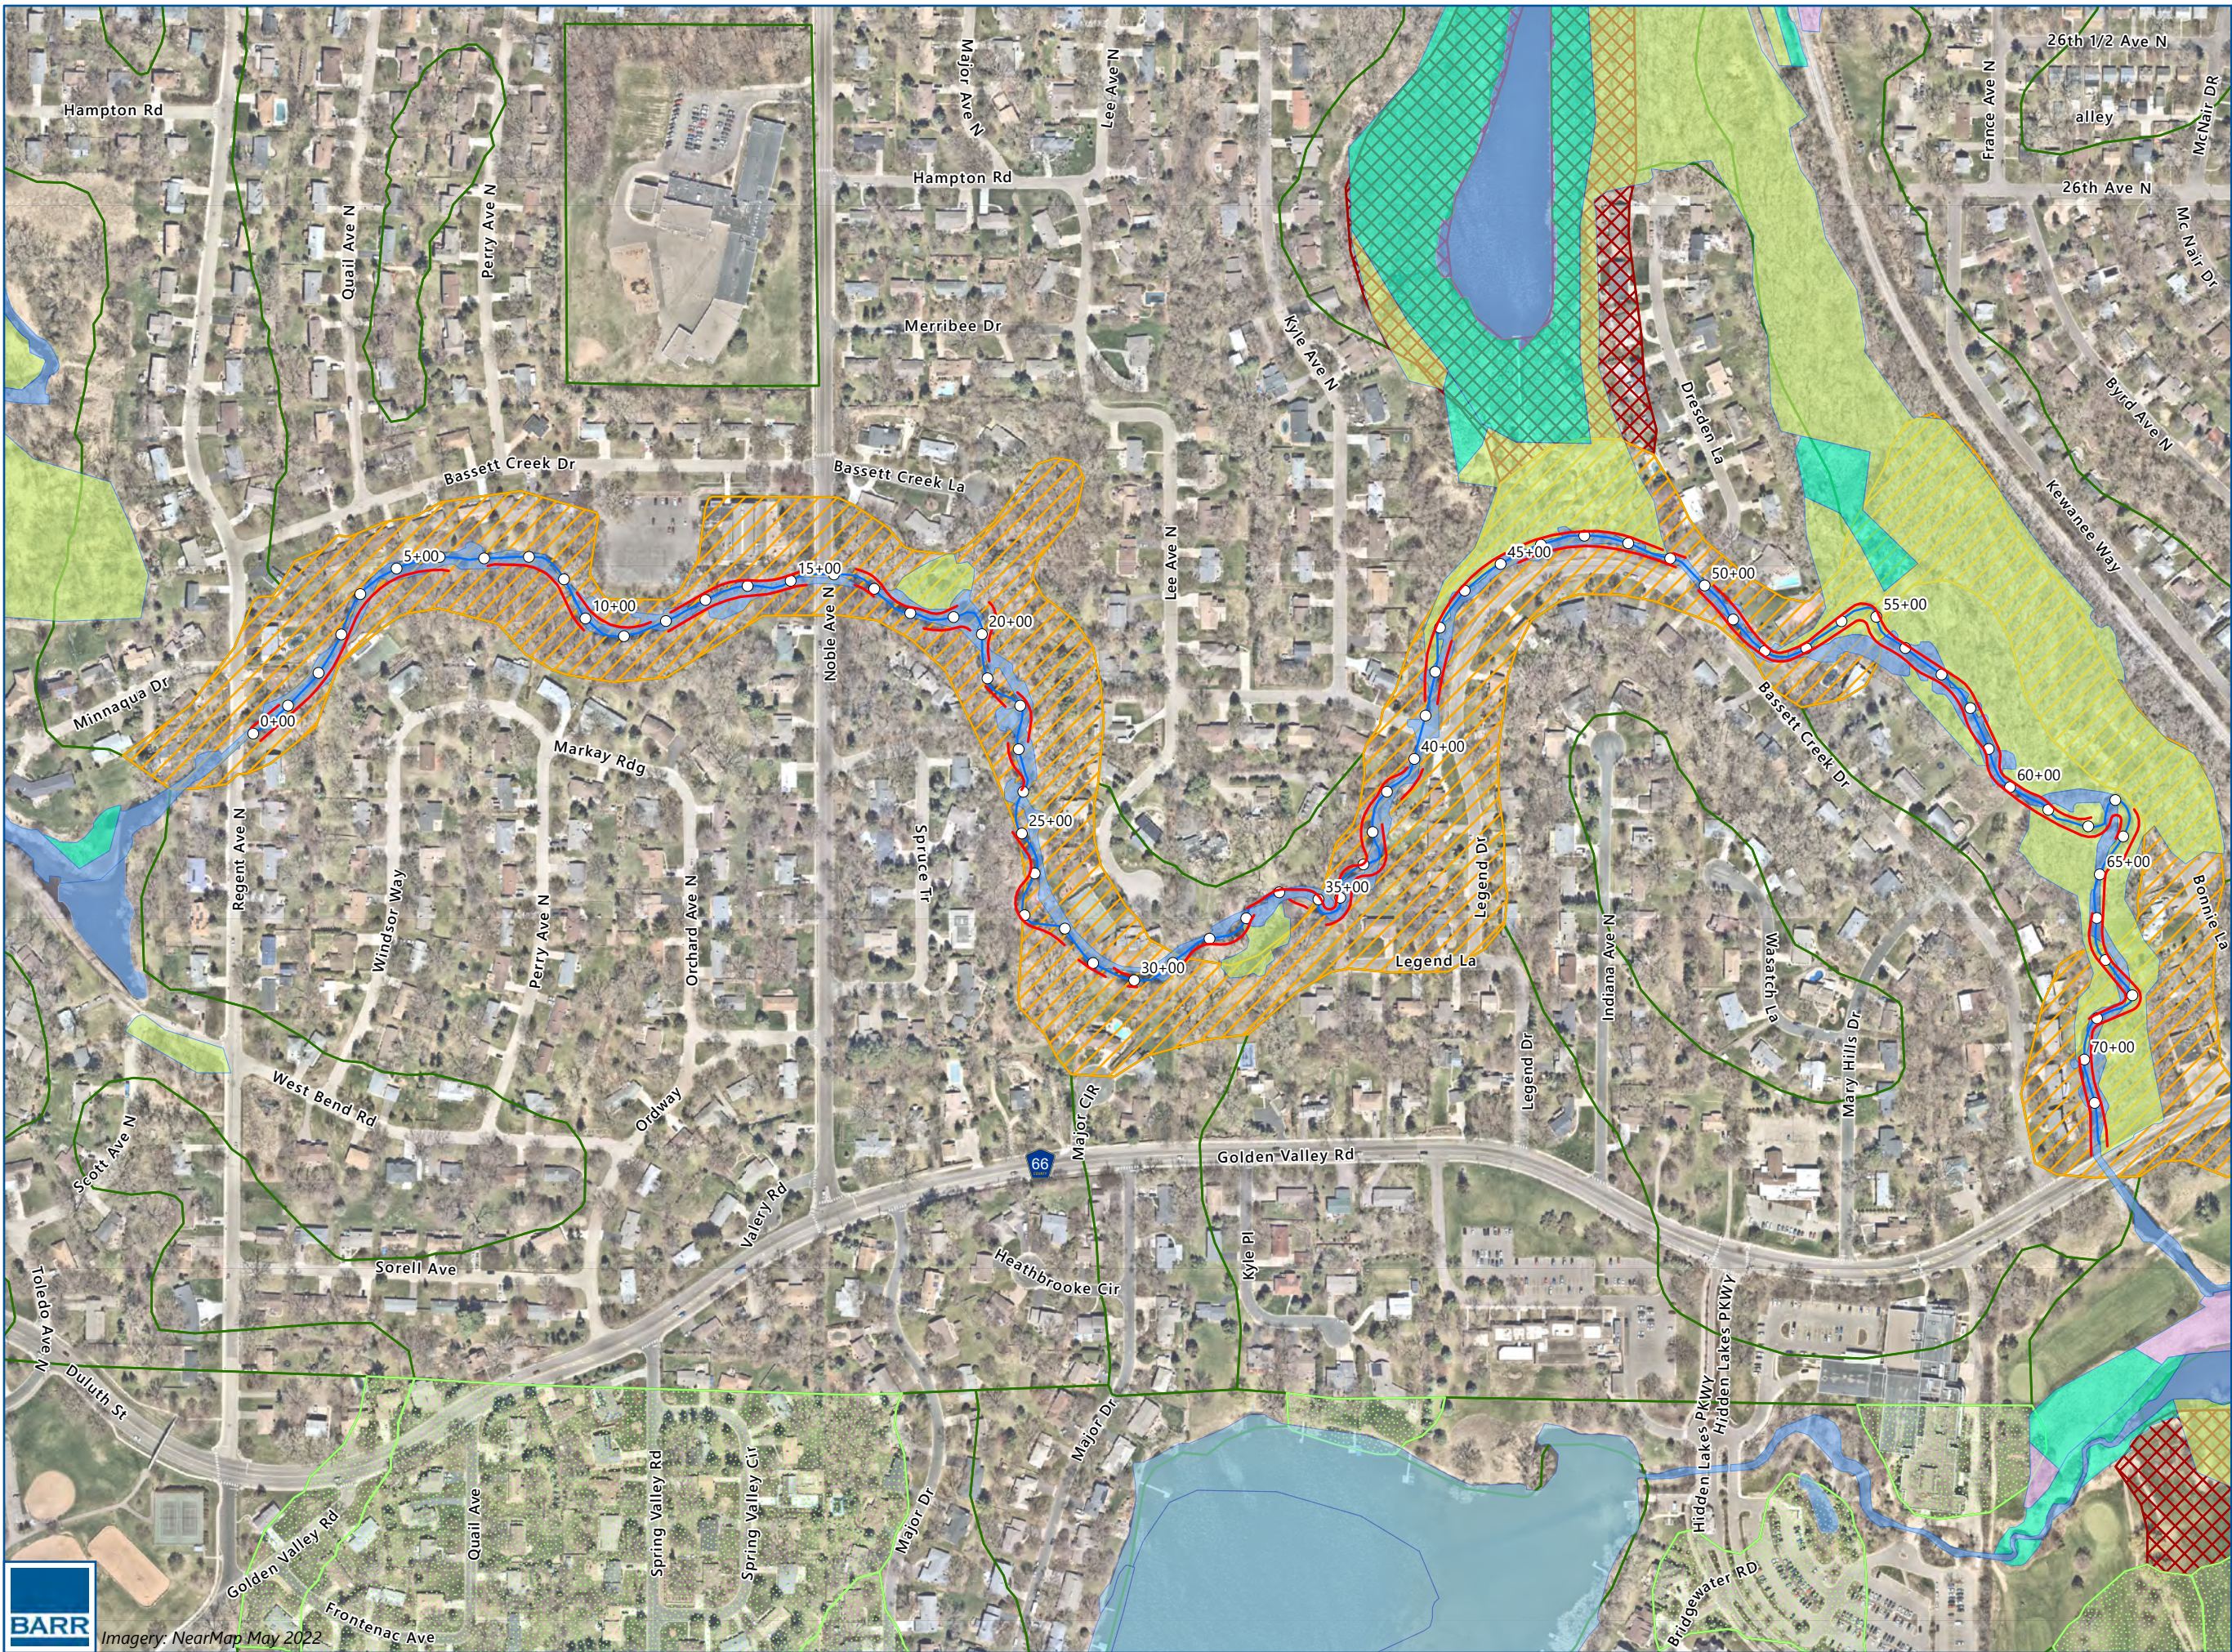
The Commission Engineer completed a Level 1 desktop wetland assessment for the project area in October 2022. The Level 1 review was completed for a 50-foot buffer from the Bassett Creek channel. The review included an assessment of multiple years of aerial imagery in addition to hydric soil indicators from the Natural Resources Conservation Service (NRCS) Web Soil Survey, LiDAR topography data, United States Fish and Wildlife Service (USFWS) National Wetland Inventory (NWI), and the Minnesota Department of Natural Resources (MnDNR) Public Water Inventory (PWI) (Figure 3-2).

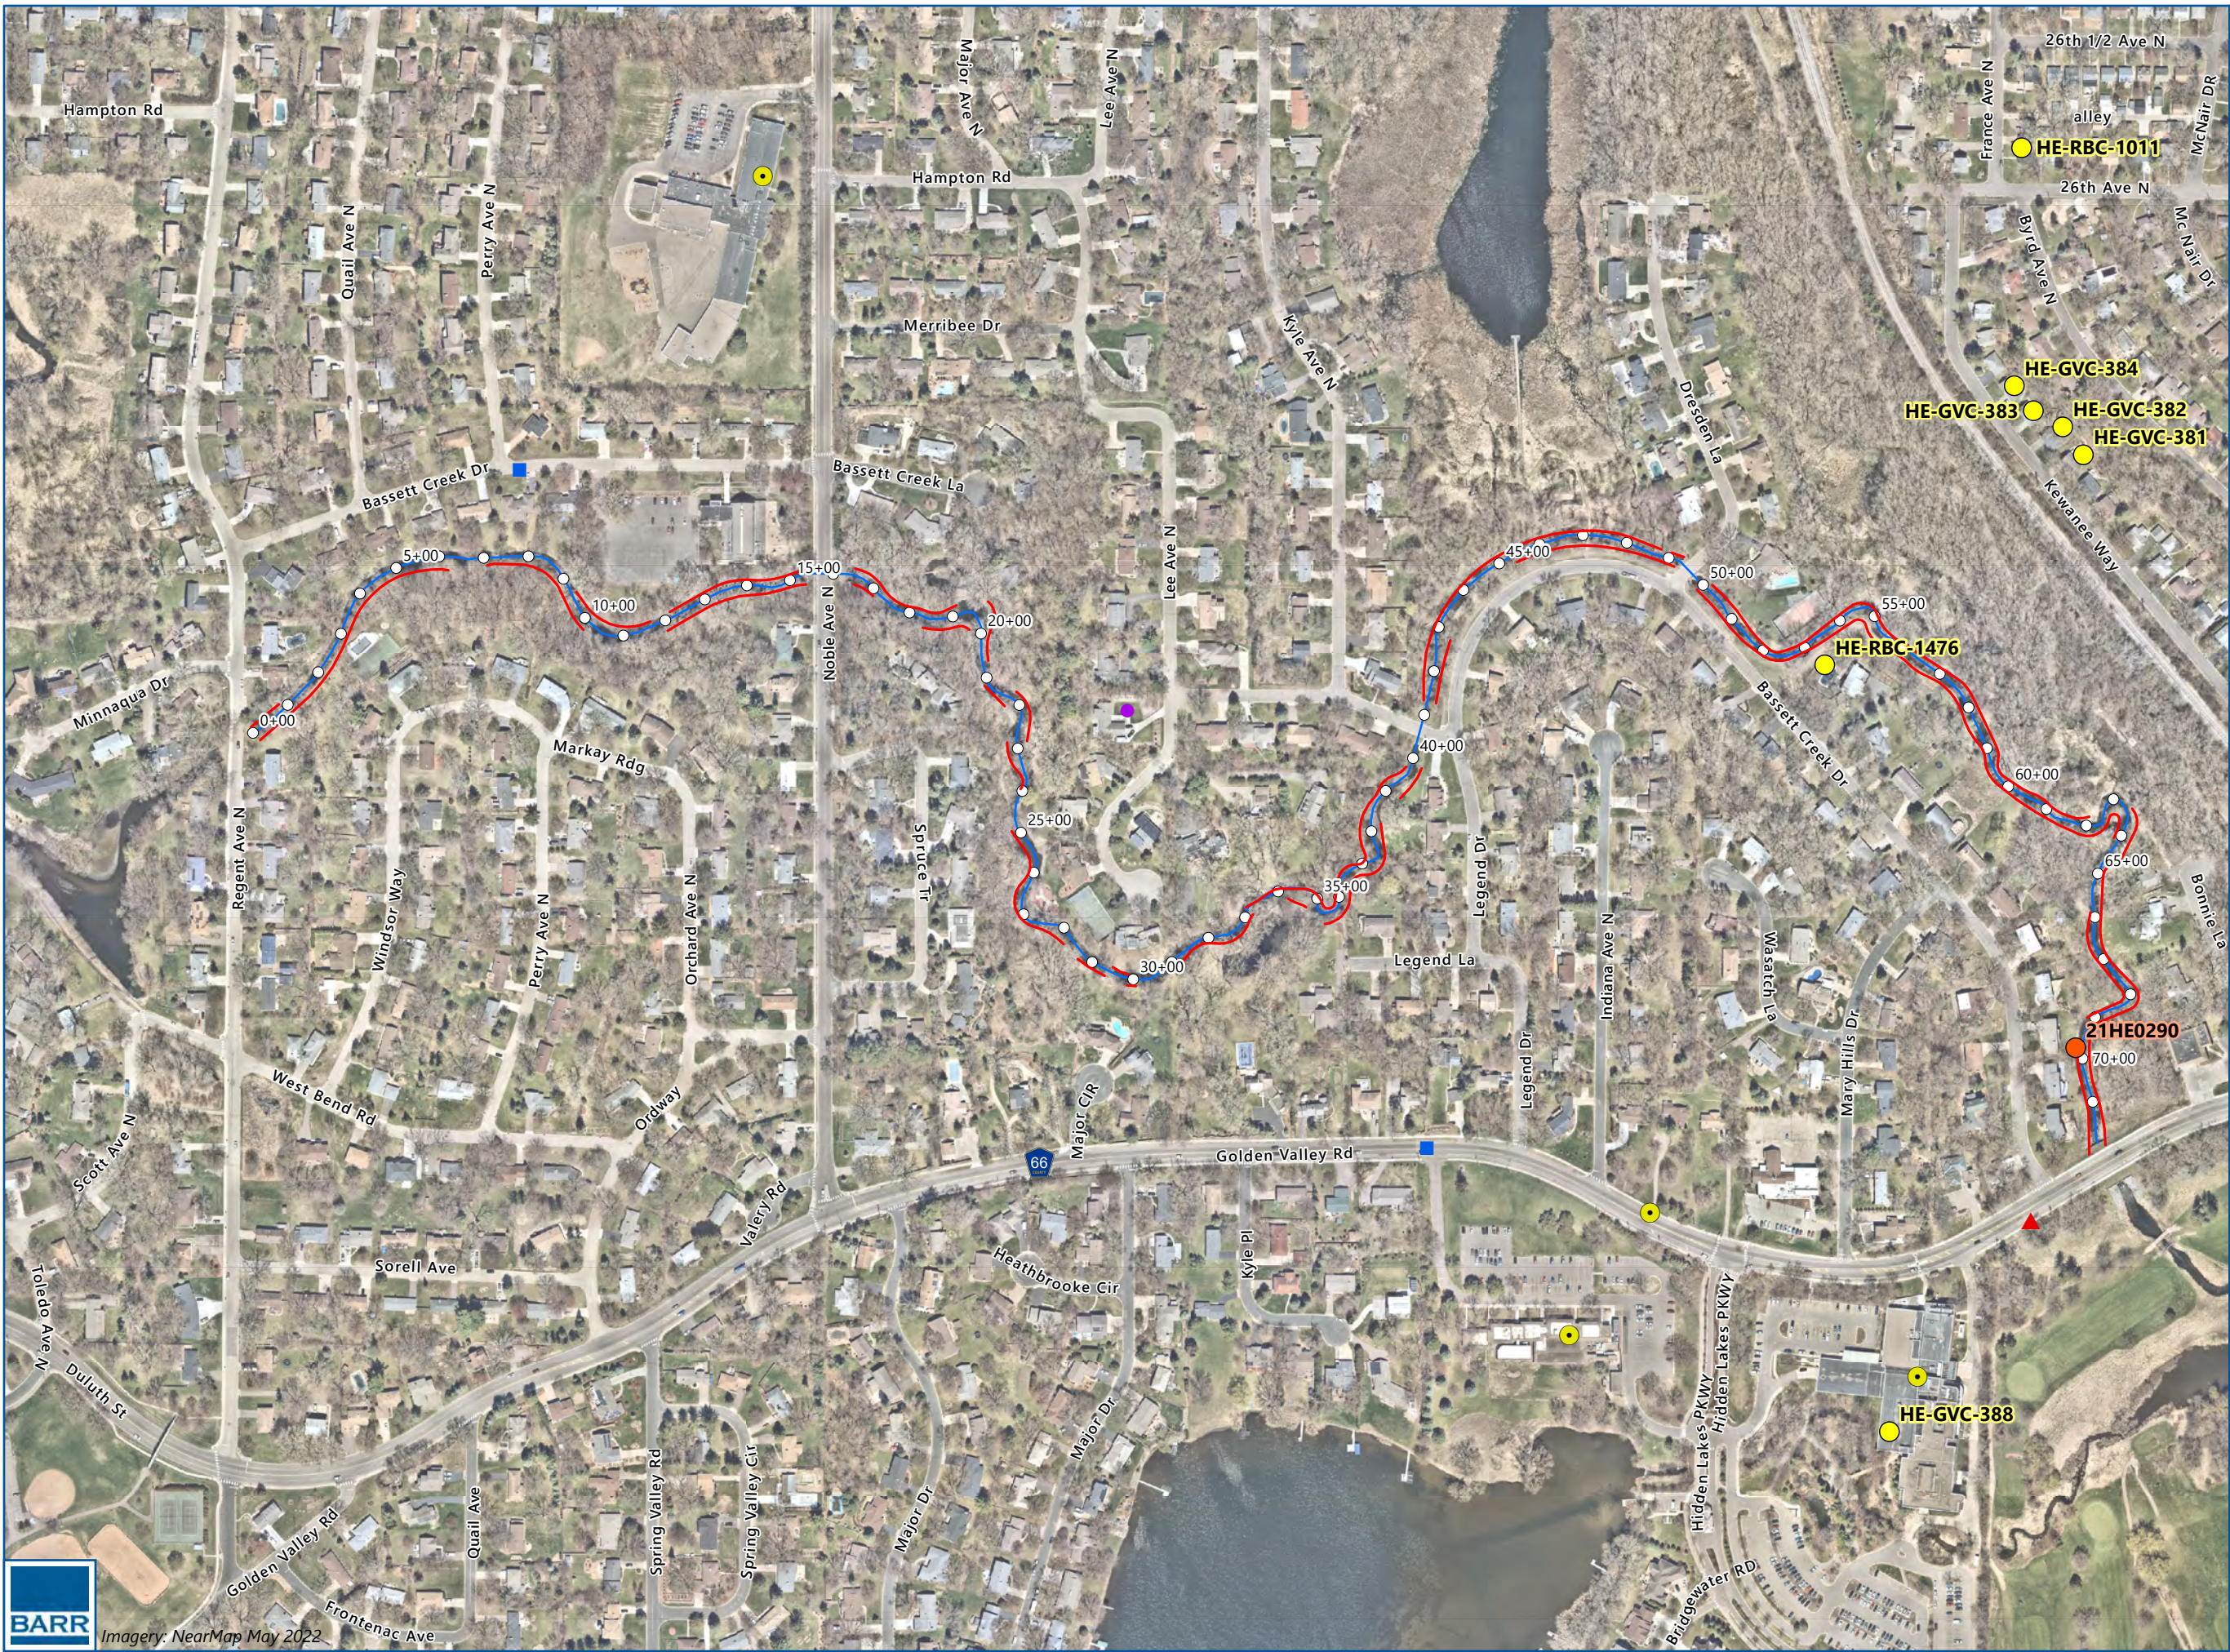
The Commission Engineer completed a cultural resources literature review of the project area and within a 1-mile buffer in October 2022. The literature review was directed toward identifying previously recorded archaeological sites, historic structures, and other cultural resources. The Commission Engineer requested data from the Minnesota State Historic Preservation Office (SHPO) to identify previously recorded archaeological sites and historic structures located within one mile of the project area. We also reviewed the Minnesota Office of the State Archaeologist (OSA) Portal for archaeological sites (Figure 3-3).

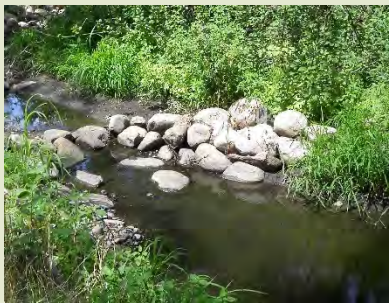
Boulders buried in the stream bed and extending entirely across the stream (“cross vanes”) to achieve one or more of the following goals: re-direct flows away from banks, encourage sediment deposition in selected areas, and control stream bed elevations	Scour pools develop over time downstream of the center of the vane, which provide habitat diversity for species that prefer pools to faster flowing in-channel habitat.

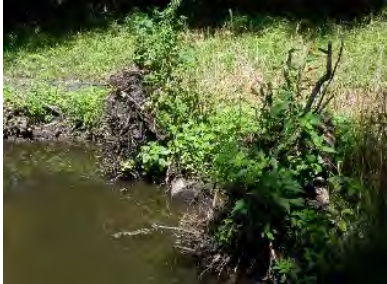
<p>Tree trunks with the root ball attached, installed either singly (root wads) or in conjunction with additional large woody debris and/or riprap to increase bank roughness and resistance to erosion, re-direct flows away from banks, and provide a bench for the establishment of riparian vegetation</p>	<p>Creates undercut/overhanging bank habitat features</p>
<b>VRSS/Toe Wood Bank Stabilization</b>

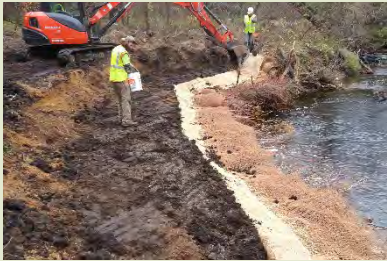
<p>Soil lifts created with a combination of root wads and long-lasting, biodegradable fabric and vegetated to stabilize steep slopes and encourage the establishment of root systems for further stabilization</p>	<p>Creates undercut/overhanging bank habitat features and vegetated floodplain bench/riparian habitat</p>
<b>Riprap Toe with Bank Grading and Vegetation Establishment</b>

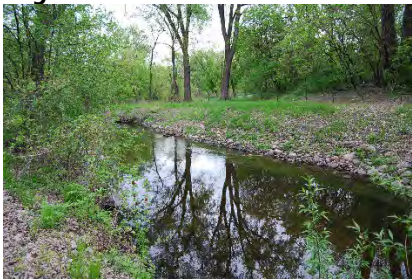
<p>Riprap placed along the toe of the streambank prevents undermining of the bank. Vegetating the bank provides surface protection while establishing root systems, and grading to a flatter slope makes the streambank less susceptible to erosion.</p>	<p>Vegetation placed above the riprap enhances riparian habitat and provides shading of the creek.</p>

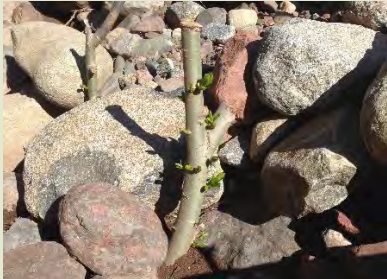
<b>Vegetated Riprap</b>

<p>Vegetated riprap incorporates habitat enhancement with hard armoring to stabilize steep slopes.</p>	<p>Creates vegetated riparian habitat and enhances biological connectivity between the channel and riparian area.</p>

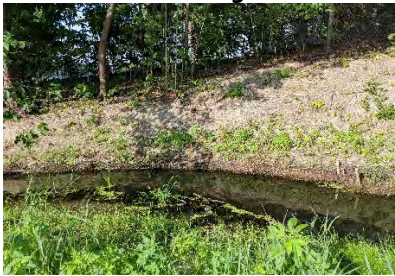
Fascines and coir logs can be placed along the toe of a stream bank in low-velocity areas to help establish vegetation and associated rooting systems to stabilize the stream bank.	Creates vegetated riparian habitat and adds roughness to dissipate energy at the toe of the slope.
<b>Vegetated Buffer</b>

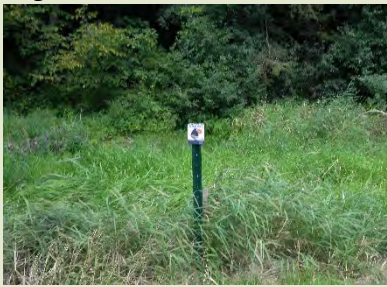
Established along a stream bank or overbank area to stabilize bare soils and increase resistance to fluvial erosion	Using trees, shrubs, and a seed mix of grass and forbs provides a diverse array of vegetation strata and habitat types. Allows for more naturalized aesthetics, with emphasis on native species.

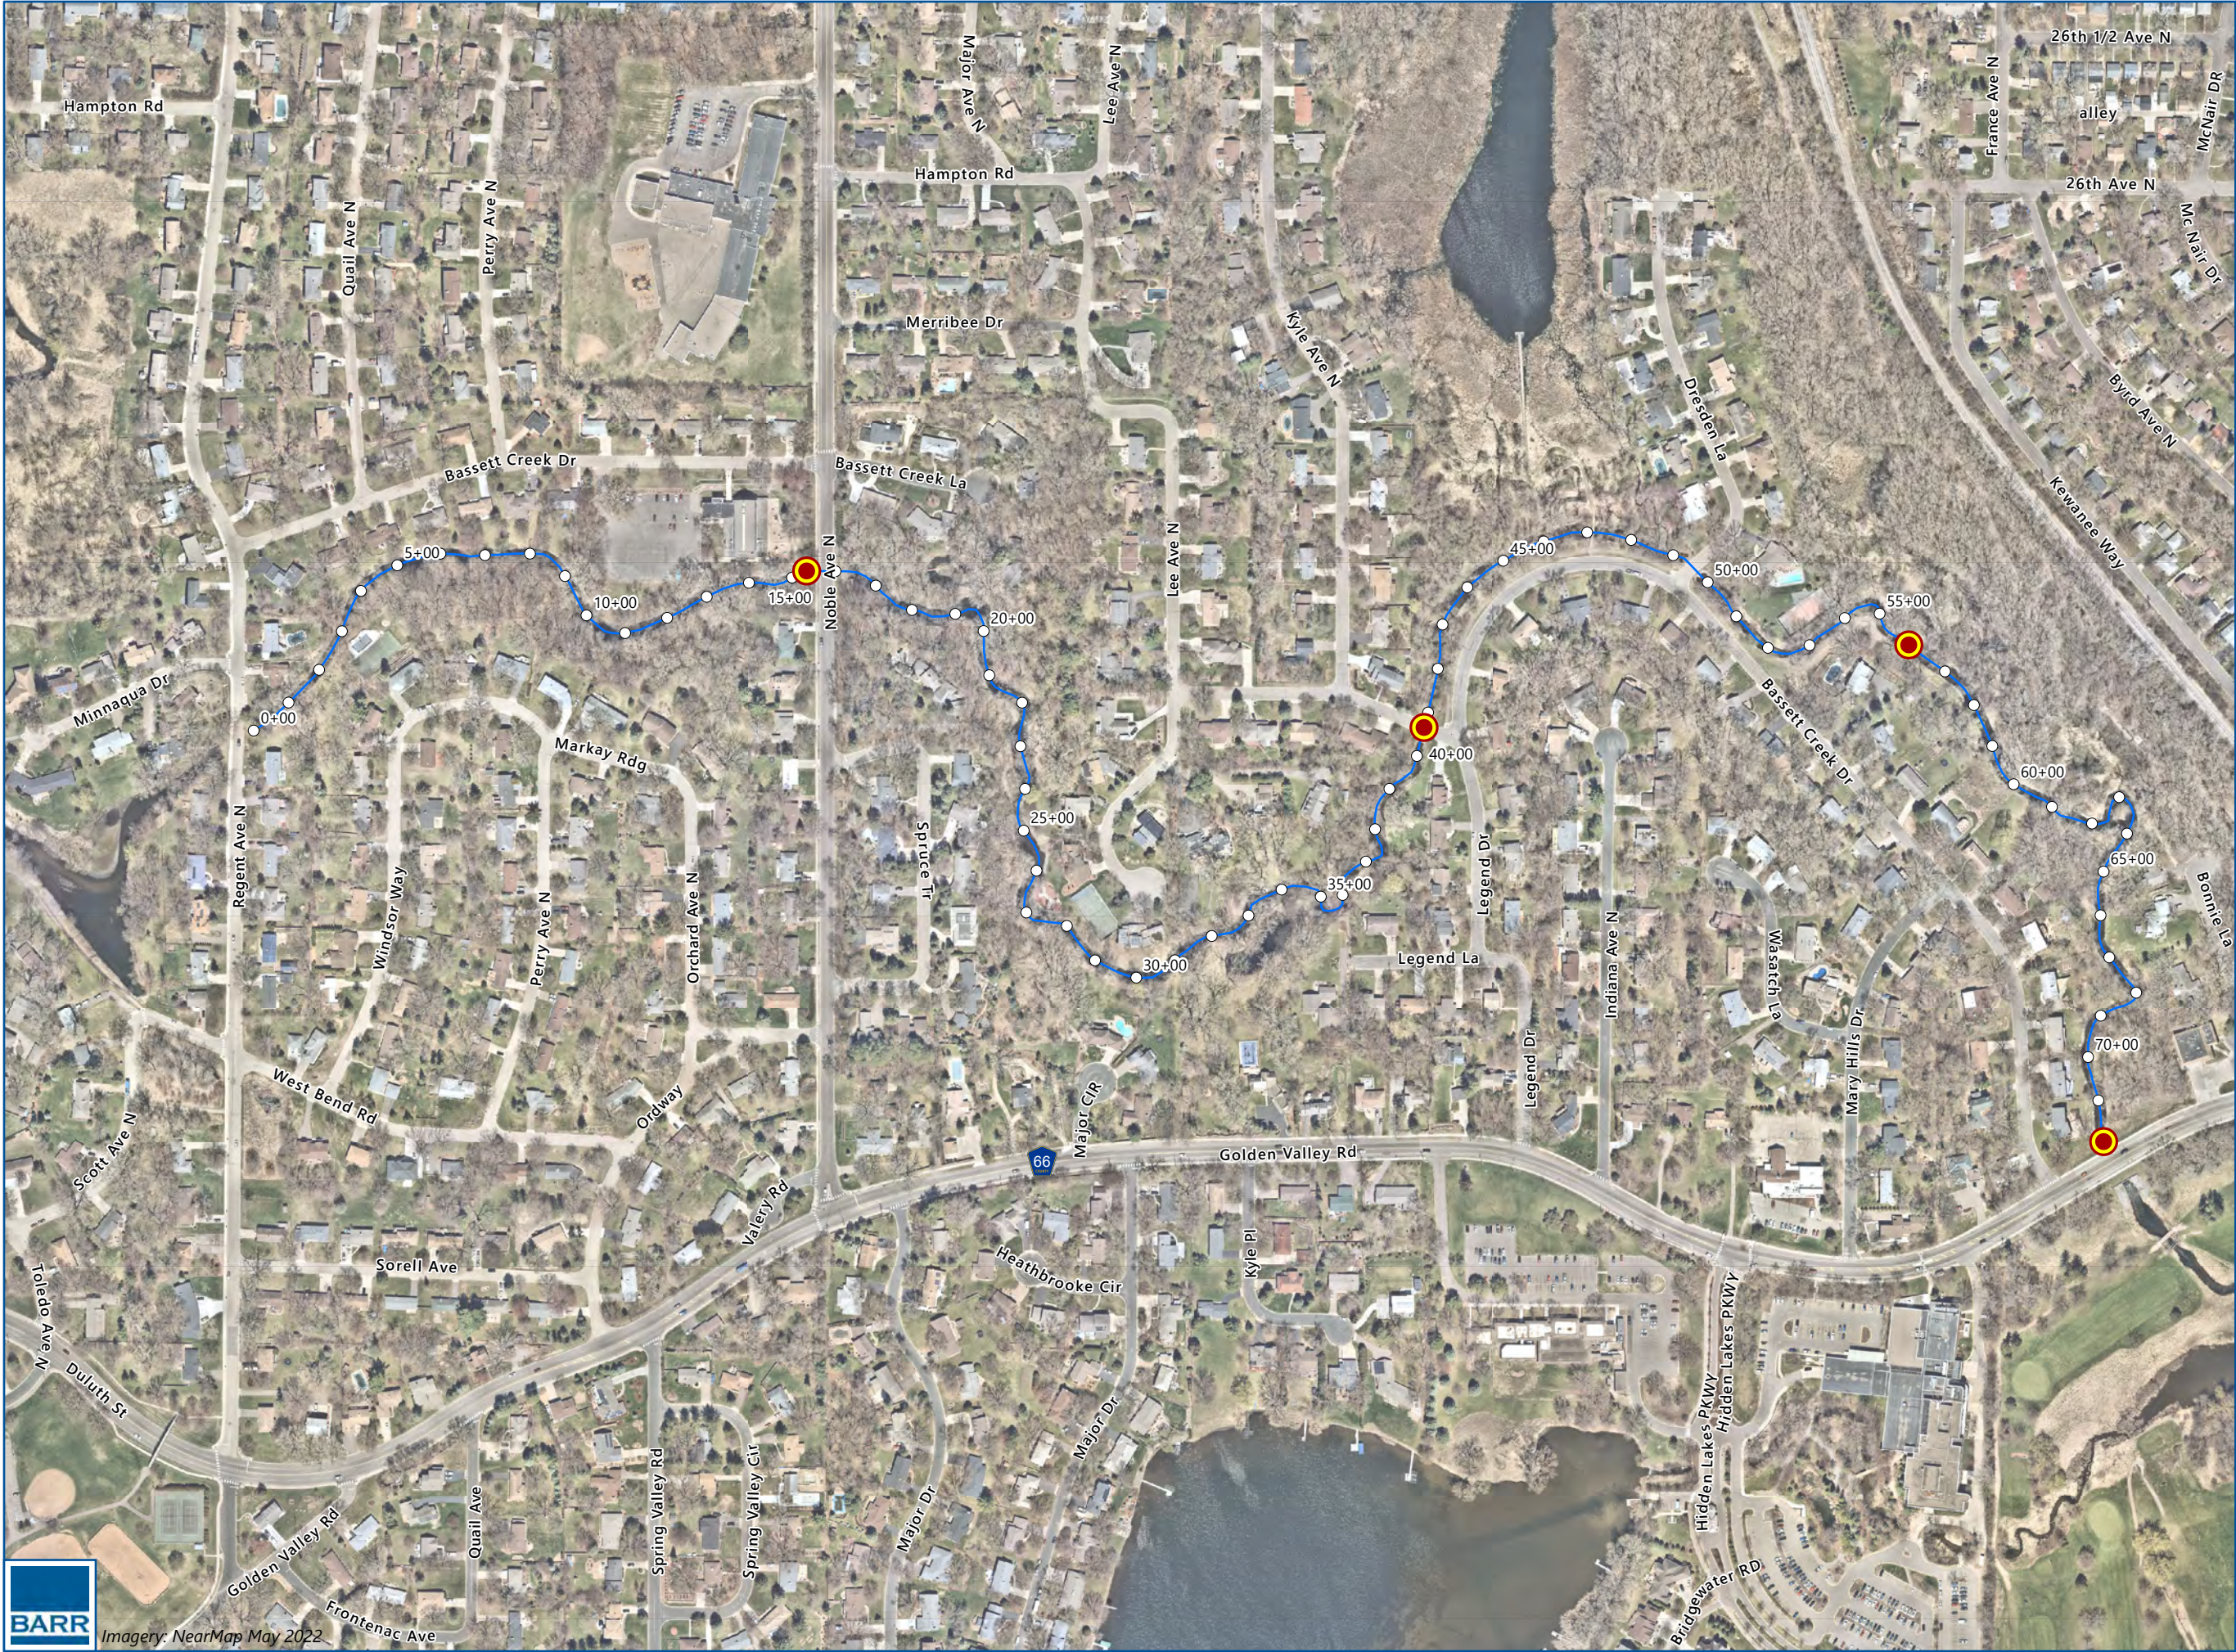
Final design efforts will require additional refinements to the XP-SWMM modeling and a review of the final design water surface profile to ensure the project does not impact adjacent property and does not increase flood elevations. Similarly, the stability thresholds for the proposed features should be reviewed to ensure the final design will be stable. The constructed improvements should be incorporated into the next update of the BCWMC XP-SWMM model after project completion.
