Sochacki Park Water Quality Improvement Project Feasibility Study

Prepared for
Three Rivers Park District

August 2023

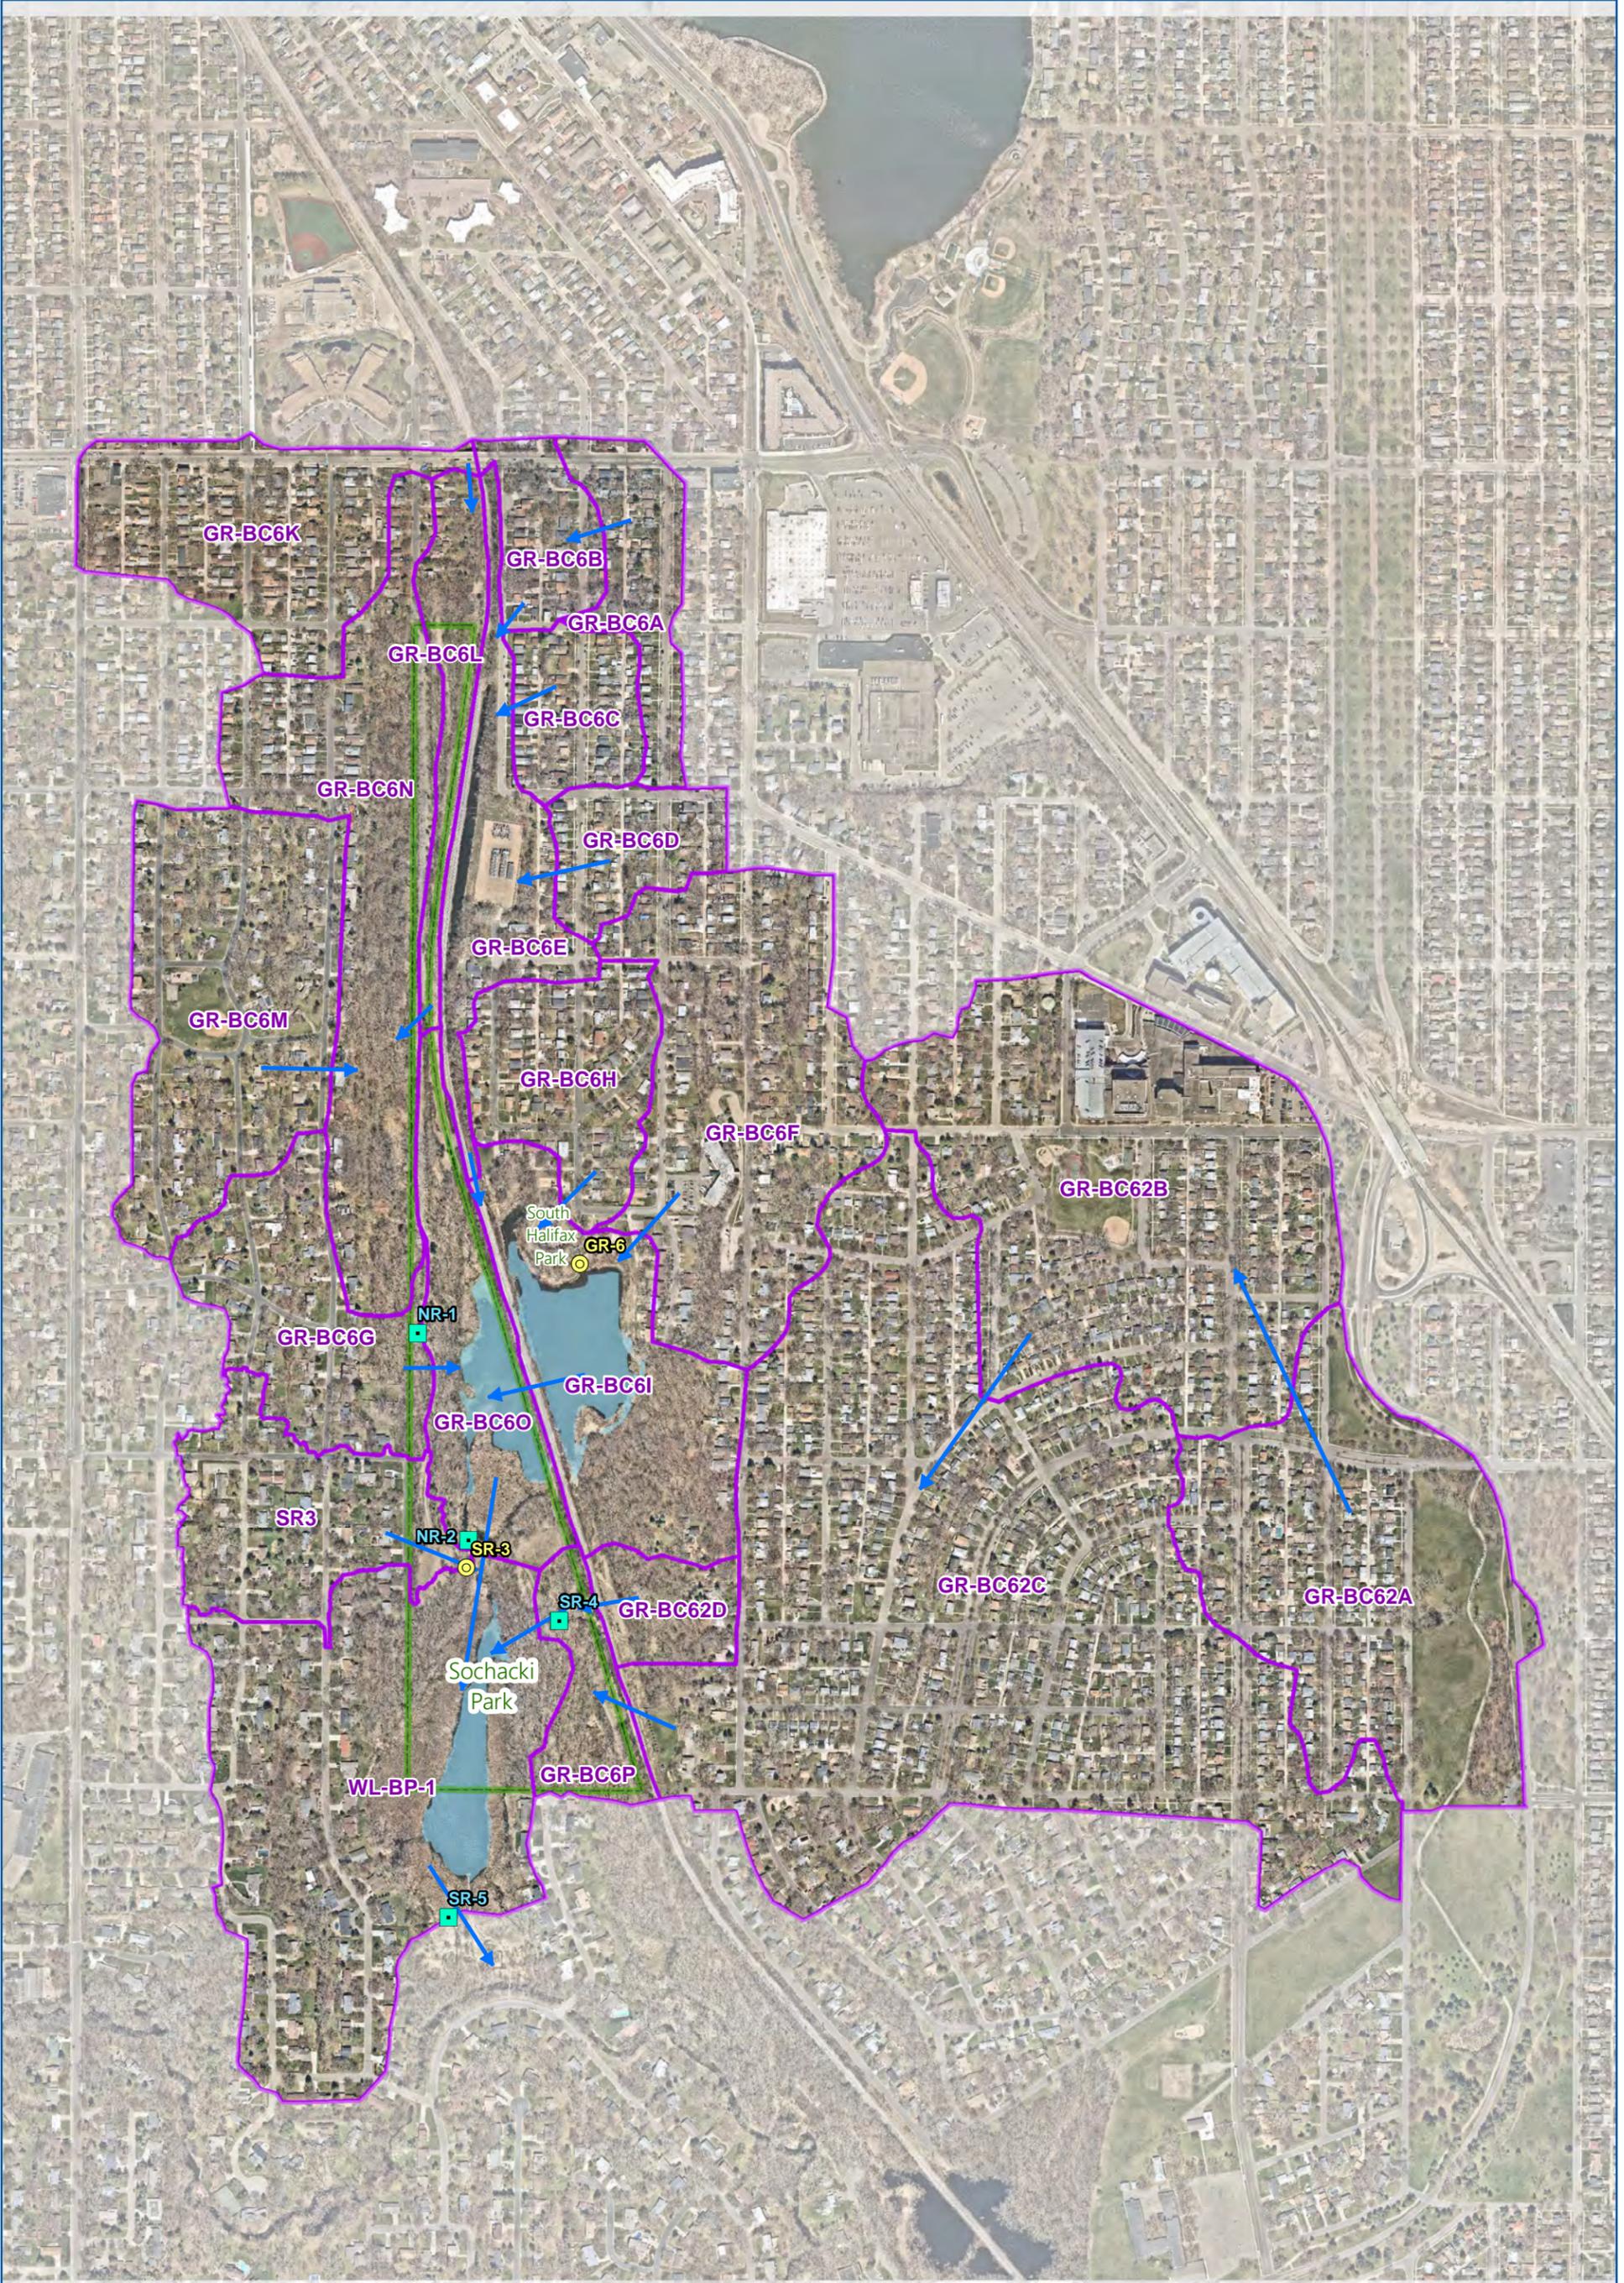
FIGURE 2-2

**SUBWATERSHEDS &
STORM SEWER**
Sochacki Park
Subwatershed Assessment
Three Rivers Park District

Figures 2-1 and 2-2 shows the automated and grab sample sites for watershed water quality monitoring. The automated monitoring sites included flow monitoring equipment to facilitate the development of pollutant load estimates. Figure 2-1 shows the wetland water quality and sediment monitoring sites. Continuous water level measurements were also collected at all three wetlands. Except for the sediment monitoring and testing, Three Rivers Park District (TRPD) staff performed all the field sampling and analytical testing for this assessment.

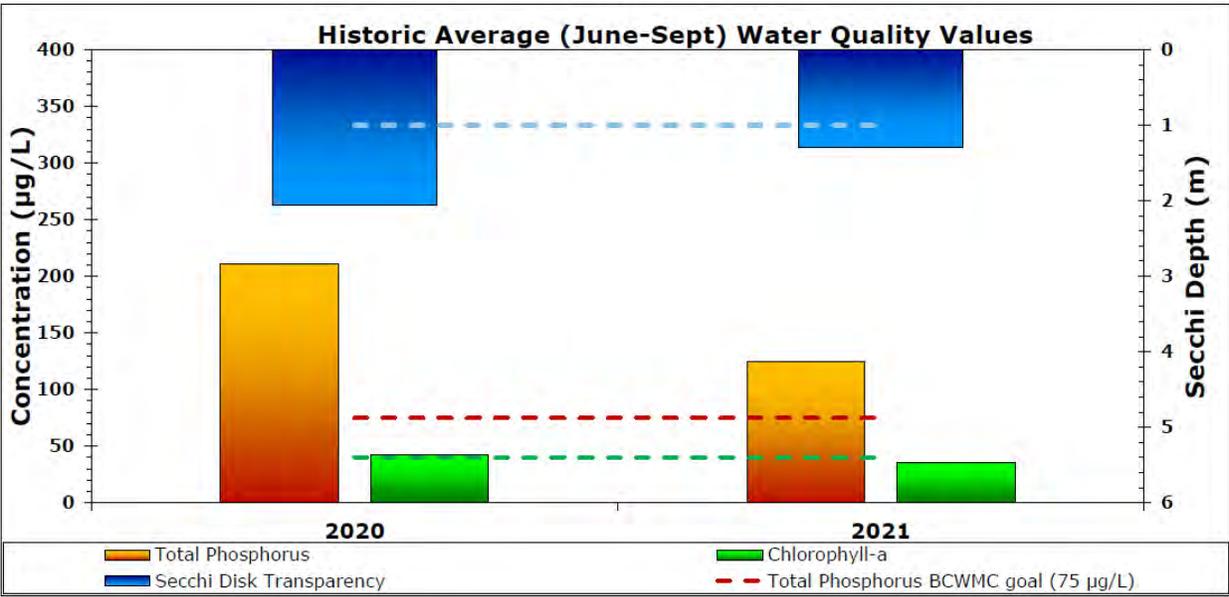
Figure 3-1 Grimes Pond Total Phosphorus, Chlorophyll-a, and Secchi Disc Transparency

Figures 3-1, 3-2 and 3-3 show the summer average TP, Chl-a and SD transparency data for Grimes Pond, North Rice Pond, and South Rice Pond, respectively. The results for all three ponds generally show that summer average TP concentrations greatly exceed the Level III goal, while summer average Chl-a and SD transparencies correspond well with the respective Level III goals. This data, together with observations of heavy growths of free-floating plants (duckweed and watermeal) across the surface of all three ponds, indicates that algae growth is being limited by the amount of sunlight that can reach the water profile. This phenomenon will also limit the growth of submerged plant growth in each pond. Nutrient reductions will be needed to shift away from floating plant dominance in each pond.

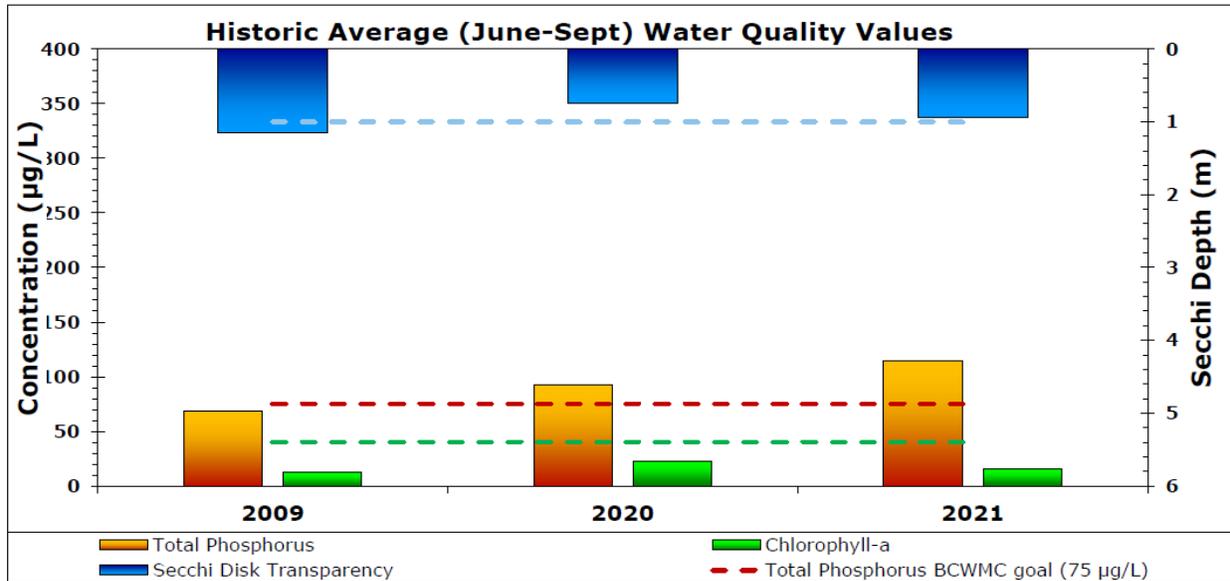
Figure 3-2 North Rice Pond Total Phosphorus, Chlorophyll-a, and Secchi Disc Transparency

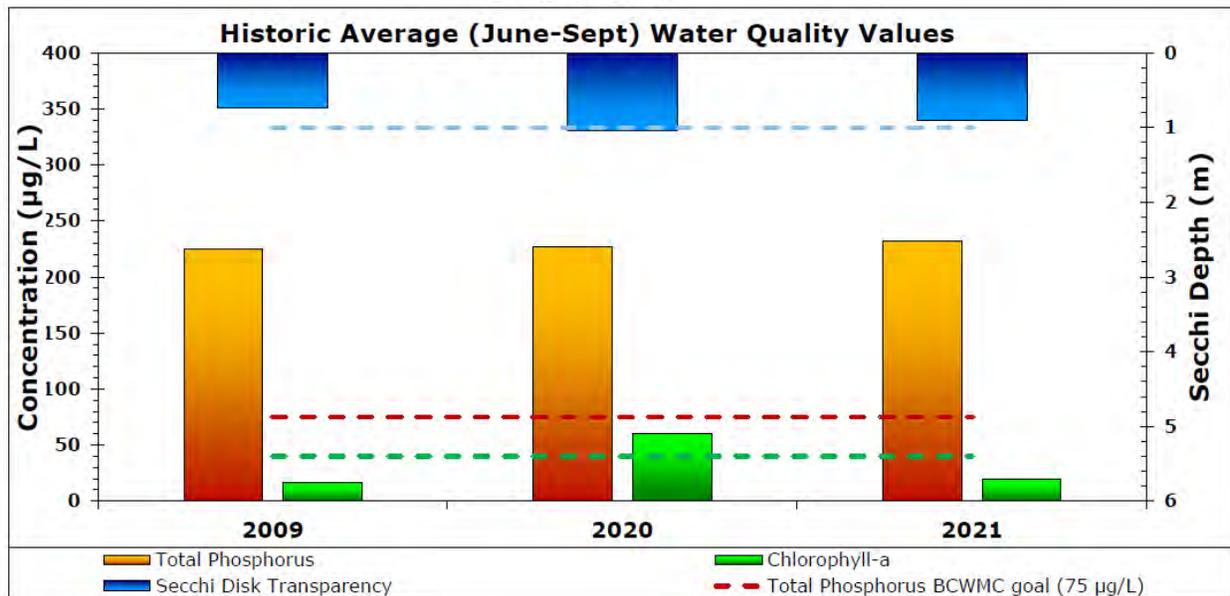
Figure 3-3 South Rice Pond Total Phosphorus, Chlorophyll-a, and Secchi Disc Transparency

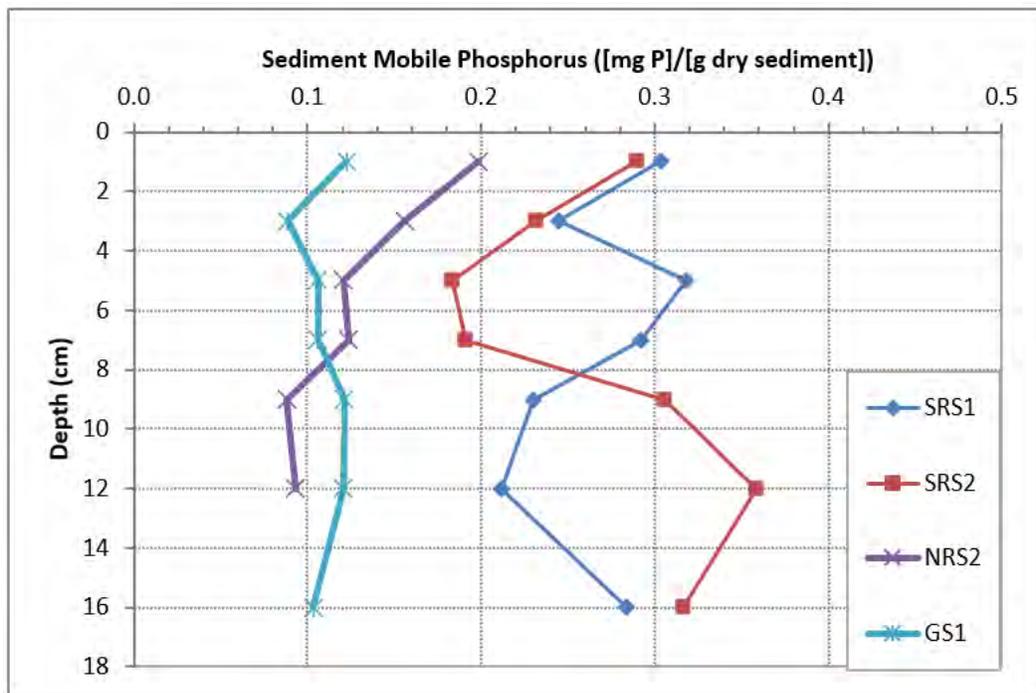
Figure 3-4 Sediment Mobile Phosphorus Concentrations

Figures 3-4 and 3-5 show how the respective mobile and organic fractions of phosphorus vary by depth in the sediment of each pond sampling location (shown in Figure 2-1). The mobile and organic fractions of sediment phosphorus are readily available for release under anoxic conditions and Figures 3-4 and 3-5 show that the concentrations at each sampling locations are elevated near the sediment-pond water interface. Results of the dissolved oxygen monitoring, combined with the pond sediment phosphorus data, confirmed that internal phosphorus loading, under anoxic conditions, can be an important source of phosphorus input to each pond during the summer months.

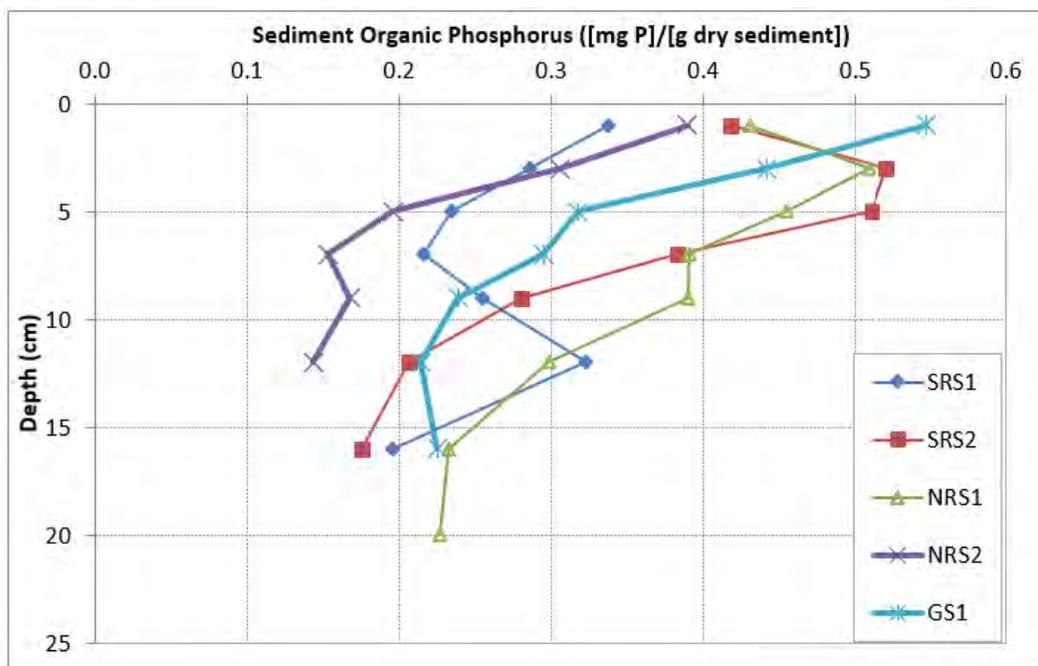
Figure 3-5 Sediment Organic Phosphorus Concentrations

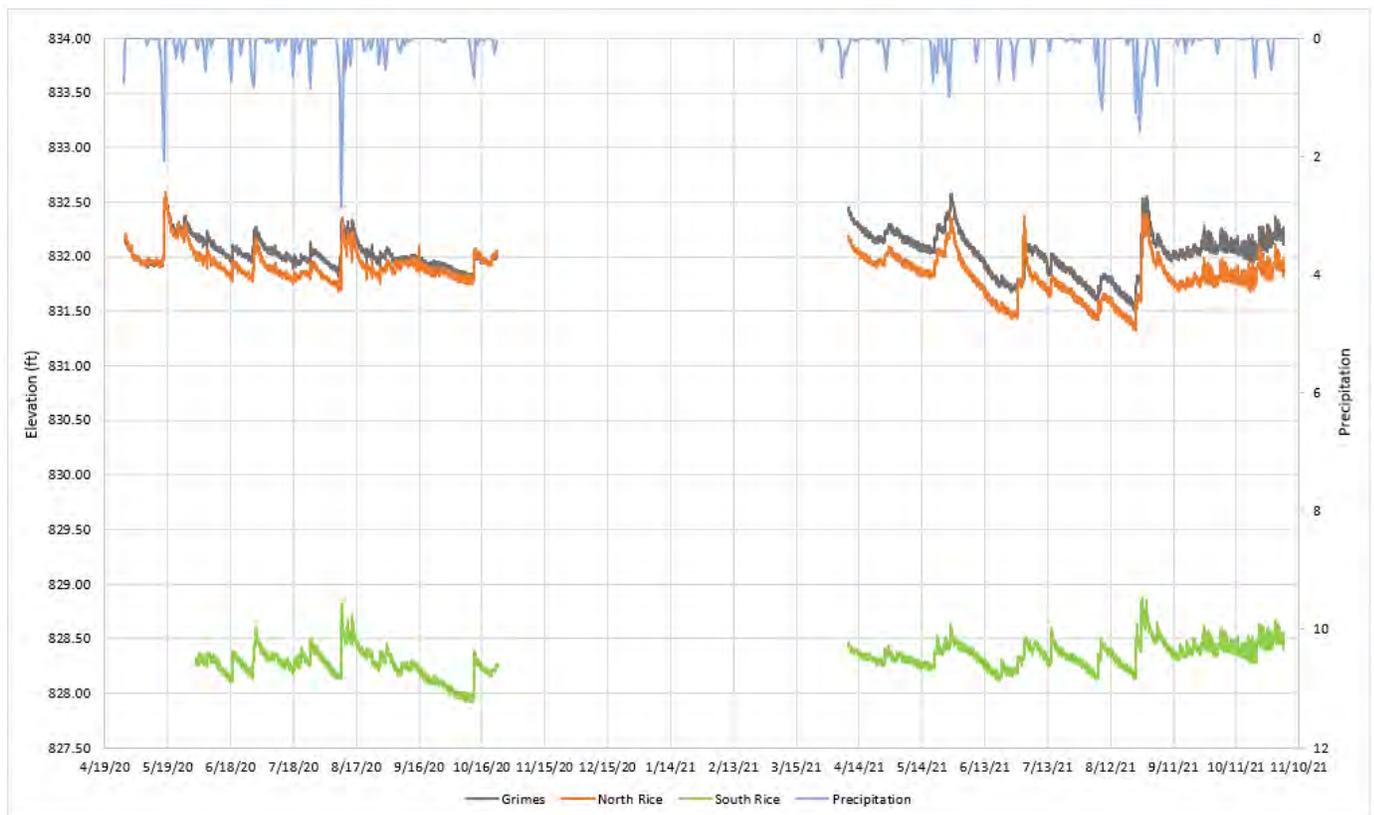
Figure 3-7 2020 and 2021 Pond Water Levels

Figure 3-7 shows the monitored water levels for each pond during the 2020 and 2021 monitoring seasons, as well as the corresponding precipitation amounts. The largest storm events during the monitoring period resulted in water level changes of about one foot in Grimes and North Rice Pond, while South Rice Pond experienced water level changes of about three quarters of a foot. The existing outlet infrastructure for Grimes Pond would accommodate a water level drawdown (further discussed in Section 5.1) of approximately 2.5 feet using gravity flow into North Rice Pond, which in turn, could be drawn down by 3 to 3.5 feet through gravity flow to South Rice Pond. South Rice Pond cannot be drawn down by gravity due to the tailwater conditions associated with Bassett Creek, so pumping would be required to draw the pond down.

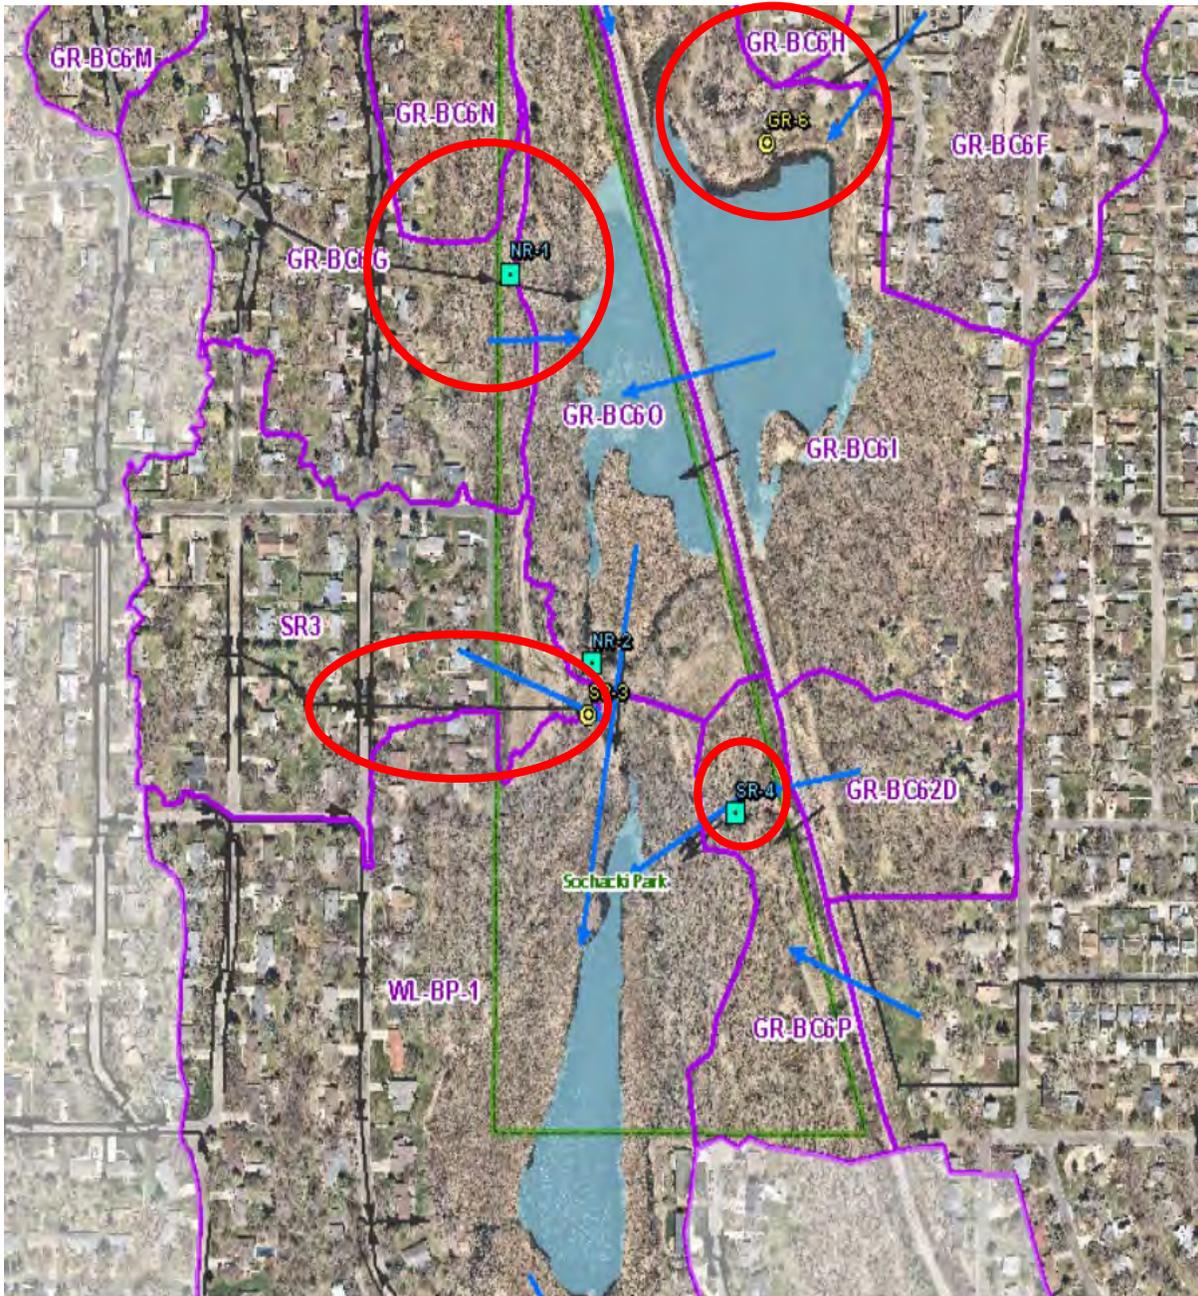
Figure 5-1 Recommended Sochacki Park Subwatershed Locations for Structural BMPs

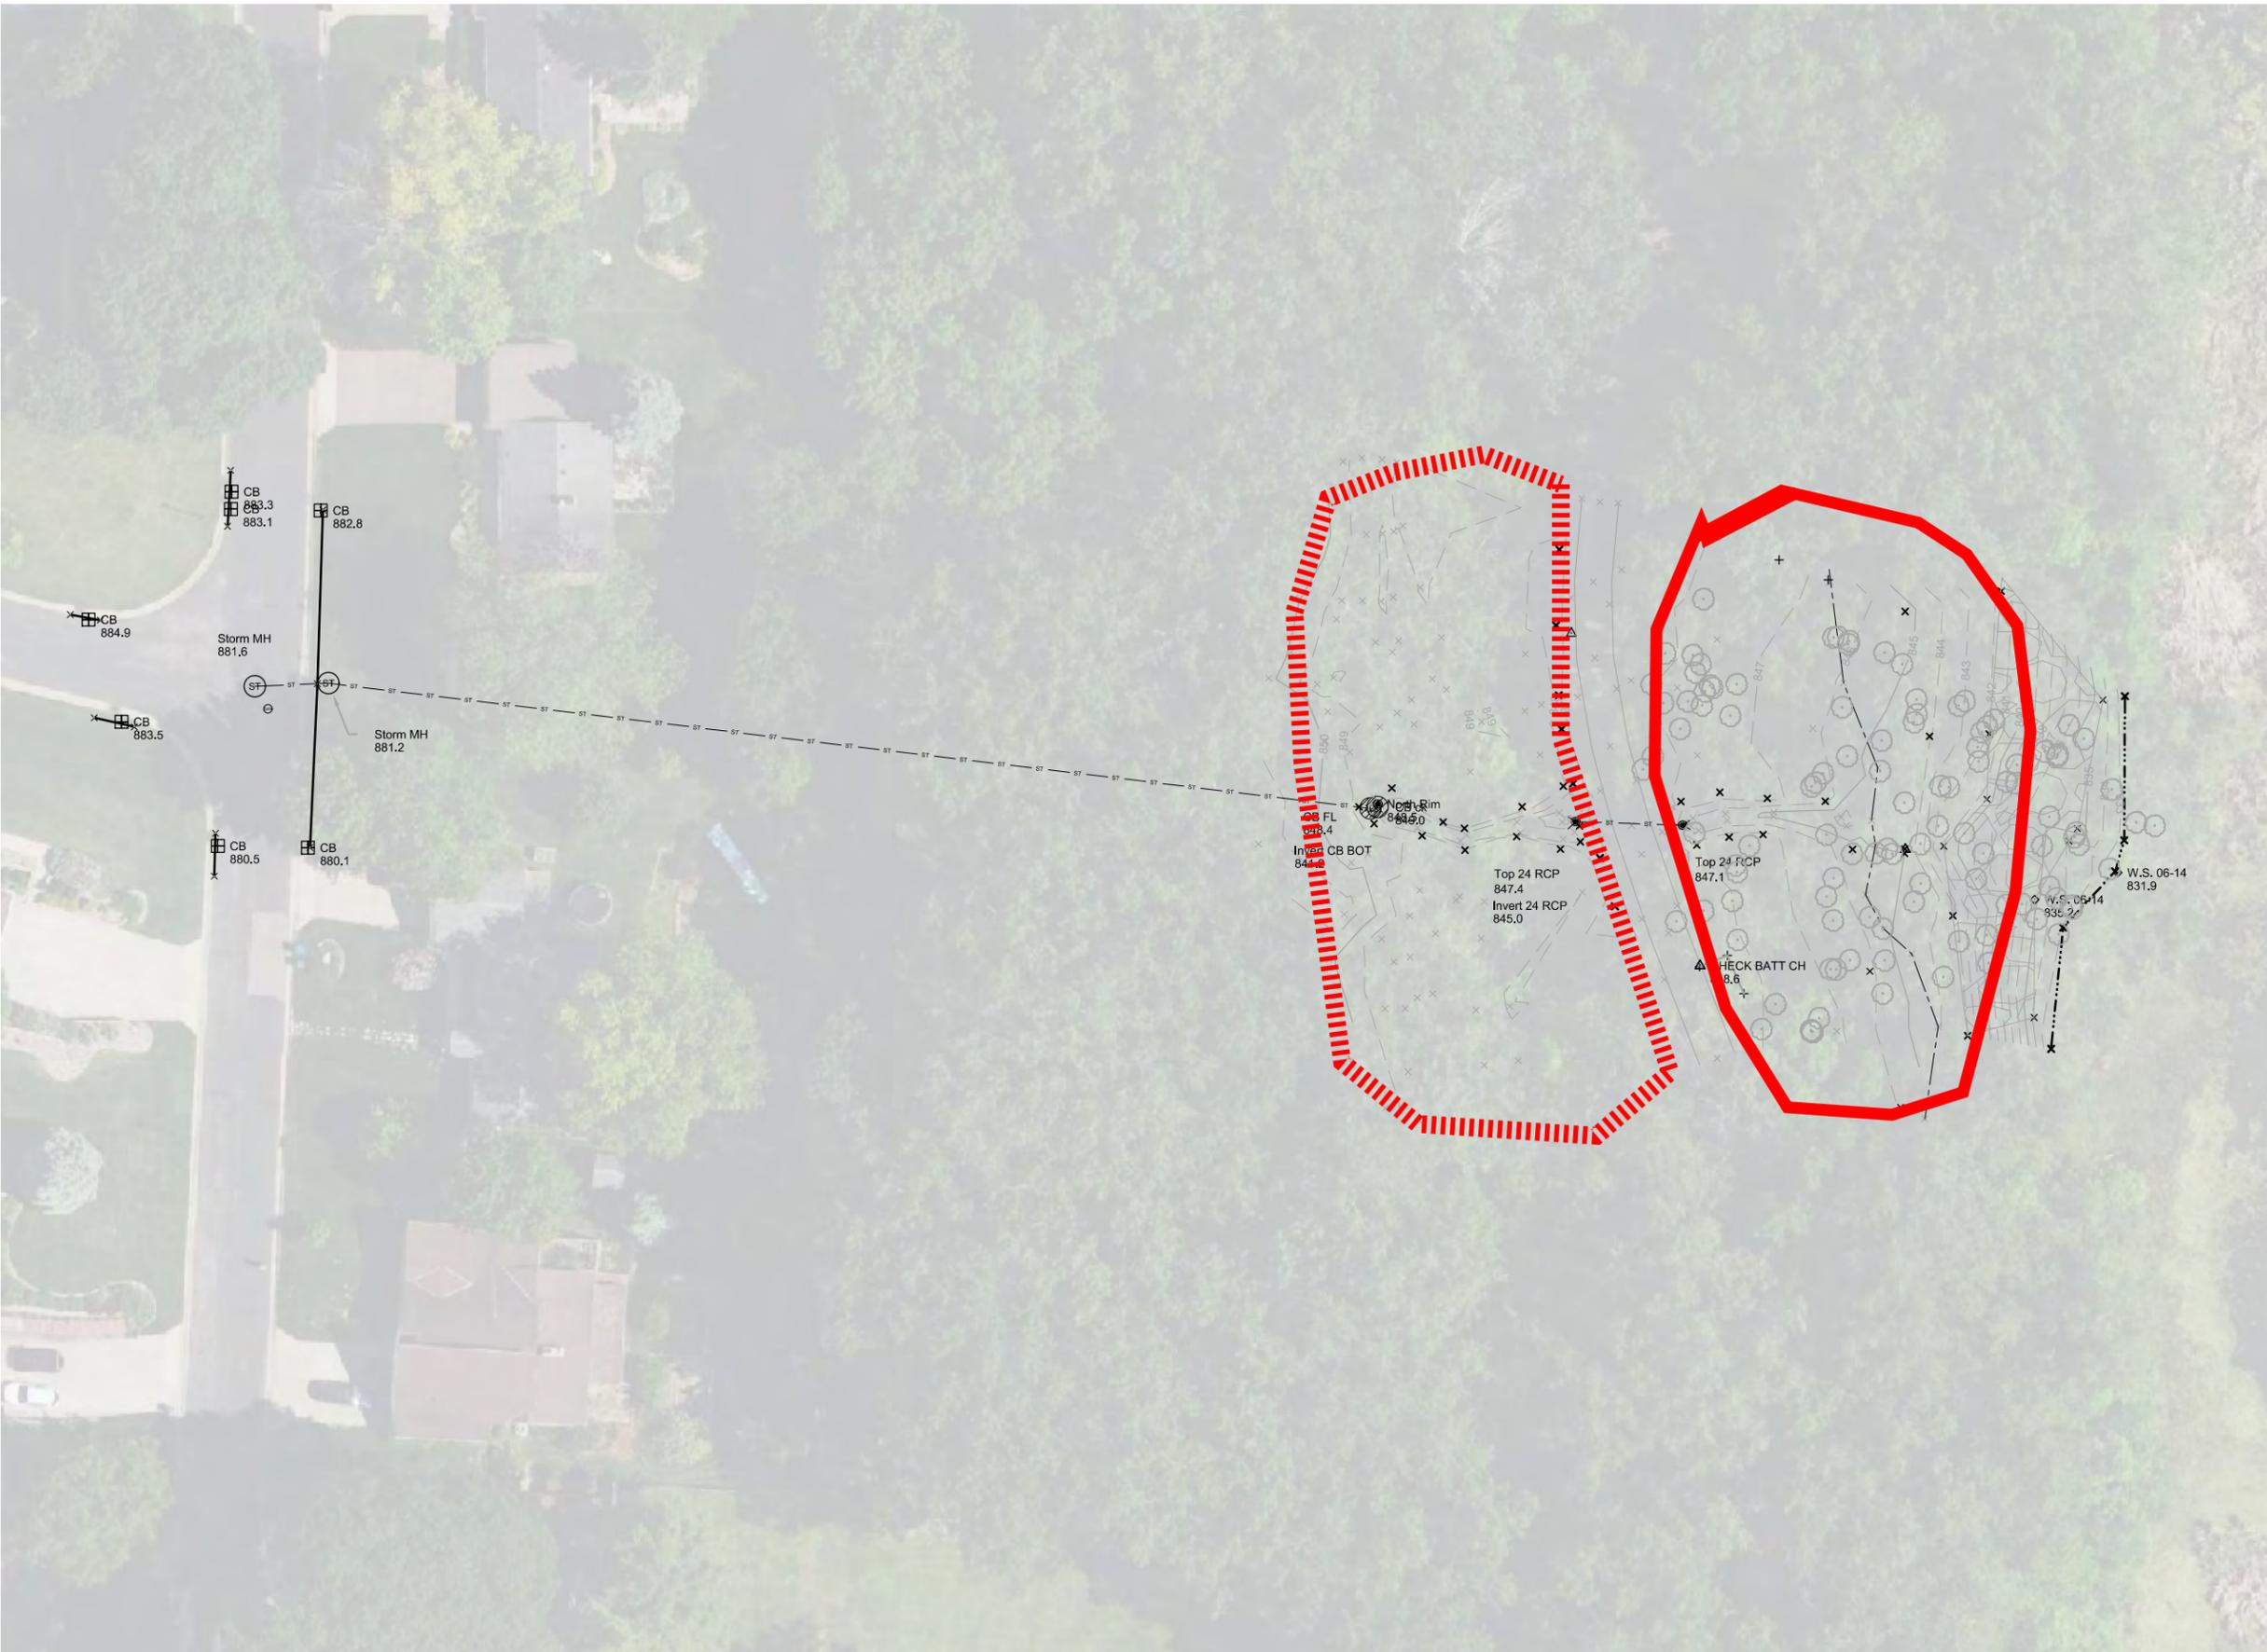
**Figure 5-2 Proposed Pond NR-1 BMP
(North Rice Pond)**

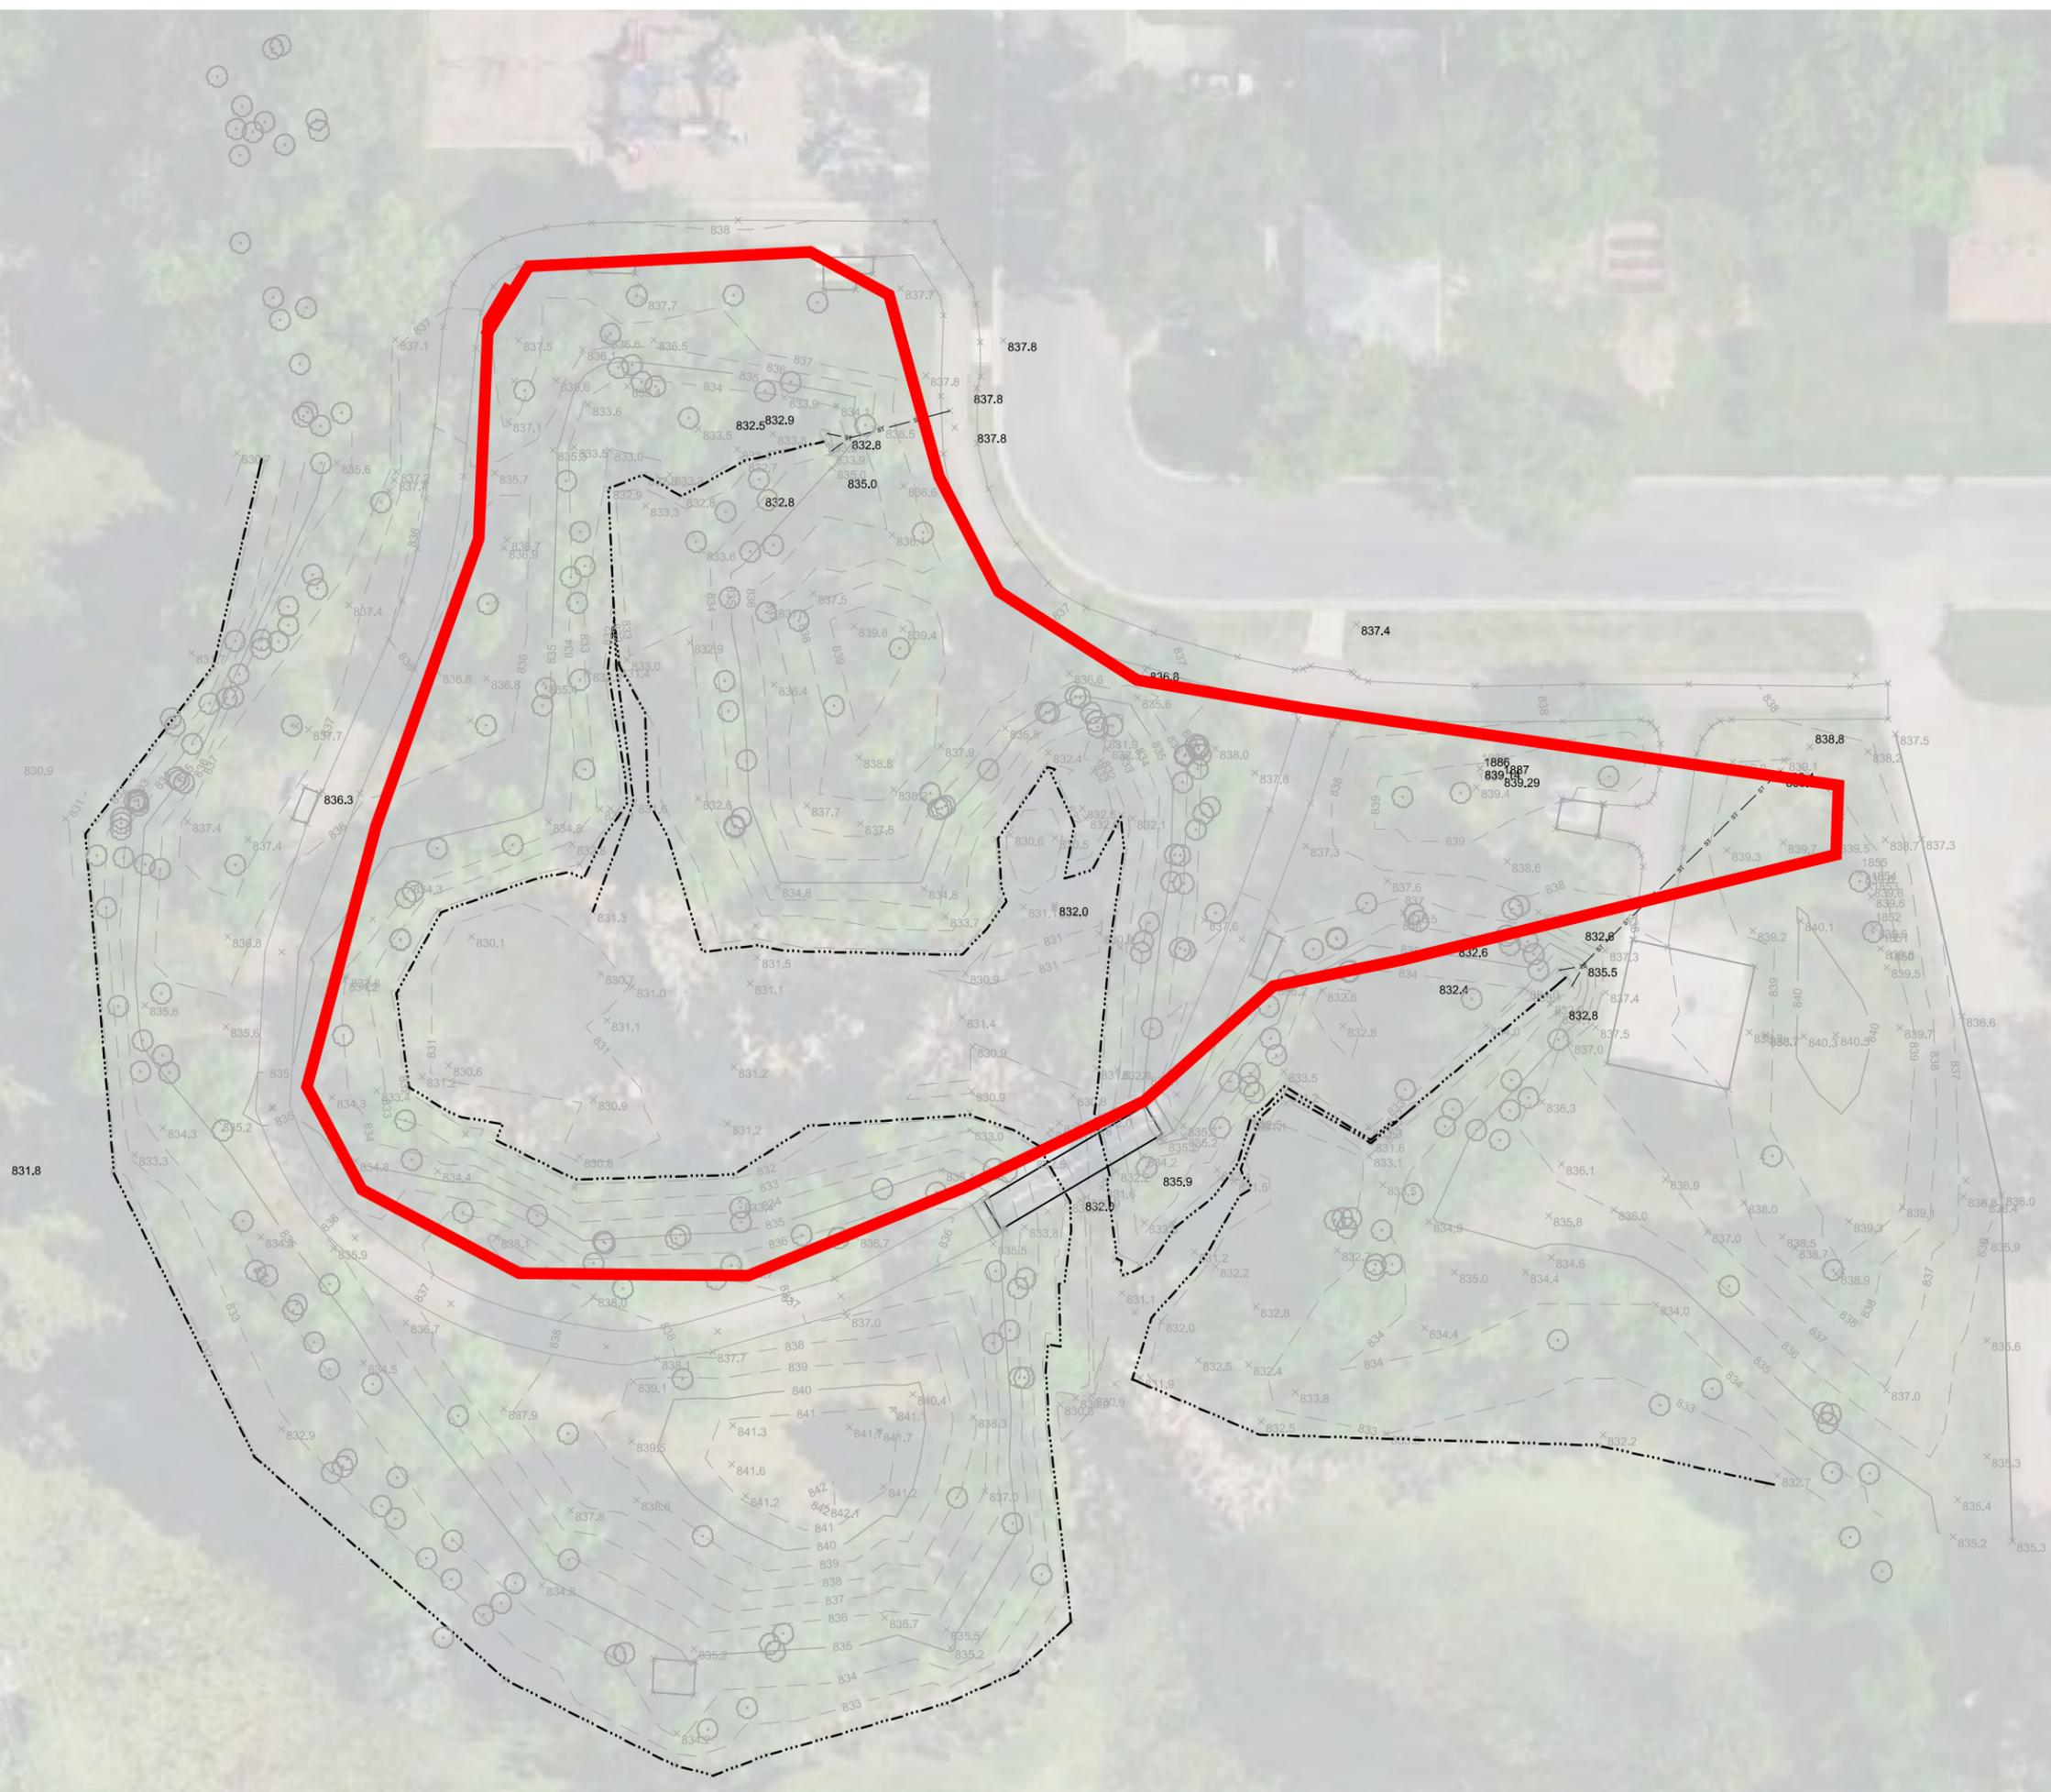
FIGURE 5-4 Pond GR-6 Retrofit BMP
Grimes Pond

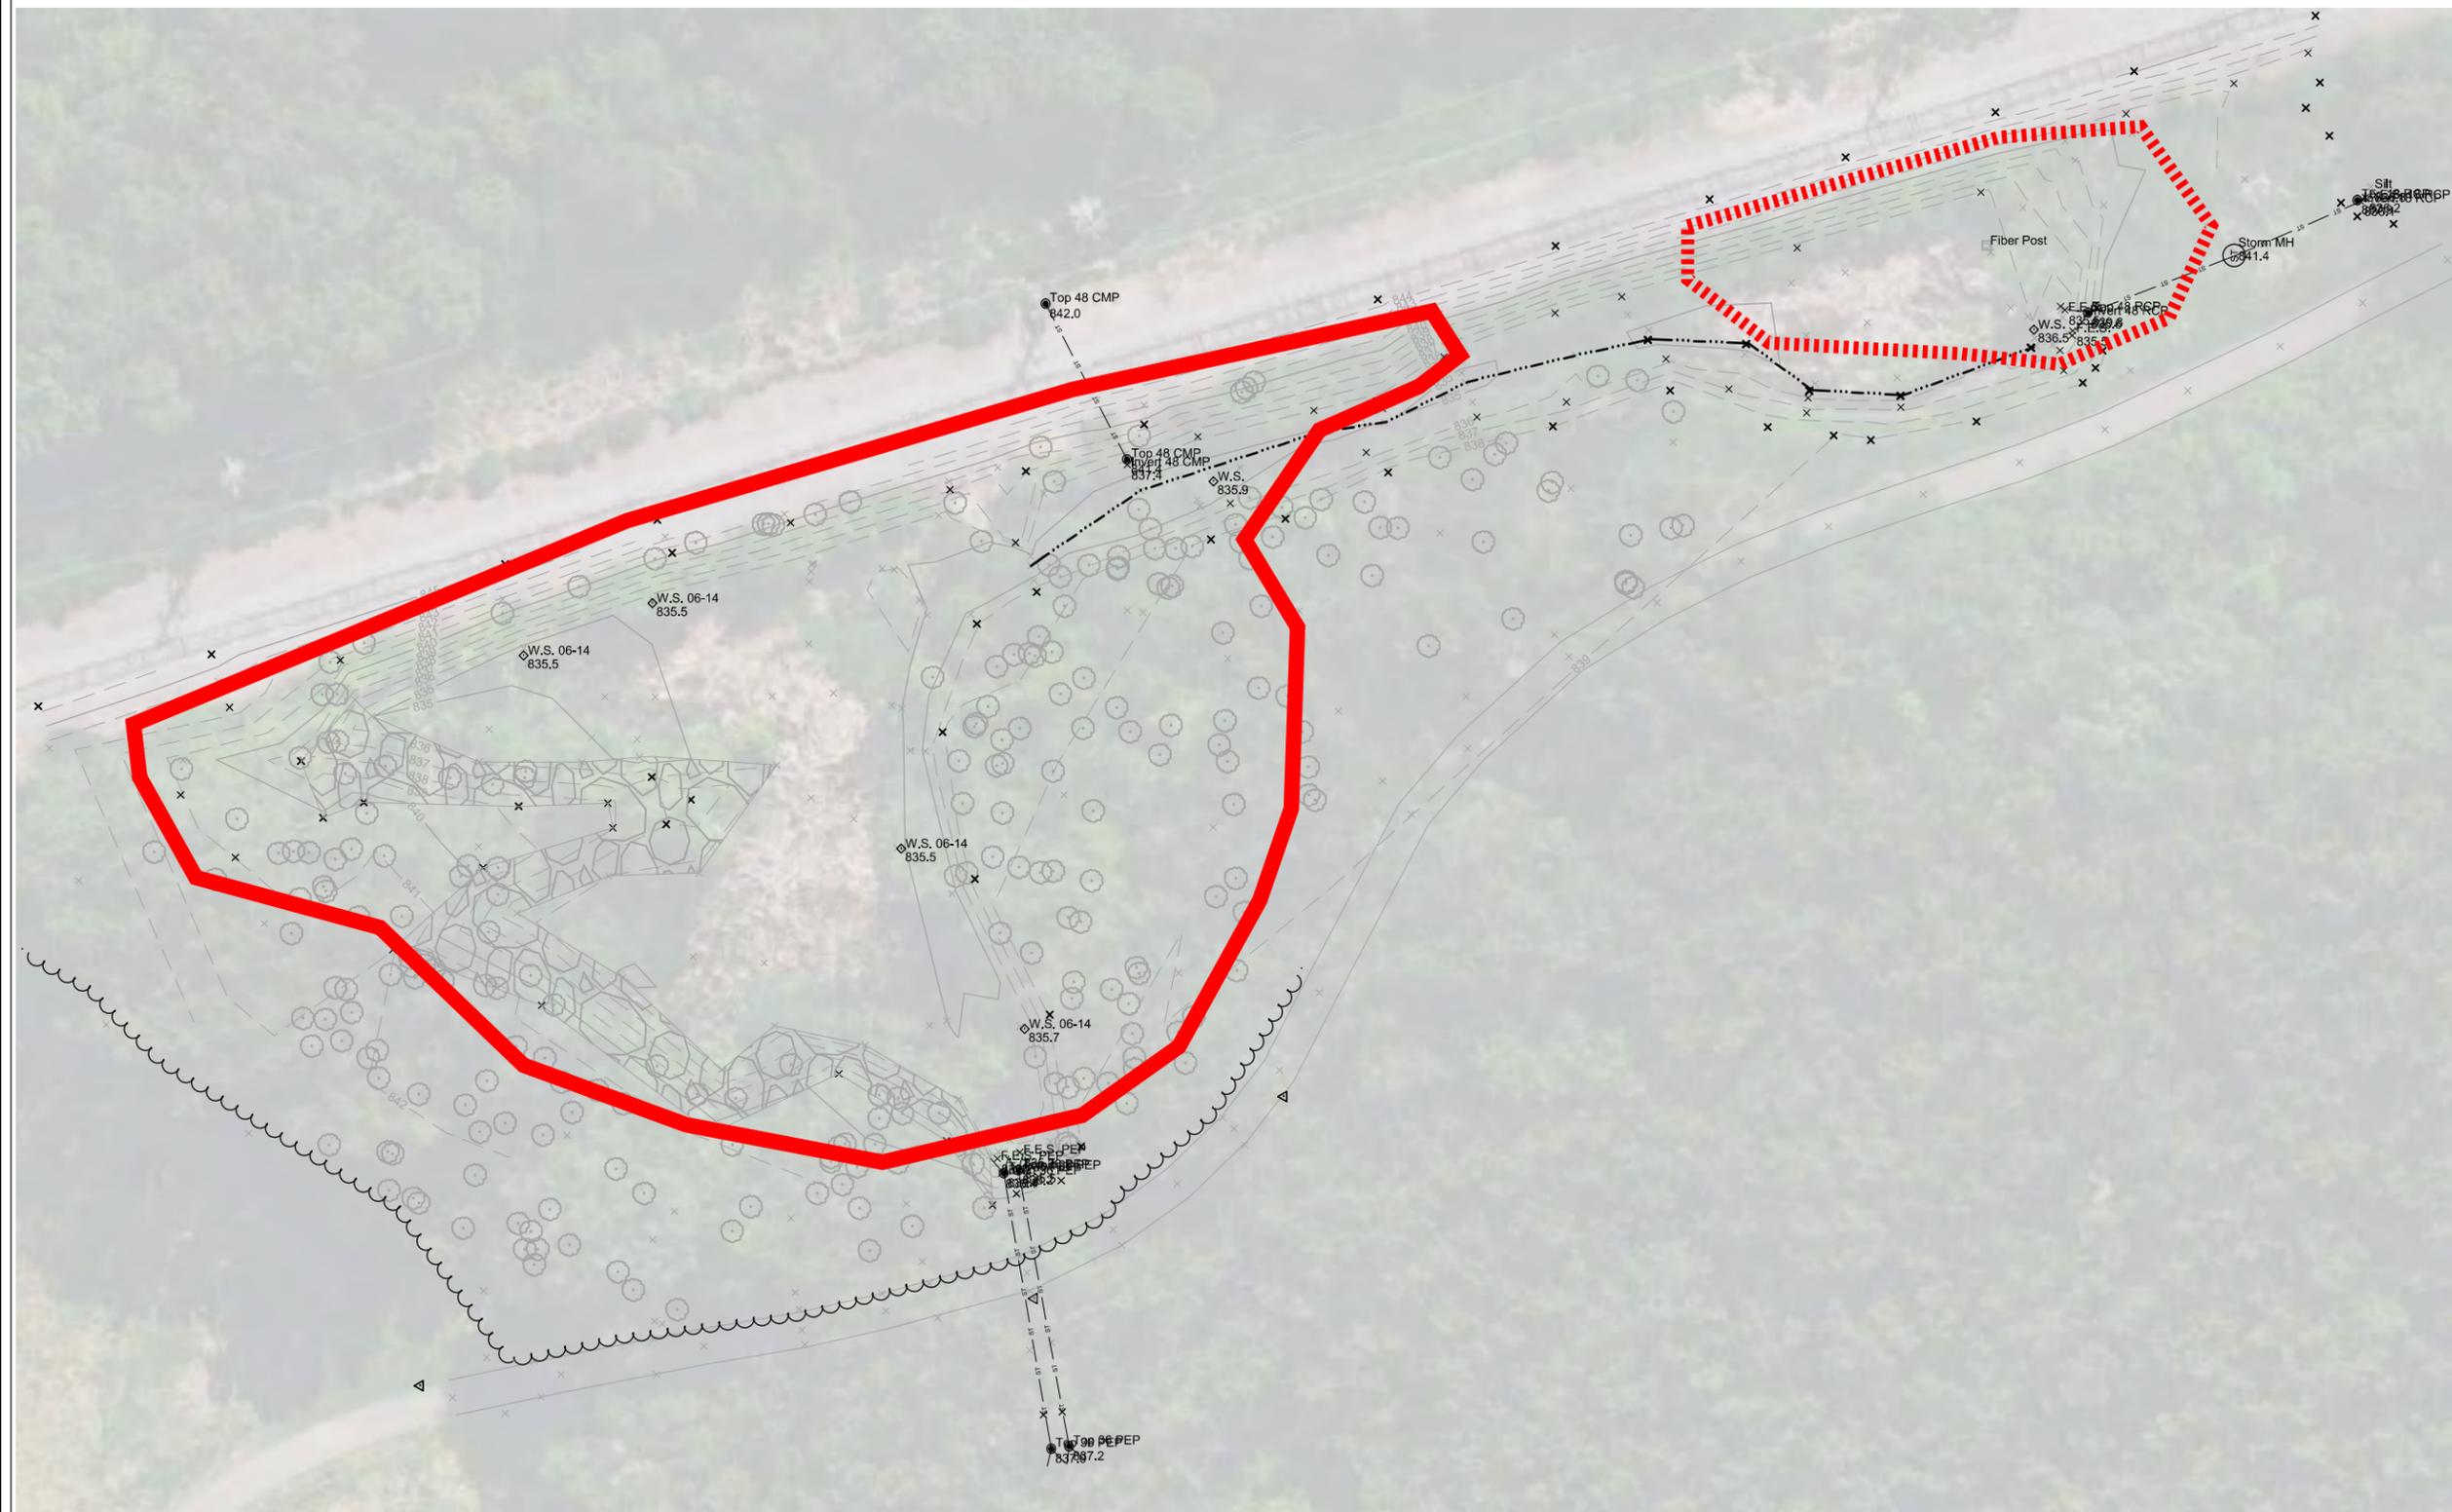
FIGURE 5-5 SR-4 Retrofit BMP

South Rice Pond

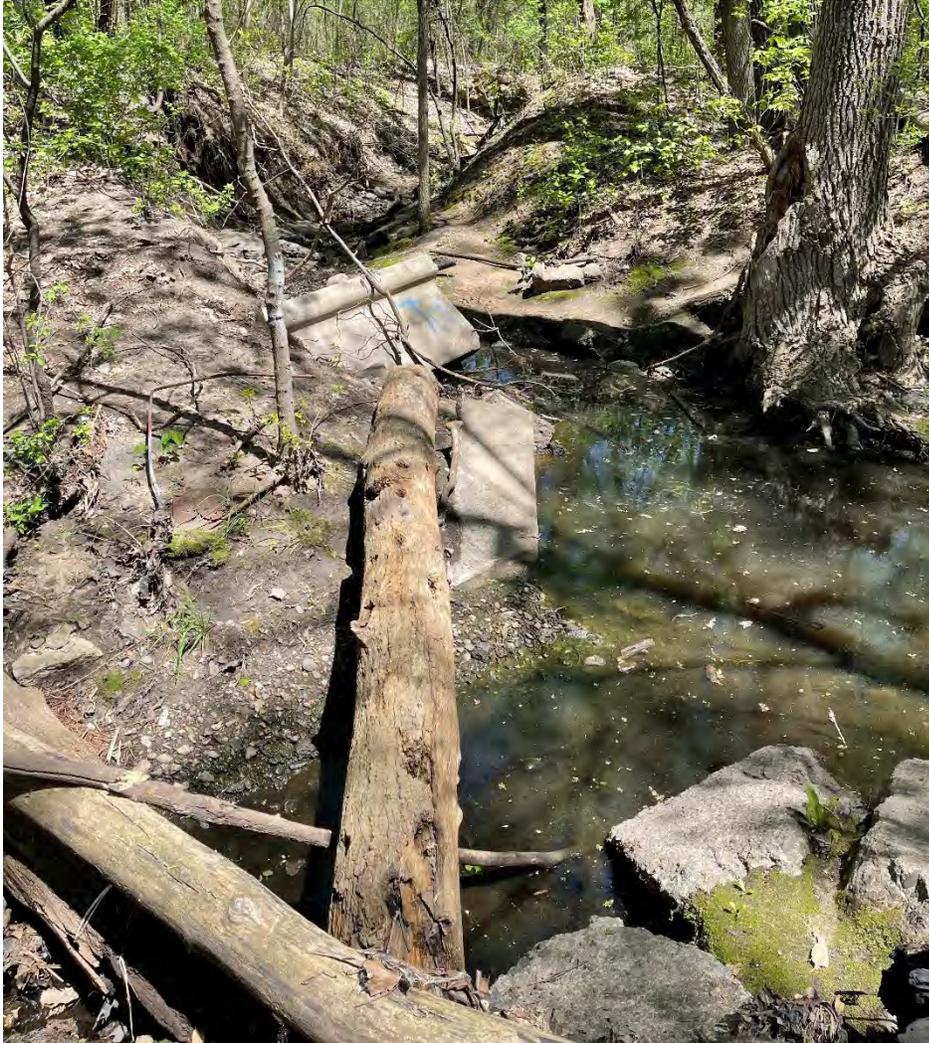
Figure 5-6 Pond SR-4 Downstream Outlet Channel Erosion and Construction Debris
