Sochacki Park Water Quality Improvement Project Feasibility Study

Prepared for
Three Rivers Park District

August 2023

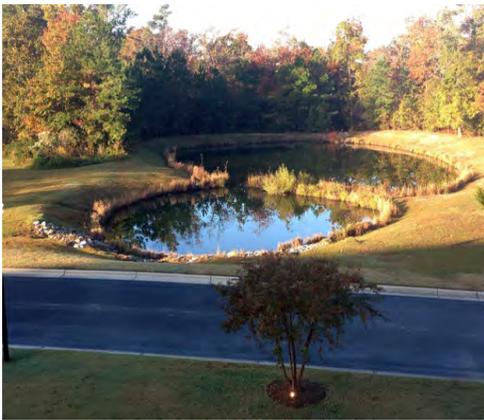
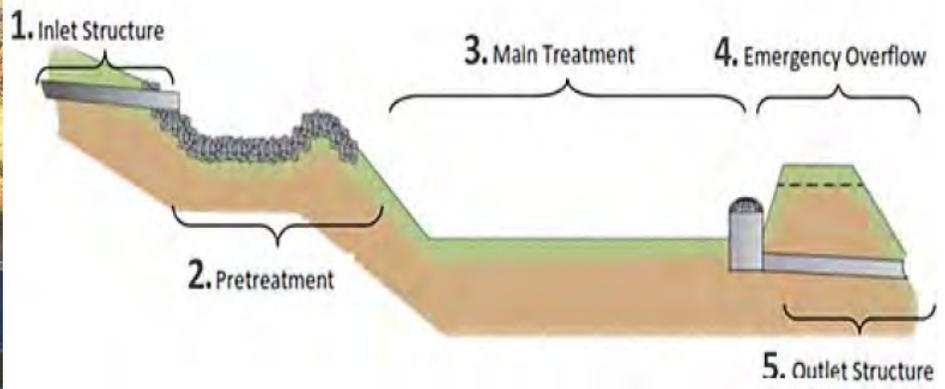
Figure 5-7 Example Stormwater Pond Treatment Elements

Figure 5-7 includes a photo and schematic as examples of the important elements of the stormwater ponds envisioned for future implementation. The expectation is that the pretreatment provided by these two-cell pond systems will ensure that most of the ongoing operation and maintenance effort will not need to involve dredging, due to excess sedimentation in the main treatment cell. Both outfalls entering

the GR-6 BMP location currently have Continuous Deflective Separation (CDS) units that have recently been maintained and can be available for stormwater pretreatment of the respective subwatersheds.

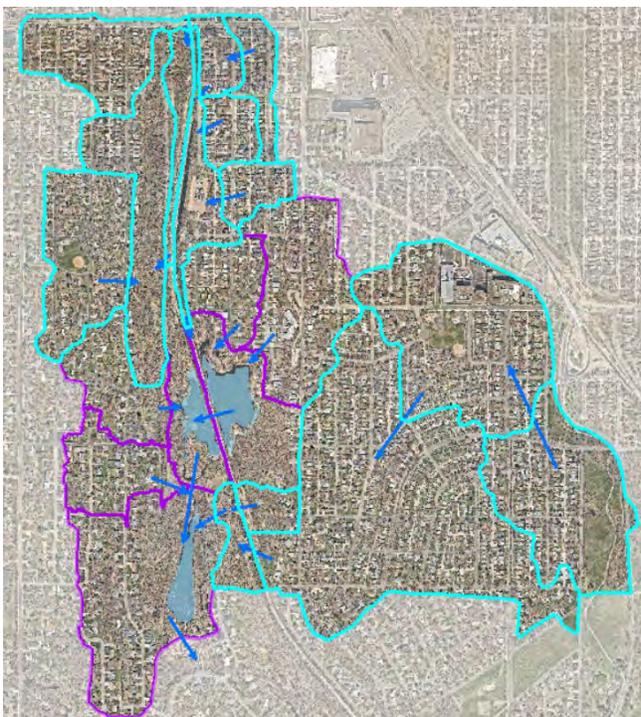
Figure 6-1 Existing Subwatersheds (Highlighted) Receiving Stormwater Treatment

We used the updated P8 modeling results and GIS mapping to identify high priority areas for implementing watershed BMPs. P8 modeling completed for the summers of 2020 and 2021 indicates that 20 and 17 percent of the current overall phosphorus load, in respective years, receives stormwater treatment before discharge to the three wetlands. Approximately 22 percent of the runoff phosphorus load in the Grimes Pond watershed receives stormwater treatment, while the respective levels of treatment in the direct drainage to North and South Rice Ponds are approximately 39 and 30 percent. Figure 6-1 highlights (in teal) the subwatershed areas that currently receiving some level of stormwater treatment with structural BMPs. Most of the subwatersheds that drain directly into the three ponds are not receiving stormwater treatment that would substantially reduce annual total phosphorus loadings.

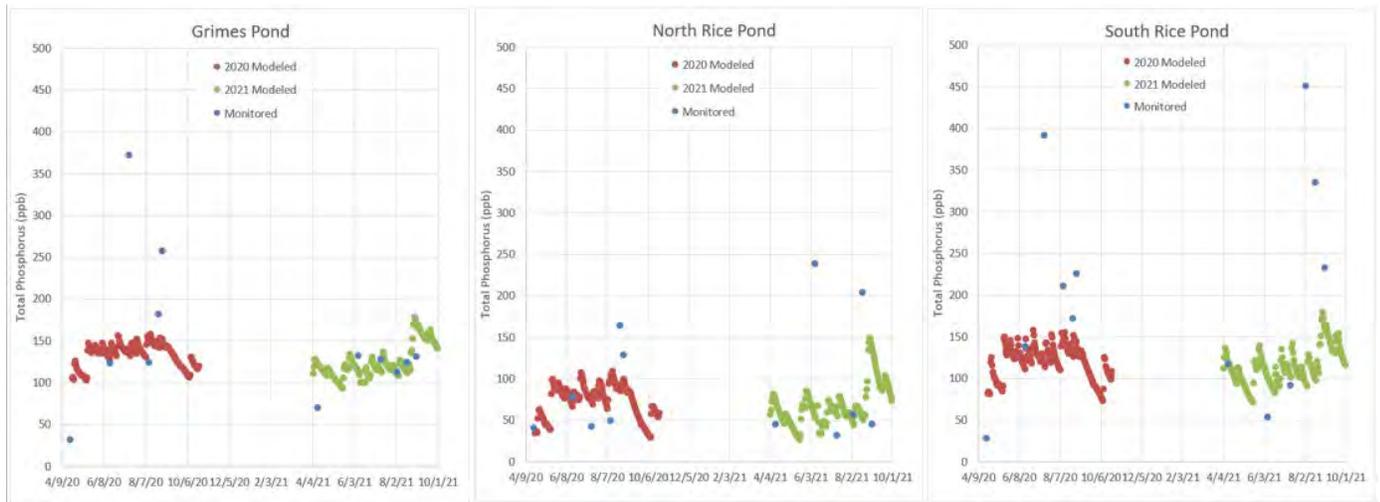
Figure 6-2 Calibrated Water Quality Monitoring and Modeling Results

The watershed modeling was calibrated and used to concurrently develop the water and phosphorus budgets that optimized the daily pond water quality modeling fit to the summer monitoring data associated with each pond. Figure 6-2 shows how the predicted pond water quality would ordinarily correspond with the water quality monitoring observations for each pond in 2020 and 2021, based on the calibrated watershed phosphorus load modeling, alone. Figure 6-2 shows that, except for Grimes Pond in 2021, each pond experienced two or more monitoring events where the monitored TP concentrations greatly exceeded the predicted TP concentration, based only on the watershed modeling. The difference in the TP concentrations during each of these pond monitoring events can be attributed to internal phosphorus loading from sediment phosphorus release. The mass balance modeling results were used to estimate and summarize the total internal phosphorus load during each summer for each pond.

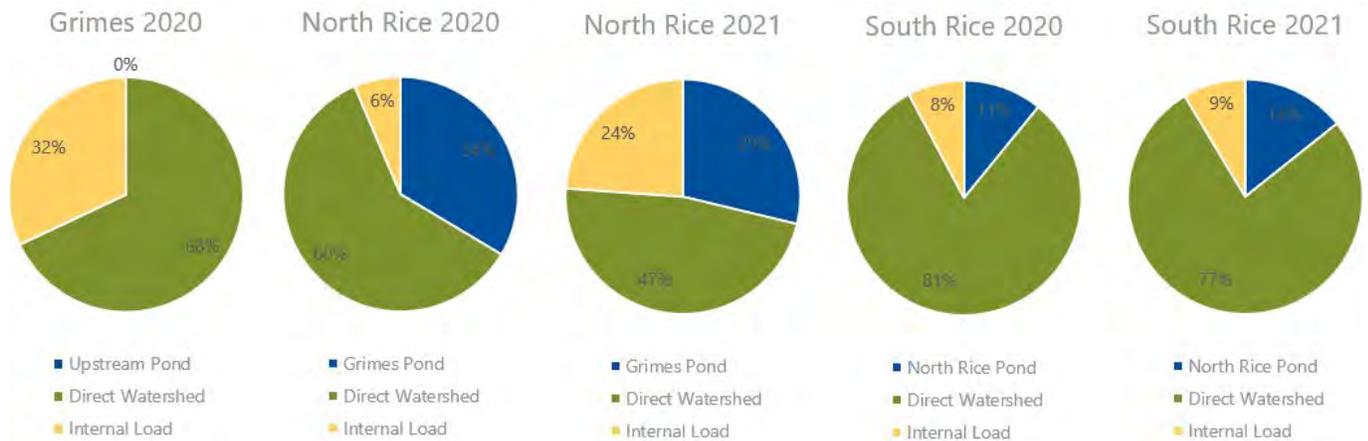
Figure 6-3 Modeled Annual TP Sources for Each Pond

A detailed analysis of the dissolved oxygen data, combined with the pond water quality modeling, confirmed that internal phosphorus loading can be an important source of phosphorus input to each pond during the summer. Internal phosphorus loading represented 32 percent of the summer phosphorus budget for Grimes Pond in 2020, as well as 6 and 24 percent of the respective summer phosphorus budgets for North Rice Pond in 2020 and 2021 (see Figure 6-3). Figure 6-3 shows that discharge from Grimes Pond represented 34 and 29 percent of the respective summer phosphorus budgets for North Rice Pond in 2020 and 2021. Internal phosphorus loading represented 8 and 9 percent of the respective summer phosphorus budgets for South Rice Pond in 2020 and 2021. Discharge from North Rice Pond represented 11 and 14 percent of the respective summer phosphorus budgets for South Rice Pond in 2020 and 2021.
