Sochacki Park Water Quality Improvement Project Feasibility Study

Prepared for
Three Rivers Park District

September 2023

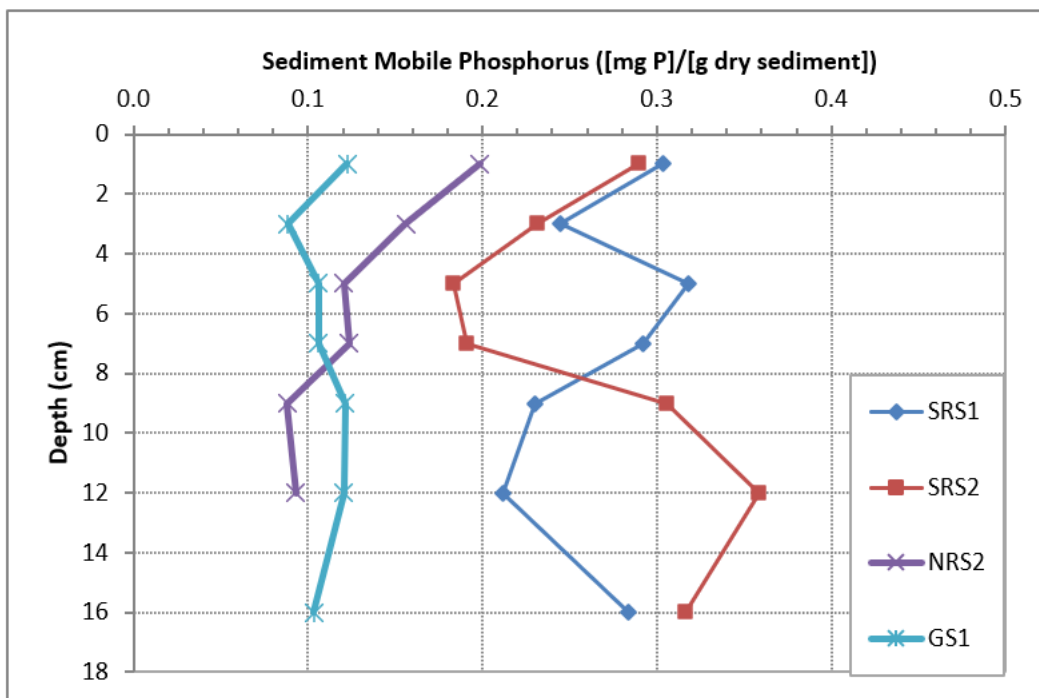
Figure 3-4 Sediment Mobile Phosphorus Concentrations

Phosphorus in sediment can be present in different forms. The mobile and organic fractions (types) of sediment phosphorus are readily available for release under anoxic conditions. Figures 3-4 and 3-5 show how the respective mobile and organic fractions of phosphorus vary by depth in the sediment of each pond sampling location (shown in Figure 2-1). Figures 3-4 and 3-5 also show that the concentrations of the mobile and organic fractions of sediment phosphorus at each sampling location are elevated near the sediment-pond water interface. Results of the dissolved oxygen monitoring, combined with the pond sediment phosphorus data, confirmed that internal phosphorus loading, under anoxic conditions, can be an important source of phosphorus input to each pond during the summer months.

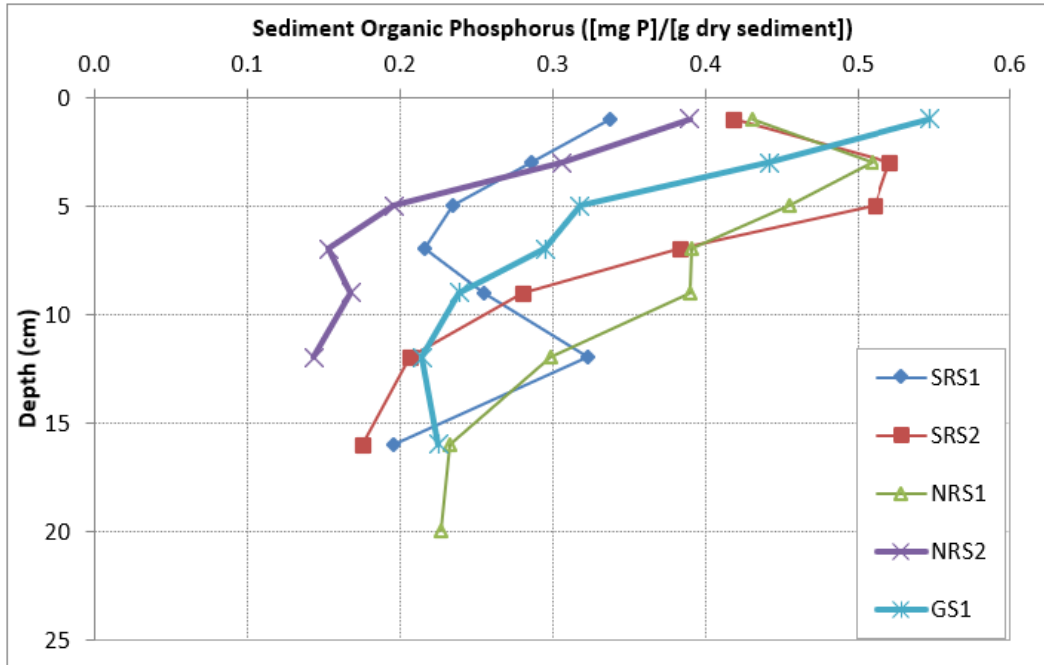
Figure 3-5 Sediment Organic Phosphorus Concentrations

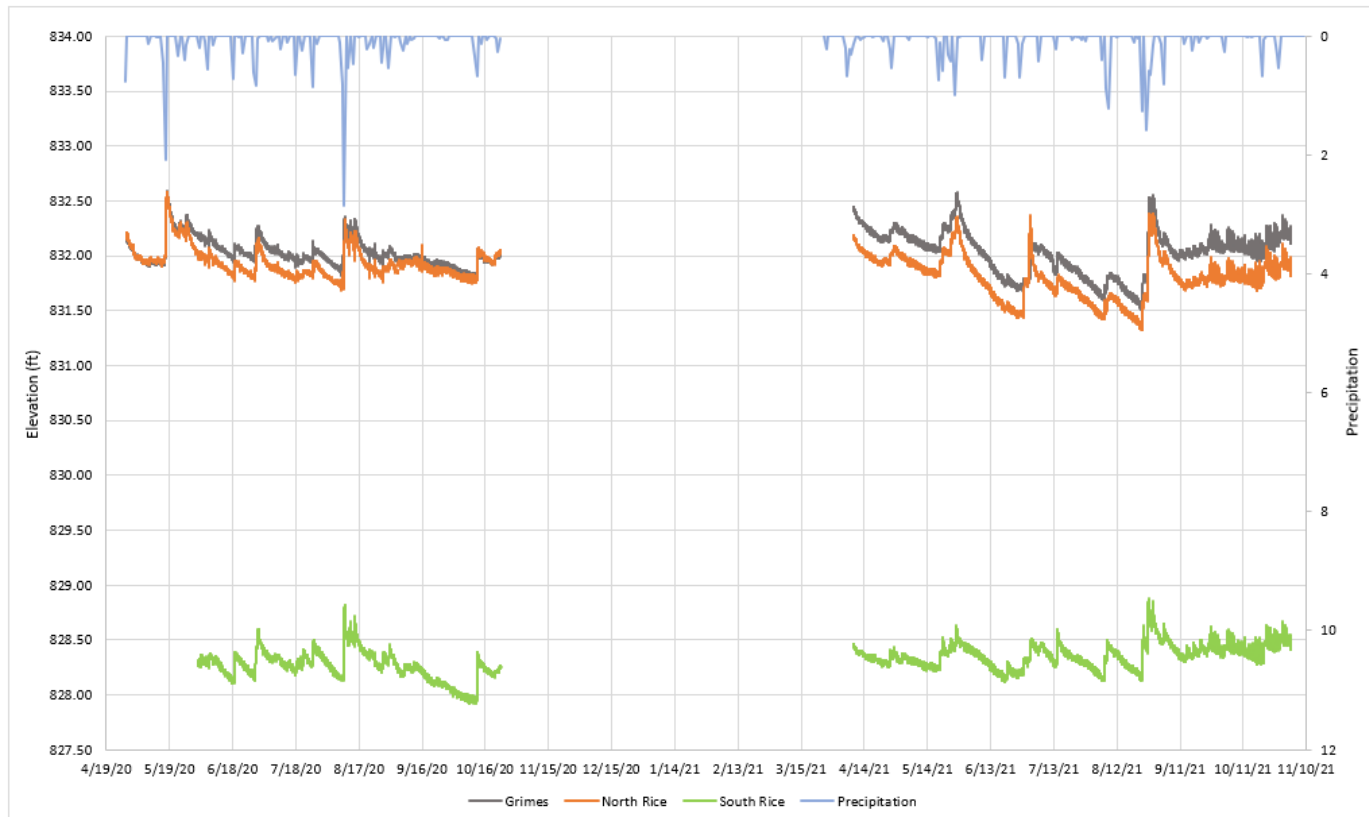
Figure 3-7 2020 and 2021 Pond Water Levels

Figure 3-7 shows the monitored water levels for each pond during the 2020 and 2021 monitoring seasons, as well as the corresponding precipitation amounts. The largest storm events during the monitoring period resulted in water level changes of about one foot in Grimes Pond and North Rice Pond, while South Rice Pond experienced water level changes of about three quarters of a foot. The existing outlet infrastructure for Grimes Pond would accommodate a water level drawdown (further discussed in Section 5.1) of approximately 2.5 feet using gravity flow into North Rice Pond, which in turn, could be drawn down by 3 to 3.5 feet through gravity flow to South Rice Pond. South Rice Pond cannot be drawn down by gravity due to the tailwater conditions associated with Bassett Creek, so pumping would be required to draw the pond down.

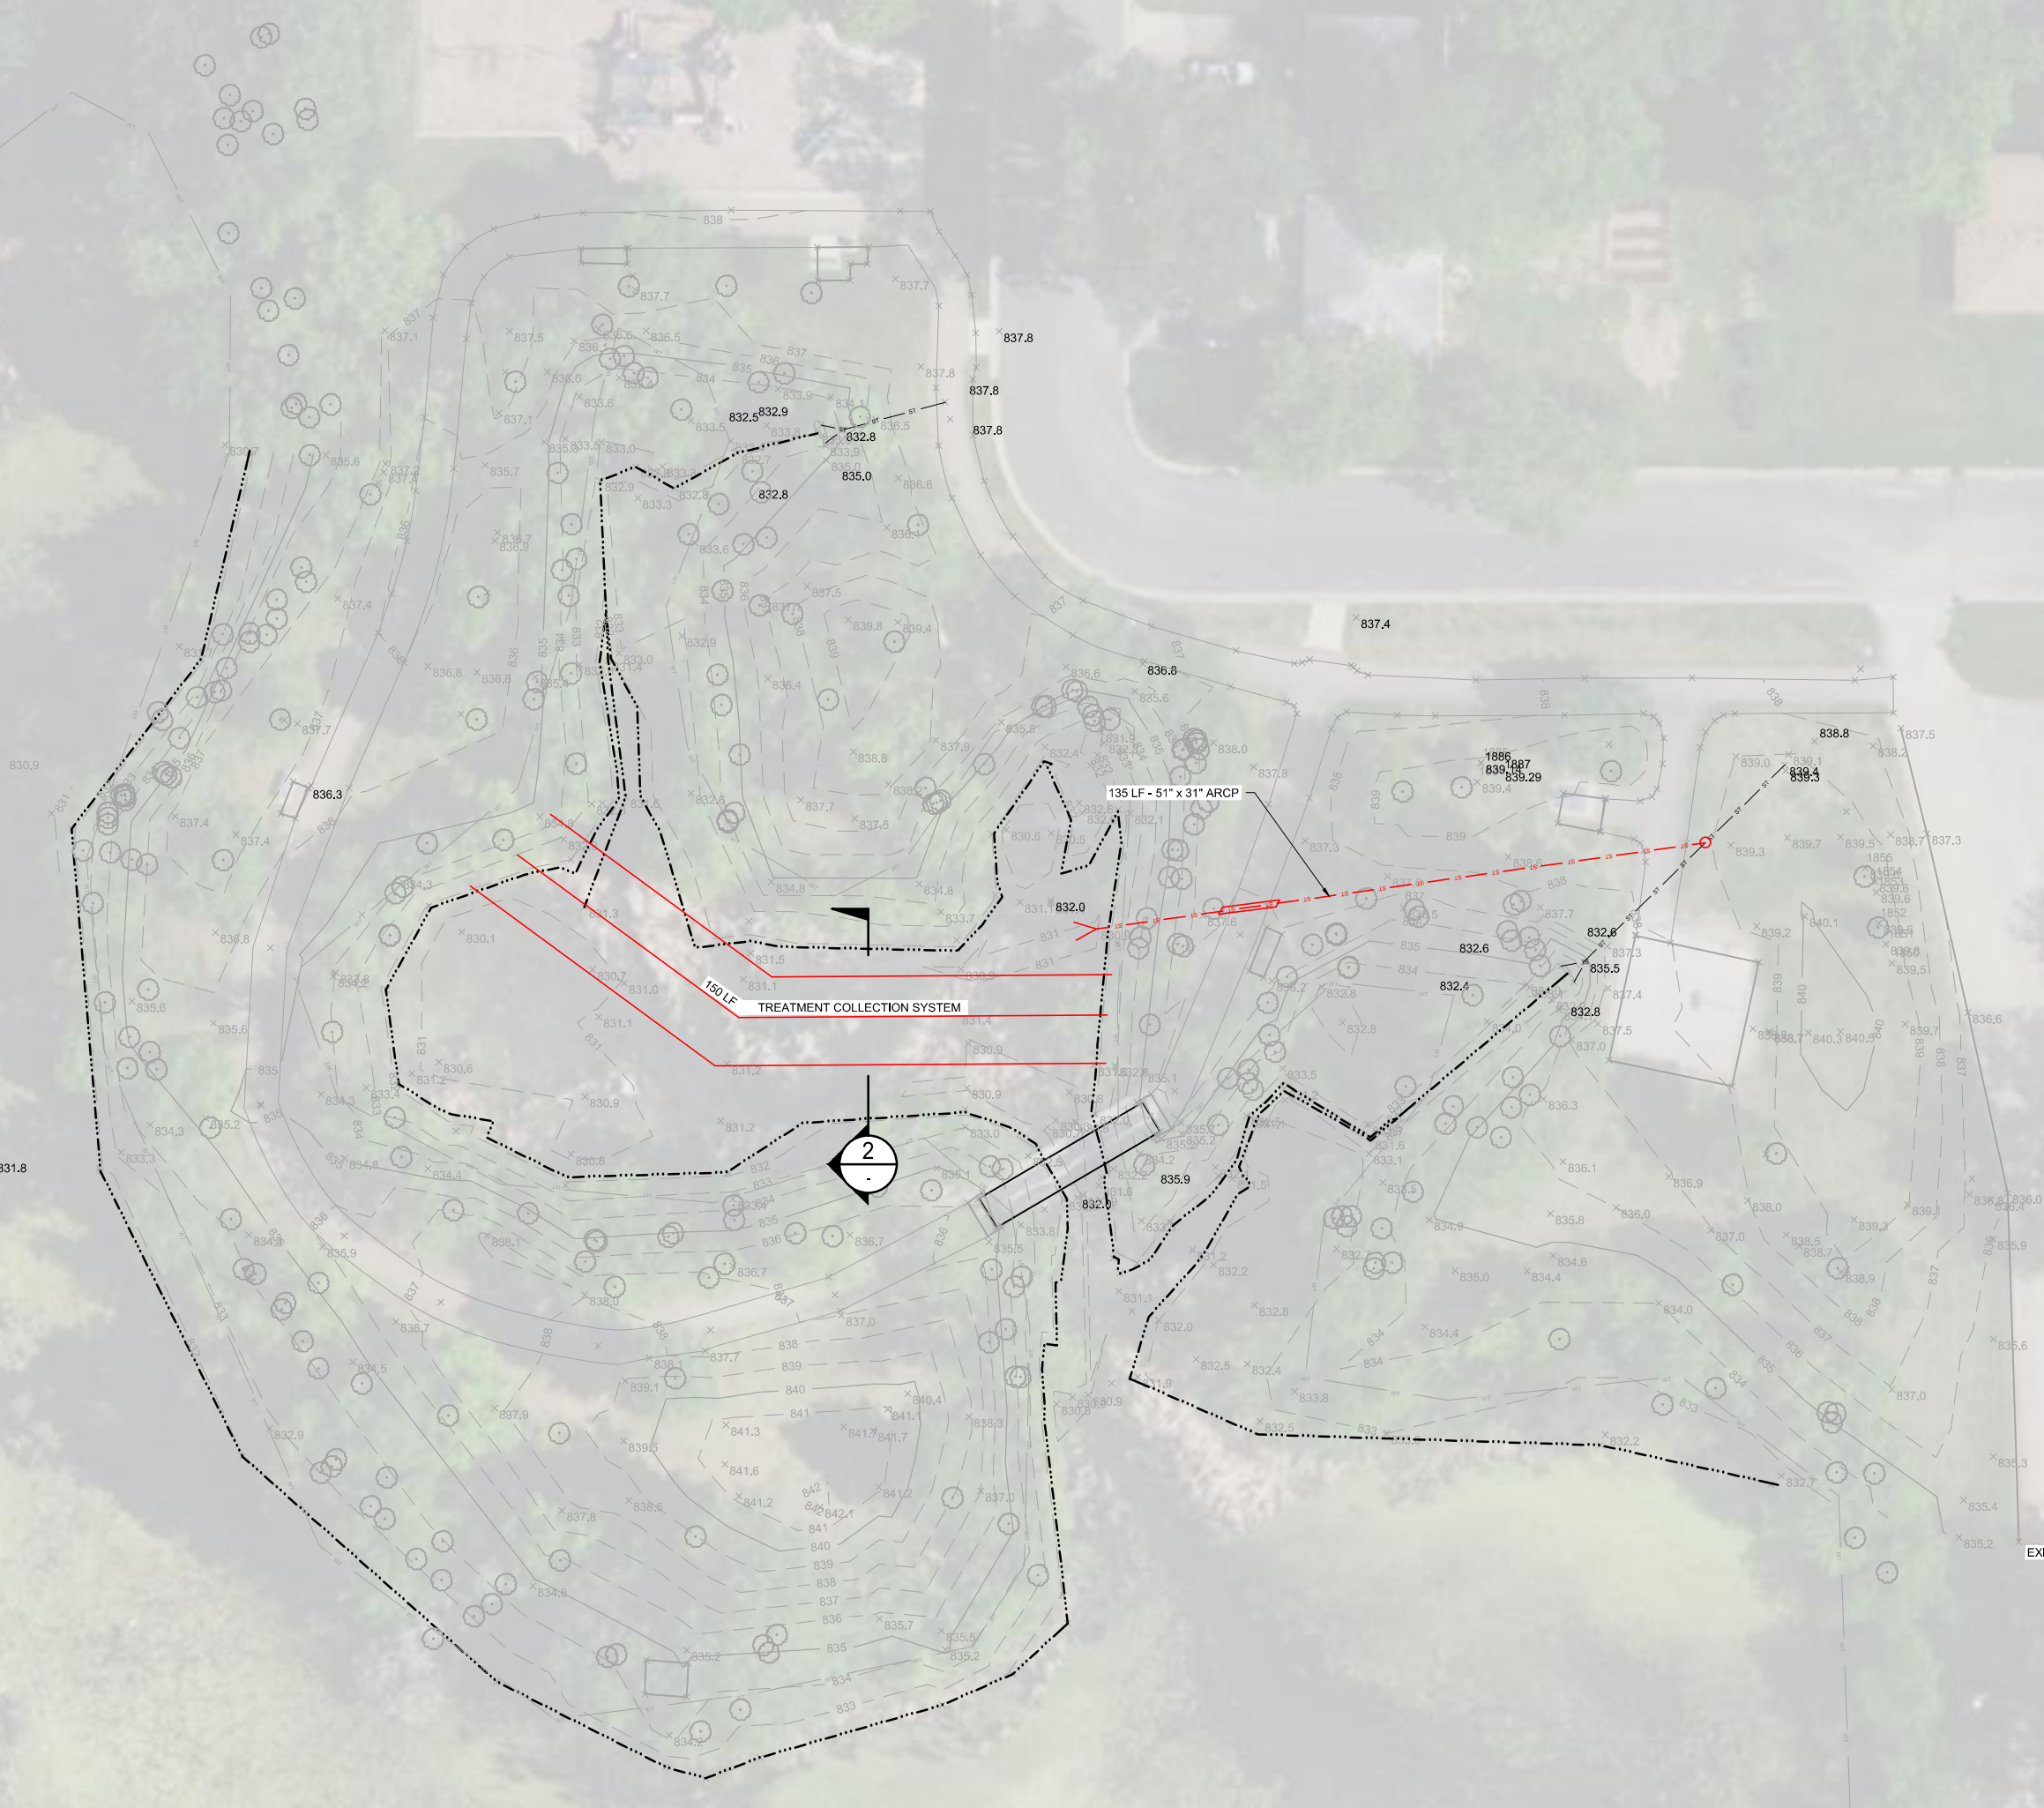
2 SECTION: TREATMENT COLLECTION SYSTEM

**Figure 5-4 Proposed BMP GR-6
(Grimes Pond)**

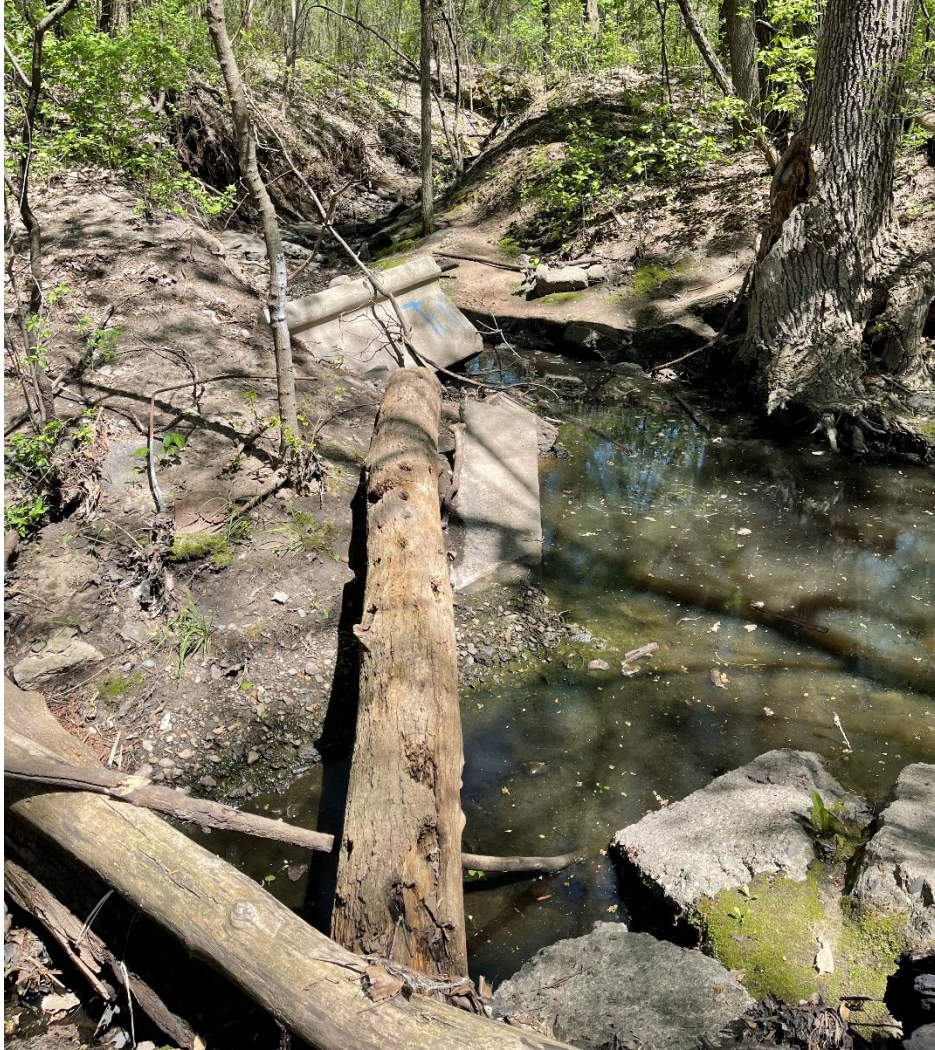
Figure 5-6 Pond SR-4 Downstream Outlet Channel Erosion and Construction Debris

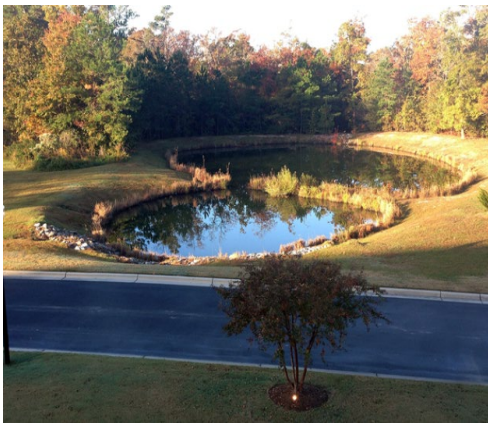
Figure 5-7 Example Stormwater Pond Treatment Elements

Figure 5-7 includes a photo and schematic as examples of the important elements of the stormwater ponds envisioned for future implementation. The expectation is that the pretreatment provided by these two-cell pond systems will ensure that most of the ongoing operation and maintenance effort will not need to involve dredging, due to excess sedimentation in the main treatment cell. Both outfalls entering
