# Feasibility Report for Bassett Creek Restoration Project - Reach 1

***Golden Valley, Minnesota***

***Prepared for  
Bassett Creek Watershed Management Commission***

***September 2010***

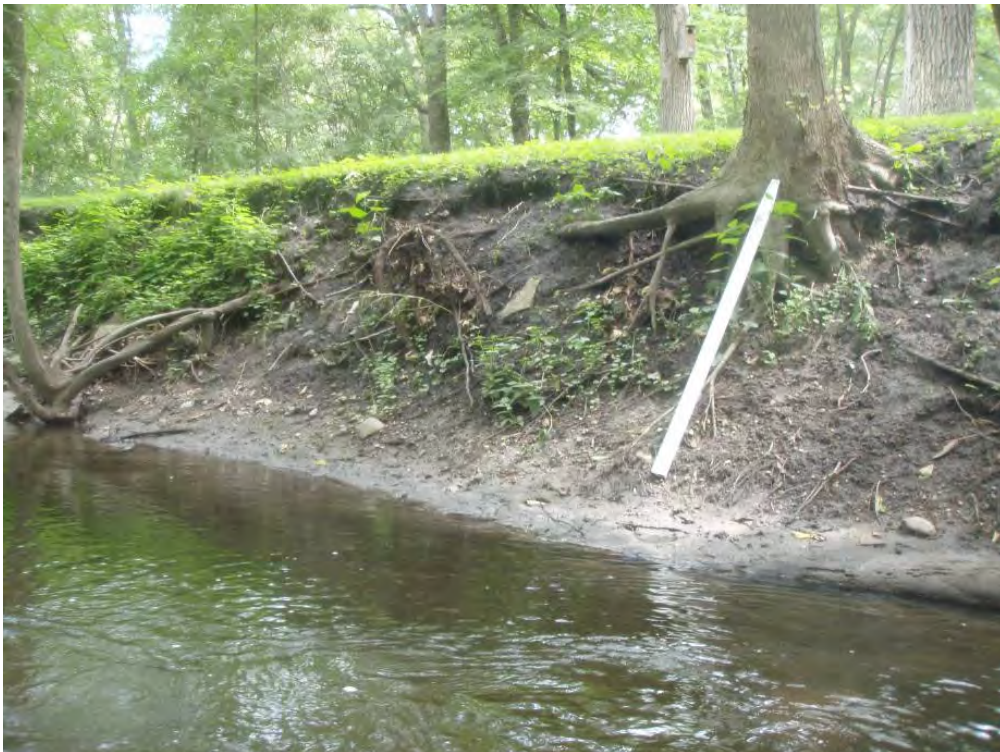
**Photo 3.** *Site 2.* Severely eroding bank.

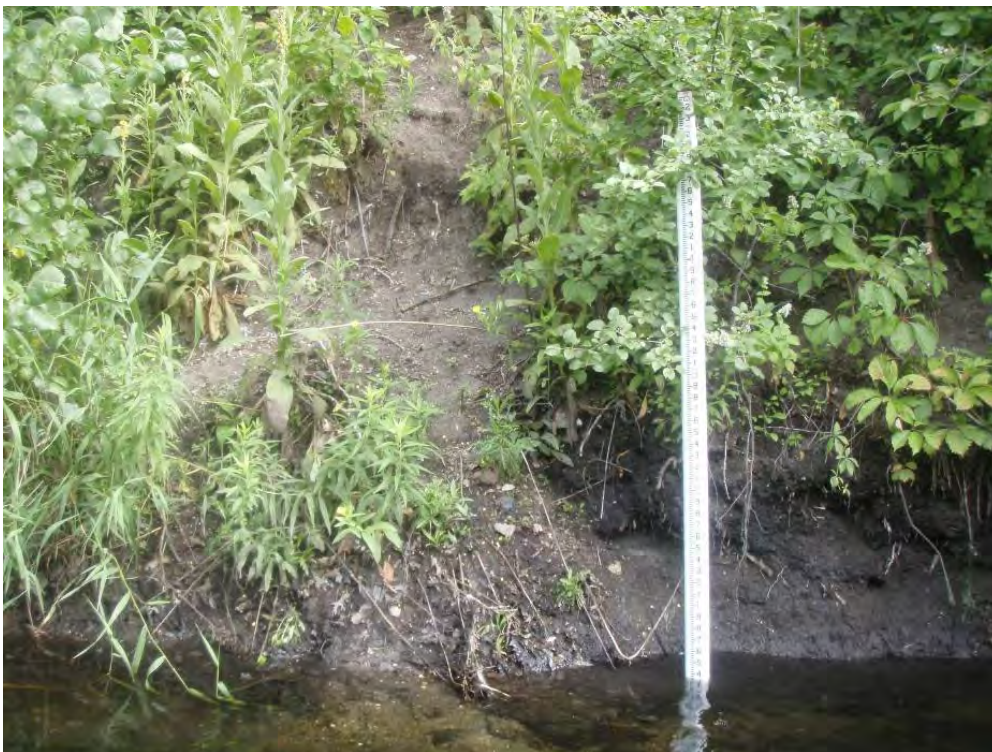
**Photo 21.** *Site 14.* Moderate bank erosion from concentrated parking lot runoff.

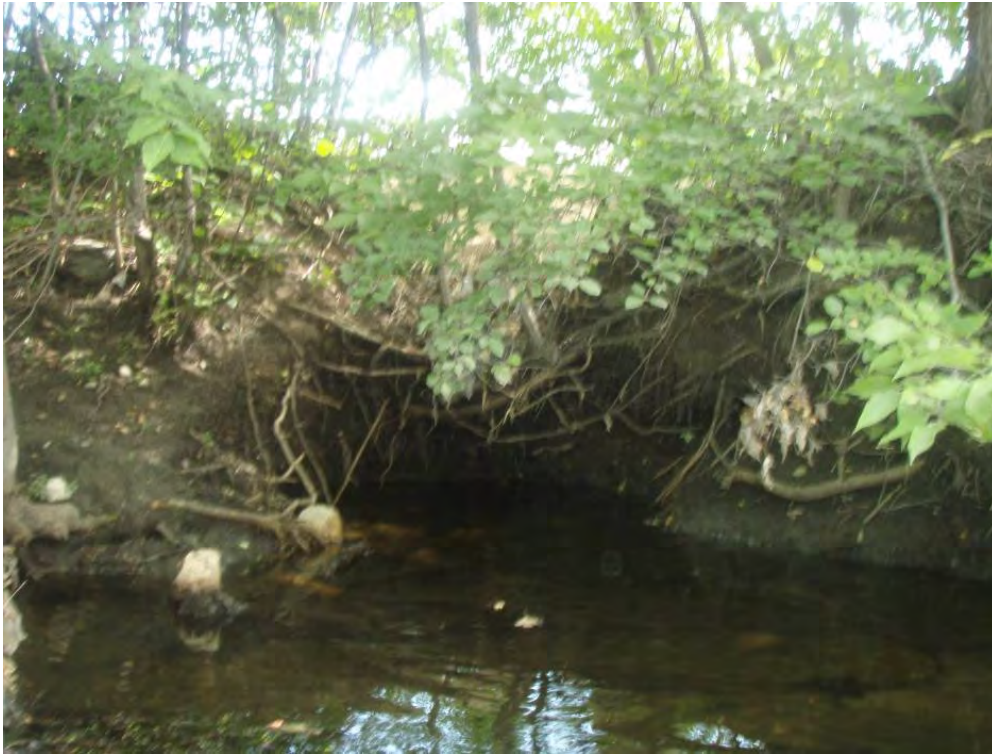
**Photo 22.** *Site 15.* Moderate bank erosion from concentrated parking lot runoff.

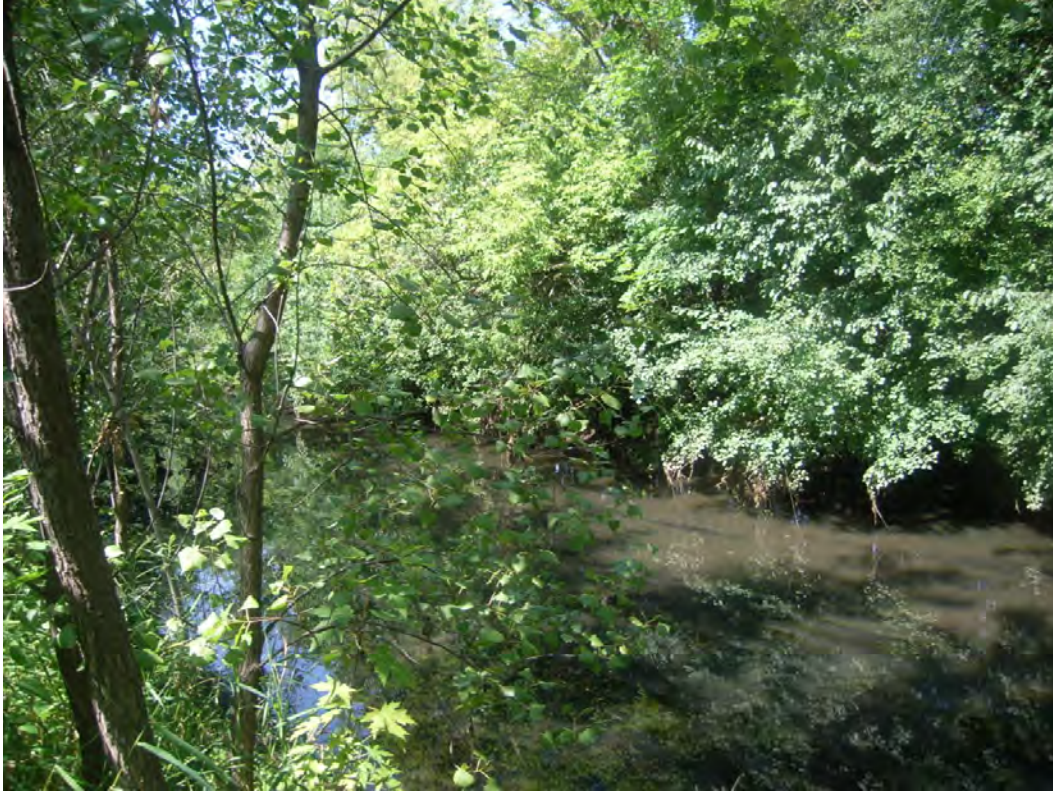
**Photo 1: Wetland A. View of Creek and surrounding vegetation.**

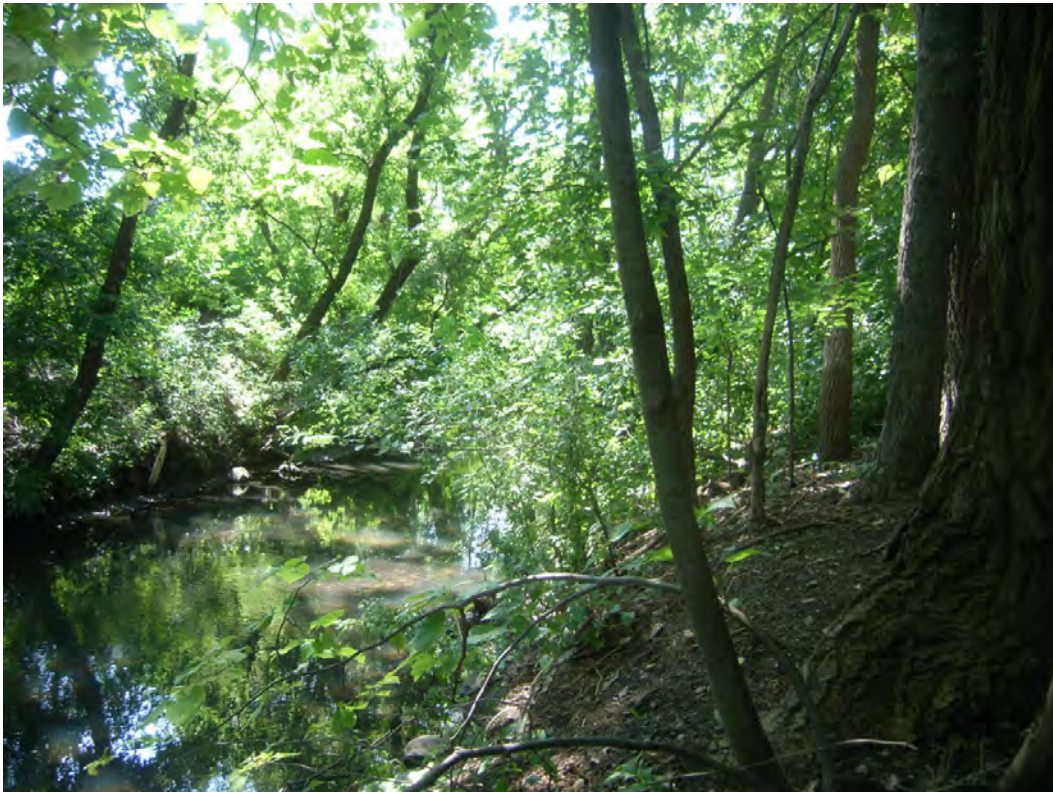
**Photo 4: Wetland B. View of Creek, steep stream bank, and typical vegetation.**

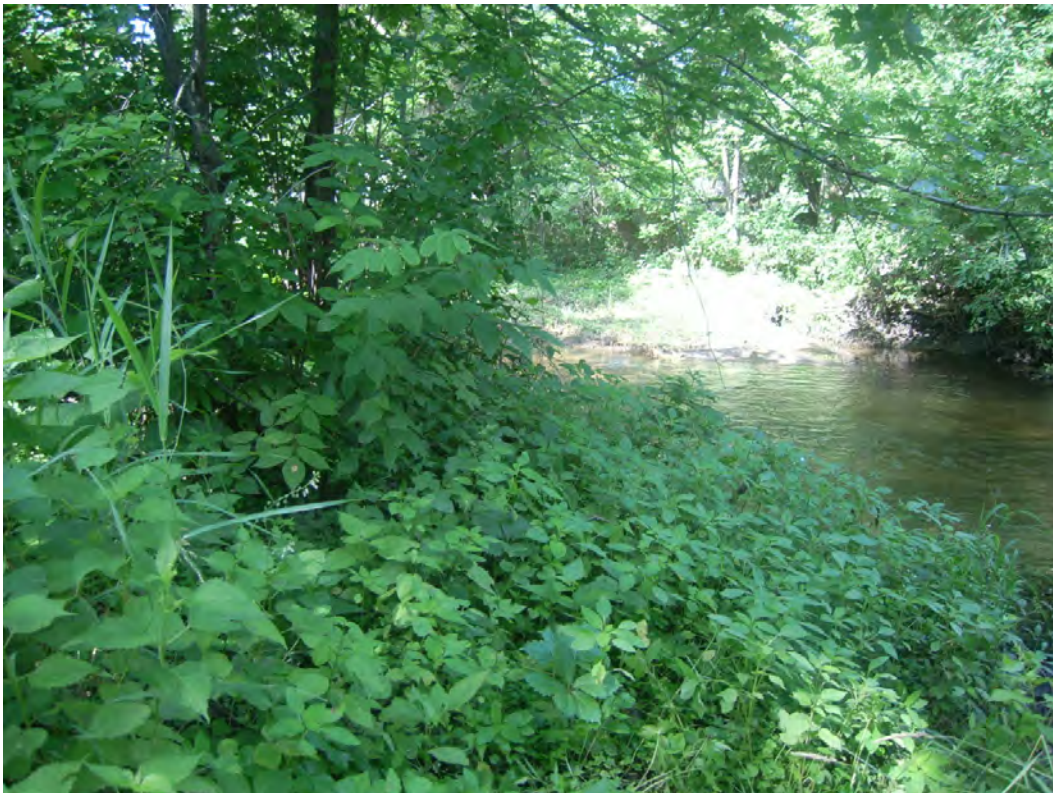
**Photo 6: Wetland C. View of Creek and wetland at Data point SB-7.**

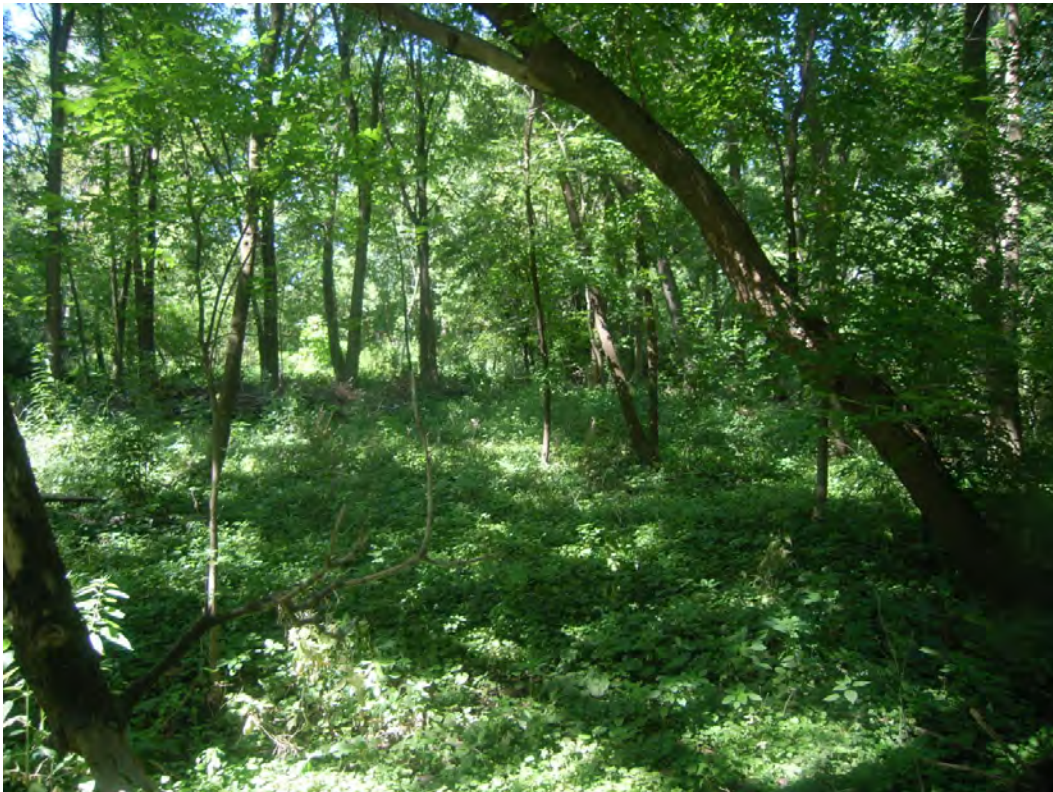
**Photo 8: Wetland D. View of floodplain.**
