Feasibility Report for Bassett Creek Main Stem Restoration, Regent Avenue to Golden Valley Road (2024 CR-M)—DRAFT

Golden Valley, Minnesota

Prepared for
Bassett Creek Watershed Management Commission

Appendix A
Site Visit Photos

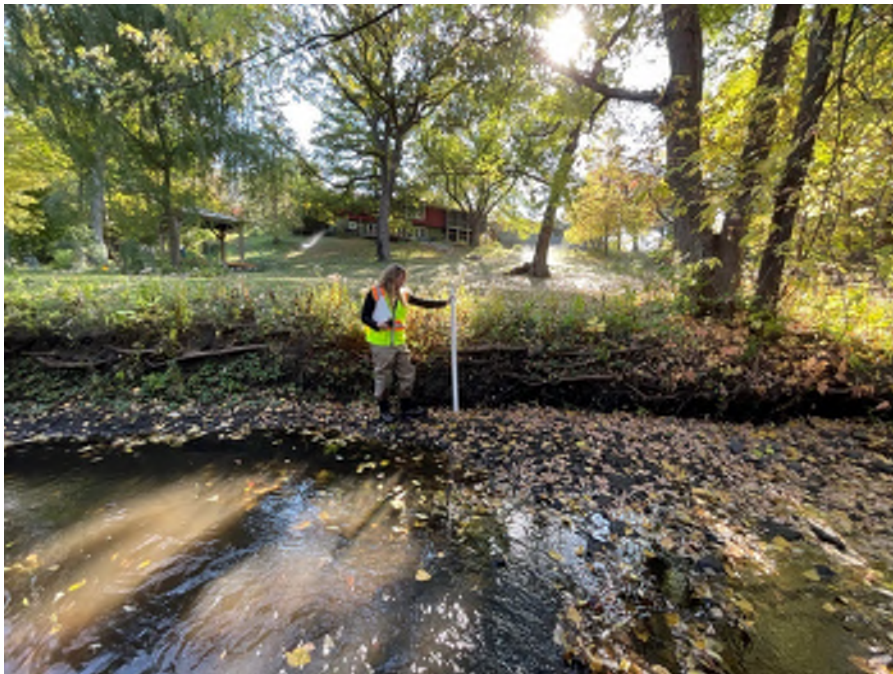
Photo 2: Site 1a. BEHI measurement at the right bank of station 1+60.

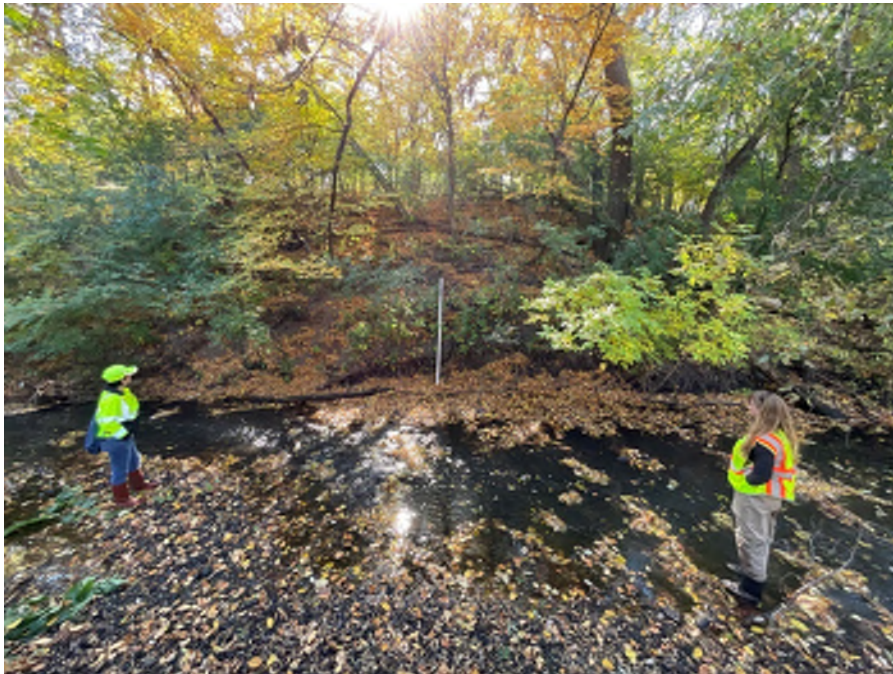
Photo 4: Site 1c. BEHI measurement at the right bank of station 7+20.

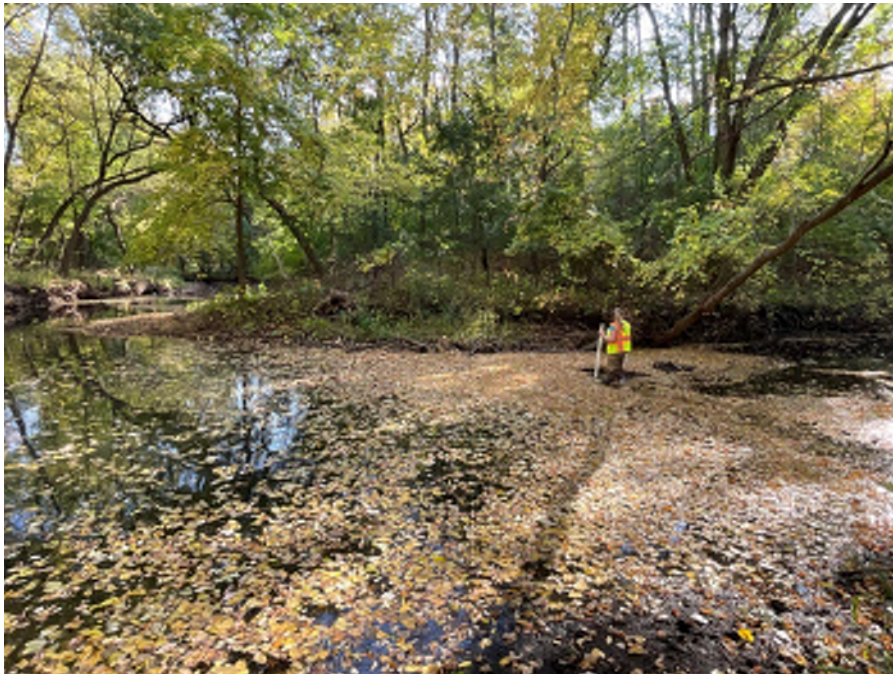
Photo 12: Site 2c. Large deposition at the right bank of station 19+50 (facing downstream).

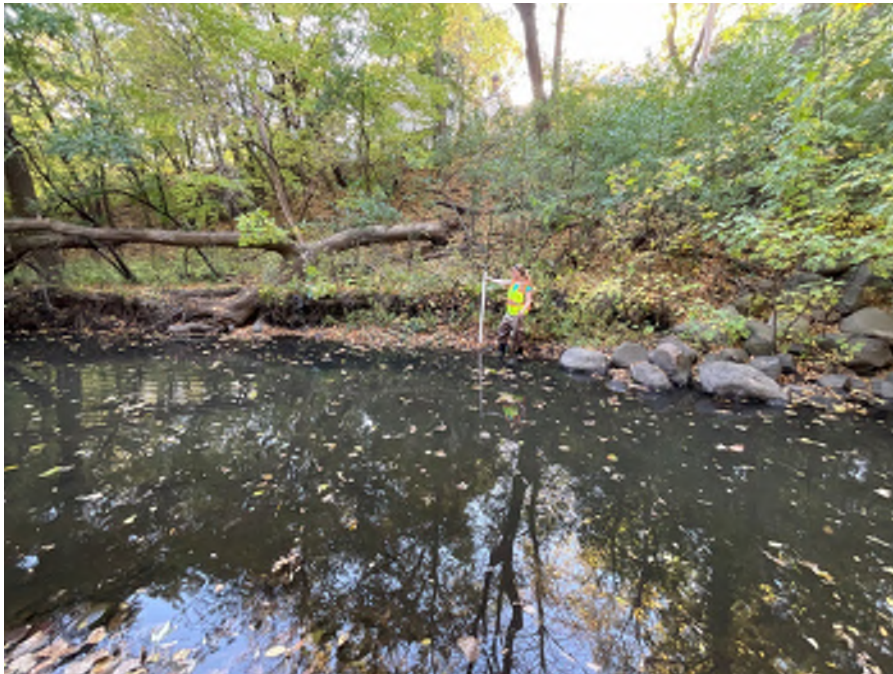
Photo 14: Site 2d. BEHI measurement at the right bank of station 21+10.

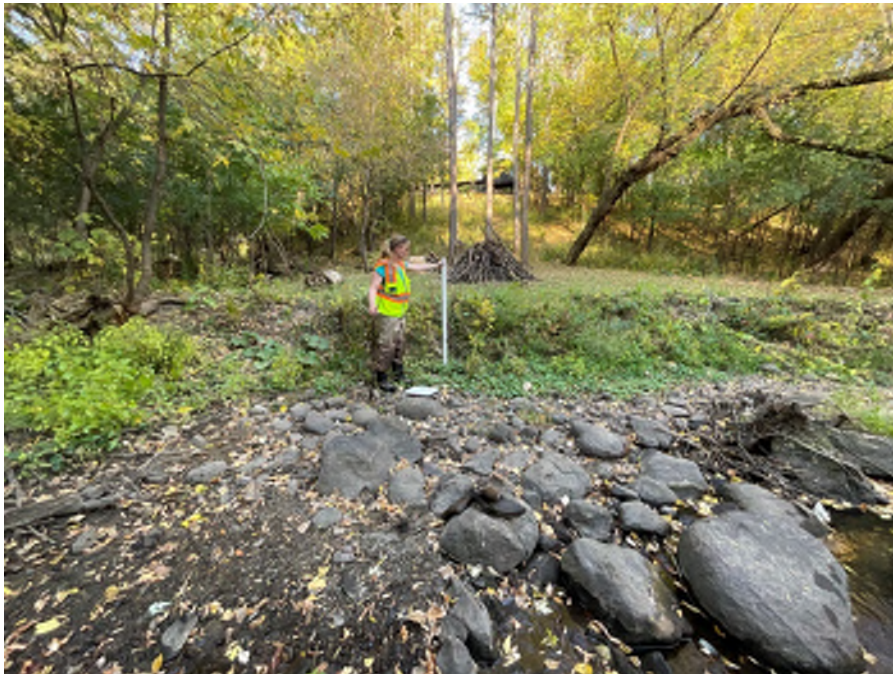
Photo 16: Site 2e. BEHI measurement at the left bank of station 22+50.

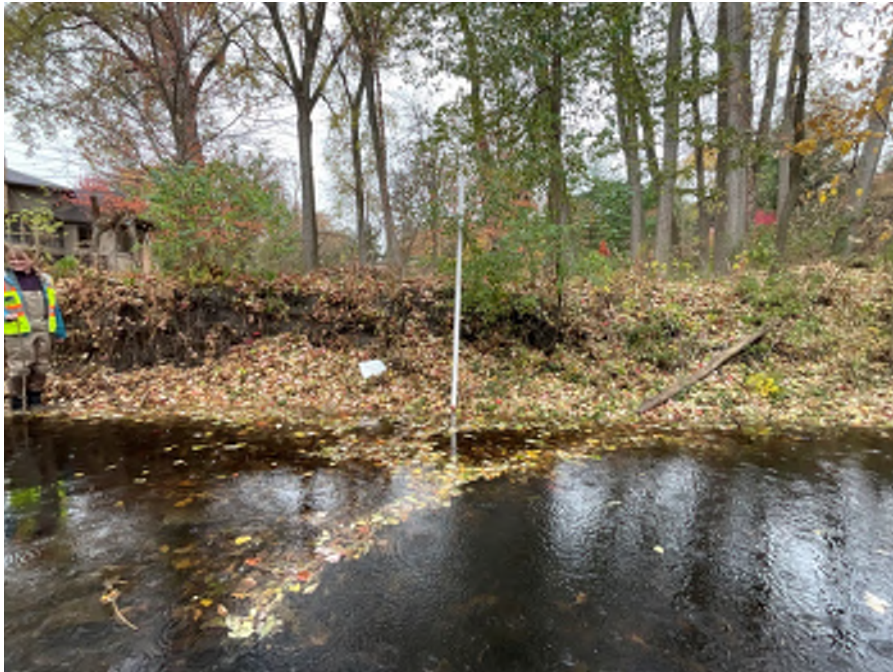
Photo 20: Site 2h. BEHI measurement at the right bank of station 29+00.

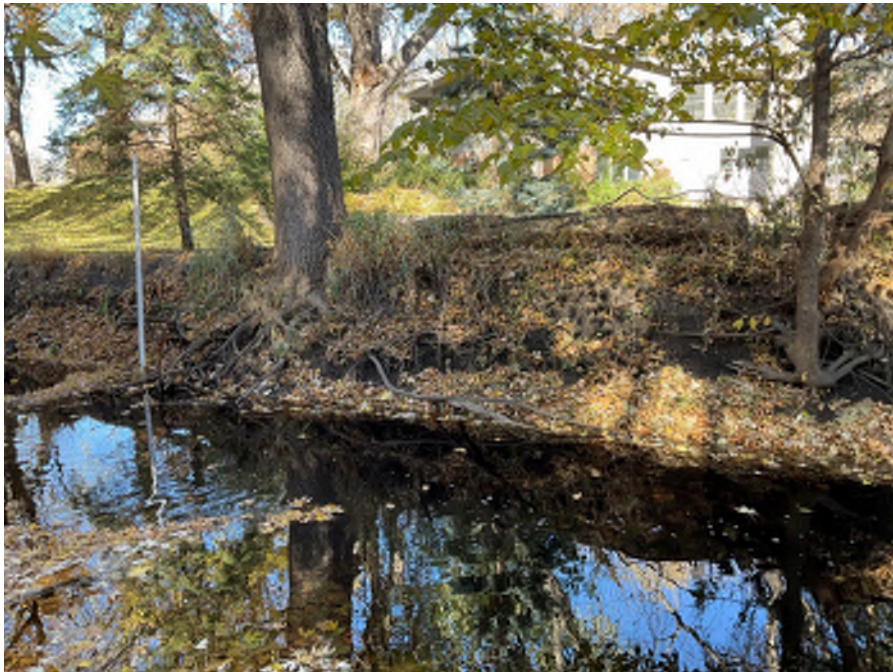
Photo 34: Site 3f. Bare soil at the upstream section at station 50+90.

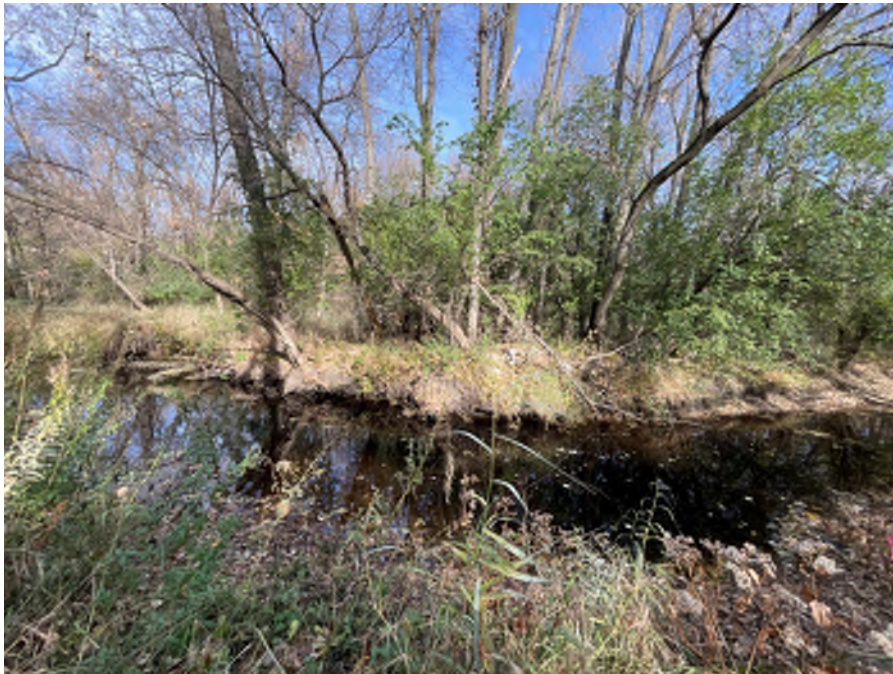
Photo 40: Site 3j. Undercut at the left bank of station 55+20.

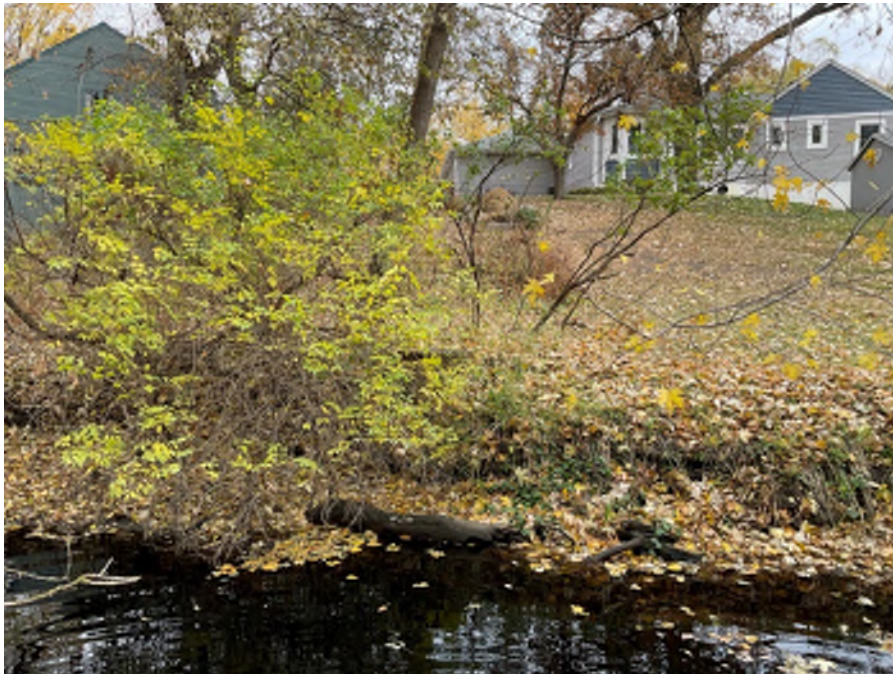
Photo 46: Site 4f. Sanitary manhole at the left bank of station 65+90.
