Appendices

Appendix A
Site Visit Photos

Bassett Creek Main Stem Erosion Issues and Restoration Prioritization

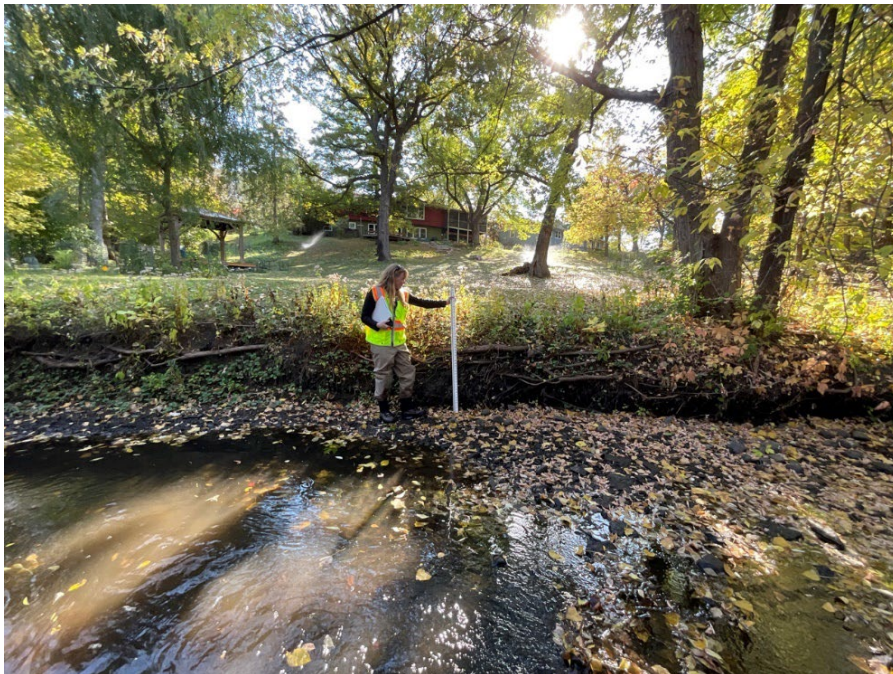
Photo 2: Site 1a. BEHI measurement at the right bank of station 1+60.

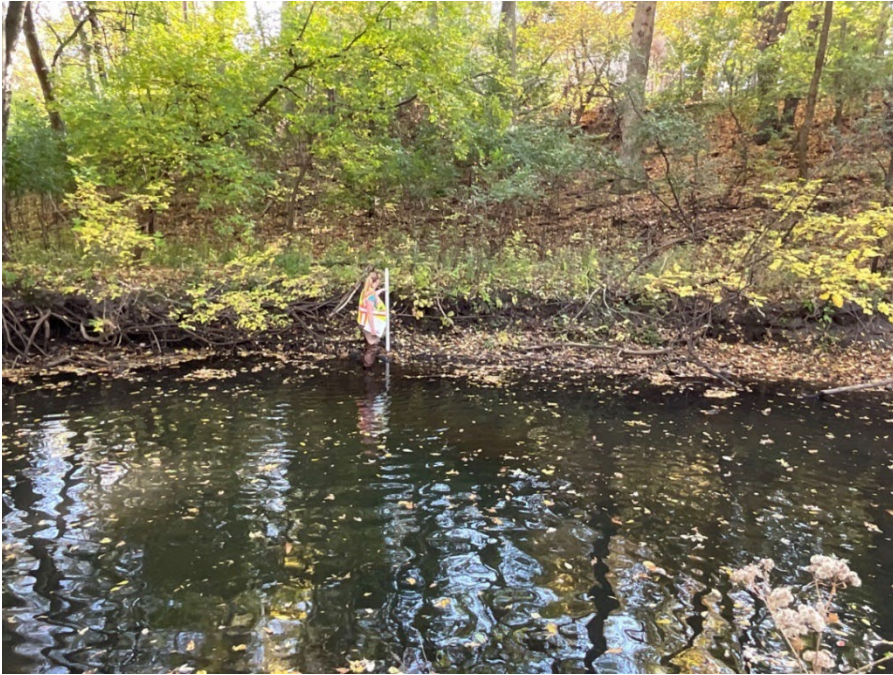
Photo 11: Site 2b. BEHI measurement at the right bank of station 18+50.

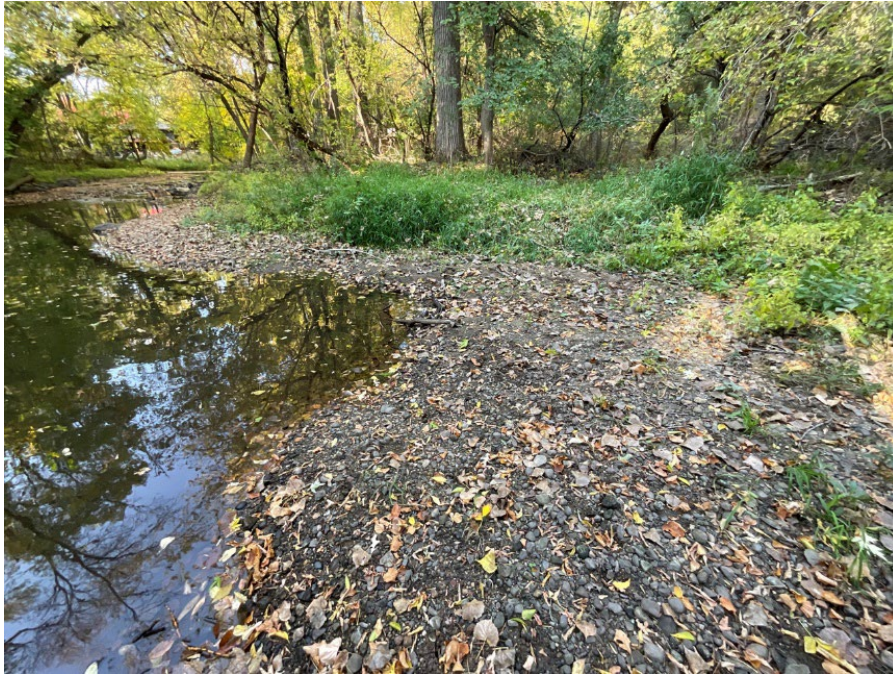
Photo 15: Site 2d. Upstream section of the left bank at station 21+10.

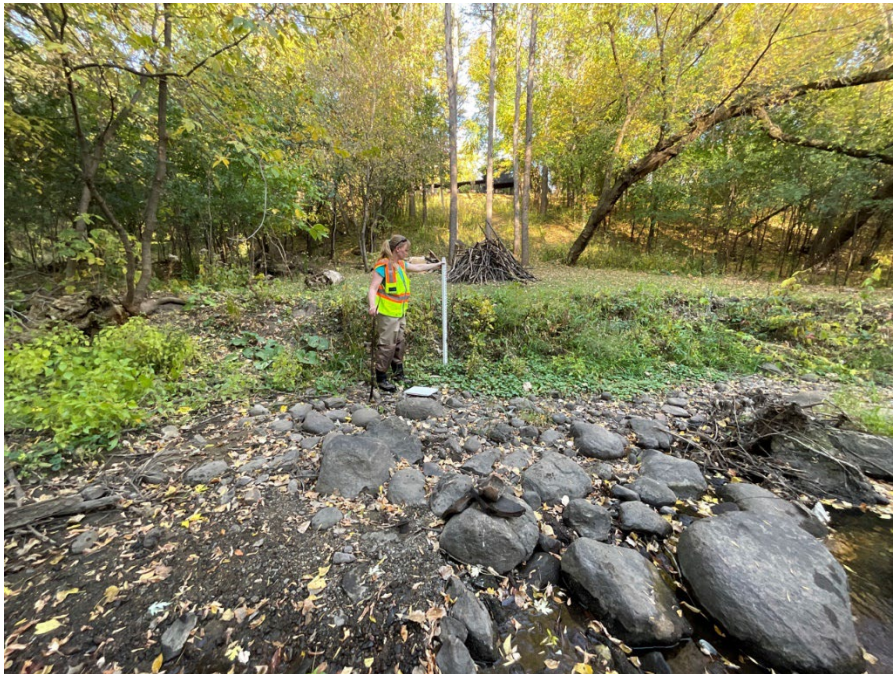
Photo 16: Site 2e. BEHI measurement at the left bank of station 22+50.

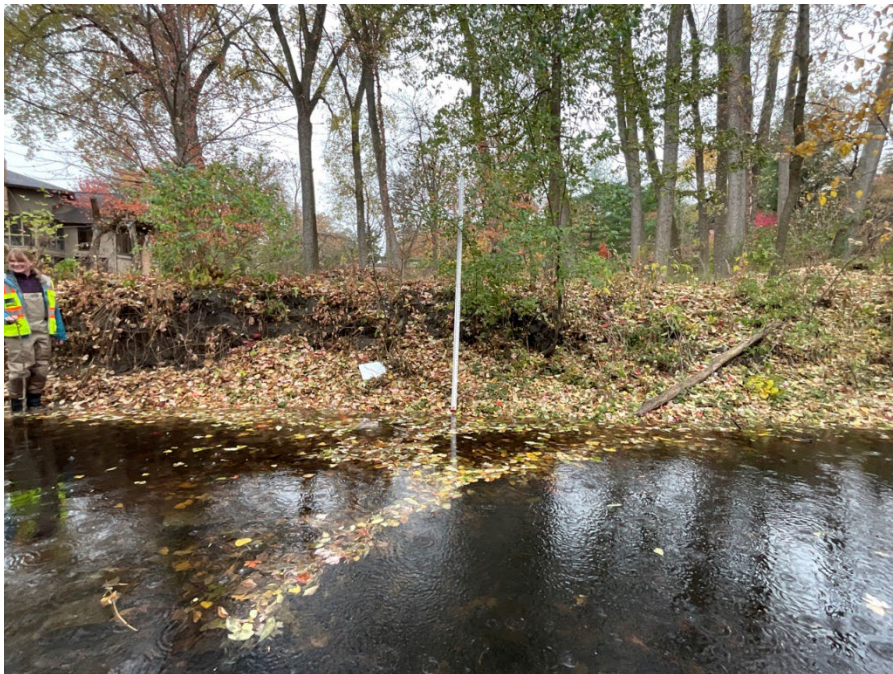
Photo 20: Site 2h. BEHI measurement at the right bank of station 29+00.

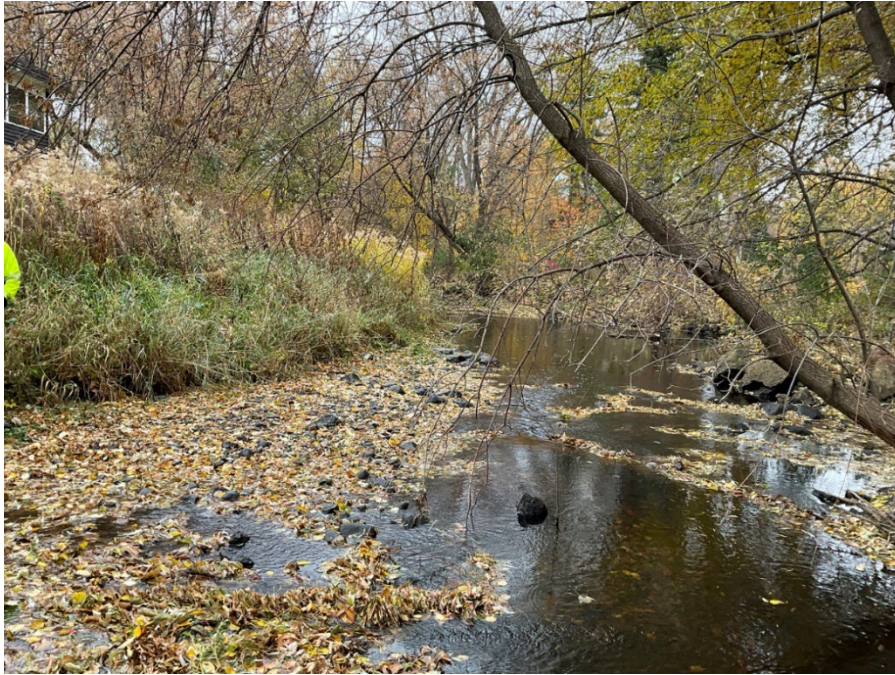
Photo 21: Site 2i. Downstream section at station 29+90.

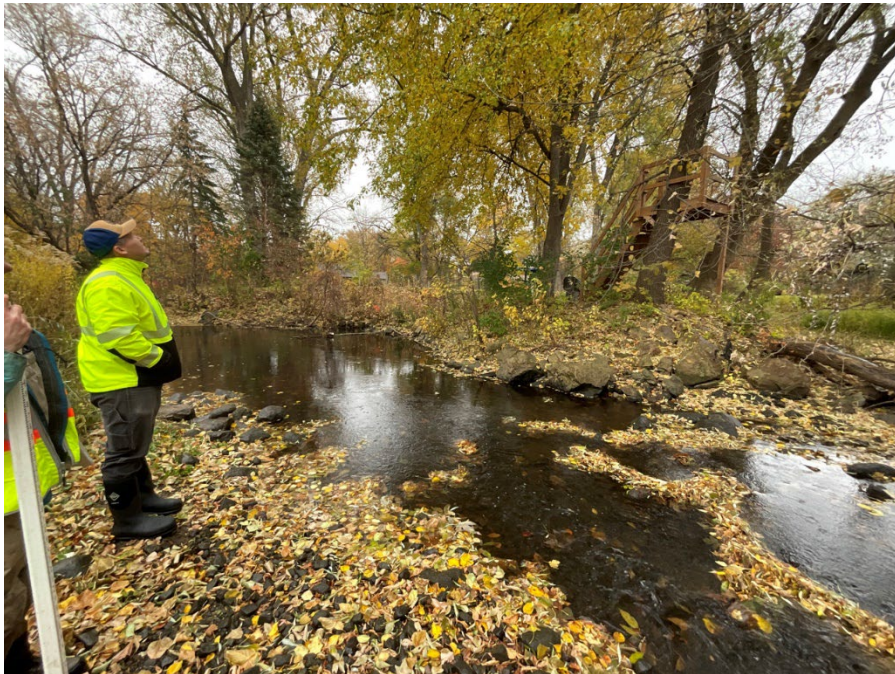
Photo 22: Site 2i. Right bank of station 30+10.

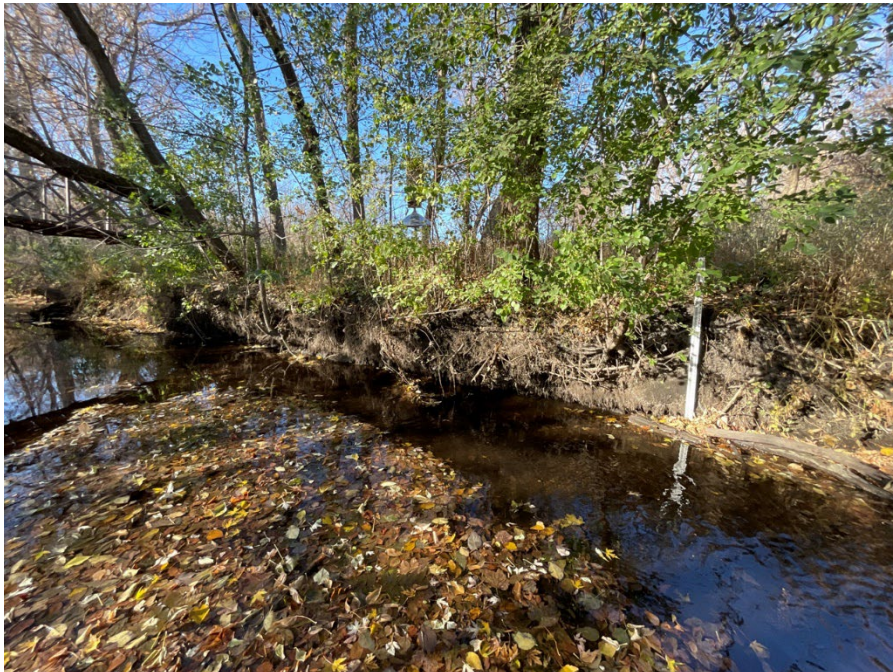
Photo 32: Site 3d. Upstream section of the left bank of station 47+50.

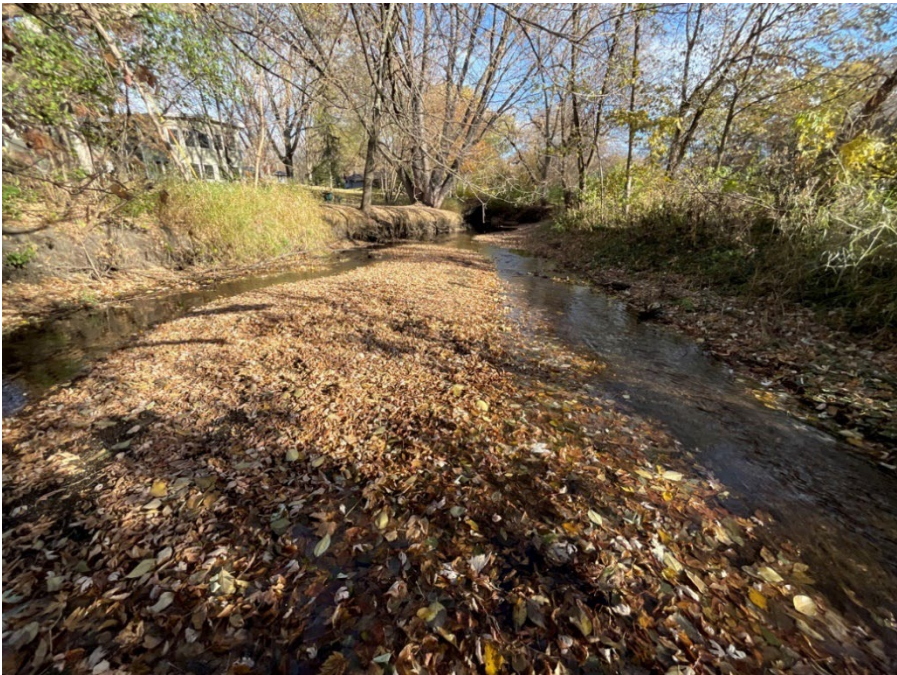
Photo 33: Site 33e. Downstream section at station 47+70.

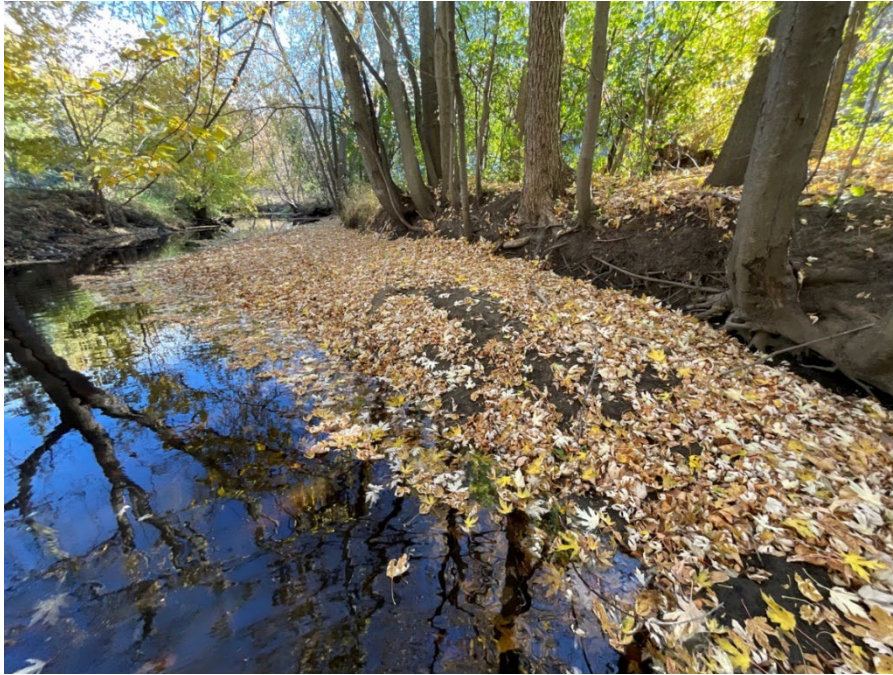
Photo 35: Site 3g. Undercut and deposition at right bank of station 50+20.

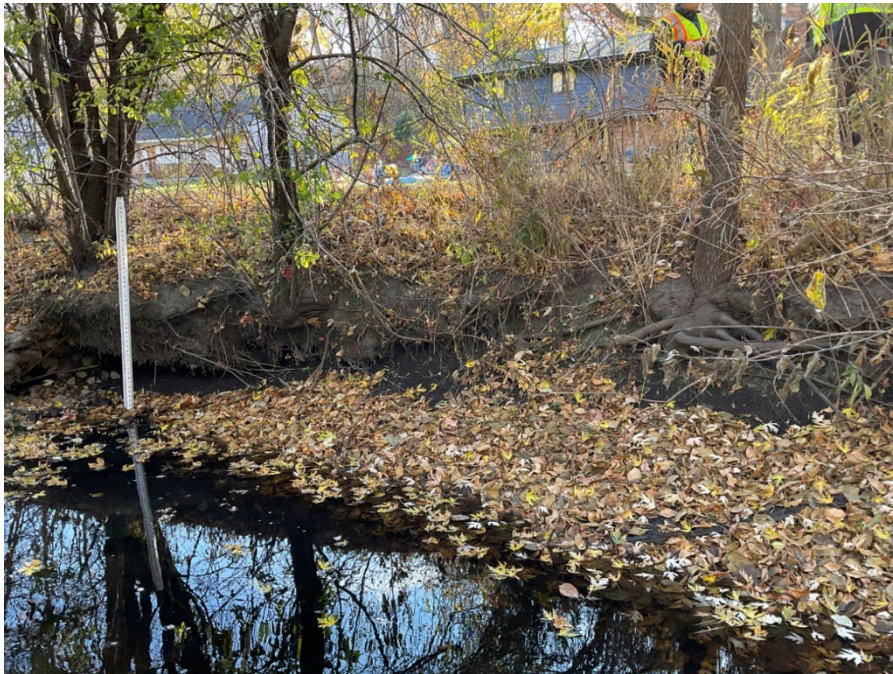
Photo 36: Site 3h. BEHI measurement at right bank of station 51+00 with undercut and deposition.

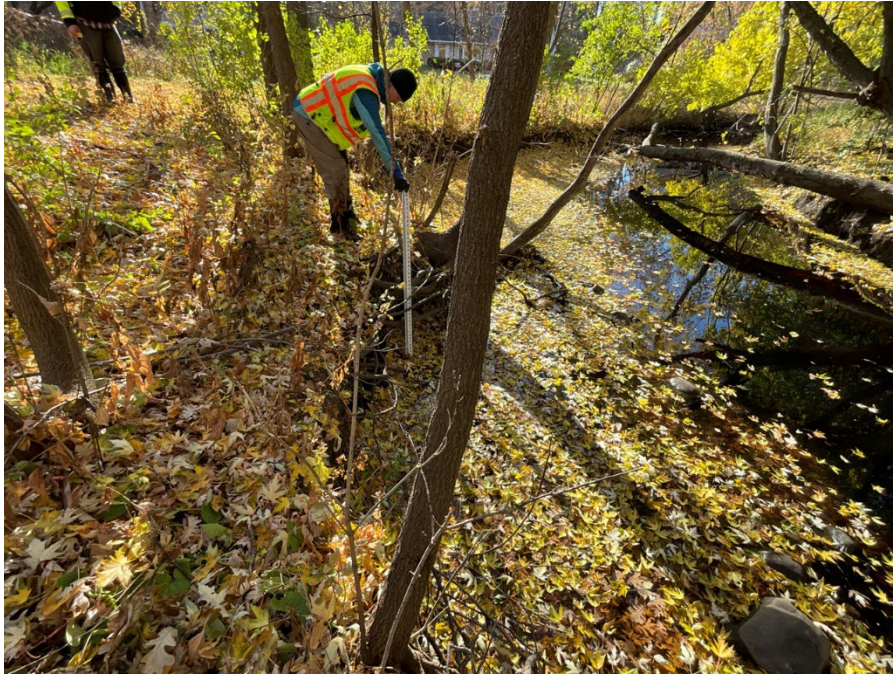
Photo 39: Site 3i. BEHI measurement at the right bank of station 53+00 (facing upstream).

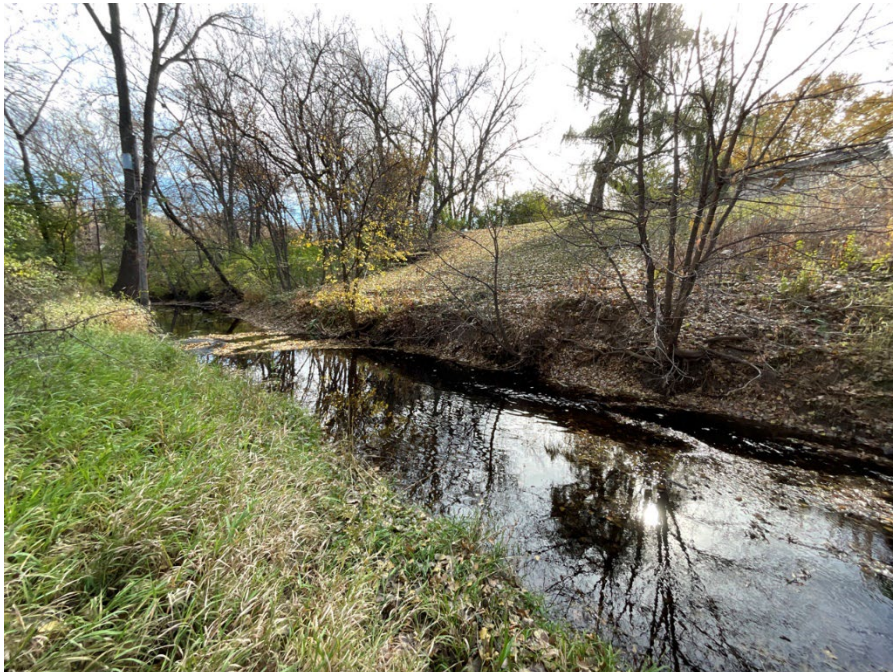
Photo 42: Site 4b. Right bank of downstream section at station 60+00.

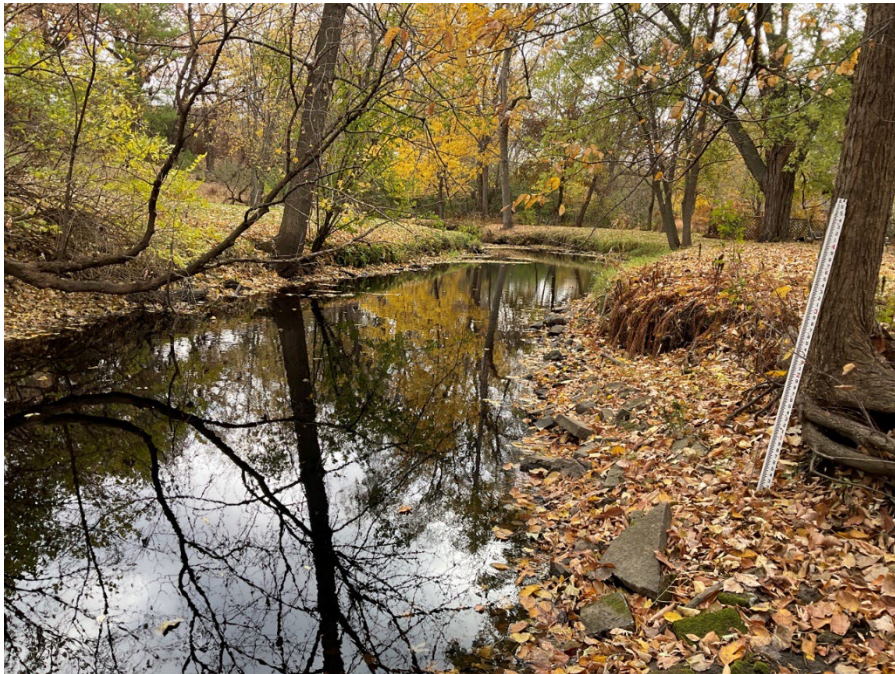
Photo 44: Site 4d. Right bank of station 65+70 (facing downstream).

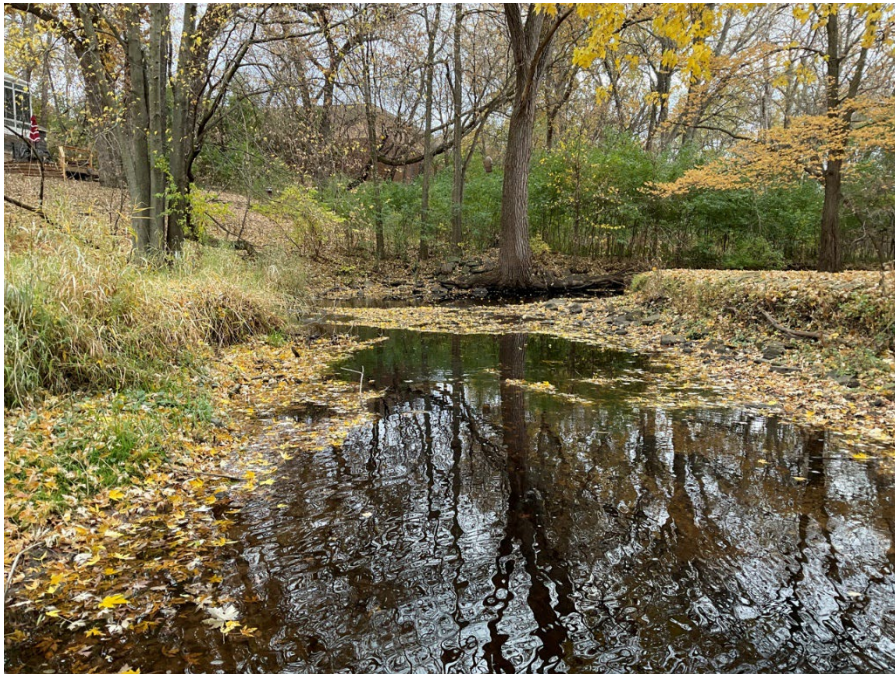
Photo 48: Site 4g. Downstream section of station 67+50.

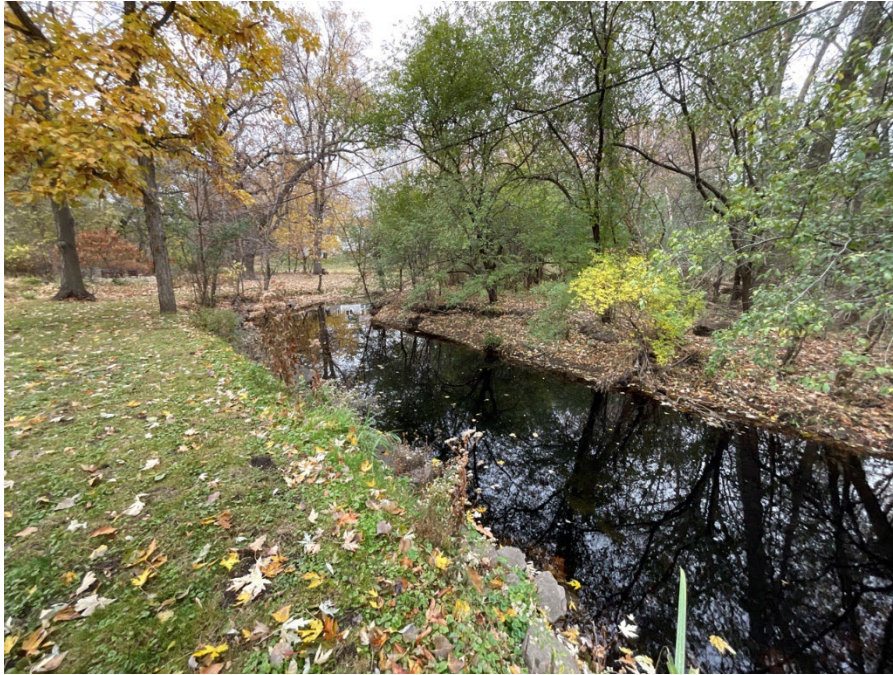
Photo 49: Site 4h. Left bank at station 68+80 (facing upstream).

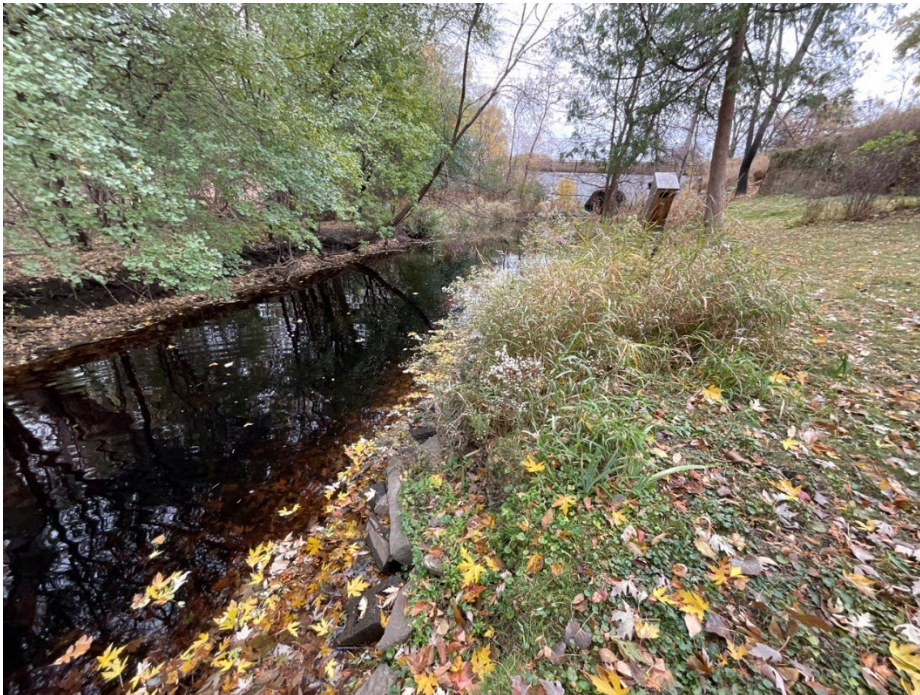
Photo 50: Site 4h. Downstream section at station 70+70.
