Appendices

Appendix A
Site Visit Photos

Bassett Creek Main Stem Restoration (2024 CR-M)

Bassett Creek Main Stem Erosion Issues and Restoration Prioritization

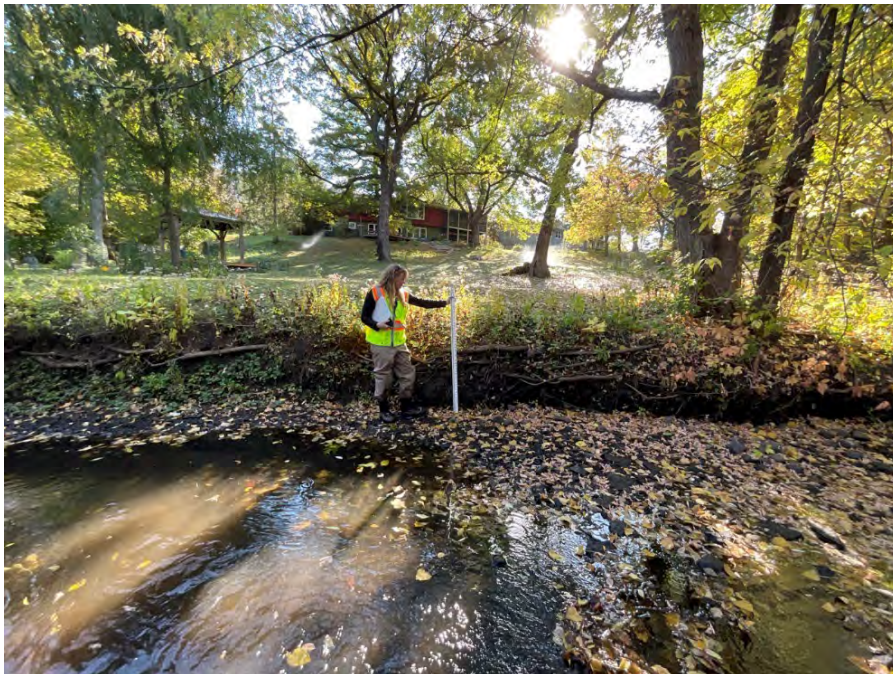
Photo 2: Site 1a. BEHI measurement at the right bank of station 1+60.

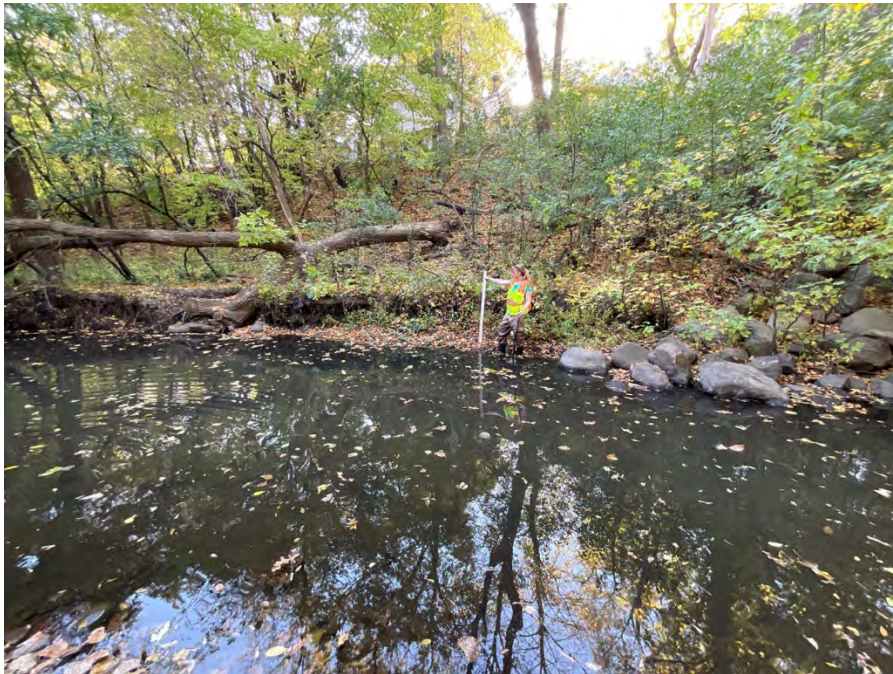
Photo 14: Site 2d. BEHI measurement at the right bank of station 21+10.

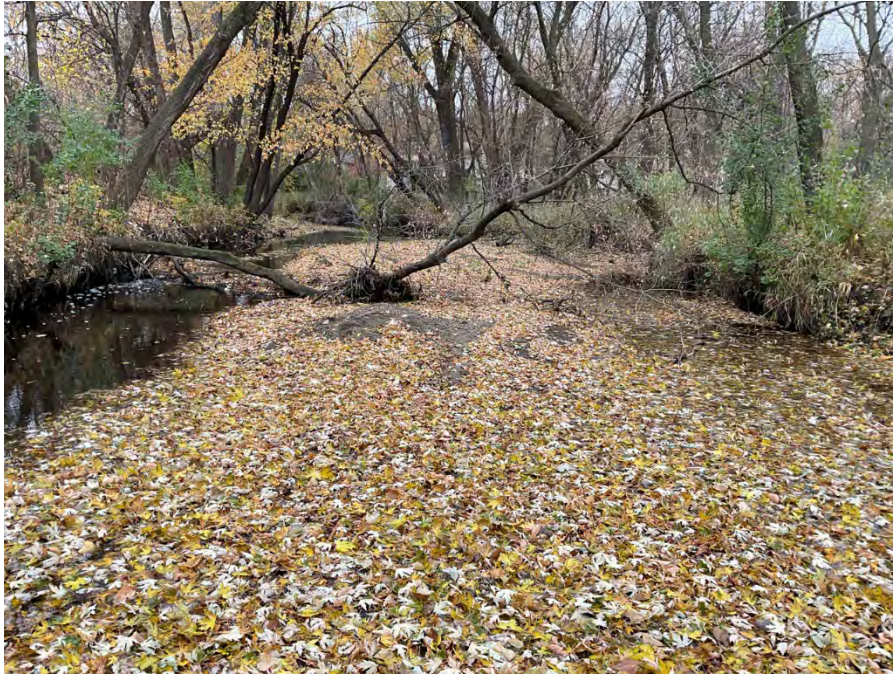
Photo 31: Site 3c. Undercut at the upstream section at station 46+50.

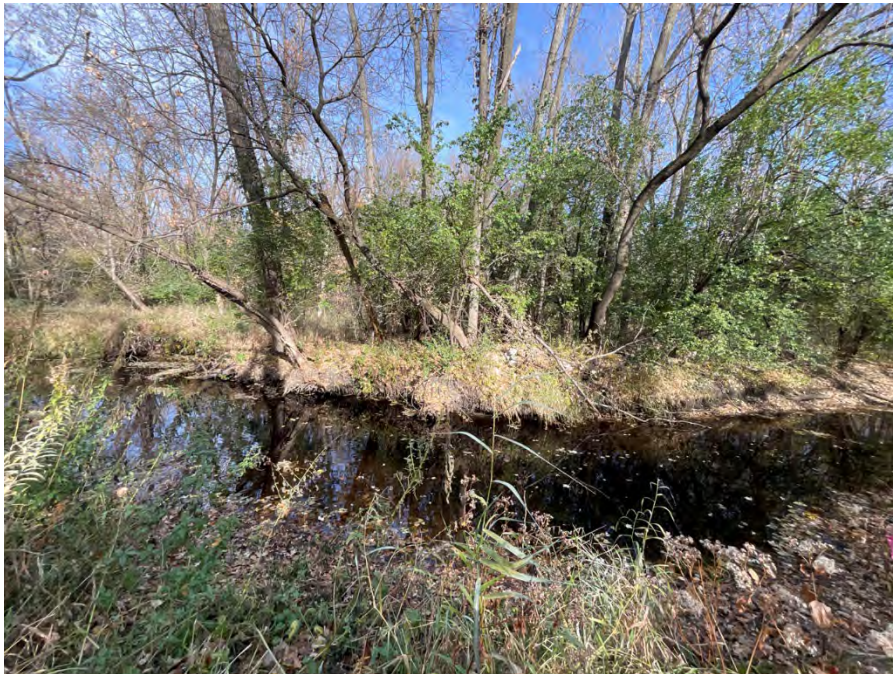
Photo 40: Site 3j. Undercut at the left bank of station 55+20.

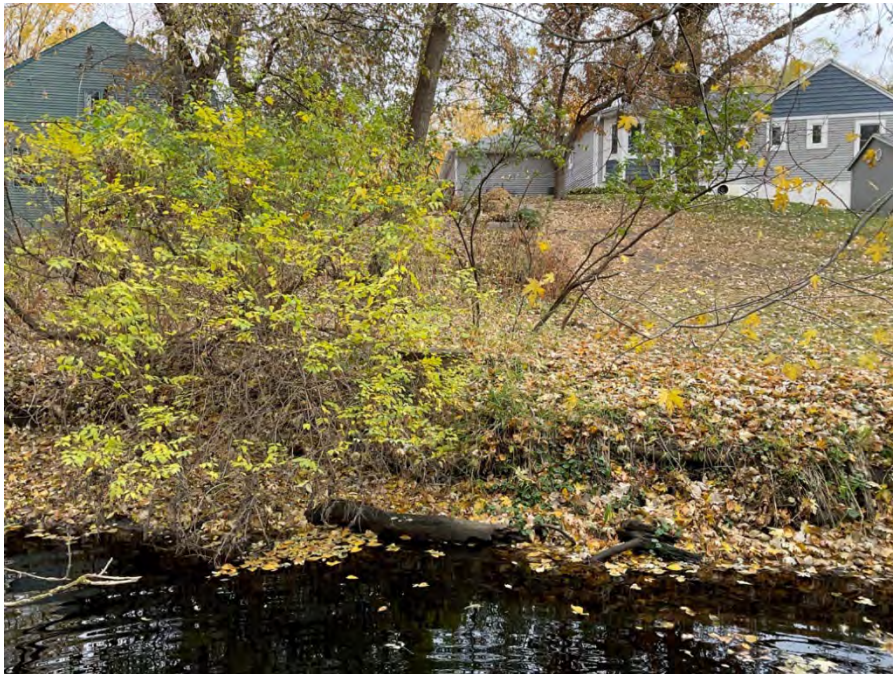
Photo 46: Site 4f. Sanitary manhole at the left bank of station 65+90.

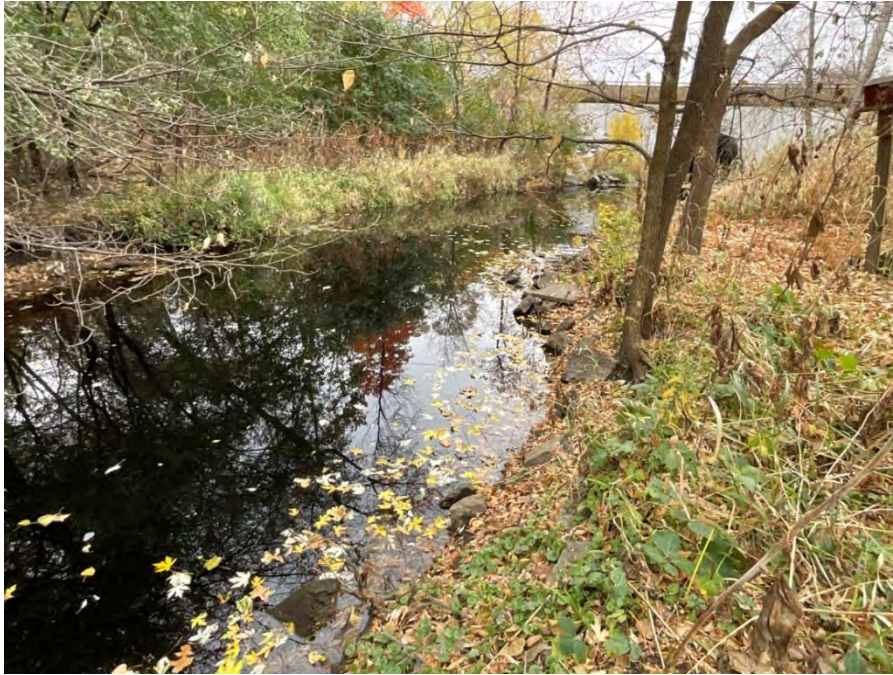
Photo 51: Site 4i. Poor riprap at the right bank of station 70+80 (facing downstream).
